# CO<sub>2</sub> Experience @ Belle2 VXD Test Beam

# CO<sub>2</sub> Experience @ TB: Outline

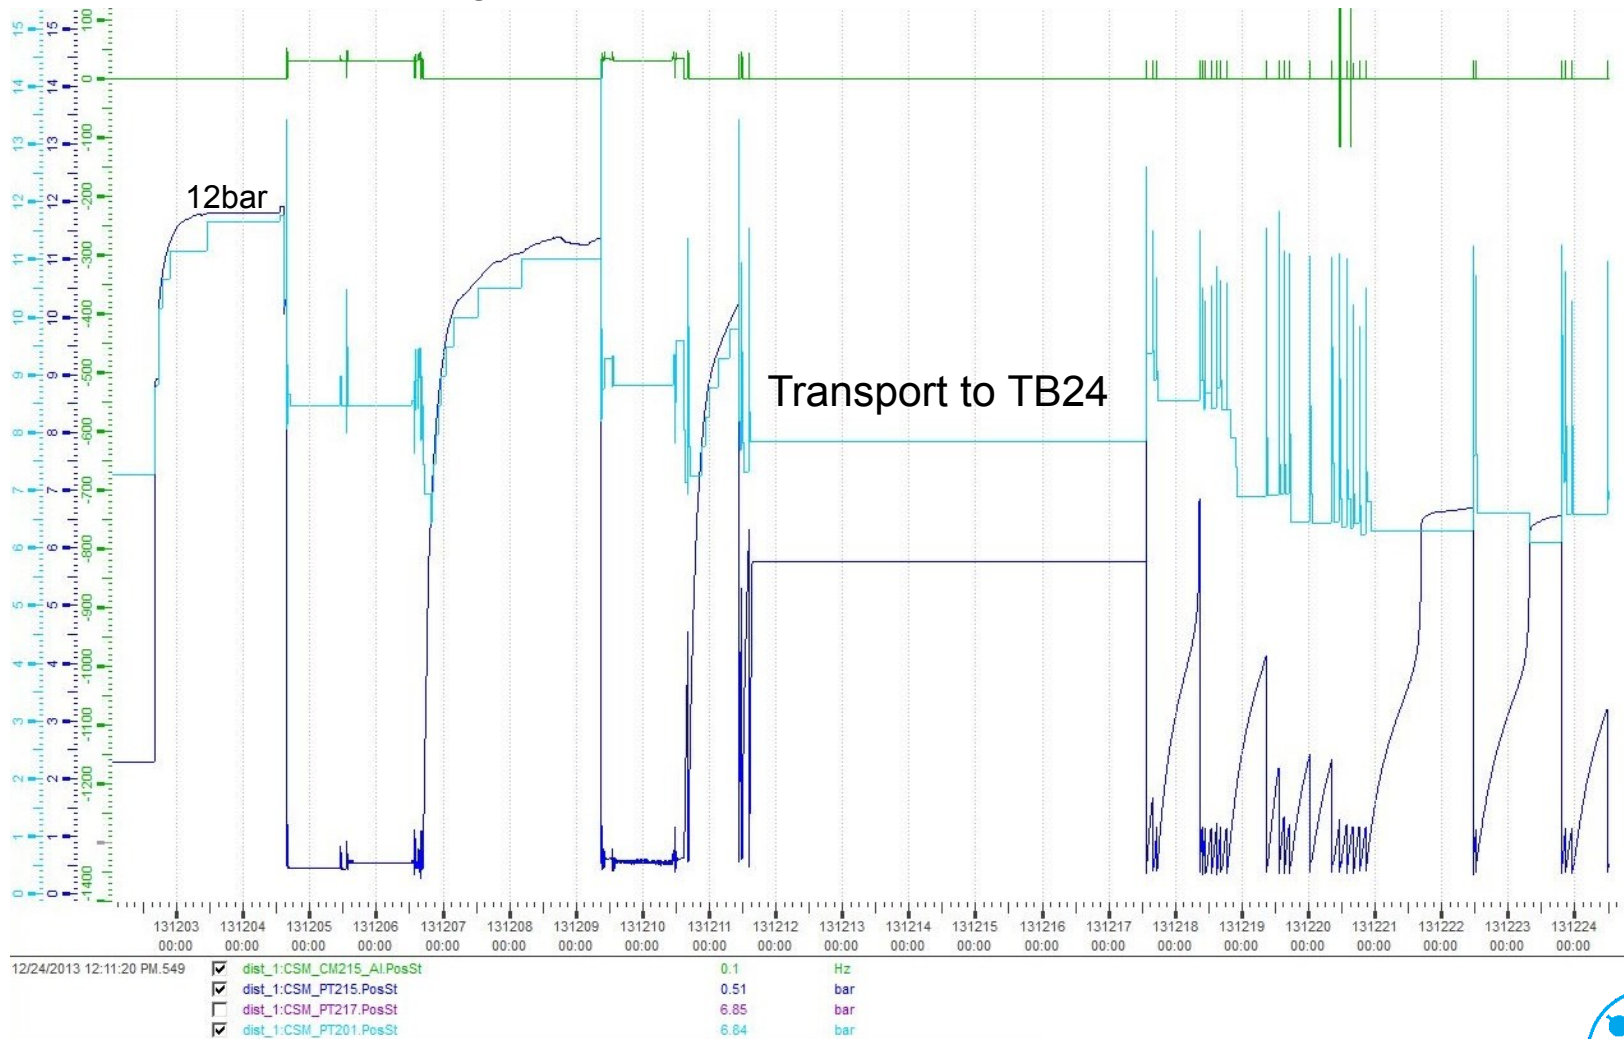
# Chiller Error

- Already during installation in December starting Marco ended repeatedly with a time consuming chiller error:

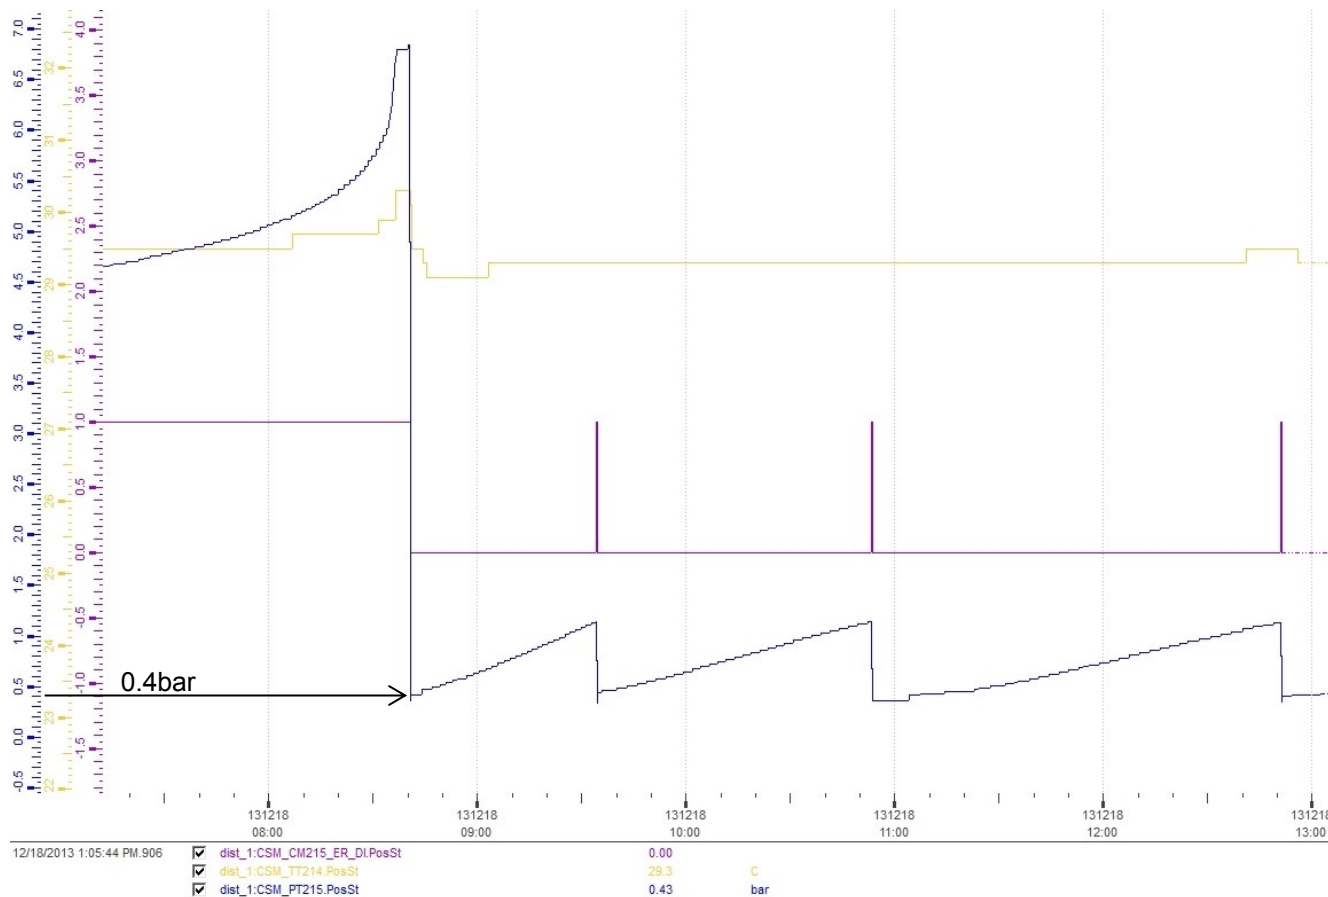
- A pressure of under 0.4bar in front of the chiller pump during start up indicates that the refrigerant might not be in fluid state.
- The compressor stops and waits for the pressure to rise to 1.2bar.

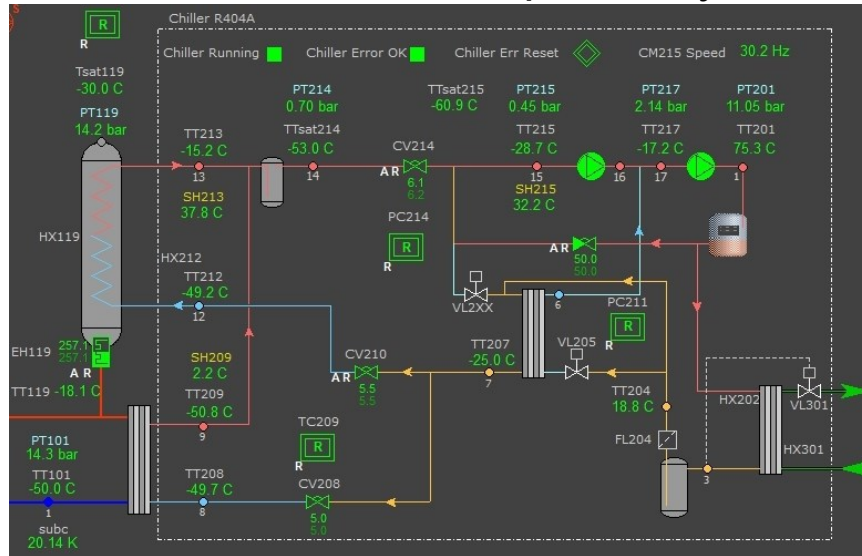
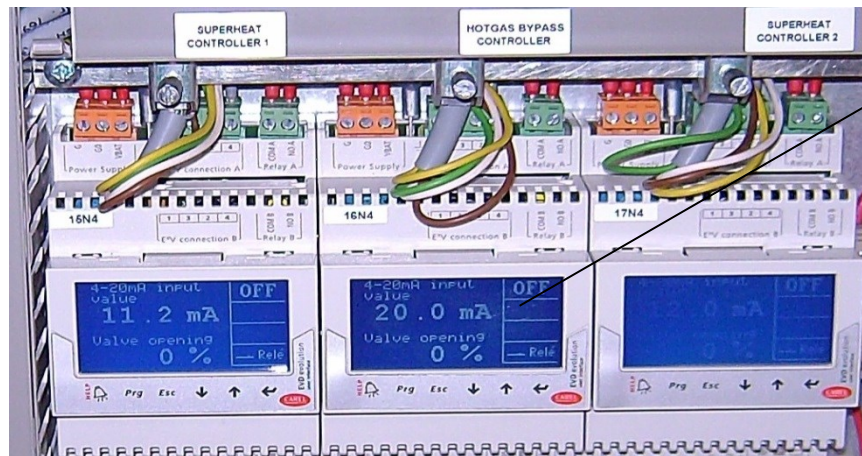
- Valves could not be opened by PVSS to increase pressure PT215

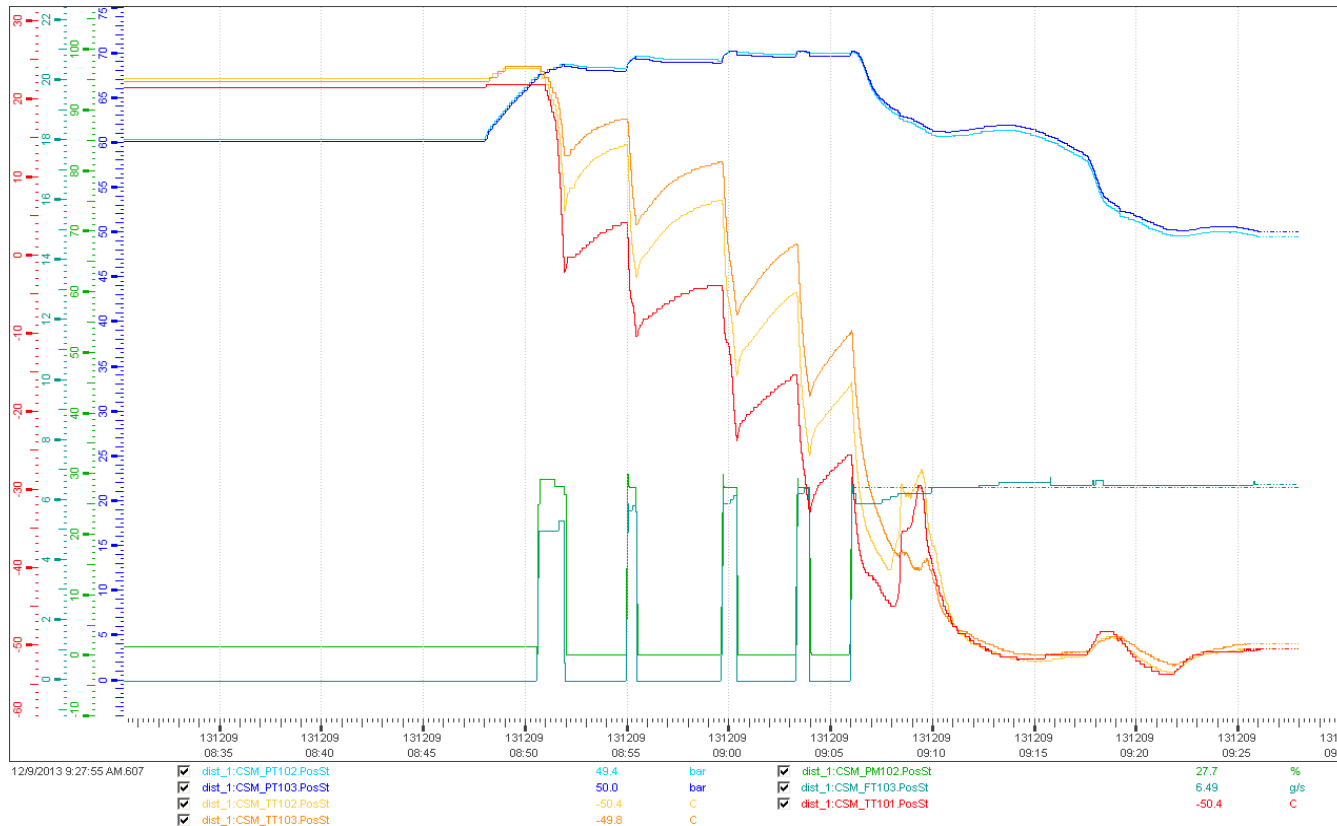
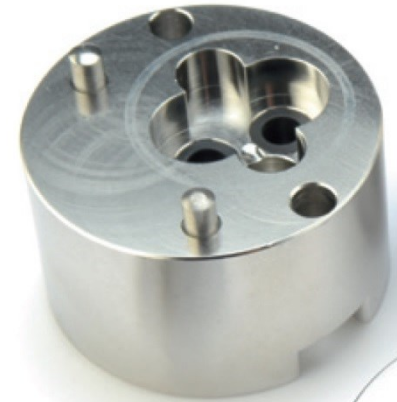
- During start up the CO<sub>2</sub> pump head leaked.
- The rapid cool down from ambient to -50°C
- let the pump head shrink more than its fixation screws
- first I tried to slow the process down in a stop and go manner

- but the chillers compressor may suffer by this.
- A firm tightening of the pump head screws helped.
- This should be done regularly.

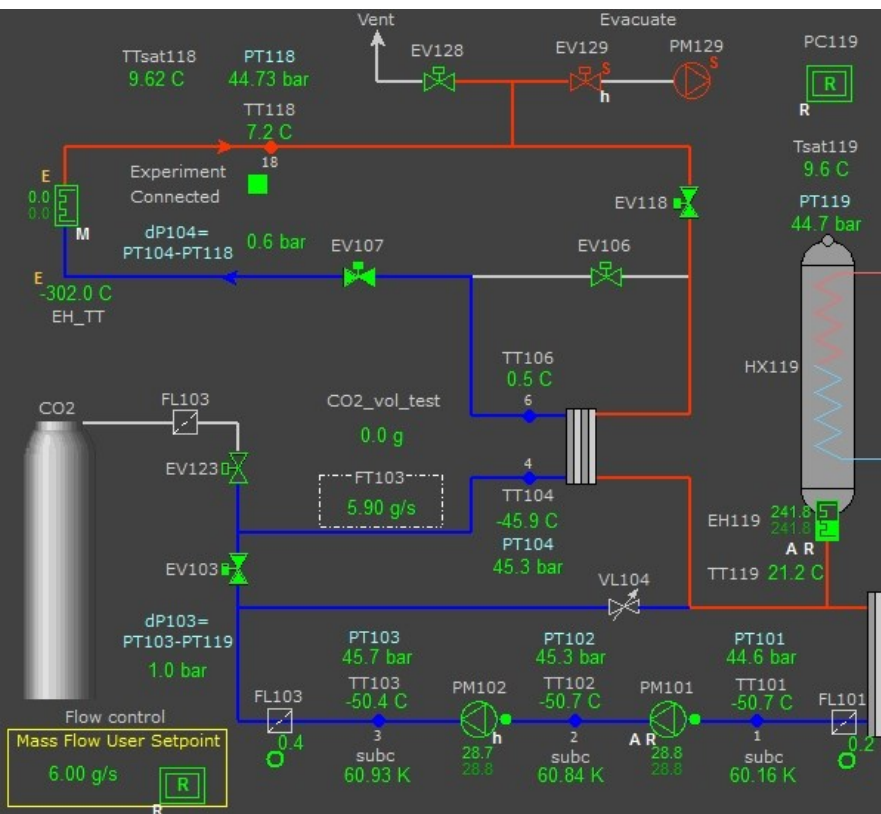
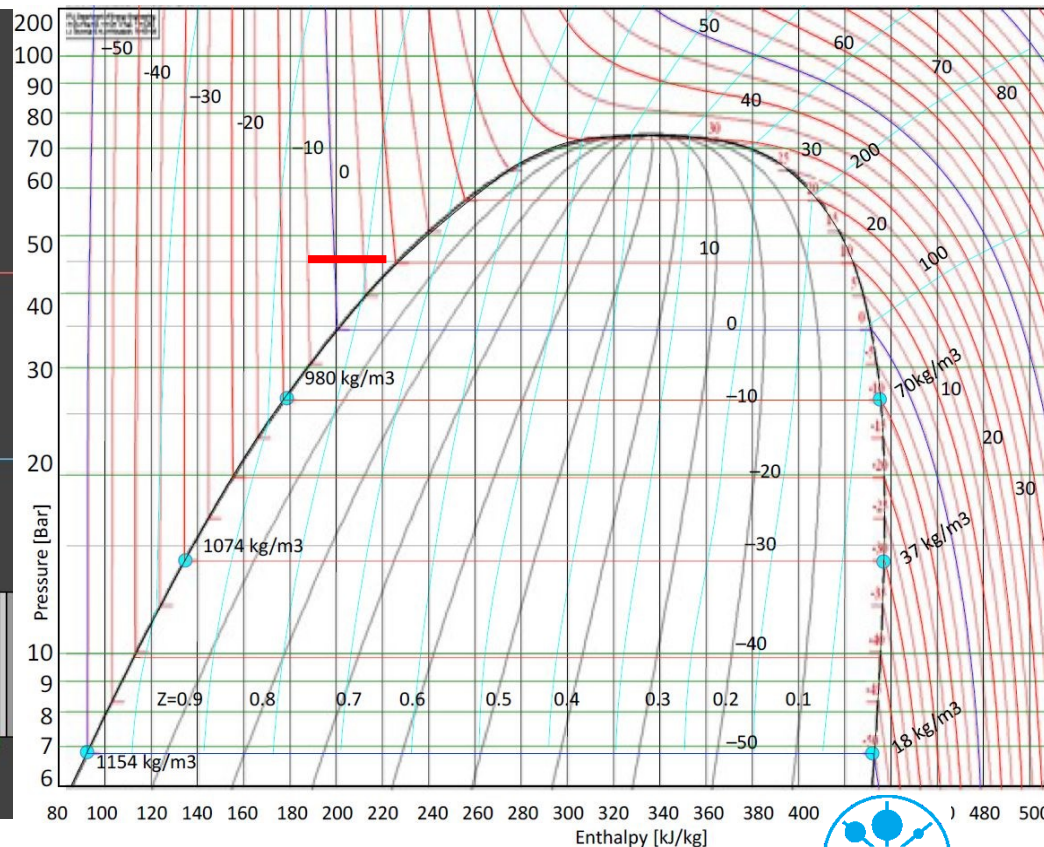
- With no or little heat load applied the CO<sub>2</sub> does not enter the 2-phase regime and stays fluid.
- In fluid state the temperature is not correlated with the pressure set by the accumulator and reaches lower values.
- To keep the inlet temperature stable additional heating of the experiment return flow is needed.

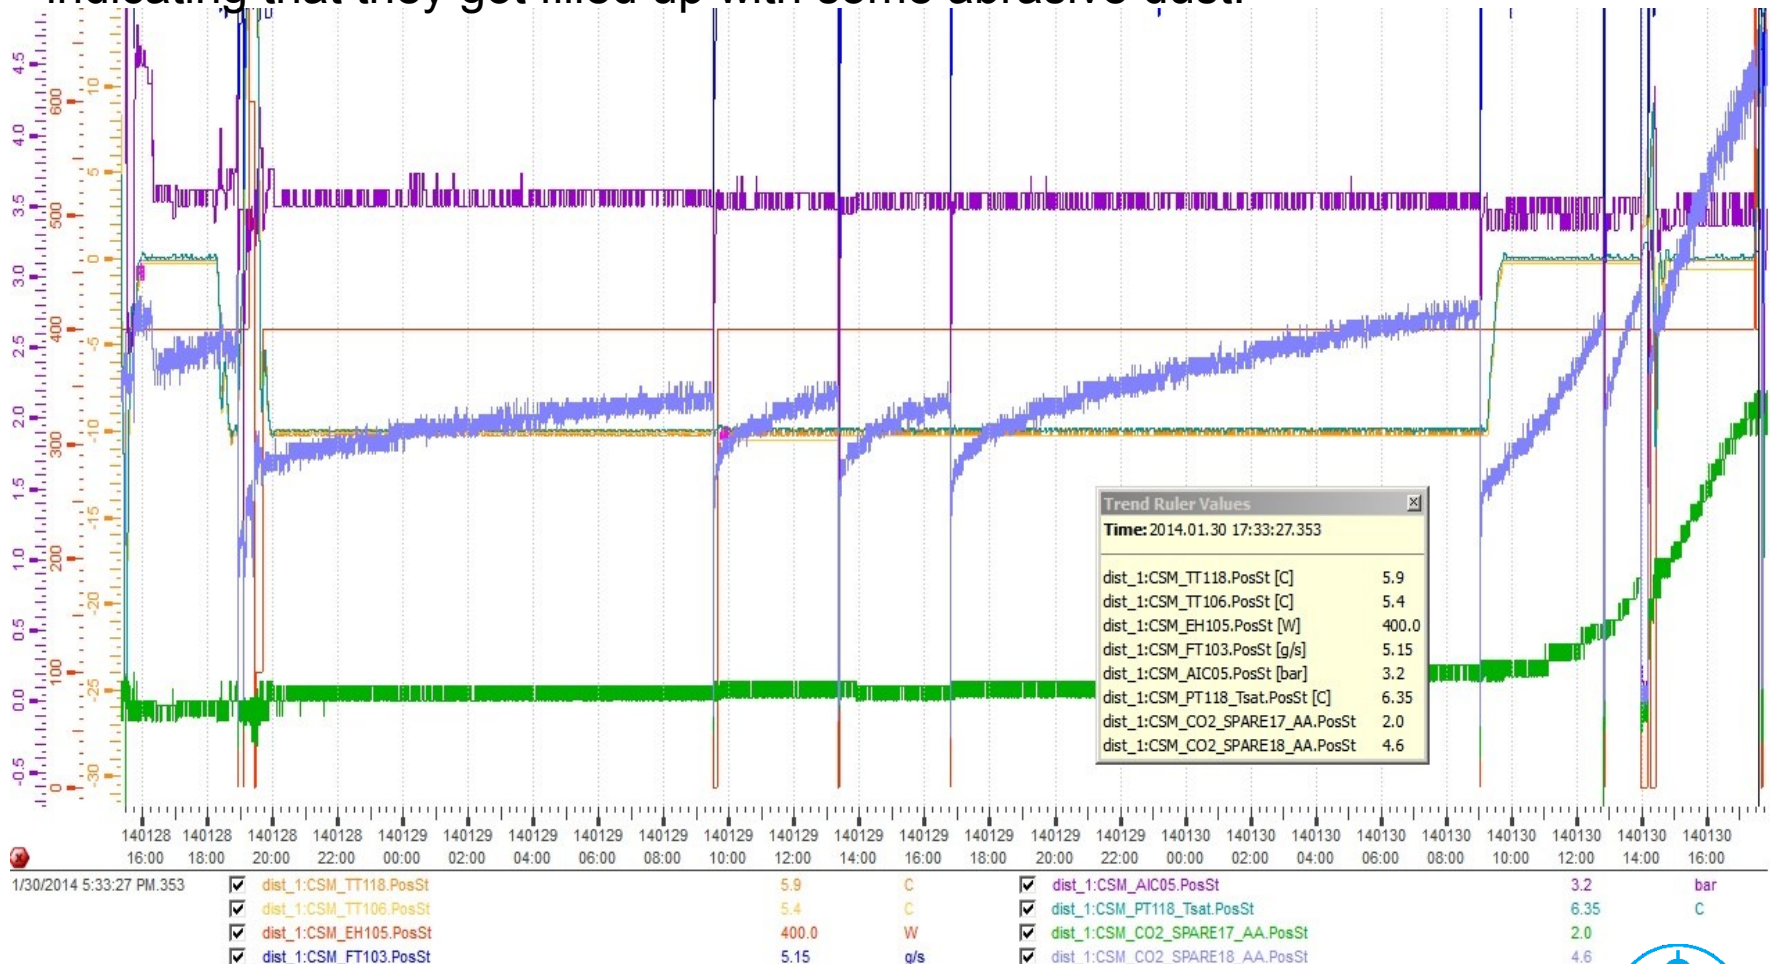
- After 2 overnight runs the pressure drop over the filter FL101 rose to 4.6bar. Also filter FL103 after the pumps showed 2bar pressure drop. indicating that they got filled up with some abrasive dust.

- The low viscosity of CO<sub>2</sub>
- which is beneficial for a low pressure drop
- has only a weak lubrication capacity wearing off parts under friction.
- A change of Marco's 2 Gather gear pumps to a membrane pump Lewa LDC M900 is under discussion, but
- high cost for it and a frequency converter
- and the time-consuming mechanical and electrical/control integration
- for now we stay with the Gather gear pumps and frequent filter changes and pump head monitoring and exchange.
