XFEL-Gun

F.Brinker

Short History of the XFEL Gun in HH

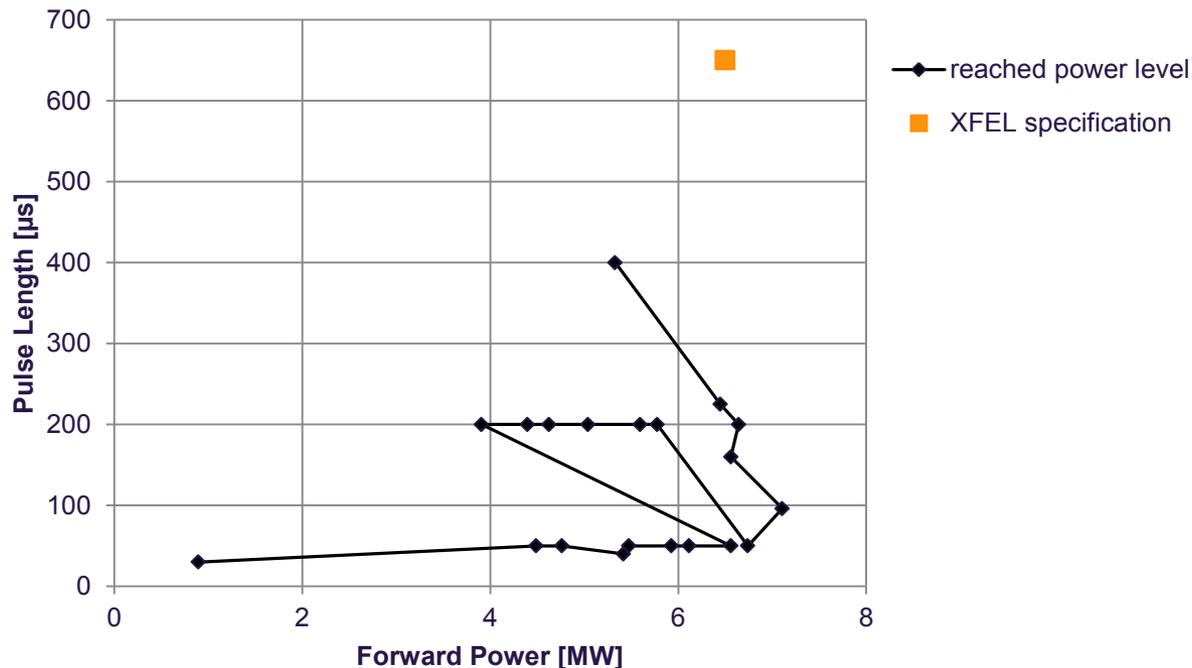
Test run September 14

- The cathode spring system had been replaced by a system where all contact surfaces had been polished and gold plated
- These improvements were successful : We don't see any damages up to now
- Unfortunately the RF-window developed a leakage after some days

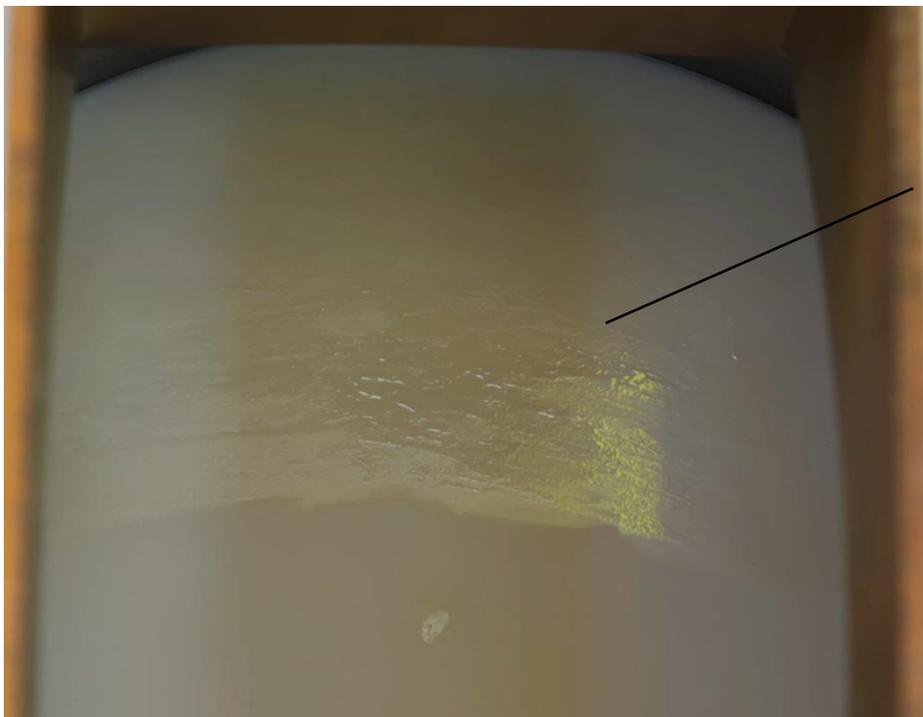
Examination of the leakage:

- Since a new Thales window was not available at that time it has been tried to localize and fix the leakage
- Surprisingly it was not the brazing but the ceramics which got leaky

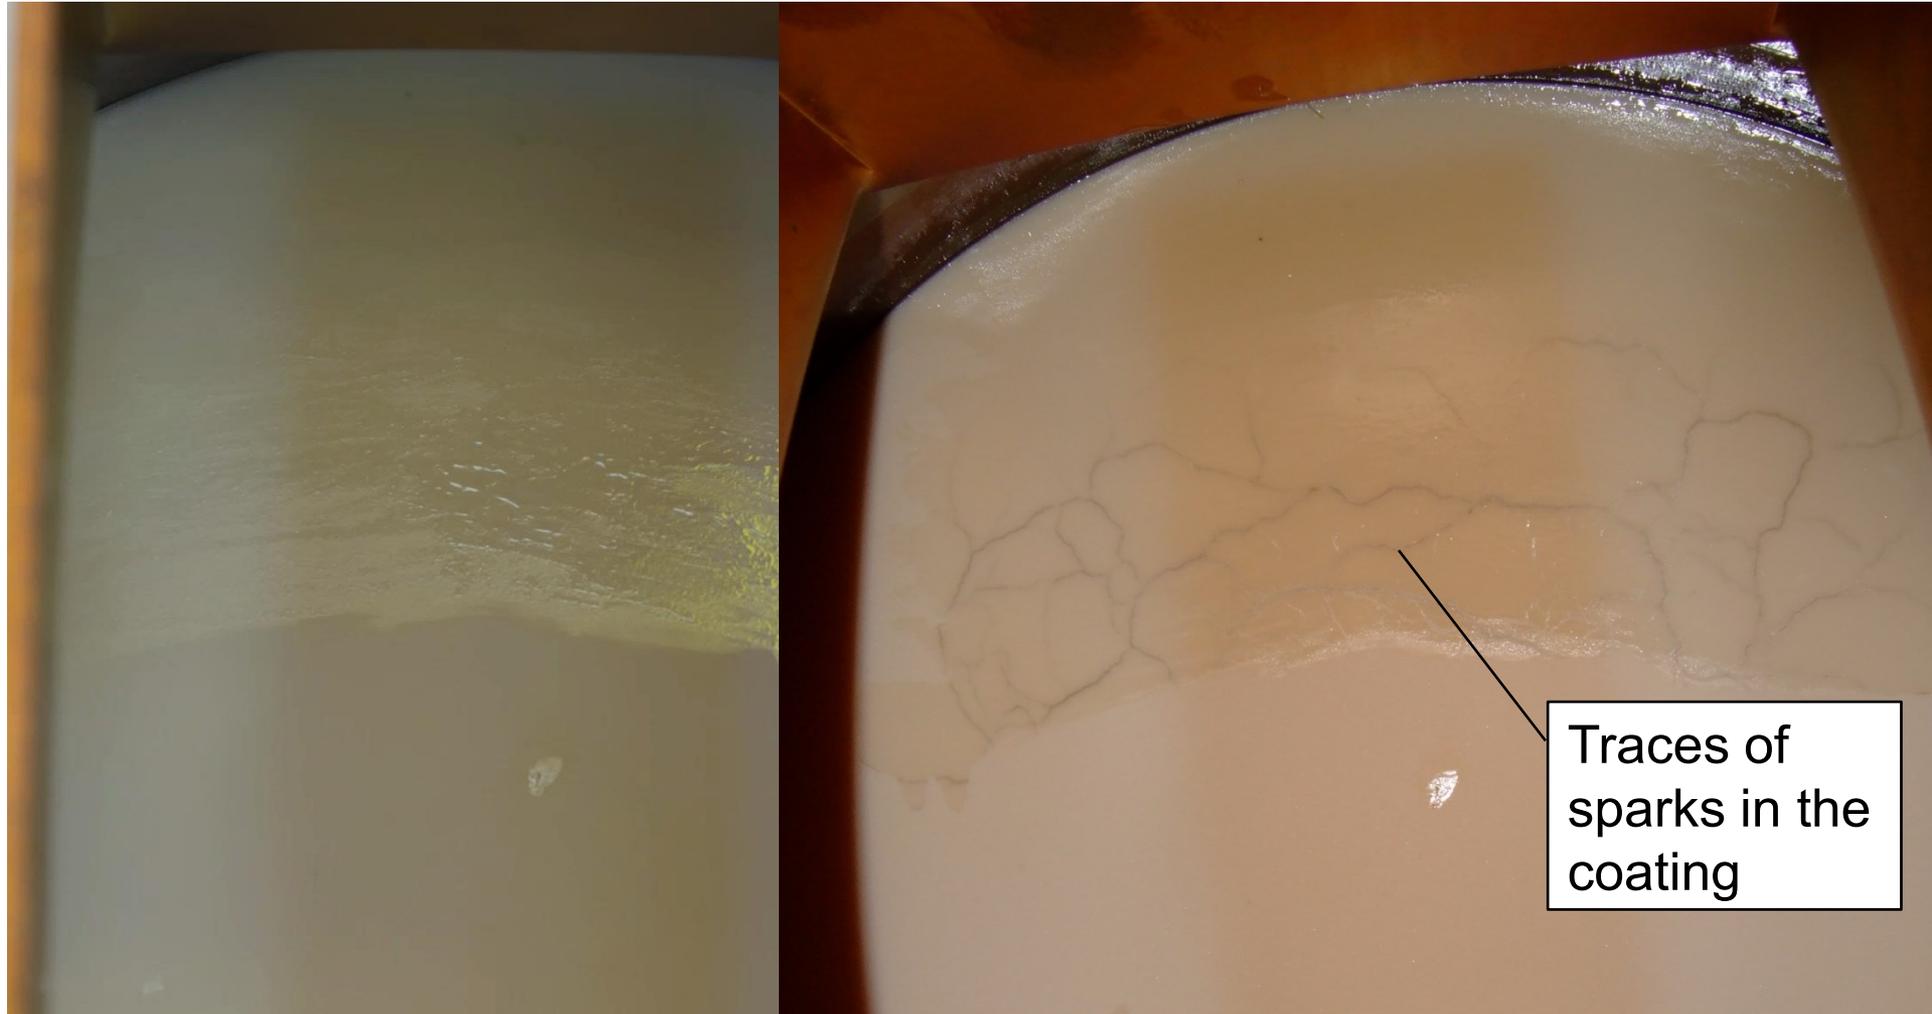
RF Window with vacuum glue before (left) and after (right) operation in Dez. 14 und February 15

Traces of sparks in the coating

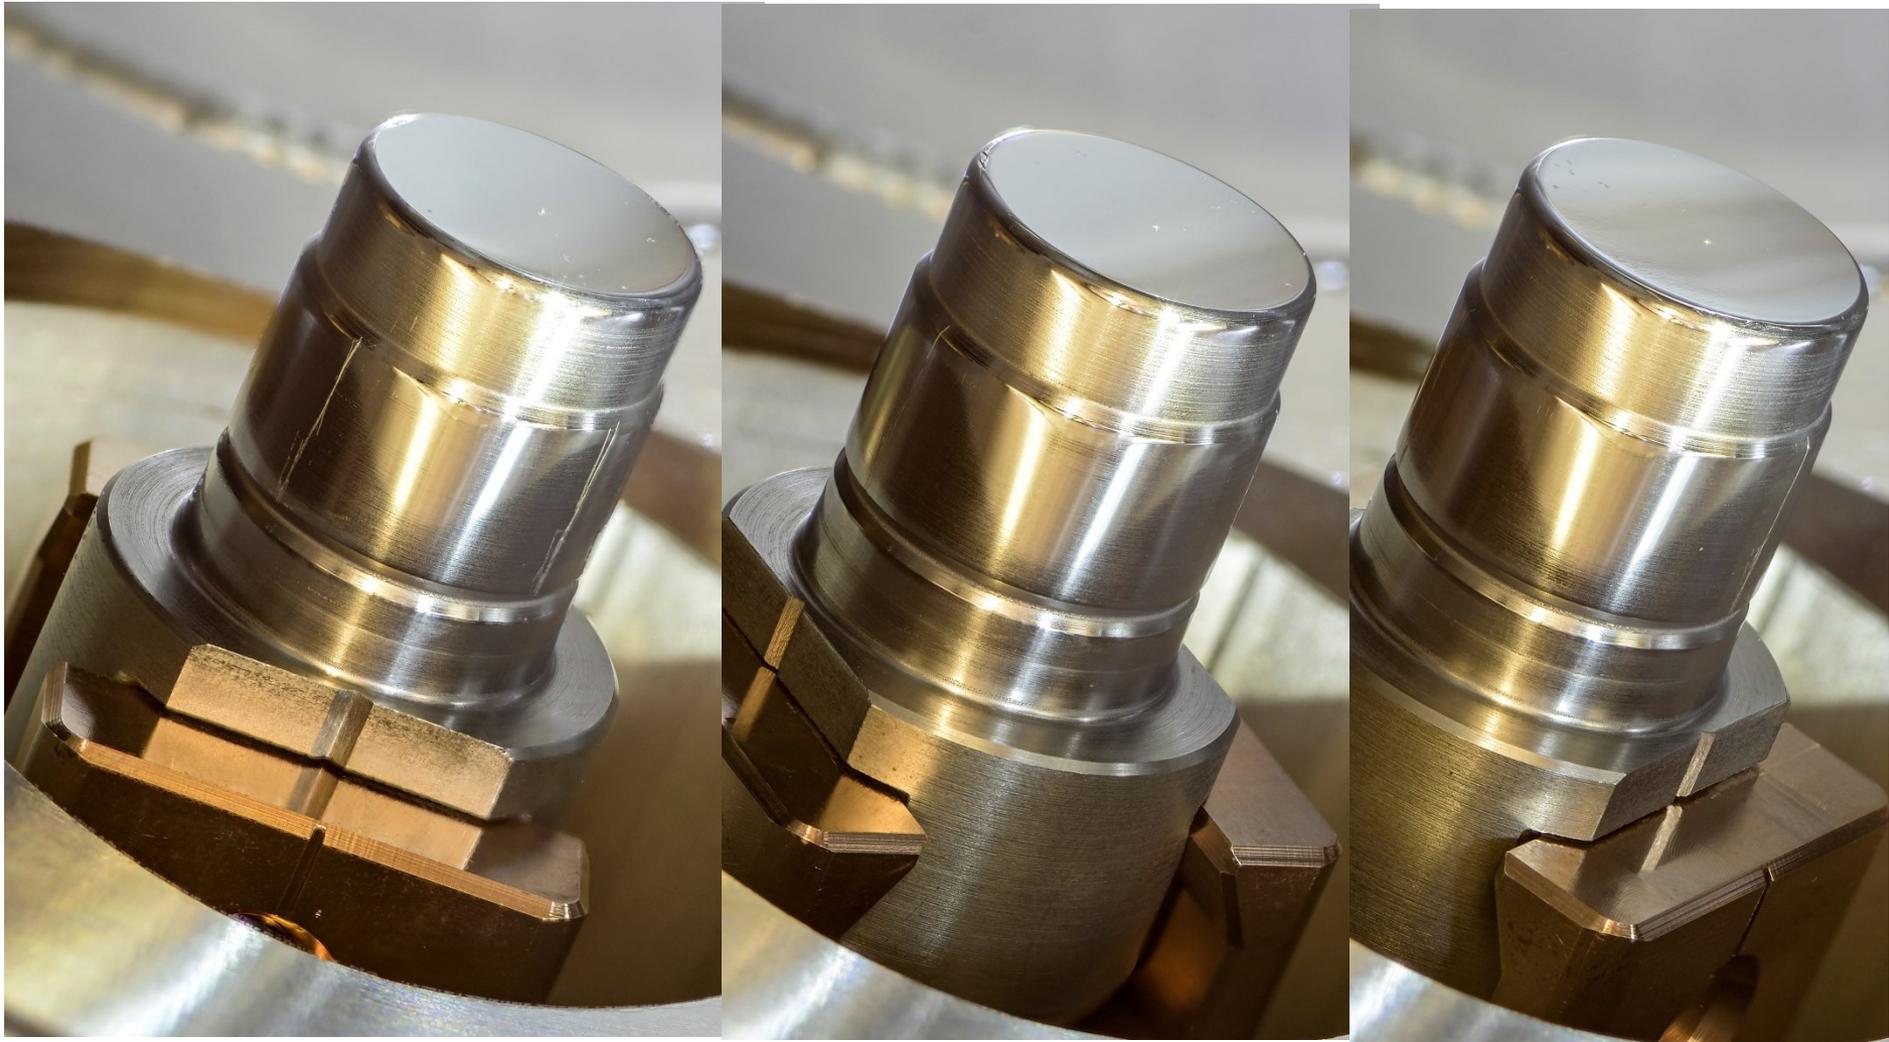
Cathode plug without any damages or marks after the December run

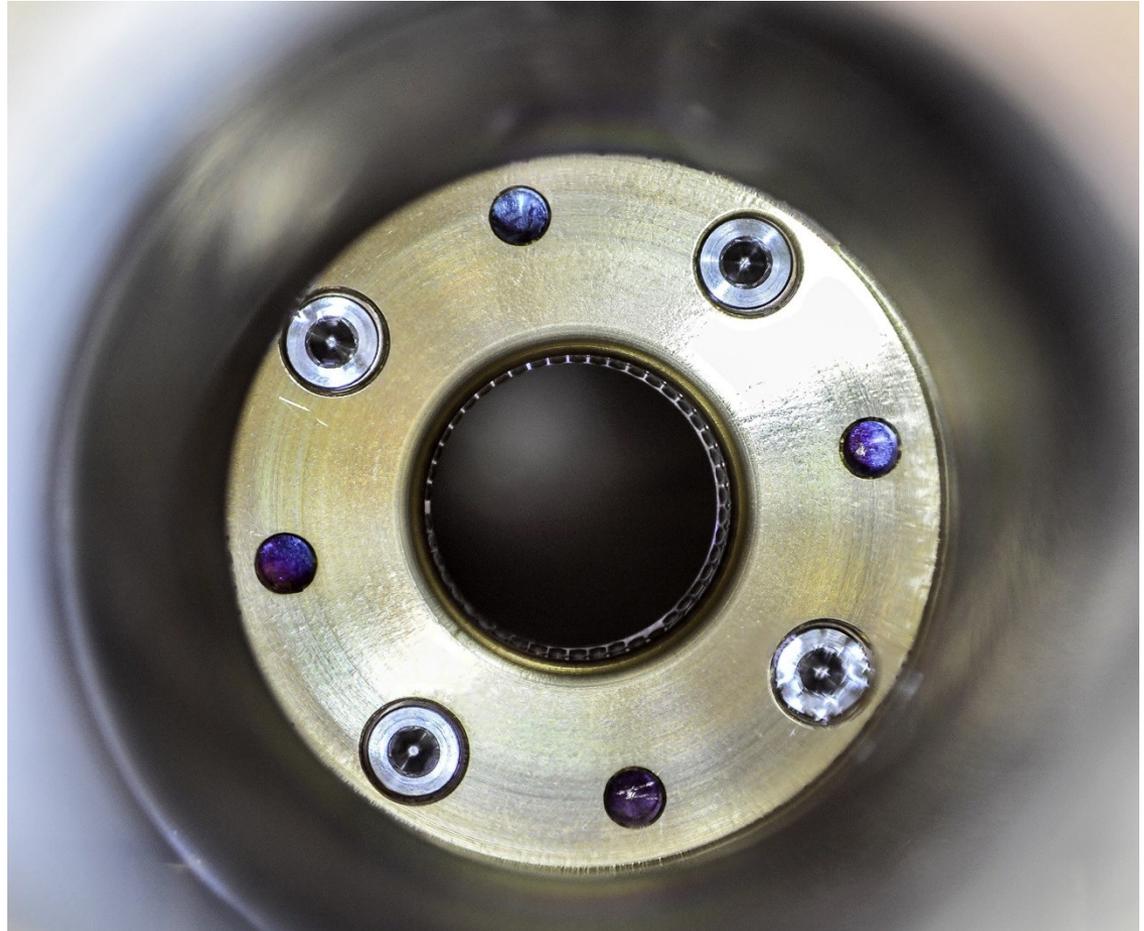
View from the backside into the cathode holder with the spring (still under vacuum)

No signs of
damage

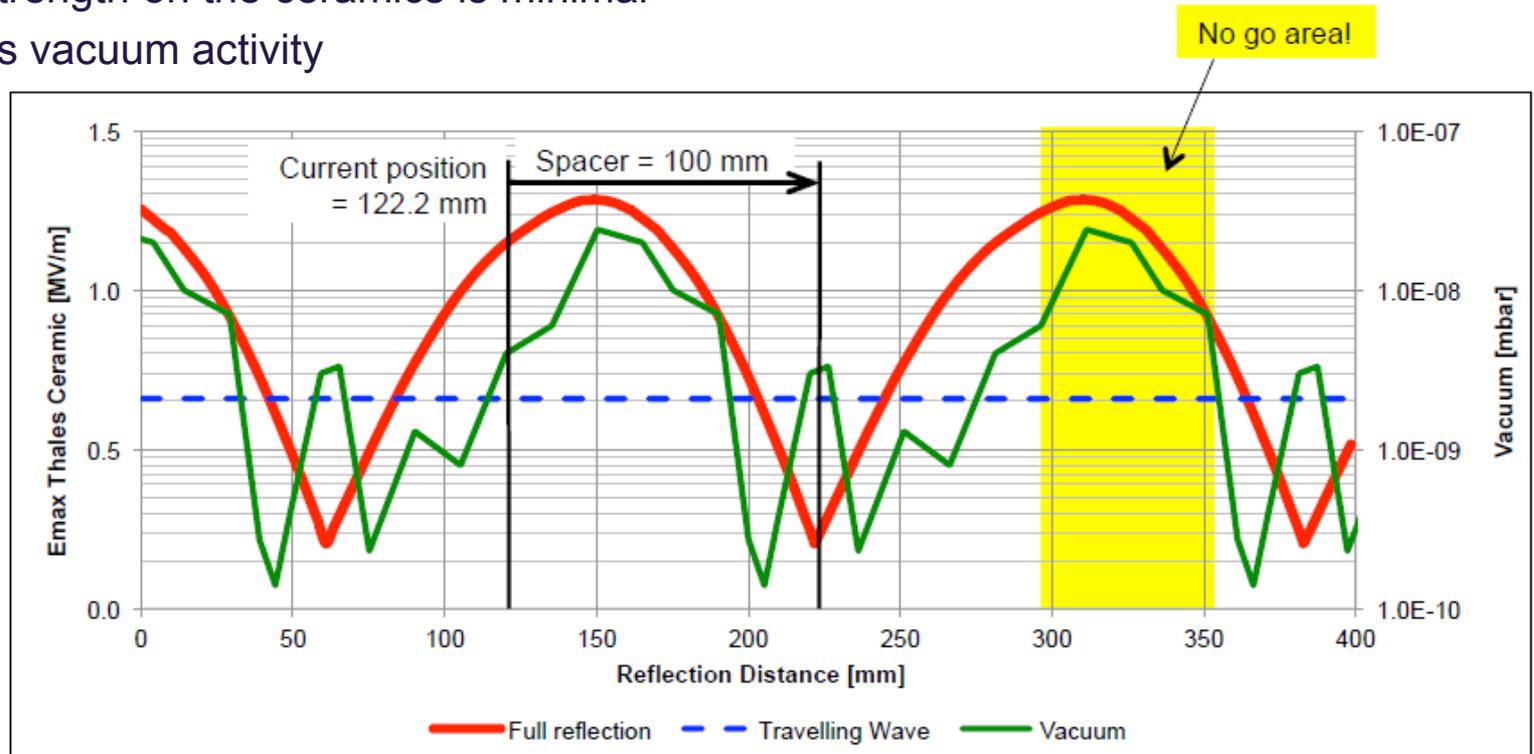
Thales window Position [M.Bousonville]

- Actual position

- field strength on the ceramics is nearly at maximum
- medium vacuum activity

- with 100mm shift:

- field strength on the ceramics is minimal
- bit less vacuum activity

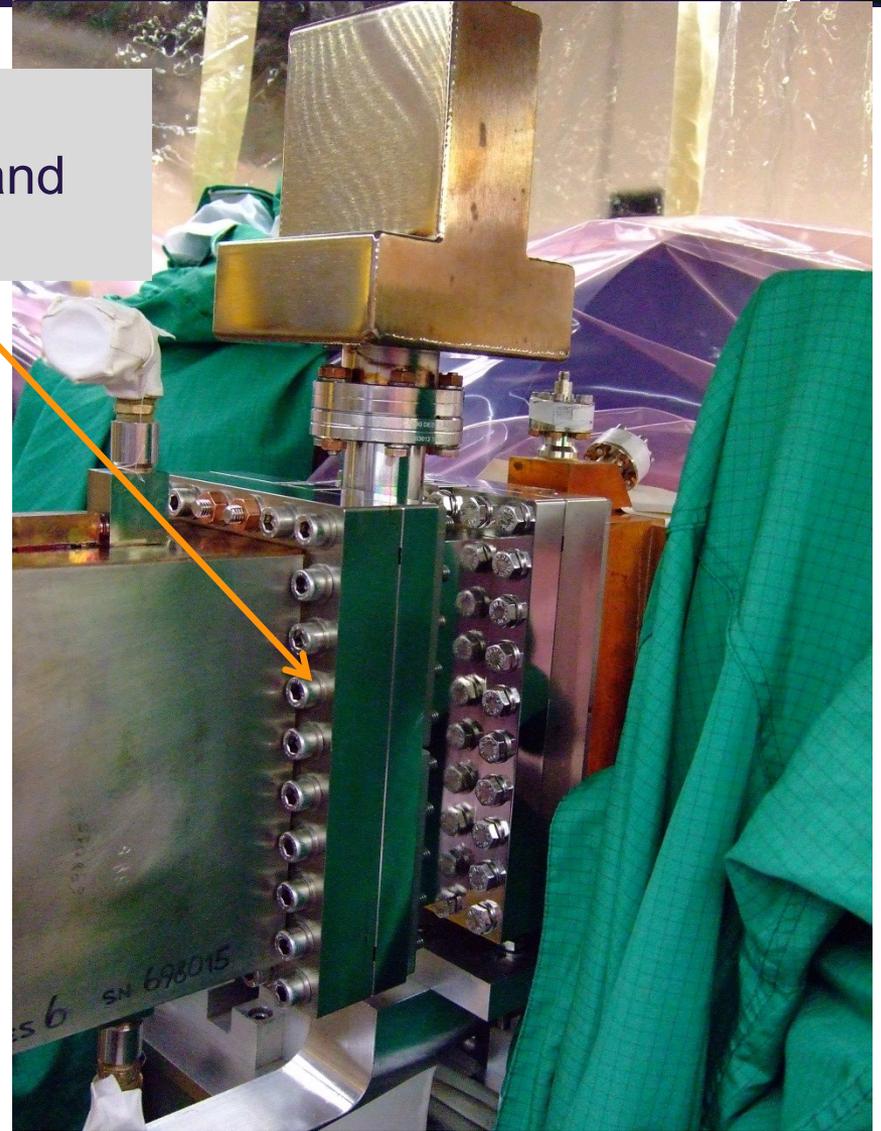
Exchange of RF-window, March '15

100mm vacuum waveguide
between Thales RF-window and
coupler

- Massive reduction of field strength on the ceramic
- Significant improved pumping speed with additional IGP
