## Switcher bumping and module situation

## 4 modules assembled

## Batch „Persy1“: DCDB4.2, SWB2.1 (Pactech bumps), DHPT1.1

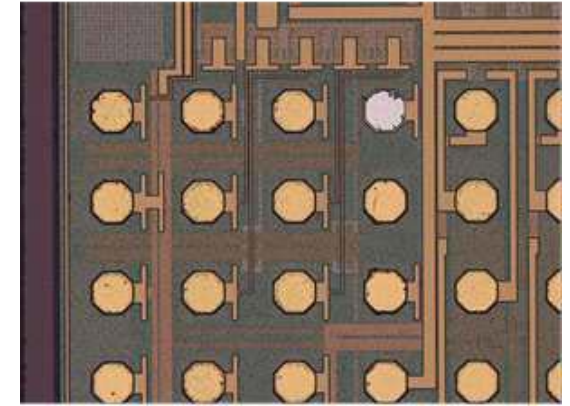
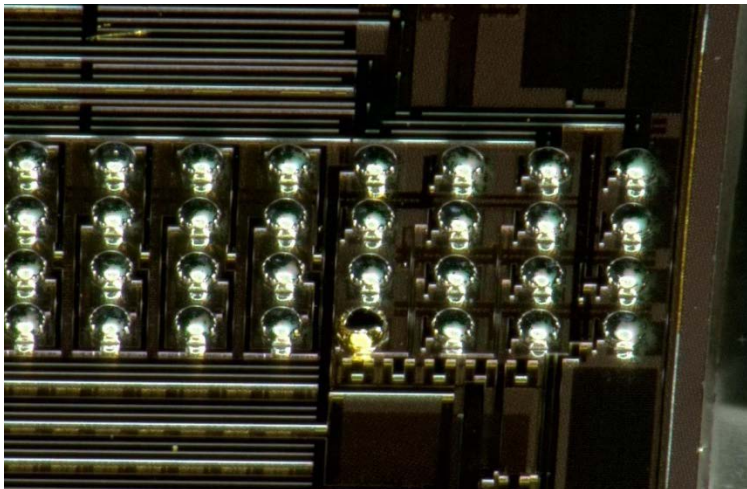
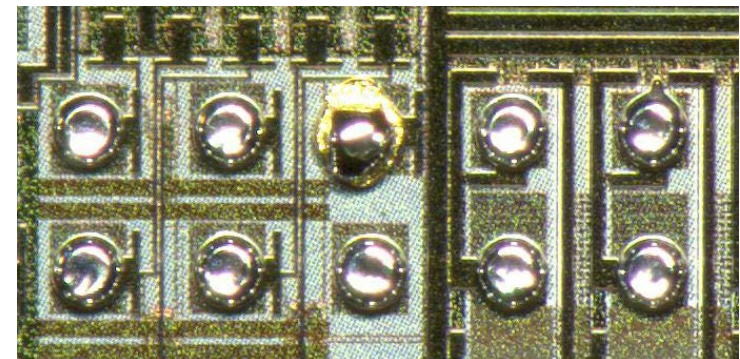
- ▷ Bumping (UBM process) causes problems with the new Switcher
- ▷ On one pad – the substrate pad – and only on this pad
  - ↳ Very little or no UBM deposition
- ▷ Main difference to old Switcher
  - ↳ Different passivation ( $1\mu\text{m}$  Nitride/Oxide  $\leftrightarrow$  PI)
  - ↳ Guard ring of the chip exposed, connected to bulk

→ Different electrochemical potential causes reduced UBM growth on substrate

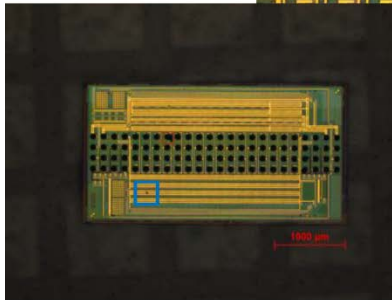
Switcher 1

Ausrichtung des Moduls  
X-Rayanalyse, 02.07.2013, Berlin  
Kurzschluss im Ausgangszustand  
Nicht entfernbare Material (SW 1 und 4)

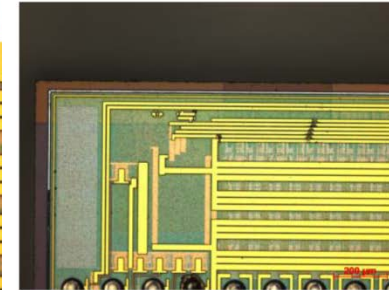
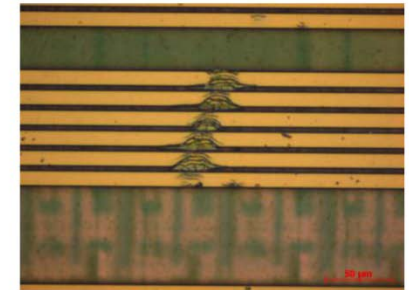
Switcher 5

Leiterbahn beschädigt

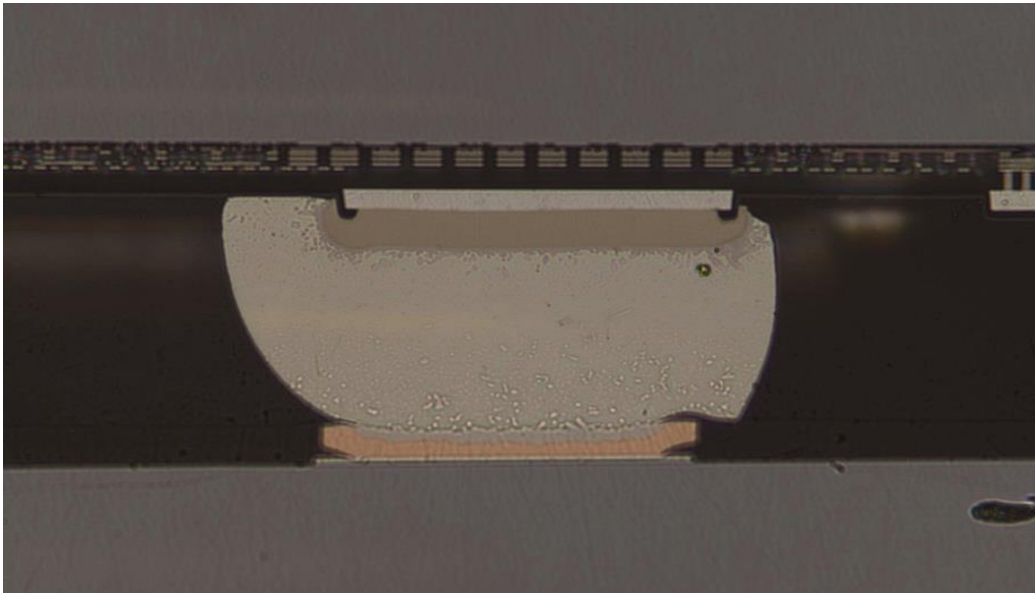
- ▷ Adapters assembled for SWB testing on hybrid level
  - ↳ Three adapters assembled
  - ↳ One assembly done with bad chip (bumping problems)
- ▷ Cross-section

- ▷ 80 $\mu$ m balls  $\rightarrow$  too much solder ....
  - ↳ Ongoing balling with 60 and 70 $\mu$ m balls

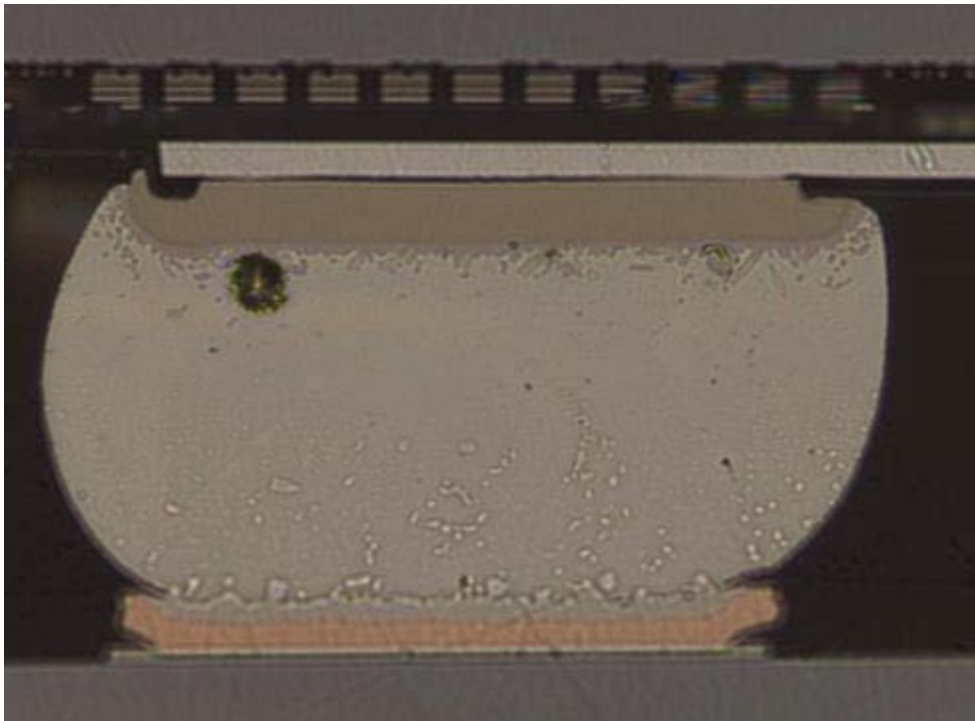
- ▷ Delamination between SWB Alu and Ni?
  - ↳ Not certain if is this real
  - ↳ Could be due to contamination before UBM....

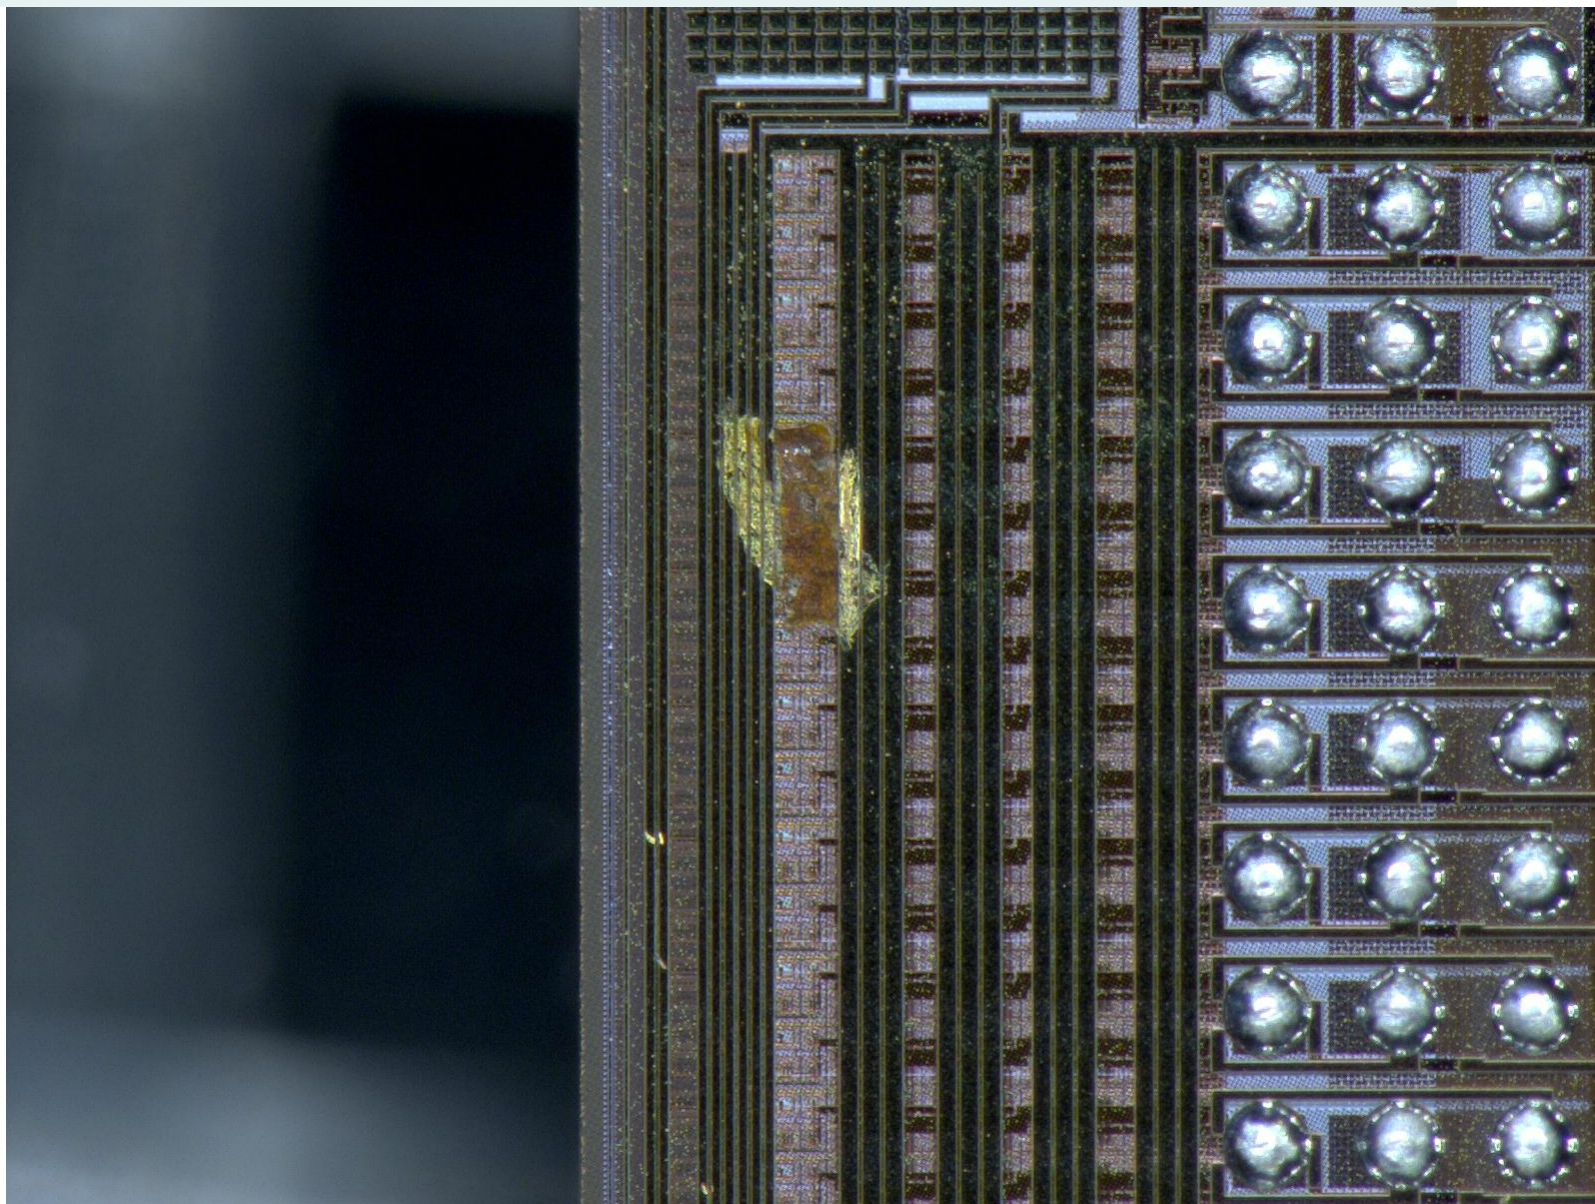
# Residues? Photo resist?

Not clear ... (from adhesive tape??)
