# **Status update on phase 3 beam pipe**

# Gold peel-off problem: Phase 3 Beam pipe

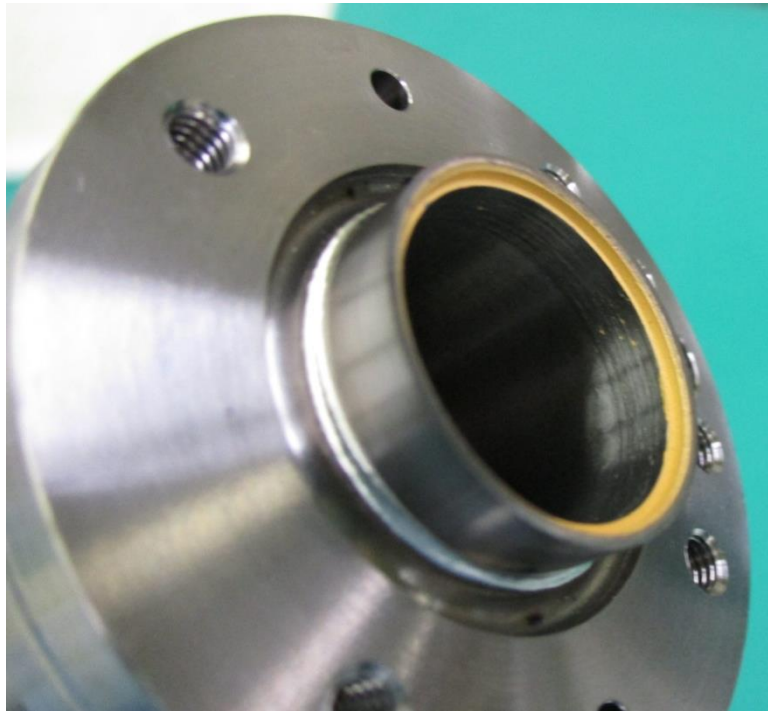
Gold peel-off has happen after the sputtering process again.

Considerable reason of this issue

1, The pipe is an double tube with Titanium part and sputtering is applying on vacuum condition

The heating up process might not be enough, as like “thermos structure”.

Remedy plan:

re-production of IP part,

- It started (preparation process)
  - BP will complete in Apr. 2018
- Gold sputtering inside after removing of Gold.
- Gold plating on BP outer surface
  - Most quicker and safe solution but we should keep clearance with PXD
    - BP Can complete in Mar. 2018

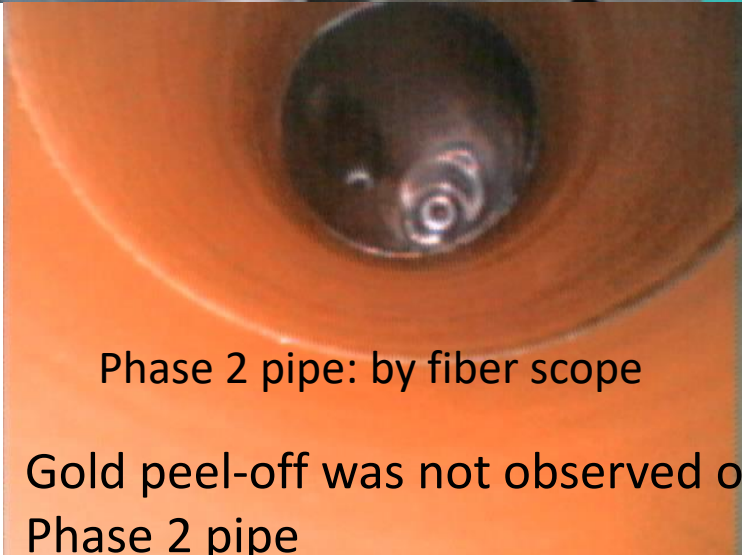
Phase 2 pipe: by fiber scope

Gold peel-off was not observed on Phase 2 pipe

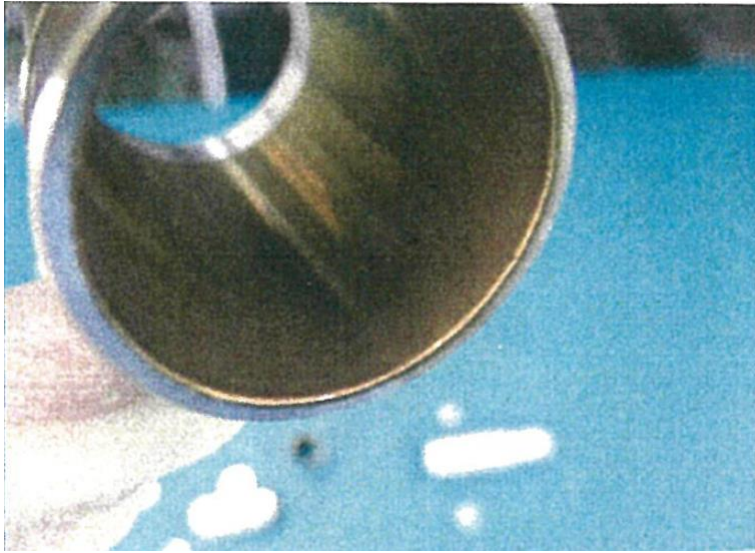
Be pipe: No peel-off

Ti pipe: partly peeled-off  
(peel was in the Au layer)

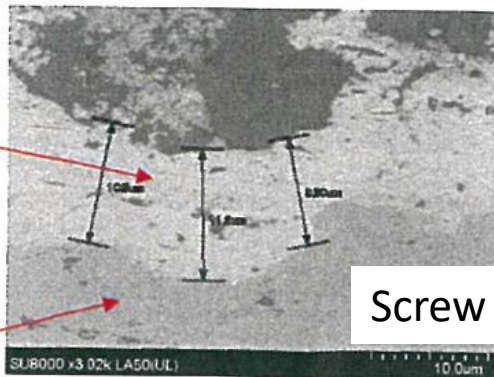
No1断面( $A_u = 10.33\mu\text{m}$ )

Sputtering parameter seems not to be not properly optimized  
Be part has passed for Peel-off test, but some area of Ti part has not..

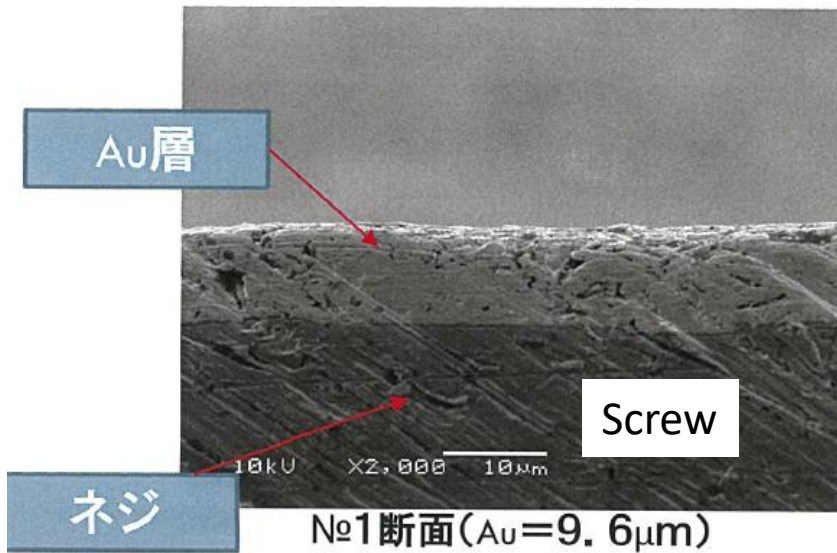
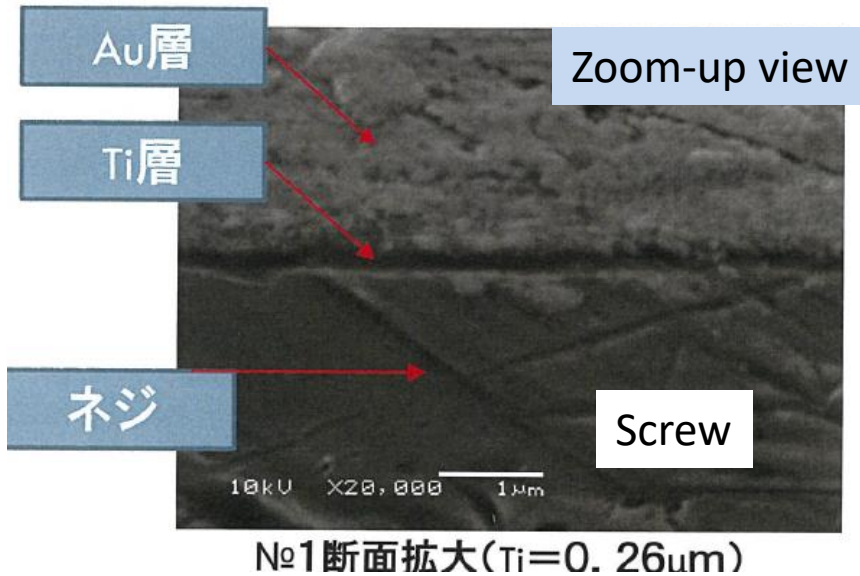
No peel-off has happen both for Be, Ti part

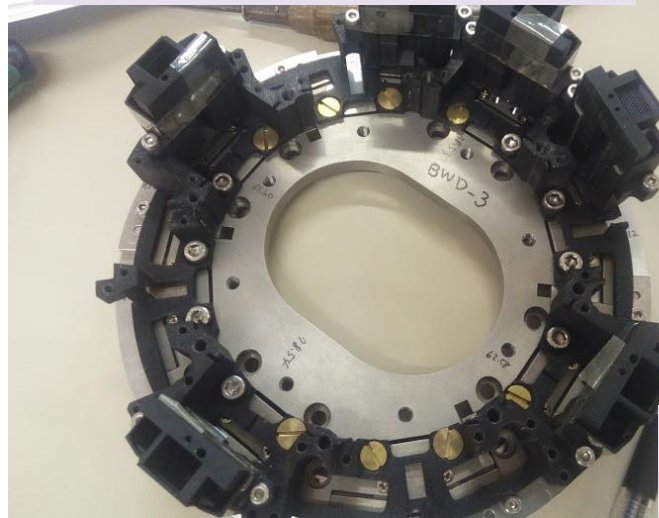
Conflict with bracket  
(Now it is solved)
