SASE3 Experiments

Personnel interlock Commissioning

WP-38

XFEL Technical Meeting XHEXP1, 9. March 2018

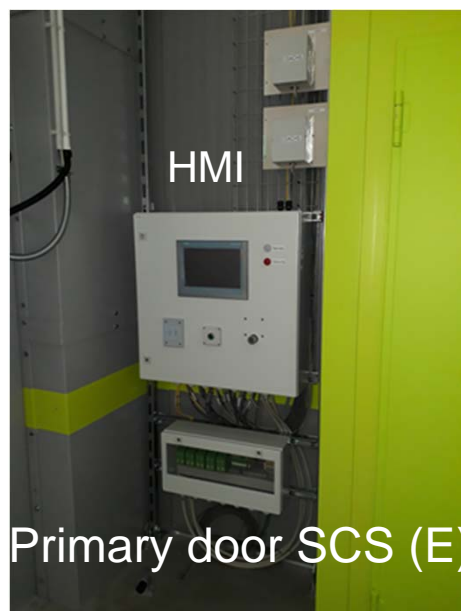
Primary door SCS (E)

Motorized doors Fa. Alien:

- Wrong switch type
- No mechanical redundancy
- Wrong cable (door E)

- Motorized sliding doors (Fa. A. Lien)
 - Wrong (but safe) switches are accepted (WP38)
 - Cable has to be replaced (G. Wellenreuther, Fa. Wille)
 - Mechanical redundancy: under construction (A. Lien)
