# Service Test @ DESY

PXD Workshop @ DESY 08-10 October 2018

Systematic test of all final service components for PXD before connecting the final detector

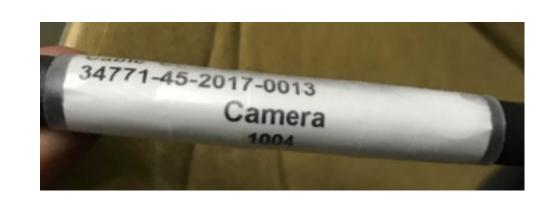
#### Camera Link cables with "physical" issues

- One bent screw on the connector
- ▶ 2 cables with inconsistent labels on cable and connectors which side should be "Camera" and "Frame Grabber"
- No repair / further investigation as we had enough cables
