**HELMHOLTZ  
ZENTRUM BERLIN**  
für Materialien und Energie

# **MAGNETIC DUST PARTICLES IN THE ID CHAMBER**

**P. Kuske – for the BESSY team**

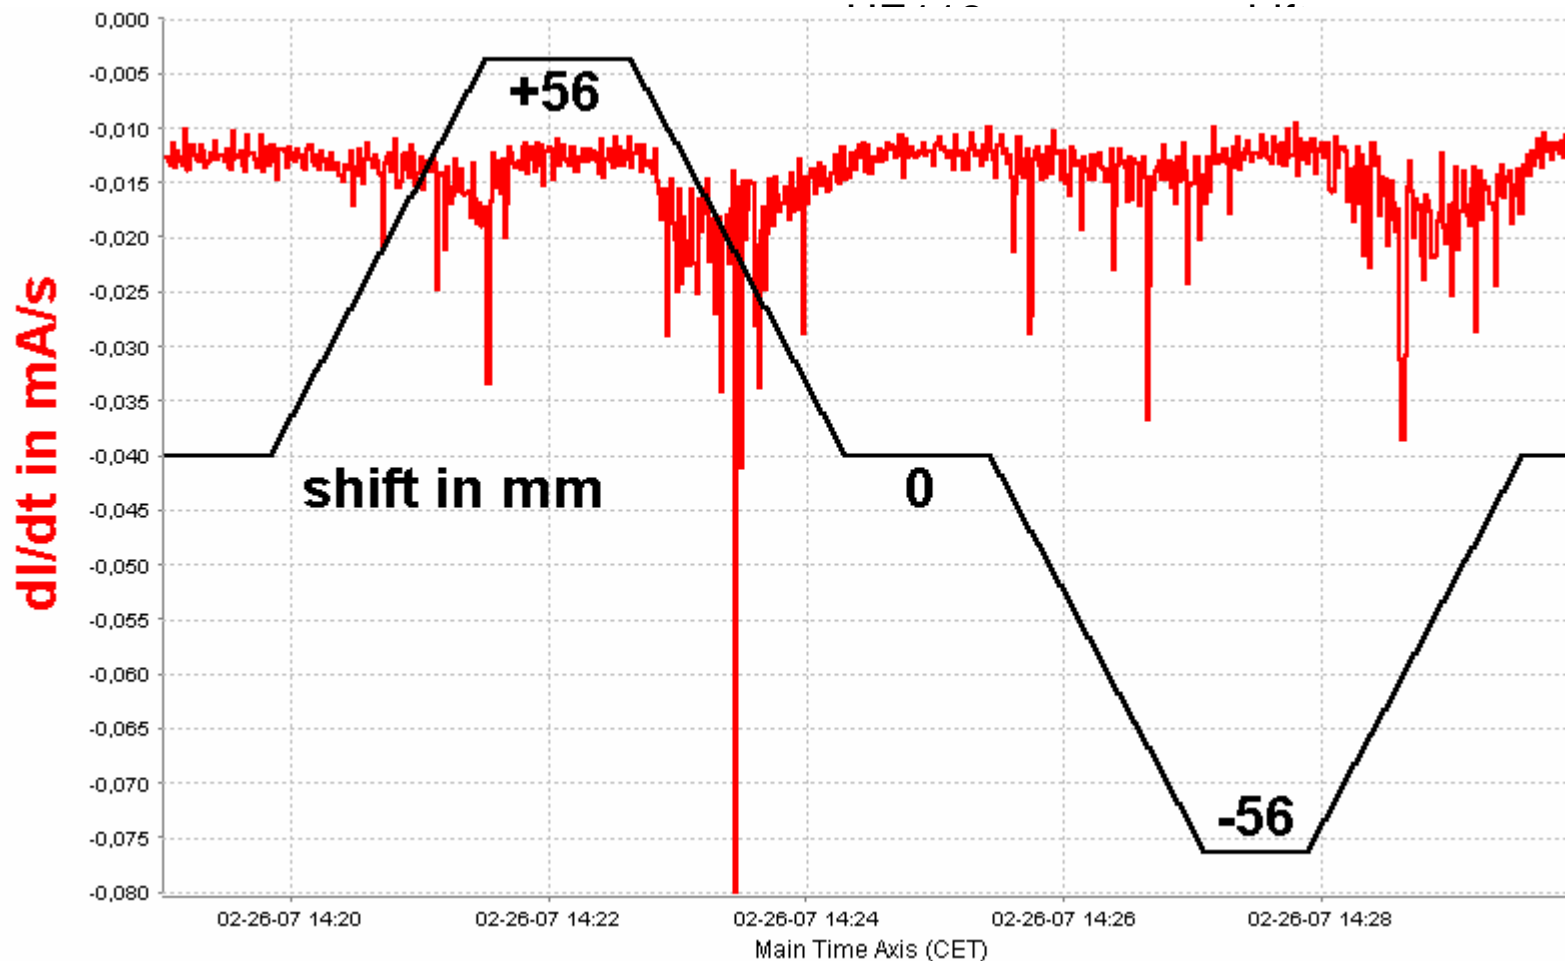
chamber exchanged in the fall shut down of 2007

## molten mirror in the slicing section caused 1 week loss of beam time

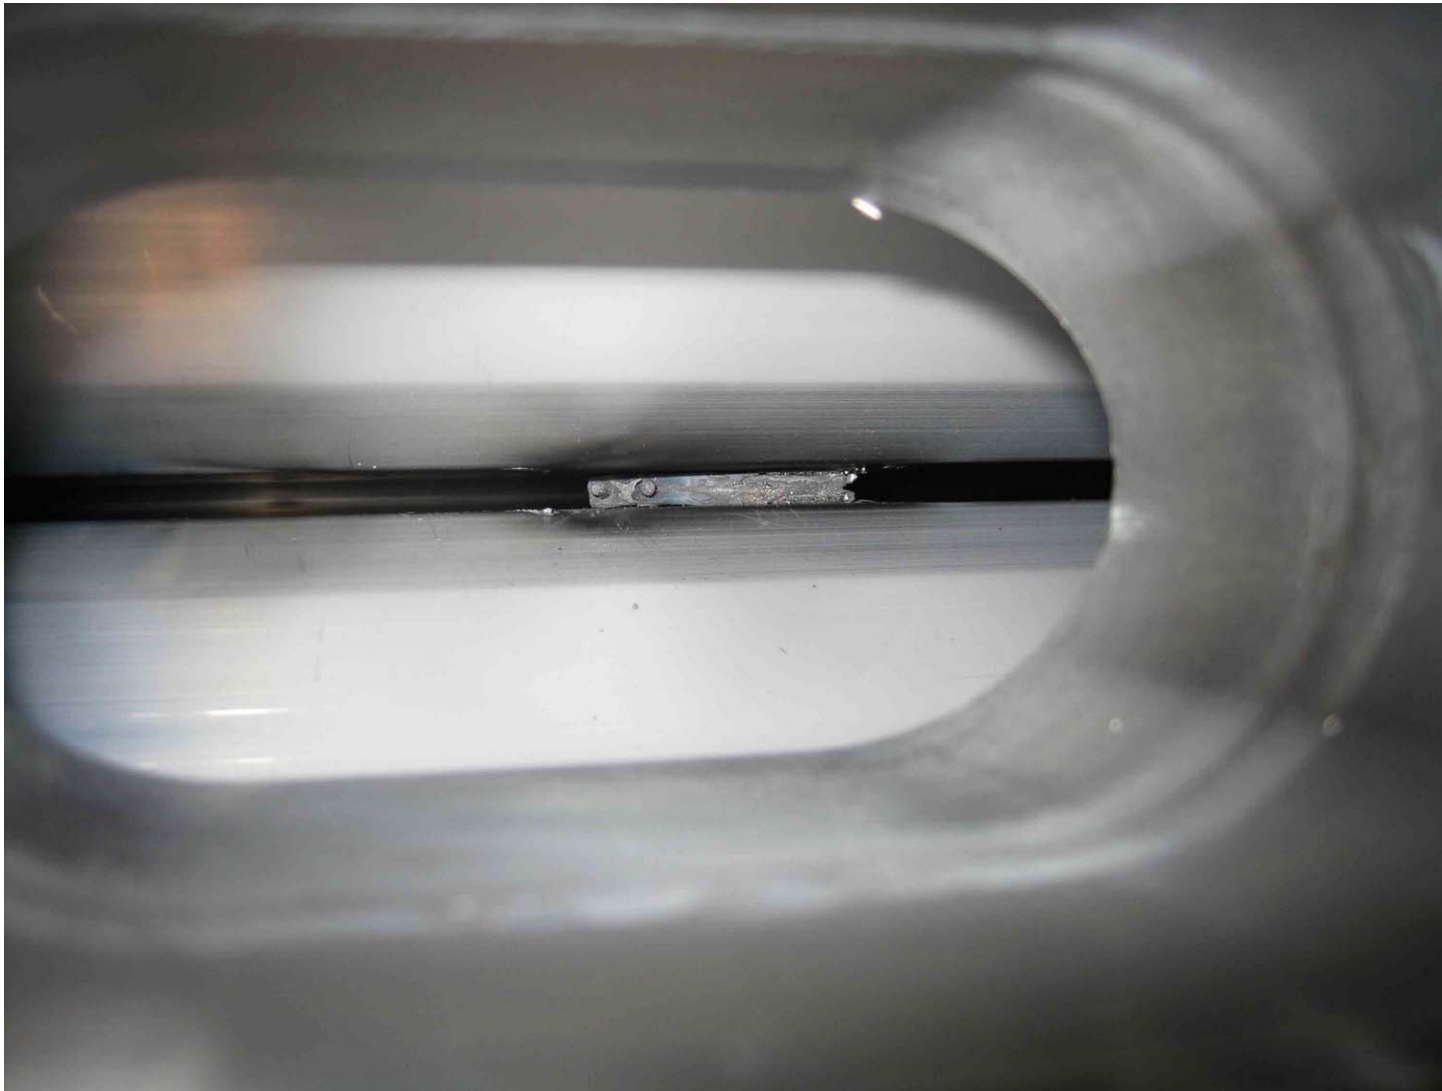
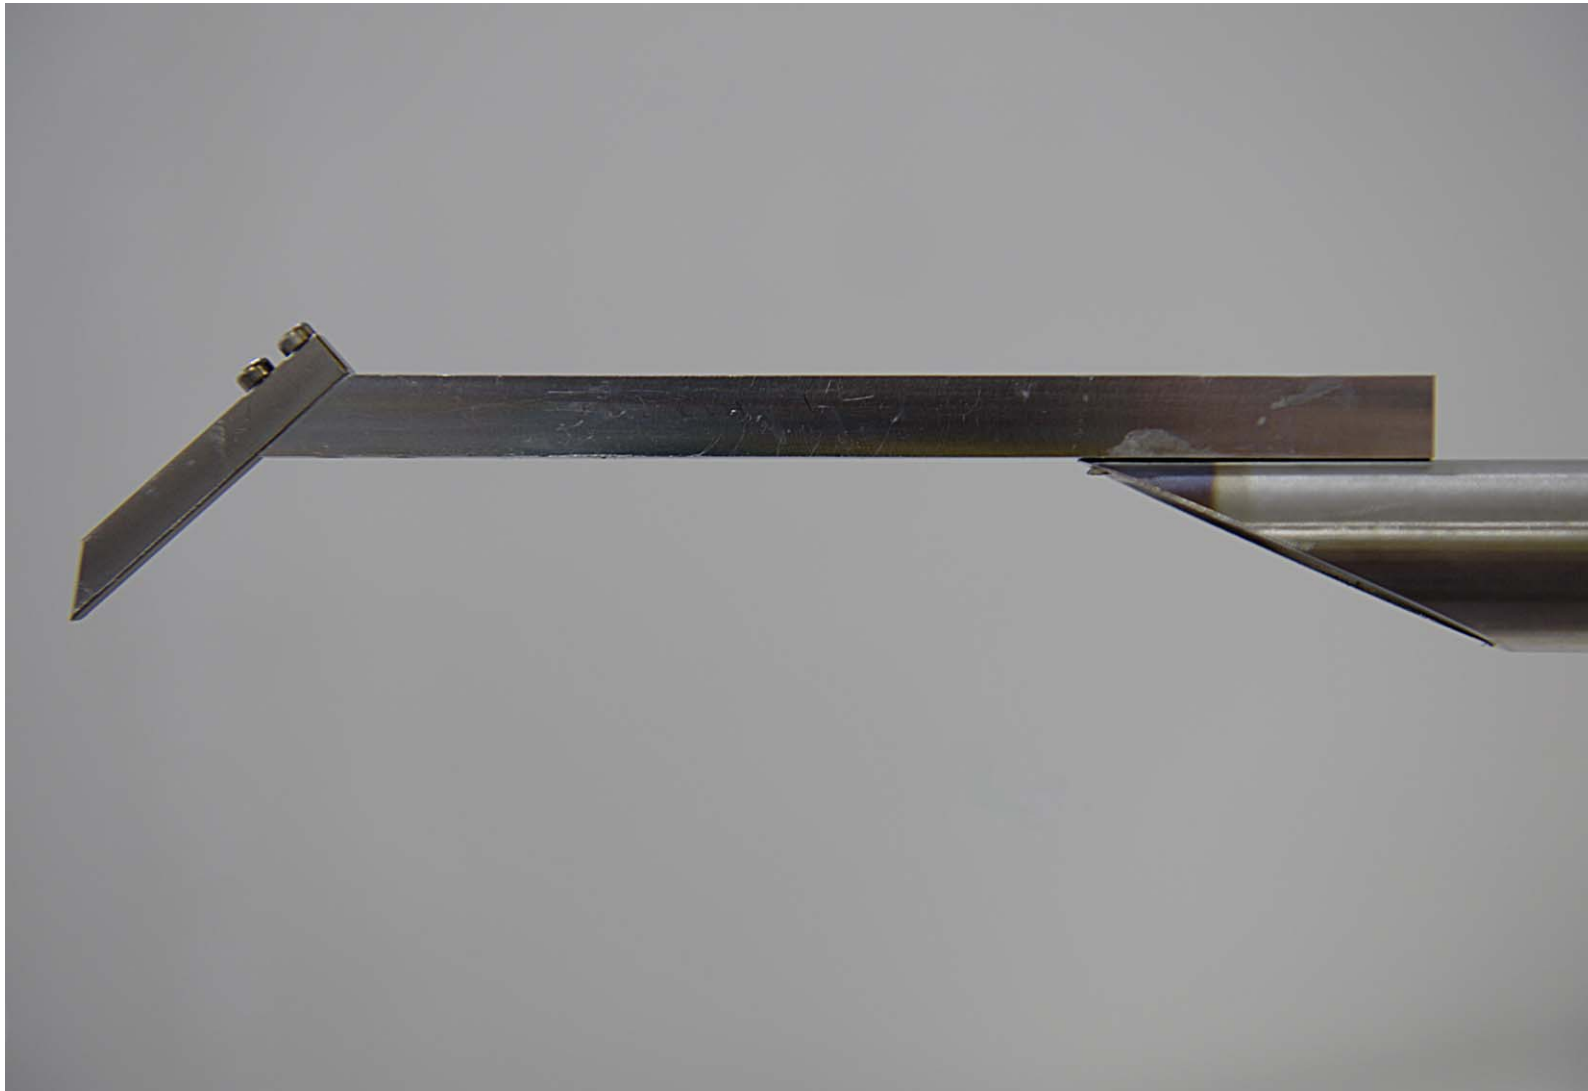
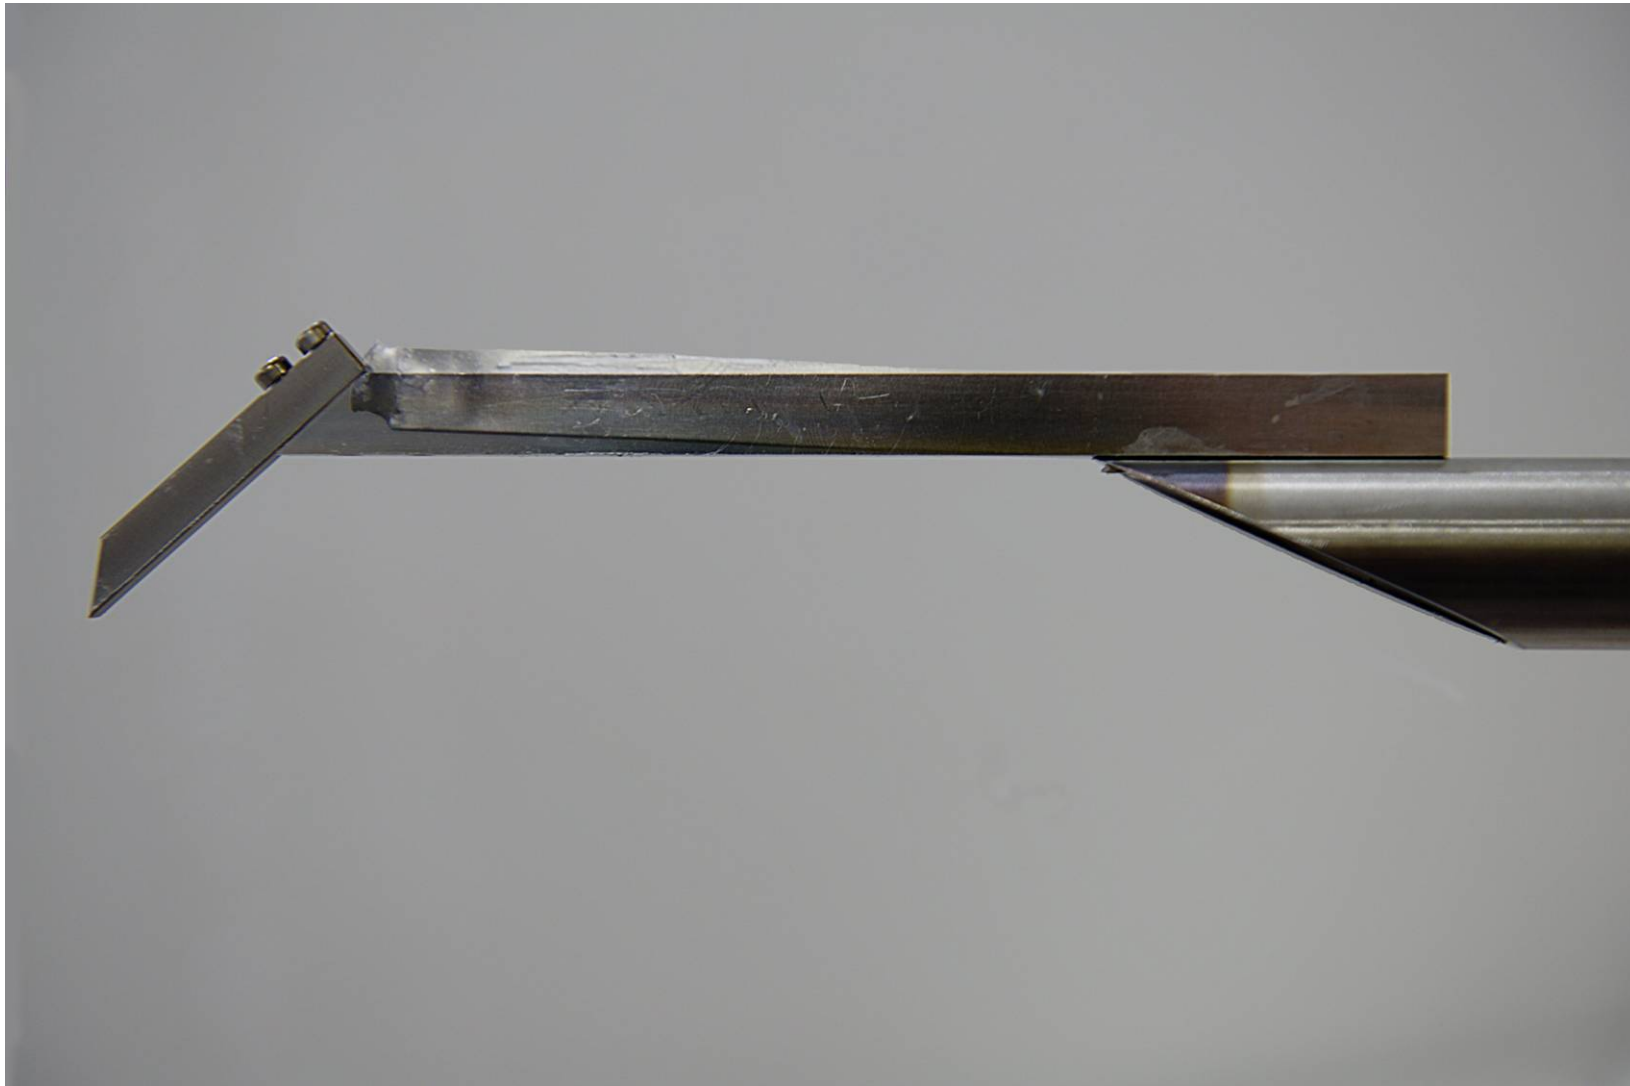
On Wednesday after a few minutes at 300 mA beam loss and further injections impossible

With certain orbit bumps injection and beam accumulation → slicing section

After a while at high intensity no injection any more

50 – 100 W

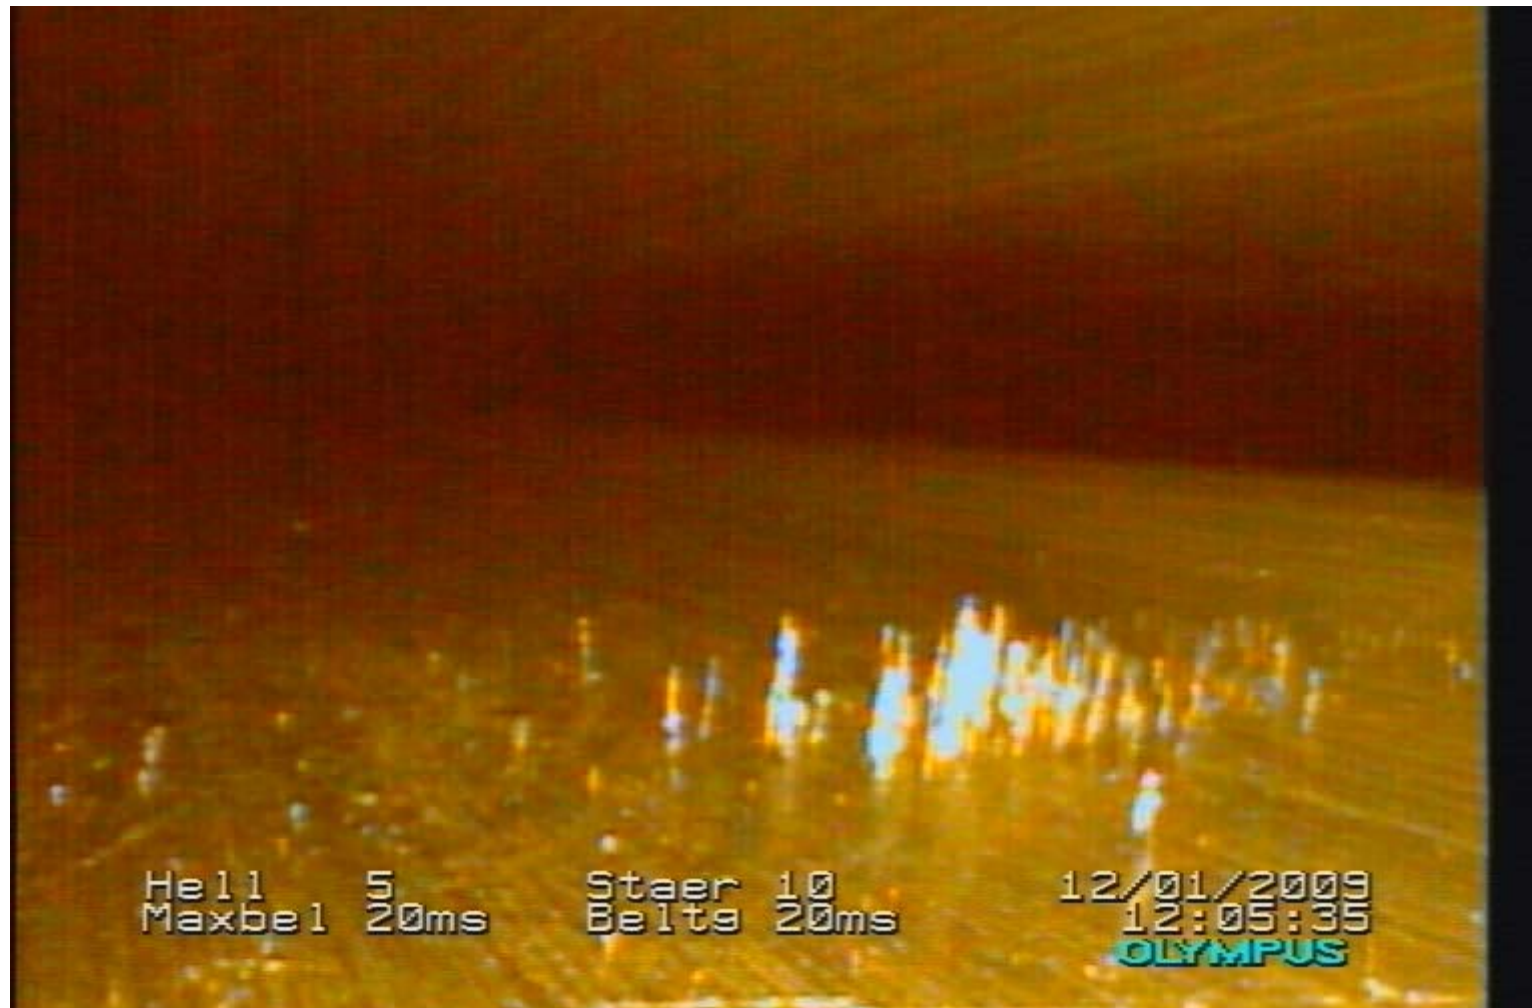
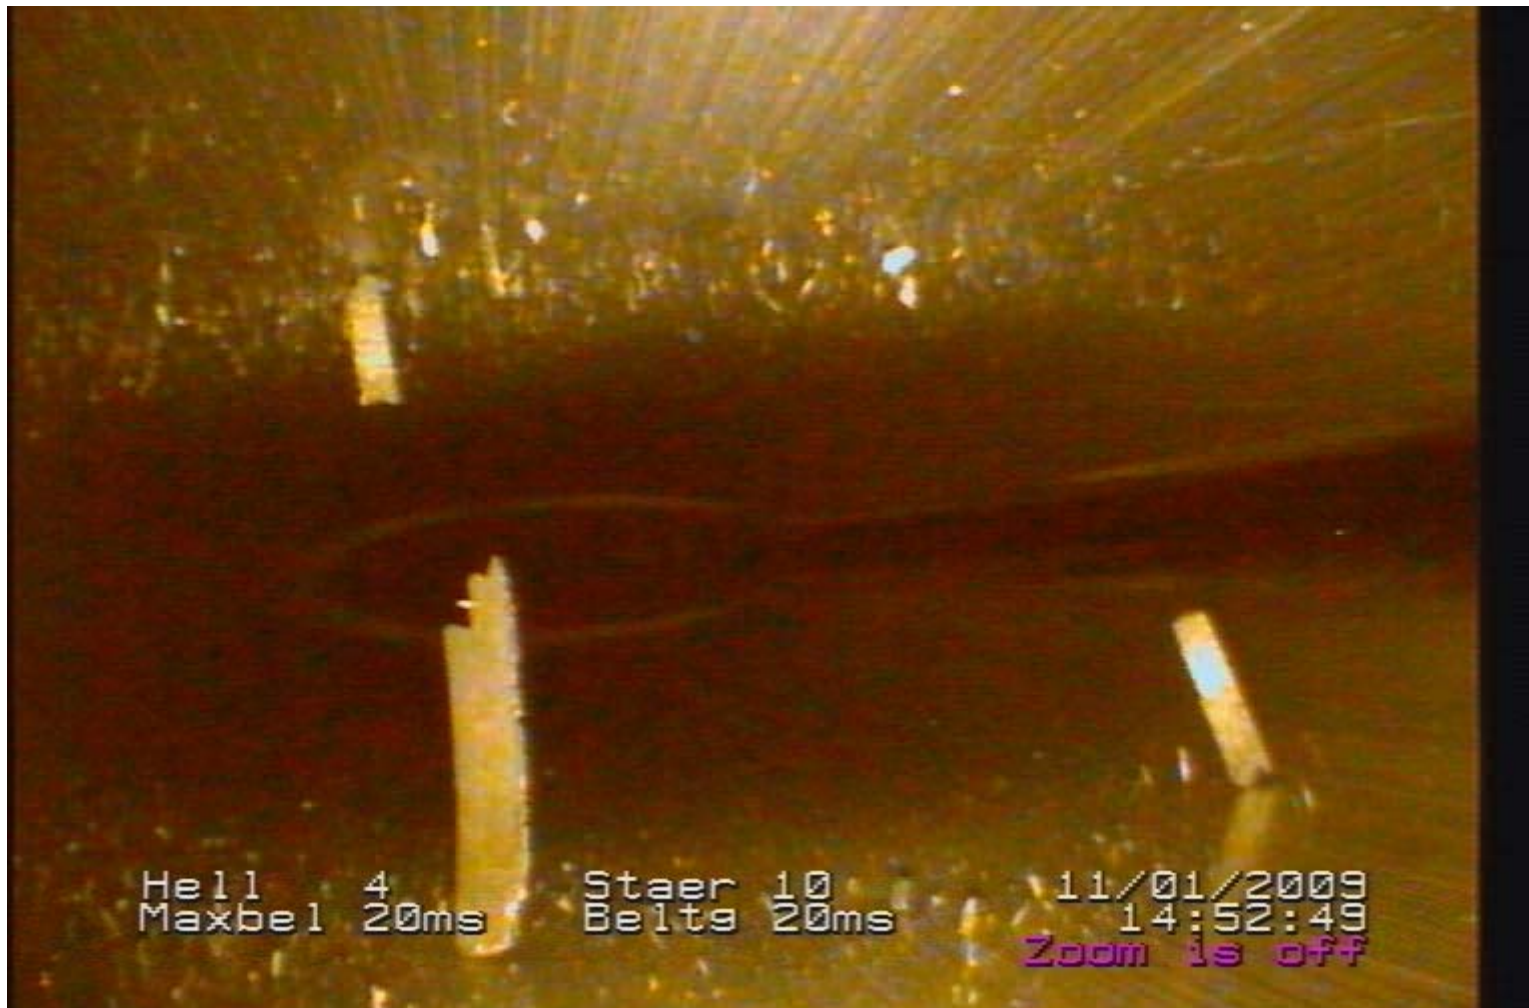
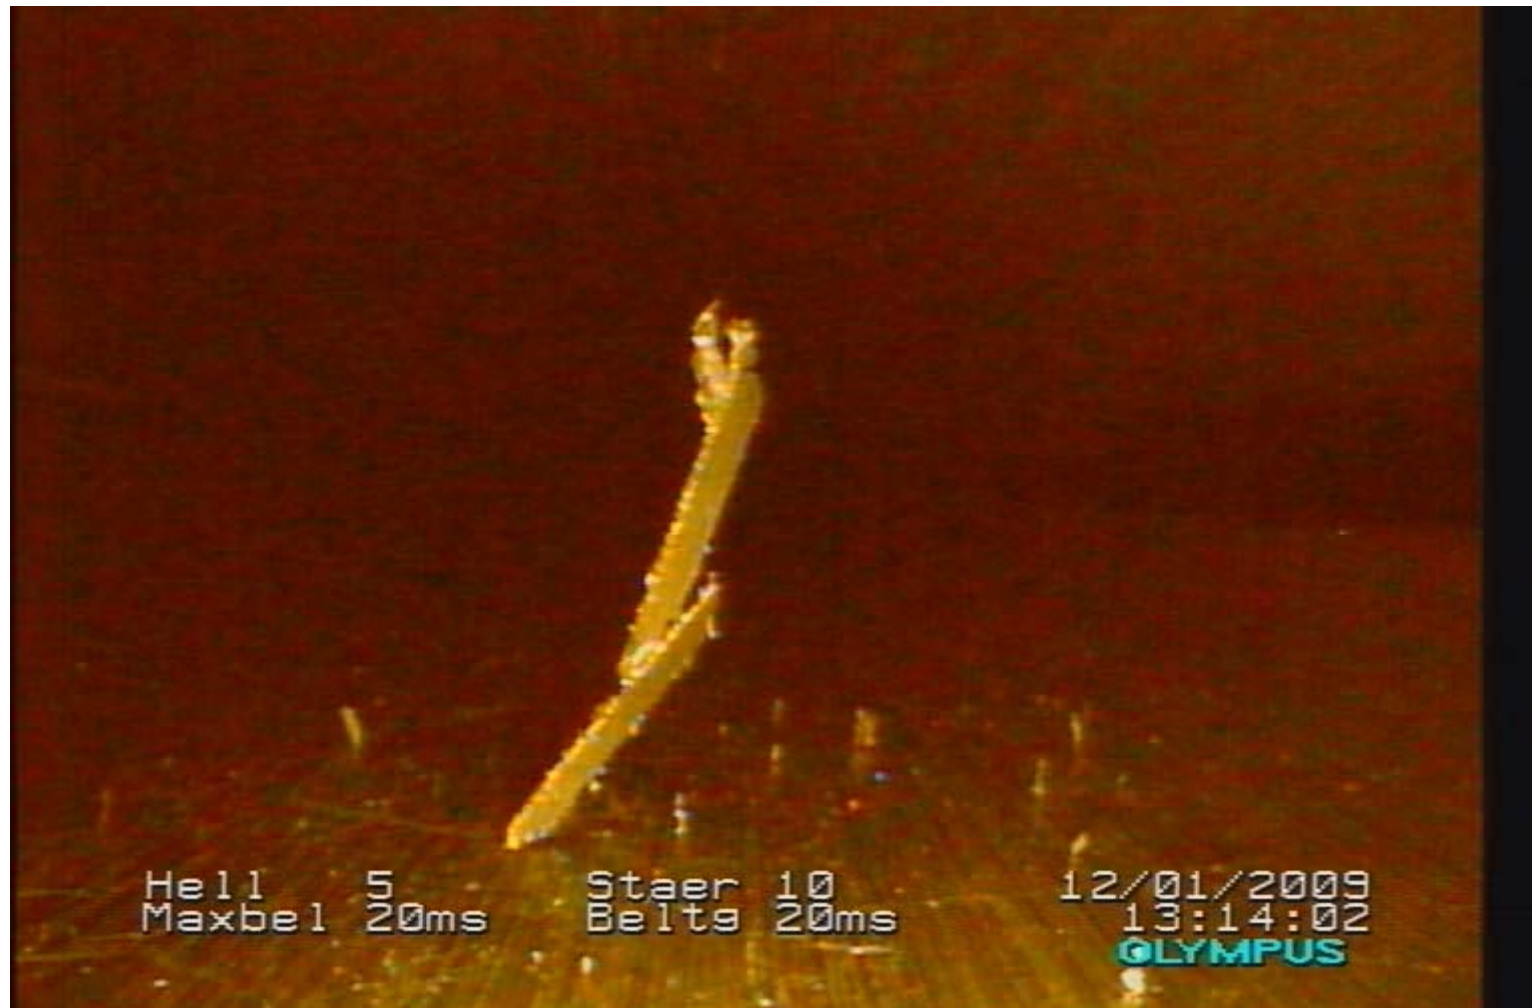
Pile up of dust particles after many attempts to remove all particles

Chamber was exchanged
