IBBelle

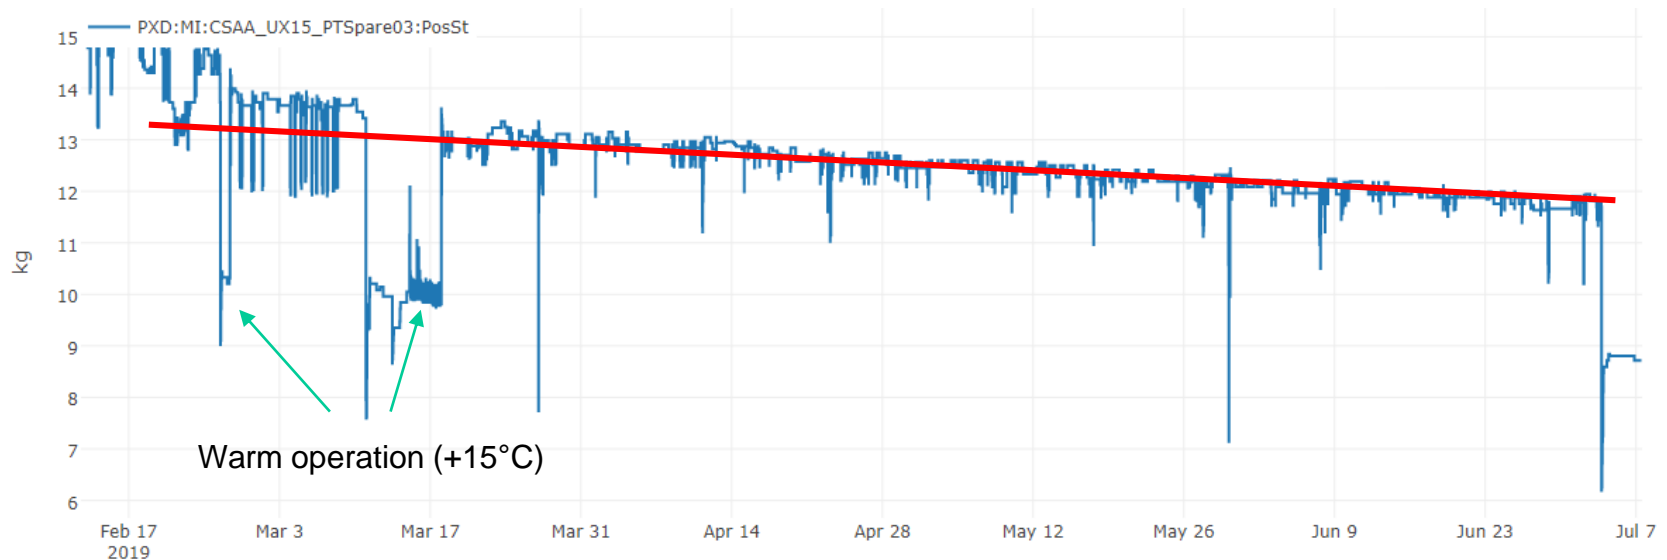
During Phase III IBBelle ran without interruptions (except ,warm operation') for 157 days.
CO₂ loss was very low, ~10 g/day.

Some oscillations of the chiller after startup could be fixed by adjusting PID parameters.

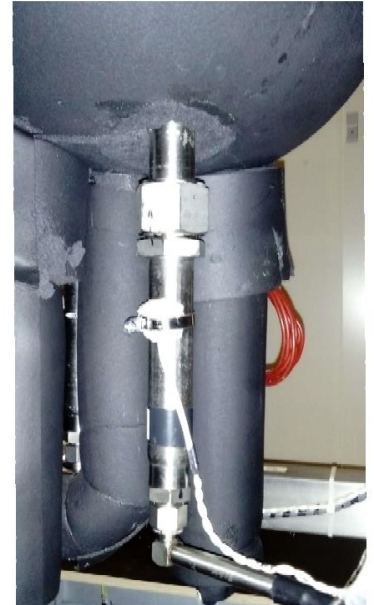
install heat pipe for improved subcooling of R404a - did not work

heat pipe did not work in the orientation needed (contrary to suppliers claim)
Install a system based on Peltier cooling in the next shutdown

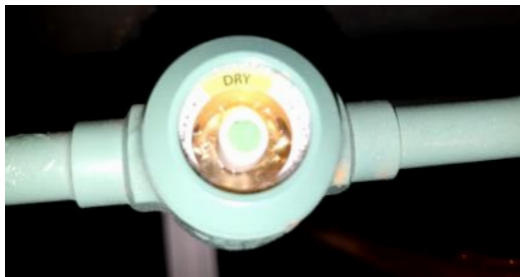
- ▶ R404a needs to be subcooled (below condensation/evaporation temperature) to avoid flash gas in TX valve, harmful for valve

- ▶ no subcooler
- ▶ ambient room temperature high (> 26°C during summer)
 - subcooling is very low in average 0,3 K
- ▶ horizontal receiver (vertical mounted would be better)

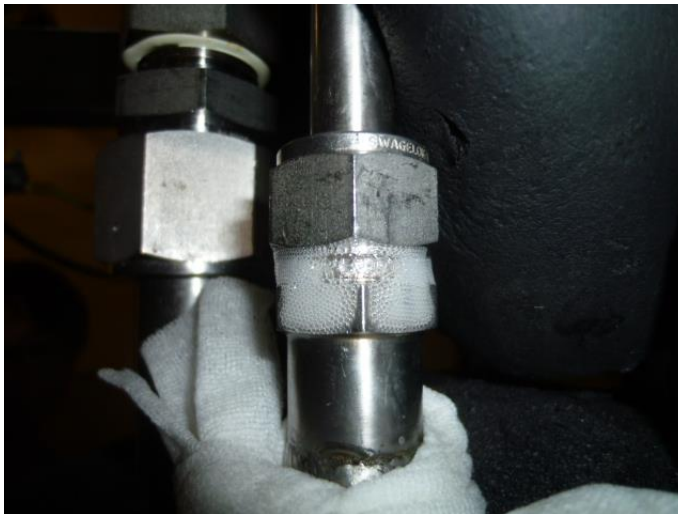
one leak confirmed: Feed through of R404a line of B unit to cooling coil in accumulator (which is not used)

Unfortunately this joint is difficult to fix.

Proper repair needs orbital welding (to be done by a company)

Some easier fixes discussed, but the problem is that the cooling coil cannot be removed

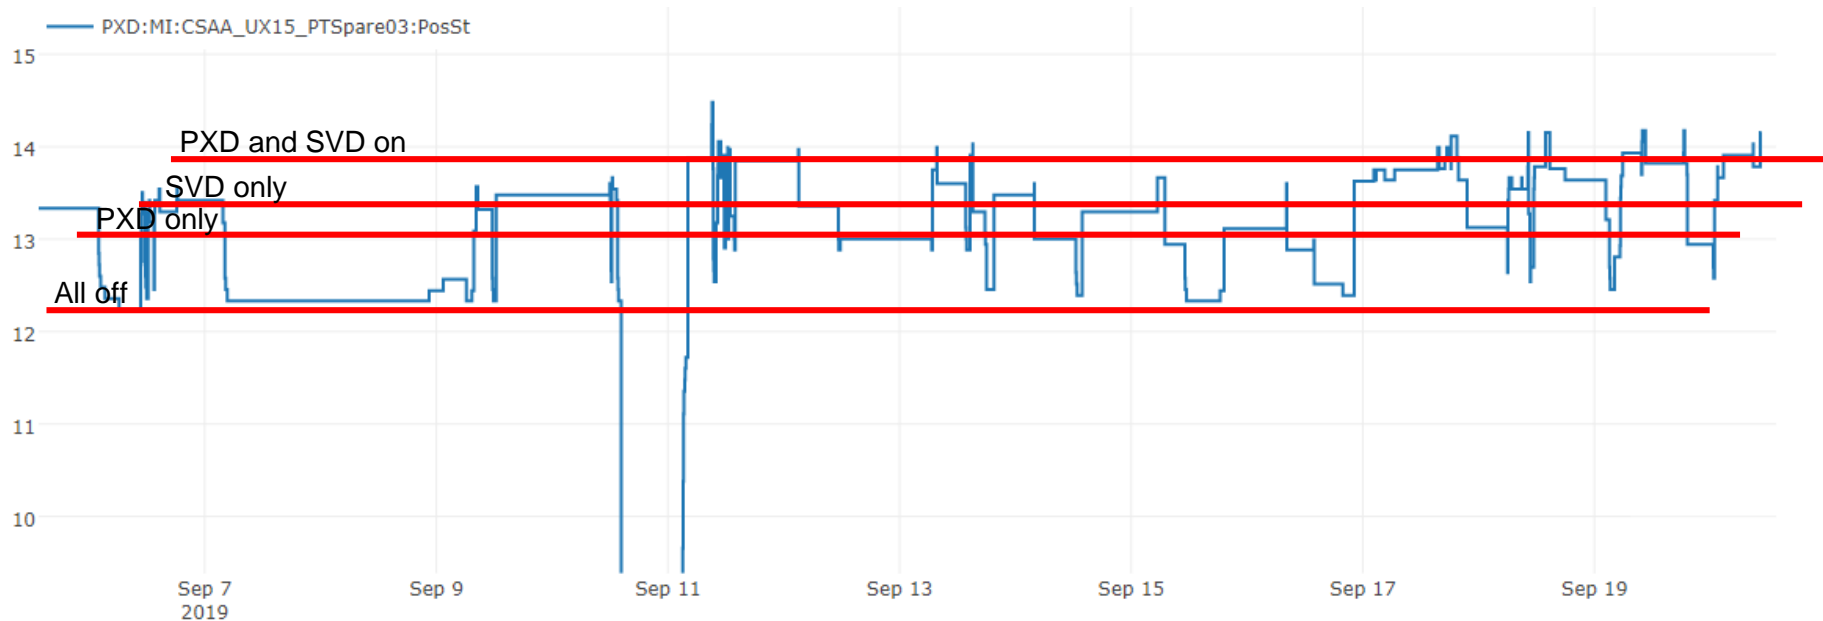
Running cold (-20°C) from September 5 (except short +5°C operation at Sep. 11):

- ⇒ No indication of a leak
- ⇒ Leak probably only open at high pressure. -20°C: 20bar, ambient: 65bar !
- ⇒ Expert from Swagelok will inspect and consult October 23, repair earliest in New Year Shutdown
