SNS Operational Experience

J. Mammosser - on behalf of the SRF/Cryo
Groups

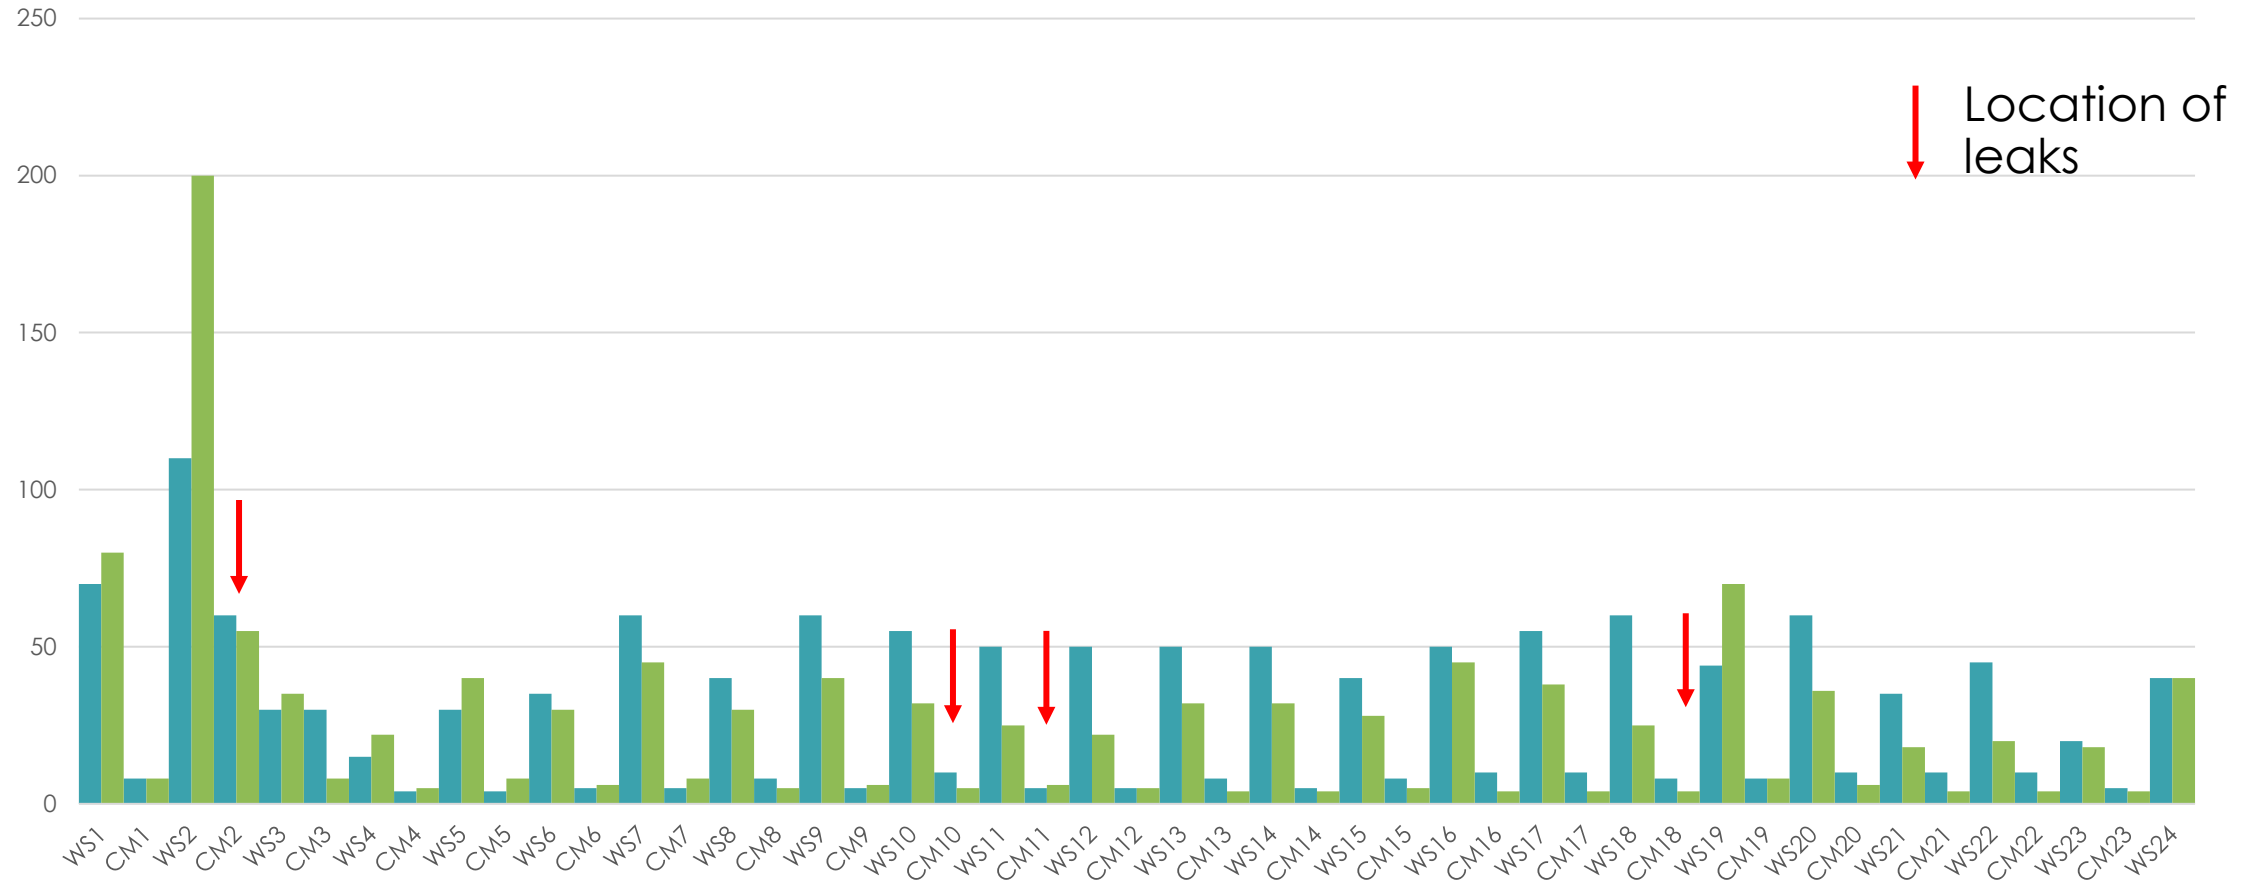
Residual Activation and Locations of Valve Leaks

- During the last two maintenance periods, warm sector gate valve through leaks have been identified.
 - The first valve leak was discovered last August on CM2 when removing CM1 for repairs.
 - During the current winter down, we identified 3 more leaky valves
 - During the current winter down, six cryomodules were warmed up for
 - CM1 for repairs upstream vacuum system
 - CM**18**, 19 for repairs on CM18
 - CM**10**, **11**, 12 for removal and replacement of CM11
- Sector gate valves are the pneumatic valves on each end of cryomodule.
- These valves are closed for cryomodules that requires maintenance.

Residual Radiation at 30cm (mRem/hr)
dark green - 06/2020, light green- 11/2020

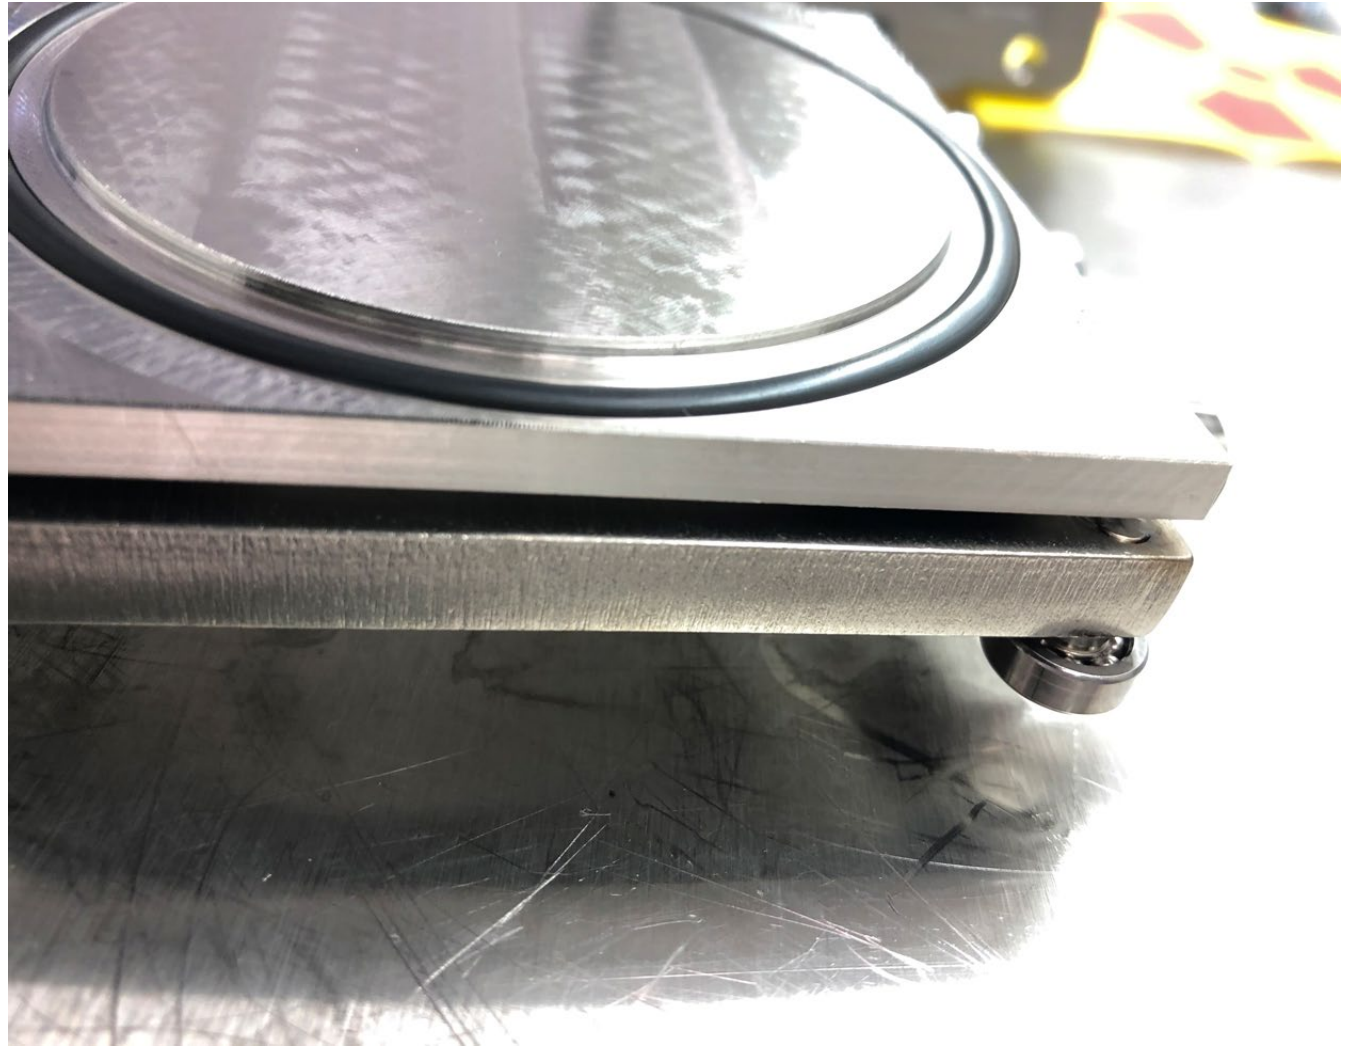
CM02 Sector Gate Valve Seal

- O-ring has lost its elasticity and was flat at the seal surface
- No signs of embrittlement or cracking

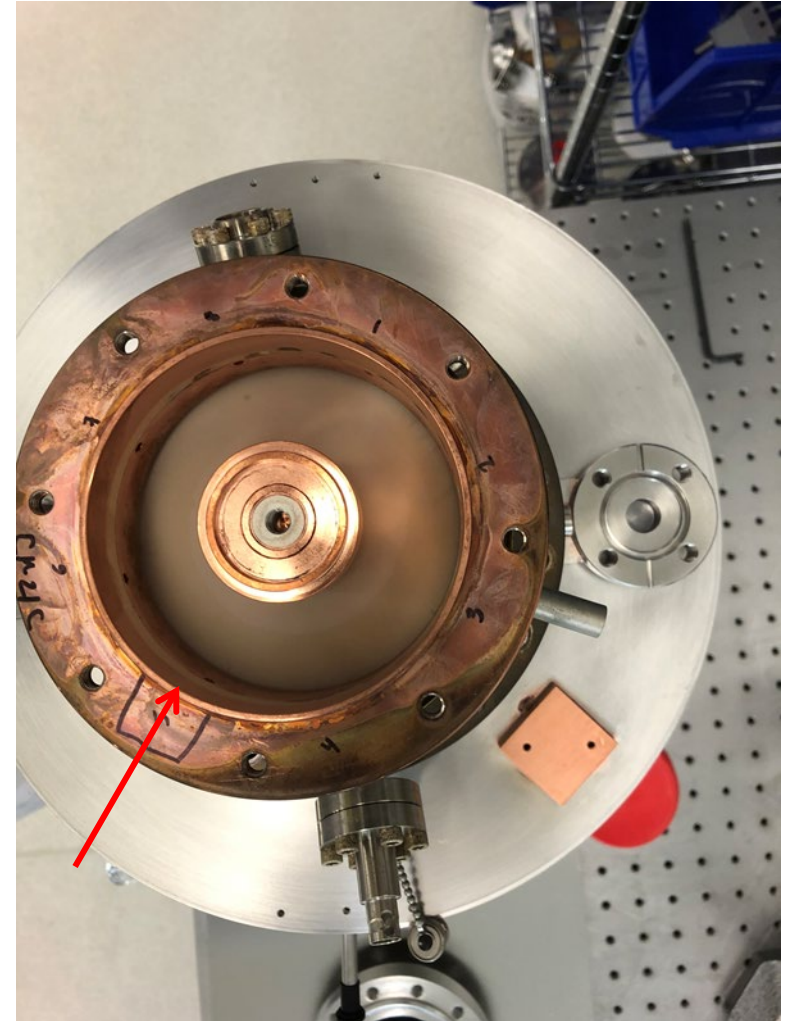
- Over the last few years FPC leaks through the ceramic window have increased
- To date 9 FPCs have been removed from cryomodules
 - 8 out of these have identified leaks of 10^{-7} Torr L/s,
 - 1 was removed due to severe oxidation (D)
- Leak locations were identified around choke joint brazing to ceramic

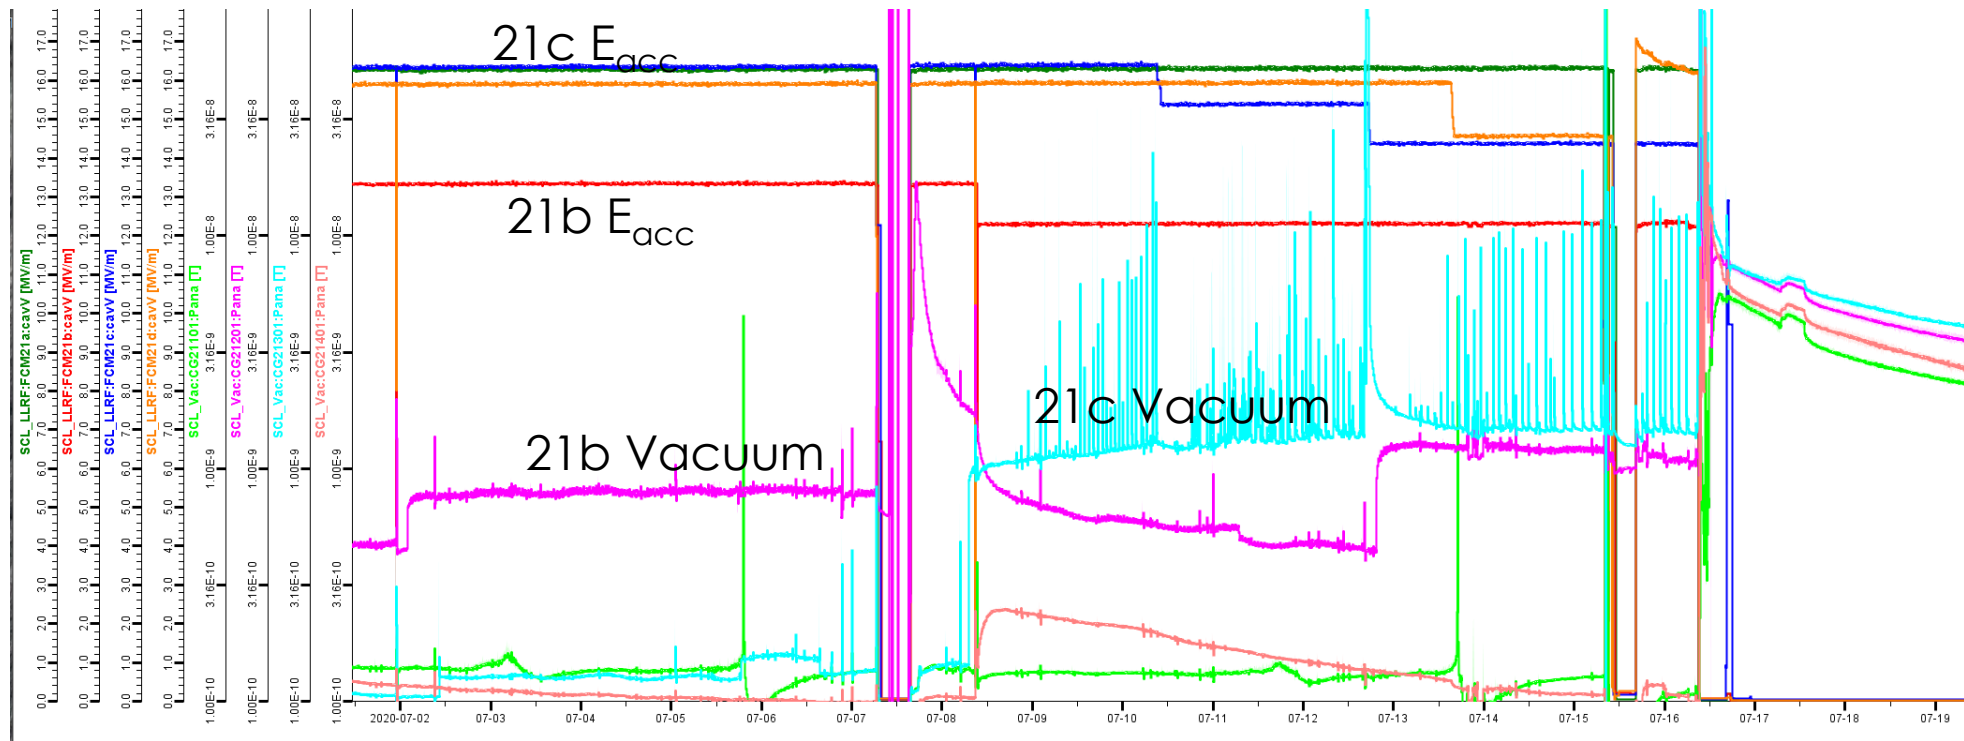
- Typically vacuum pressure becomes less stable with spikes (increase up to 10^{-9} torr range)
- Run those cavities at a reduced E_{acc} or turn-off using an energy margin
