WHAT CAN GO WRONG ...

SOME EXAMPLES

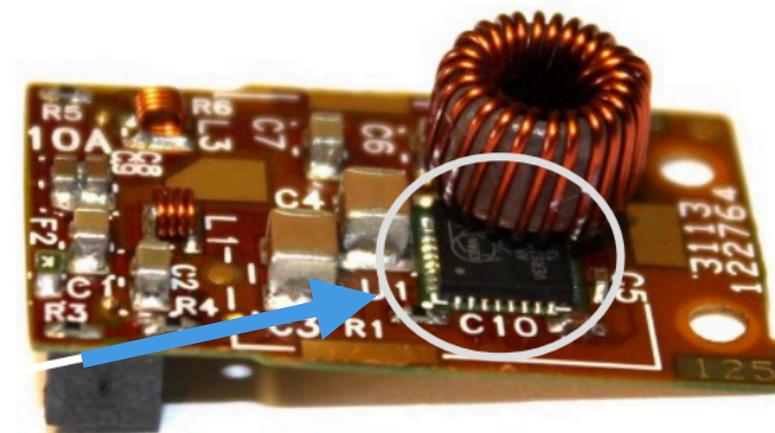
Feast2

- During 2017 new pixel detector installed in CMS with DC-DC converter for powering
 - After few months: ~5% of deployed converters failed.
 - During winter shutdown: another ~35% of converters were found partially damaged
- Extremely difficult to identify problem - over months multiple tests conducted
- Found strong correlation between radiation background and failures, as well as the functional sequence necessary for the damage to happen.
 - Damage caused by TID radiation damage opening a source-drain leakage current in **one** transistor in Feast2.1 chip
 - High-voltage transistors can not be designed in an enclosed layout to prevent this problem

- lower input voltage helps
- stop disabling the output

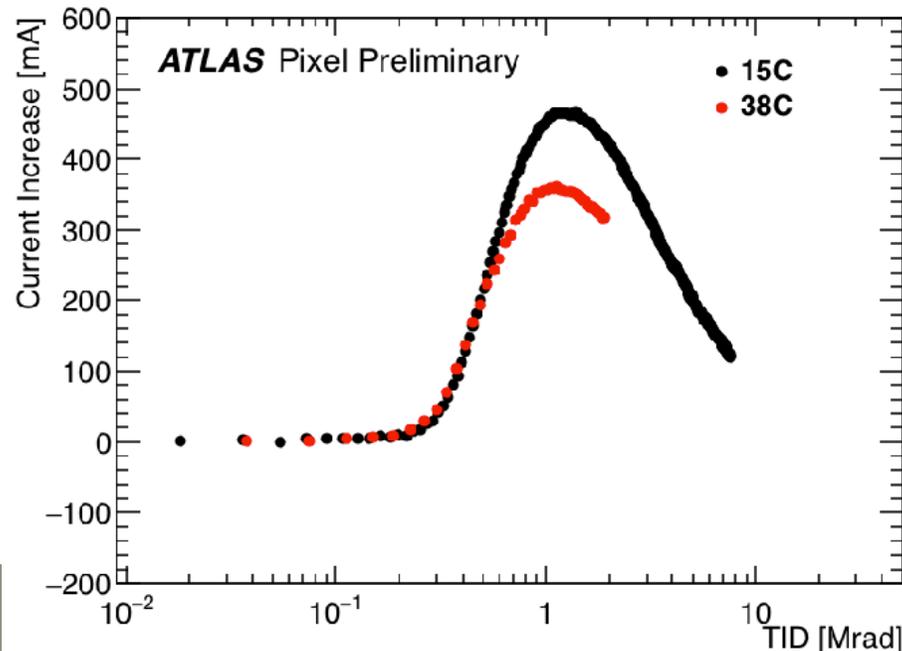
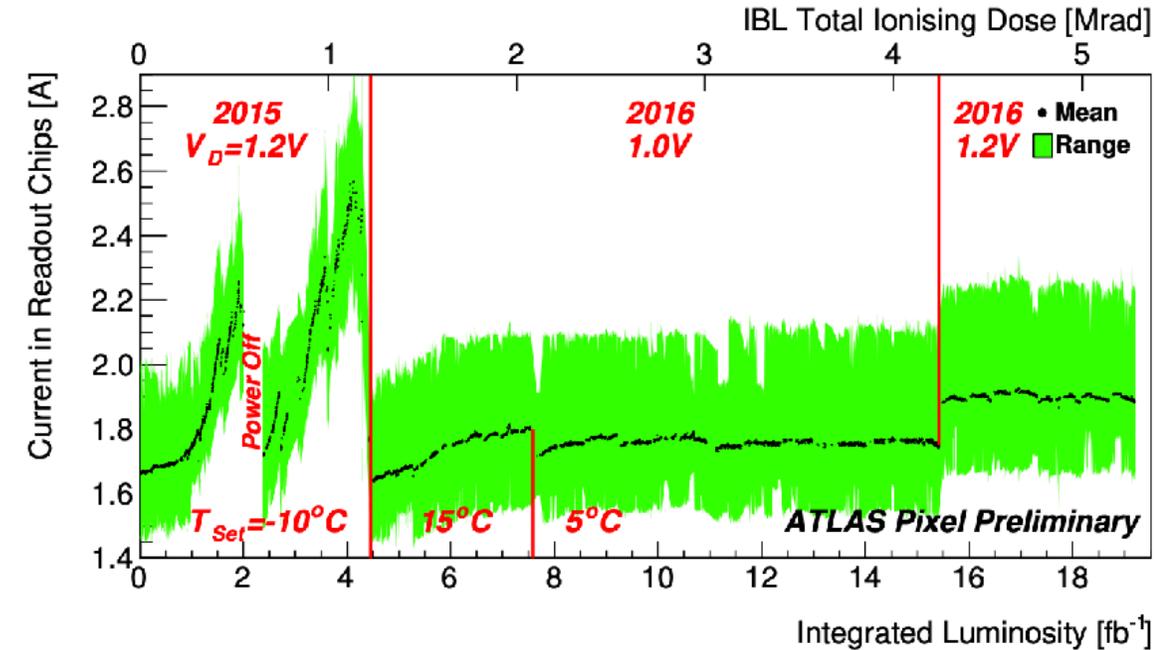
ATLAS IBL TID BUMP

- Steep increase in power consumption of IBL during operation increasing the temperature
- Effect of total ionising dose on front-end chip FE-I4B
- Caused by the effect of TID on NMOS transistors:
 - Leakage current was induced by positive charge trapped in the bulk of the shallow trench isolation (STI)
 - Temperature and voltage depending

- Operating temperature was increased from $-10^\circ C$ to and $10^\circ C$ then decreased to $5^\circ C$.
- Digital supply-voltage was decreased to from $1.2 V$ $1.0 V$ until TID approached more than $4 MRad$.

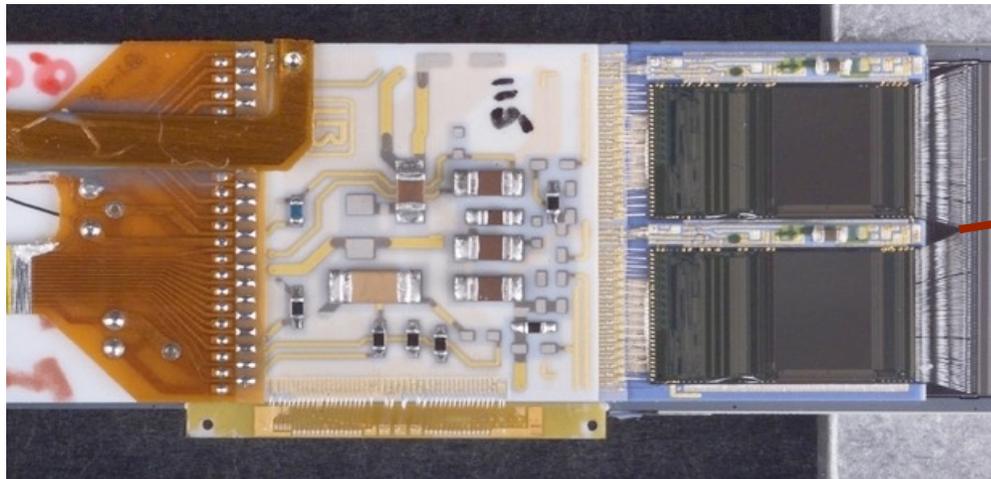
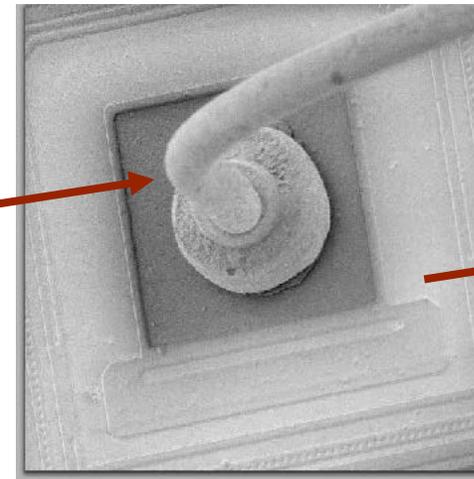
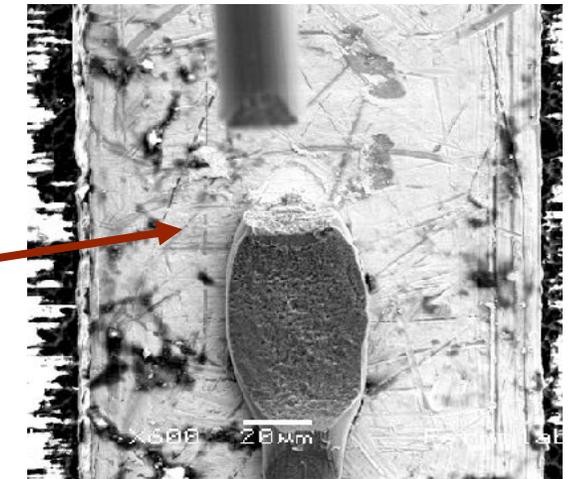
PROBLEMS WITH WIRE BONDS (CDF, DO)

- Very important connection technology for tracking detectors: wire bonds:
 - 17-20 μm small wire connection -> terrible sensitive
- Observation: During synchronous readout conditions, loss of modules (no data, Drop in current)

- Tests revealed:
 - Bonds start moving due to Lorentz Force in magnetic field
 - Wire resonance in the 20 kHz range
 - Current is highest during data readout
 - Already a few kicks are enough to get the bond excited

Implemented “Ghostbuster” system which avoids long phases with same readout frequency

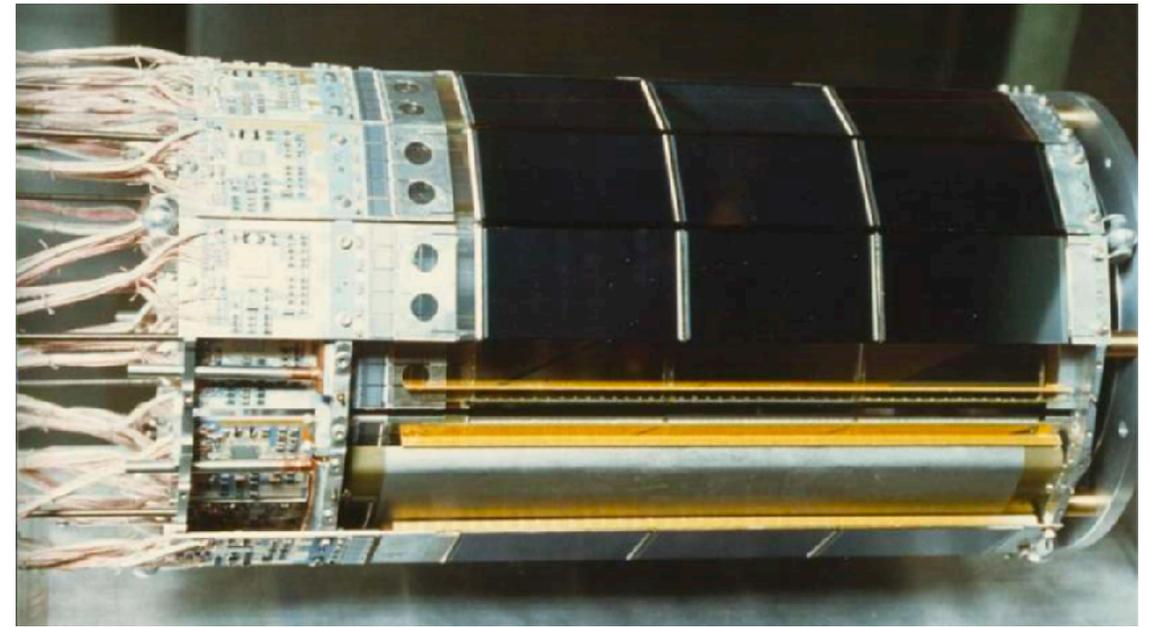
OPAL MVD 1994

- OPAL MVD ran for a short while without cooling water flow.
- Temperature of the detector rose to **over 100°C**.
 - Most of the modules to fail or to be partially damaged.
- Chain of problem causing damage:
 - MVD expert modified the control/monitoring software between consecutive data taking runs.
 - Inserted bug which stopped software in a state with cooling water off but with the low voltage power on.
 - Stopped software also prevented the monitoring of the temperature from functioning
 - Should have been prevented by additional interlock but that was also disabled....

- Damage was mostly melted wire bonds
- Detector could be fixed in winter shutdown

- new and more rigorous interlock system that could not be in a disabled state during data taking conditions.
- rule was implemented that prohibited software modifications between consecutive data taking runs.

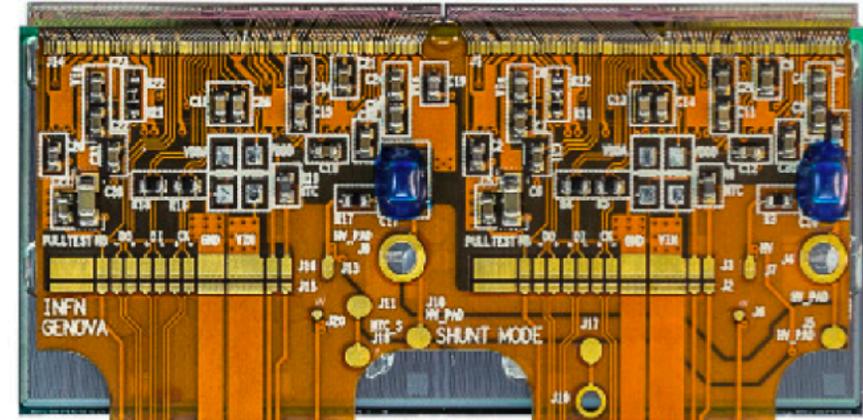
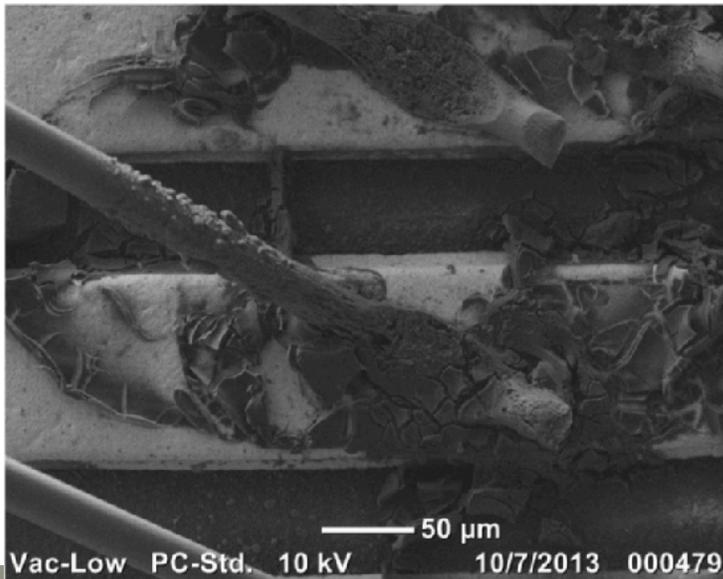
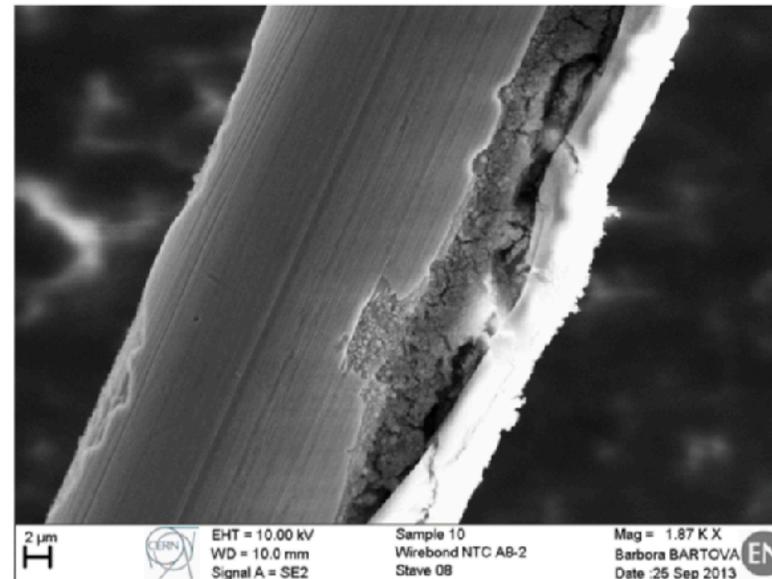
ATLAS IBL - WIRE BOND CORROSION

- Additional pixel layer for ATLAS installed in 2015
- Five months **before** installation: corrosion residues observed at wire-bonds after cold tests (-25 C)
- Severe damage of many wire-bonds
- Residue showed traces of chlorine: catalyst of a reaction between Aluminium (wire-bonds) and H₂O (in air)
- Origin of chlorine in system never fully understood

- Emergency repair and additional staves from spare parts

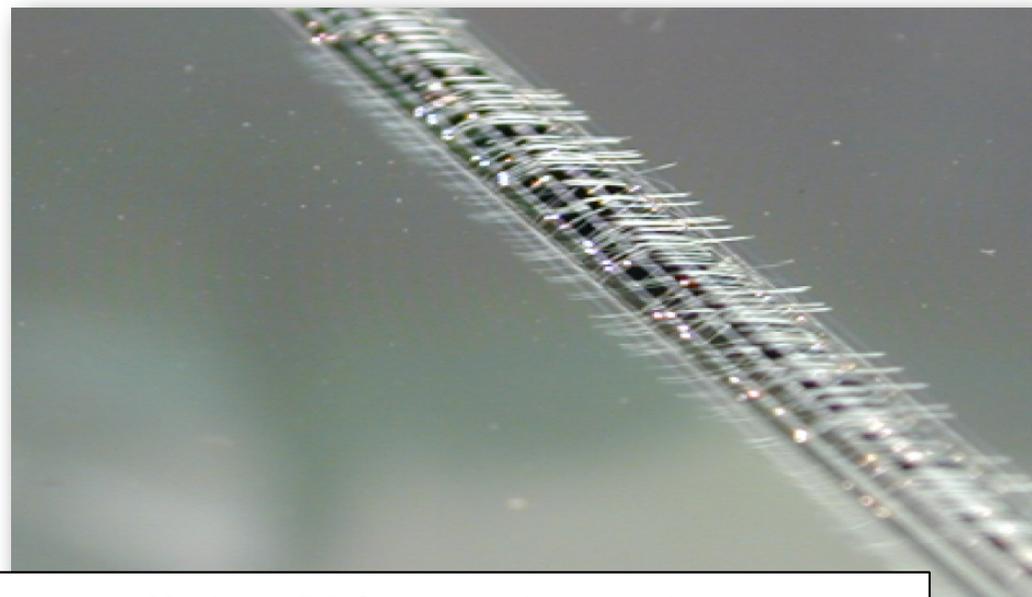
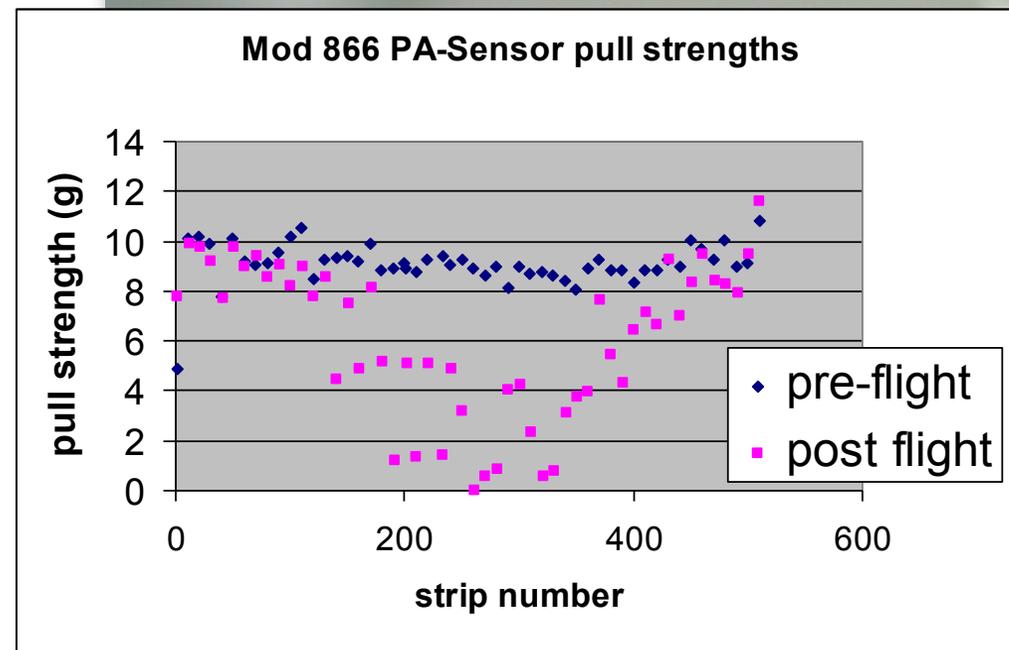
MORE WIRE BOND WRECKAGE

- During CMS strip tracker production quality assurance applied before and after transport
 - Quality of wires is tested by pull tests (measured in g)
- Wire bonds were weaker after transport with plane
- Random 3.4 g NASA vibration test could reproduce same problem
- Problem observed during production -> improved by adding a glue layer
- No further problems during production

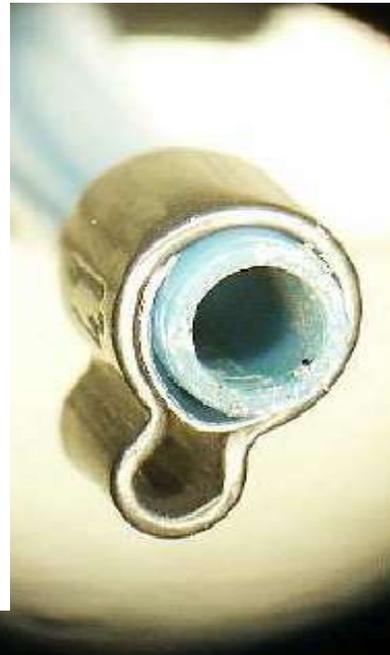
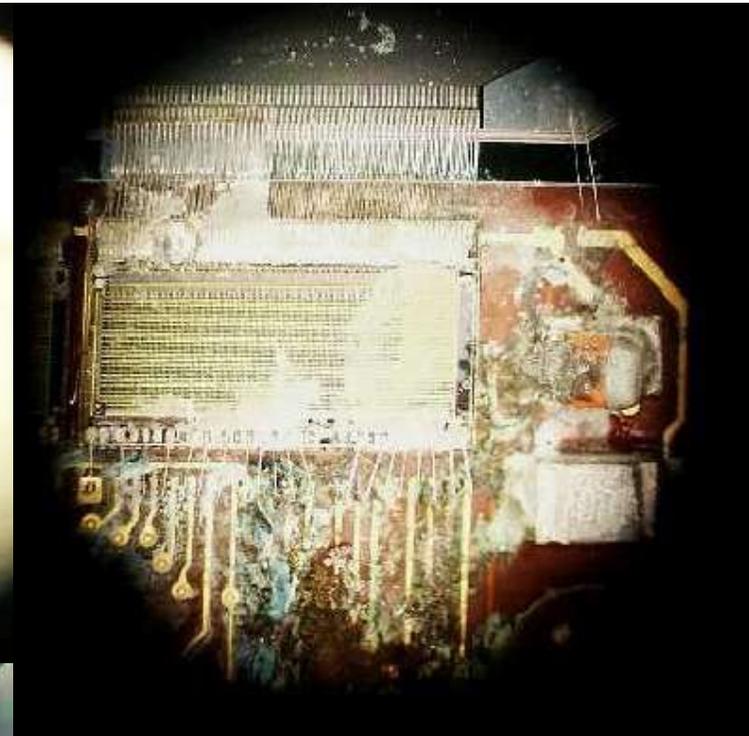
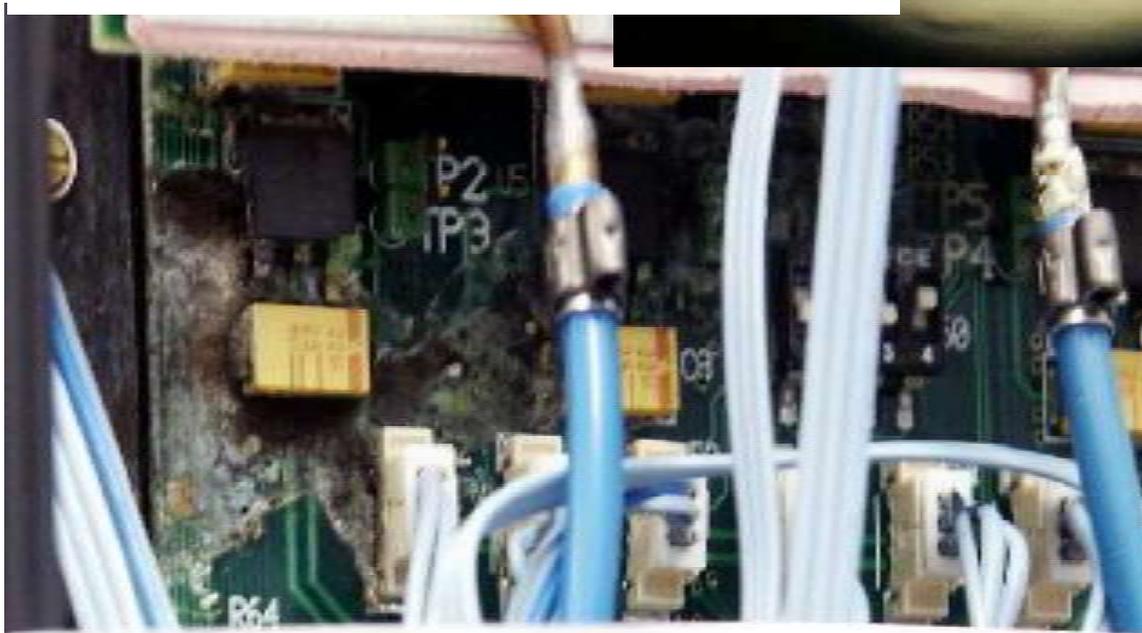
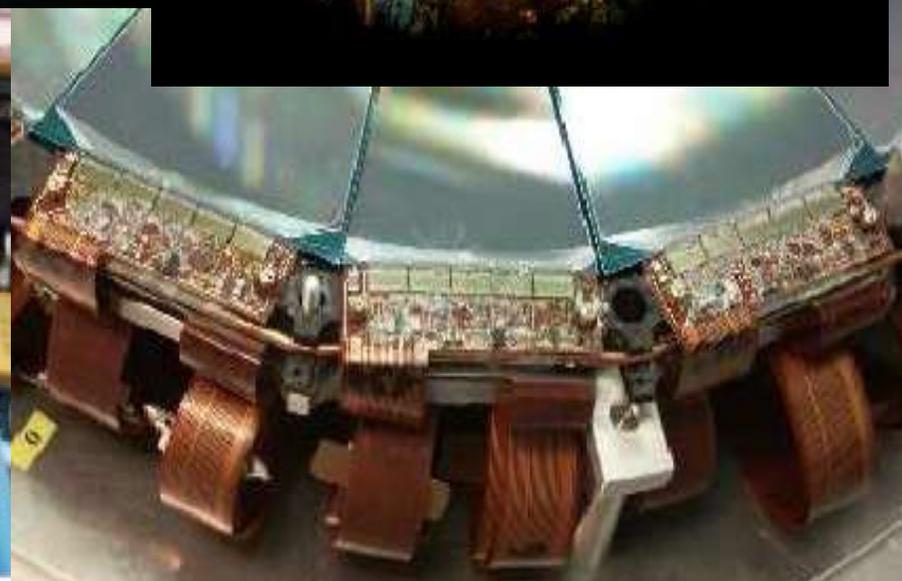
WATER DAMAGE IN TRACKER ...

- H1@HERA FST in 2004
- Imperfect crimp + hardening of plastic (age, irradiation) => water leak
- Water condensation => damage
- Tracker segment had to be rebuilt

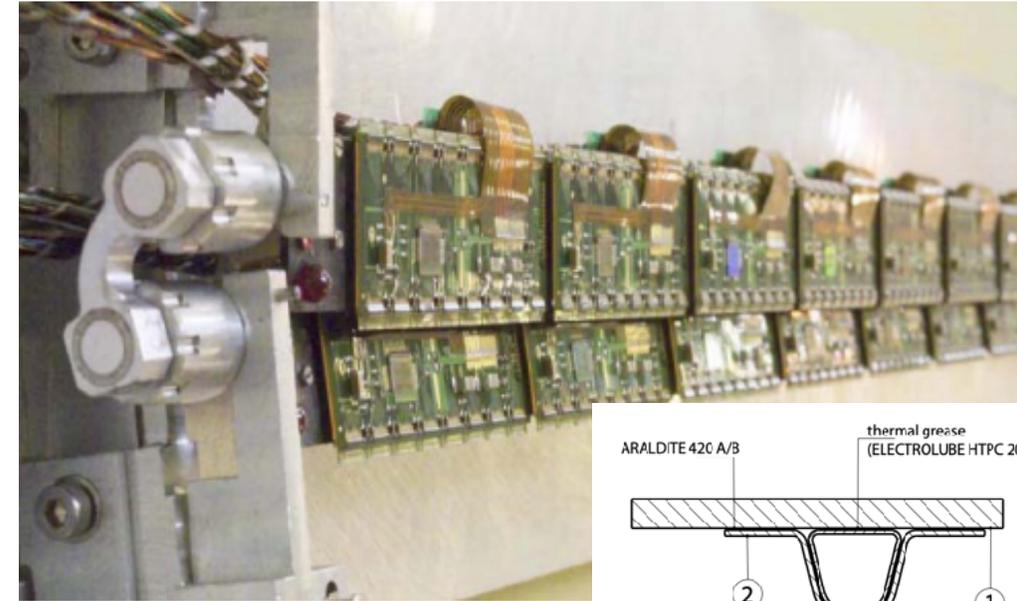
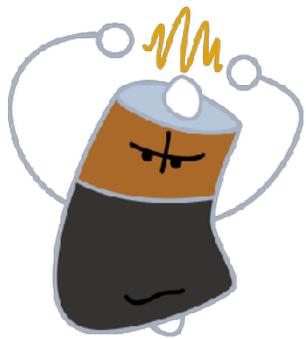
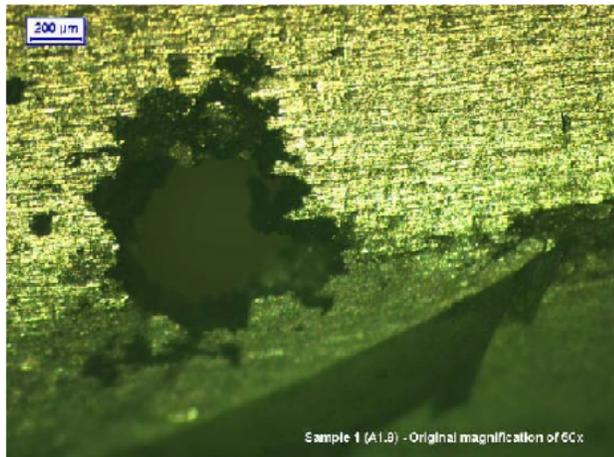
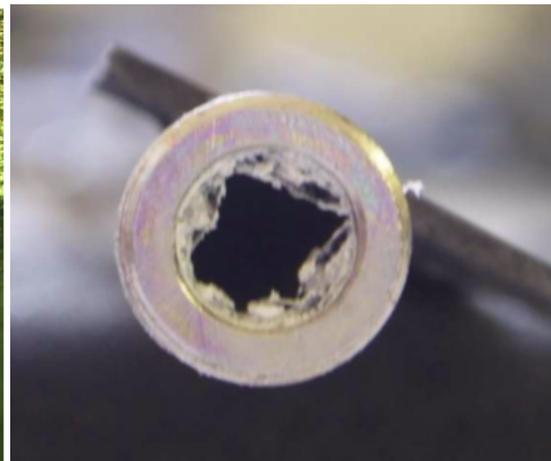
ATLAS PIXEL TUBE CORROSION

- Cooling tube of current pixel layers were supposed to be very light in material
 - Bare pipe material (Al)
 - Ni plating used to allow for brazing of the pipe fittings
 - No proper drying procedure → water
- Water triggered corrosion process in the aluminium pipes.
 - Corrosion was due to galvanic process where water and traces of halogen (like Cl) acted as electrolyte.
 - Effect of the galvanic corrosion led in some cases to holes in the pipe.

- Repair the 43 loaded staves with a pipe-inside-the-pipe
- Production of new staves with new Al compound and laser welding
- Repair of bare staves (~100)

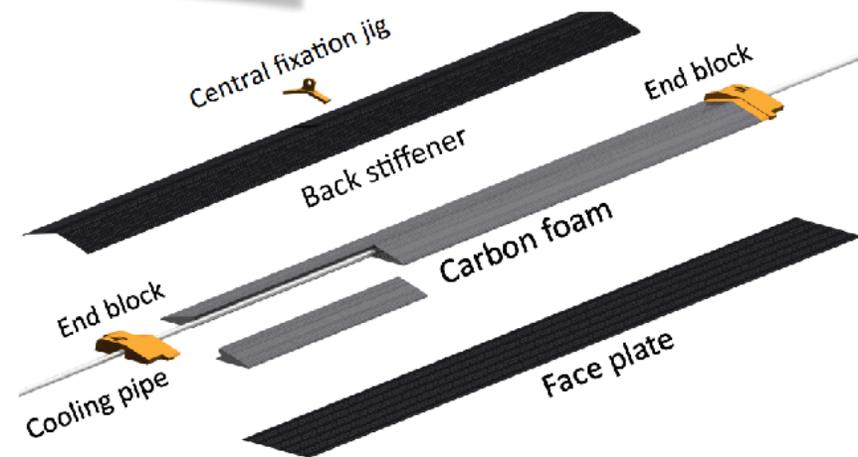
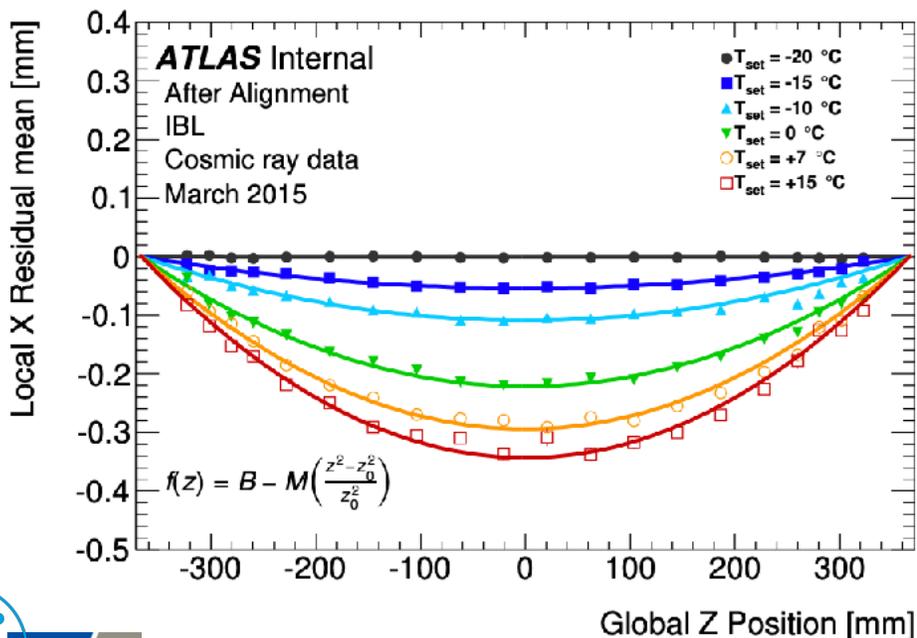
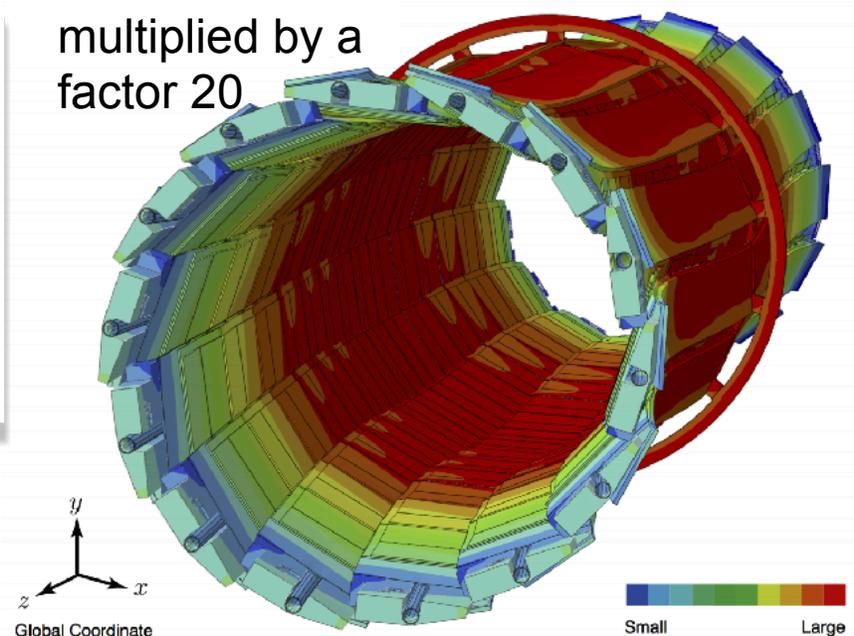
ATLAS IBL STAVE BOW

- Distortion depending on the operating temperature was observed.
- Caused by a mismatch between the coefficients of thermal expansion (CTE) of a bare stave made with the carbon foam and the flex attached on the bare stave.
- Maximum more than 300 μm at $-20\text{ }^\circ\text{C}$ with respect to the nominal position at the room temperature.

Mitigated by temperature control at the level of 0.2 K and the regular alignment correction in the offline reconstruction

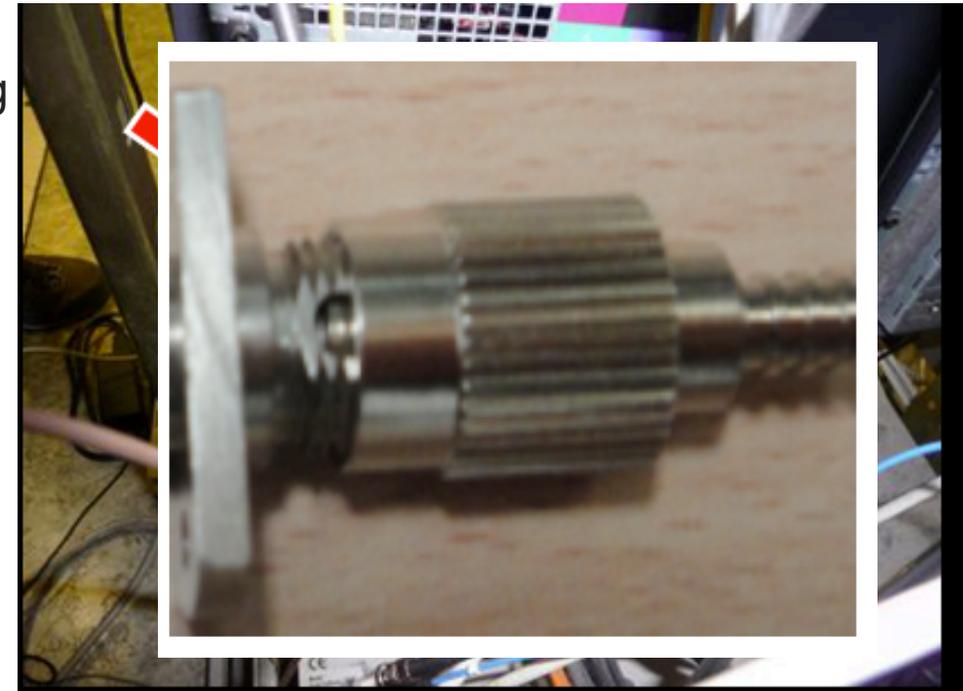
CABLE PROBLEM WITH PRESS COVERAGE

- Kink from a GPS receiver to OPERA master clock was loose
 - Increased the delay through the fibre resulting in decreasing the reported flight time of the neutrinos by 73 ns,
 - making them seem faster than light.

After finding the problem, the difference between the measured and expected arrival time of neutrinos was approximately 6.5 ± 15 ns.

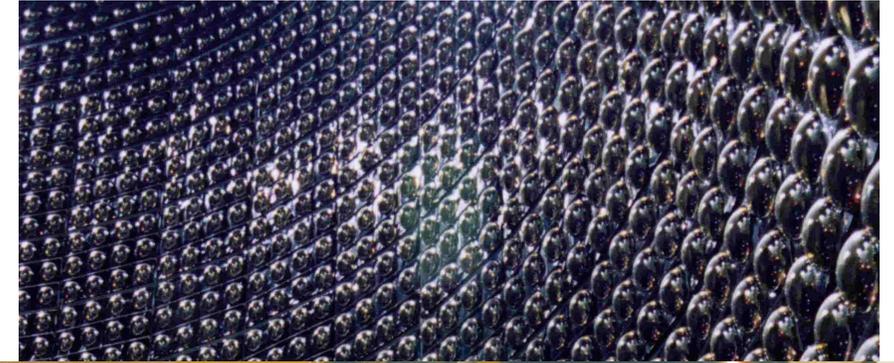
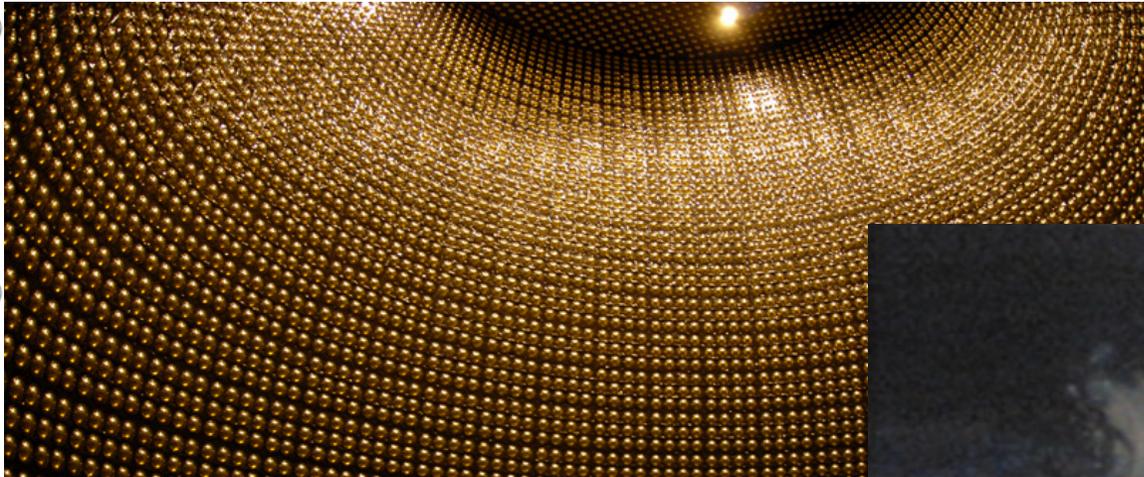
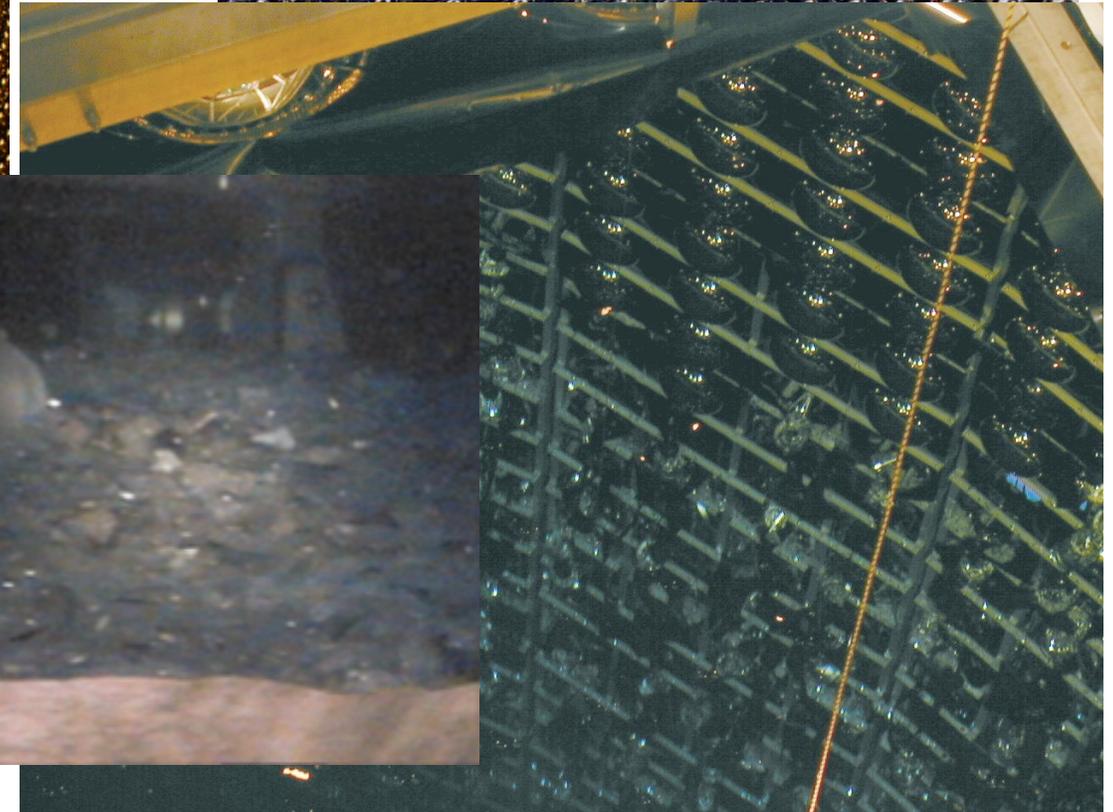
MAYBE MOST FAMOUS DAMAGE

- Underground water Cherenkov detector with 50,000 tons of ultrapure water as target material
- Nov 2001: One PMT imploded creating shock wave destroying about 7700 of PMTs

- Detector was partially restored by redistributing the photomultiplier tubes which did not implode.
- Eventually added new reinforced PMTs
