# The $^{192}\text{Ch}$ -GBP under X-ray

## 192Ch-GBP sensors

# The response of $^{192}\text{Ch}$ -GBP-W2 under X-ray irradiation

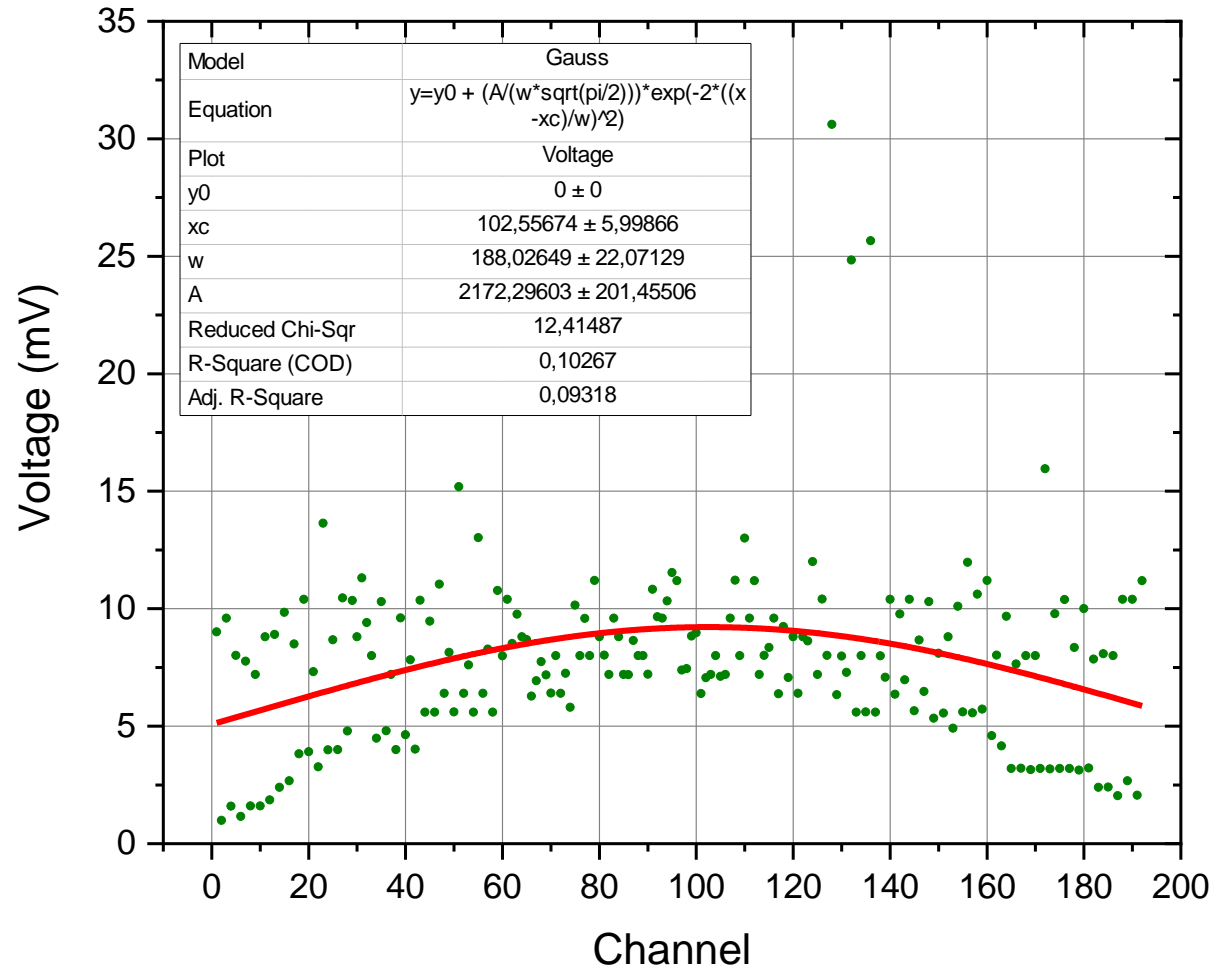
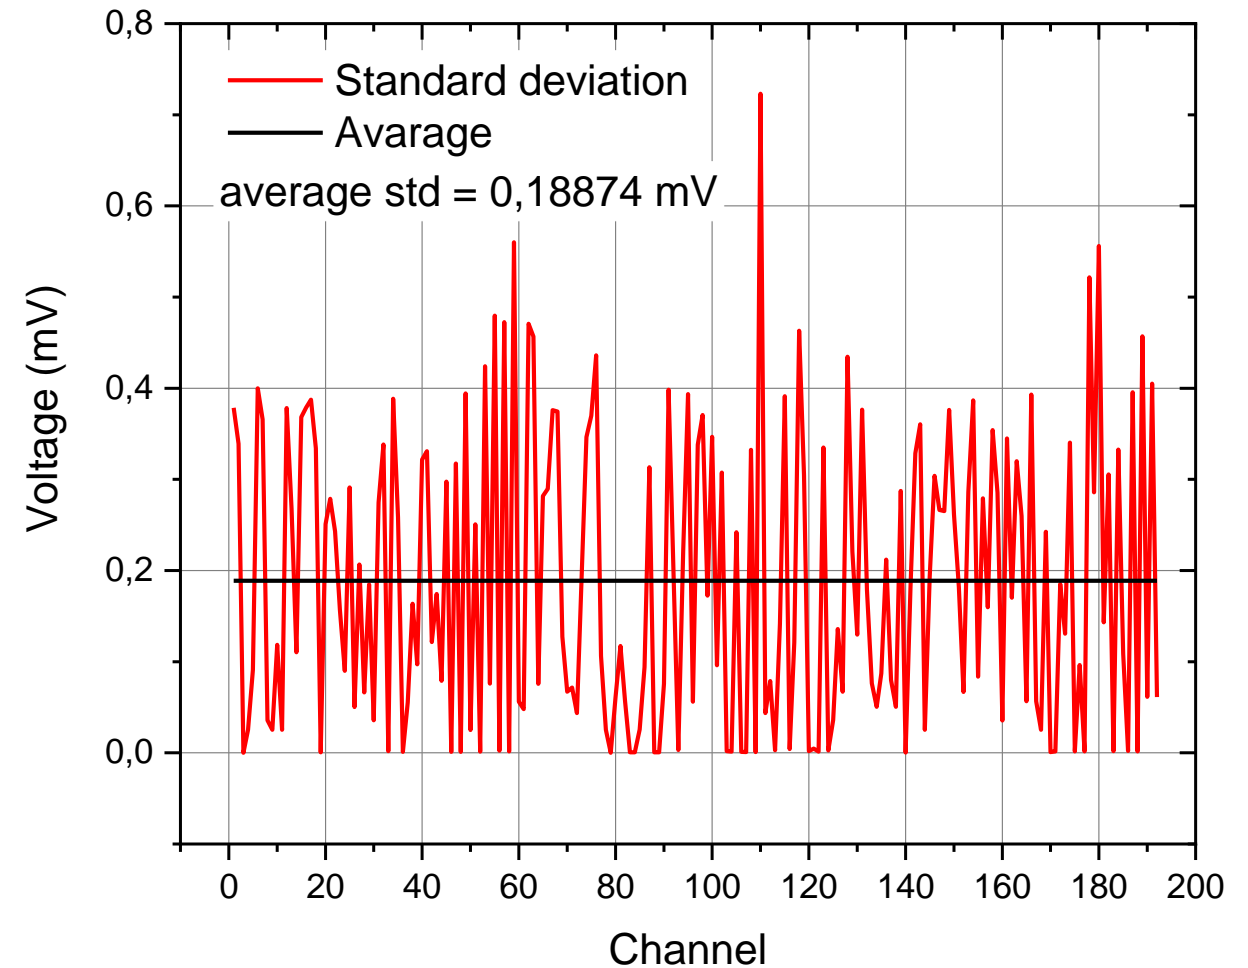
# 192Ch-GBP-W2 under X-ray - fitting

**The X-ray profile is not a normal distribution.**

*There is no information about the X-ray spot (beam size, etc.). Details are being specified and will be shared later.*

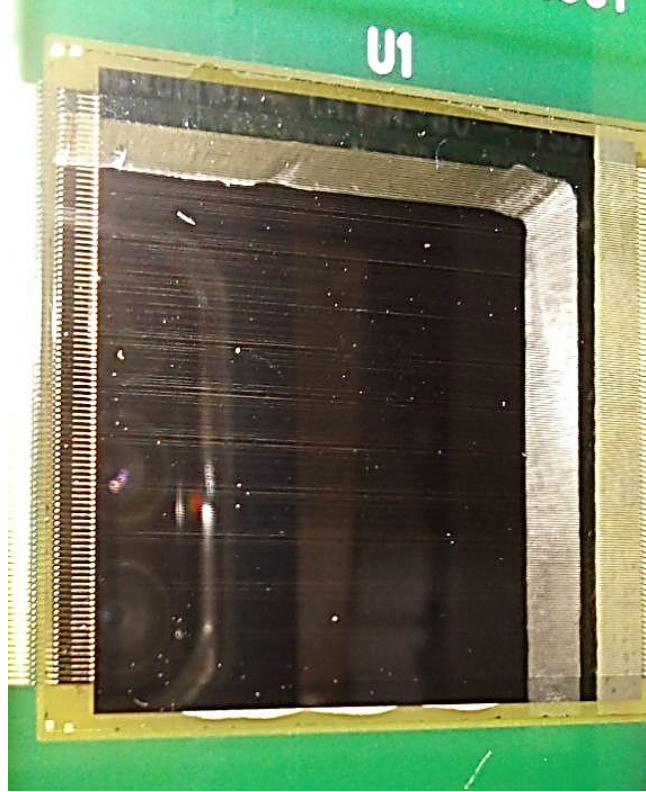
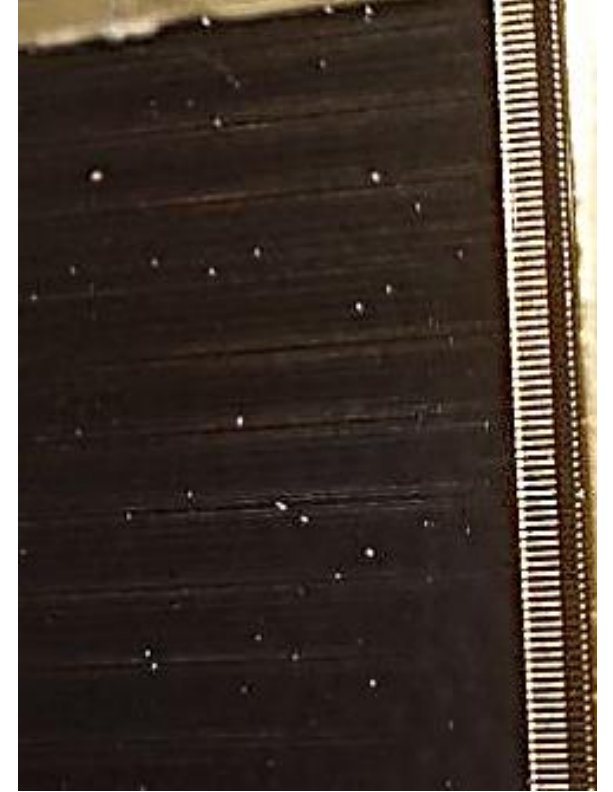
After the X-ray tests

The alternating dark and white lines appear, which coincide with the location of the strips after the X-ray treatment. The line's pitch is not regular and large than the pitch of the GBP stripes.
