Experiences gained during pre-production of a largescale detector: expect the unexpected

Sergio Díez Cornell, on behalf of the ITk strips community Detector R&D retreat@DESY, 19.01.2024

Short version title: PANIC AT THE ITK!!!

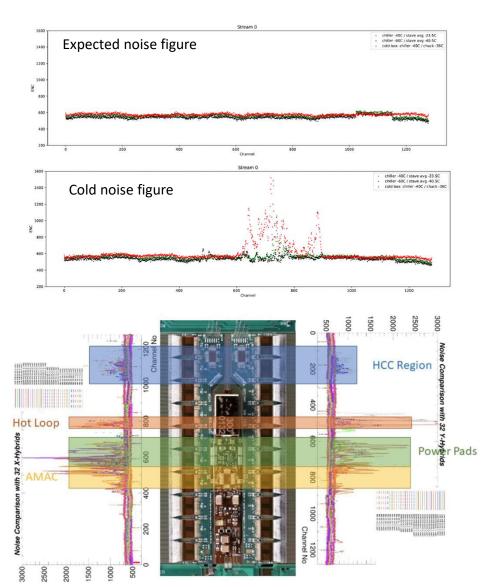
When cooled down, noise peaks occur in different areas of the module

- Turns on at different temperatures (typically -10 C)
- Affects specific sections of modules
- Typically reversible when module warmed again
- Increasing power leads to increasing effect
 - Short strip modules more prone to cold noise
- Observed on single modules as well as staves
- It was not observed on prototype modules
- It was not observed in endcap modules

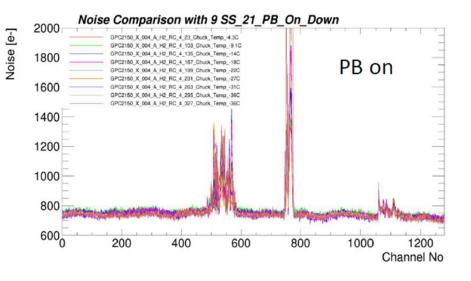
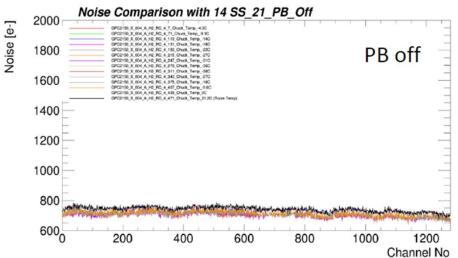
Identifying the source

Quickly isolated the source of the noise to the power board

❖ By powering hybrids externally on modules with known cold noise we were able to turn cold noise on/off via the power board

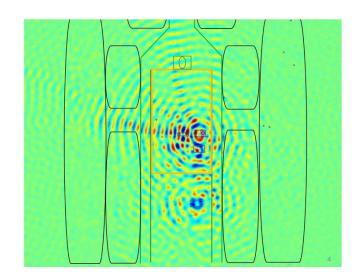
Suspected cause: **mechanical vibrations** from capacitors on the power board travelling through the sensor and inducing electrical noise

Coupled to regions covered with glue

Strong dependence on glue choice between electronics and sensor

- "True blue" (Eccobond F112) shows little cold noise
- "False blue" (Atom Adhesives F112) shows loads of cold noise

Power board substrate is one of the key parameters as well

- Type of adhesive, stacked vs. staggered vias, copper thickness,...
- Possibly explains why EC modules show no cold noise

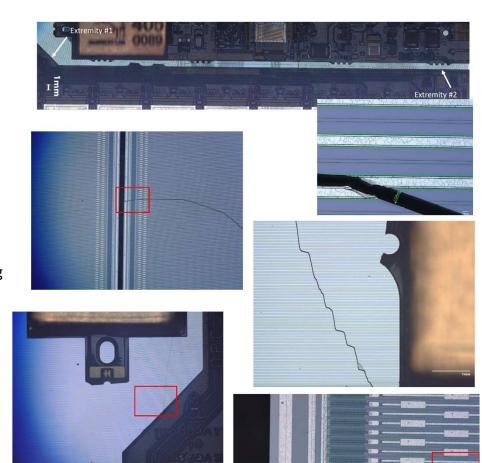
An Early breakdown << 100 V with high current was observed associated to cracking of sensors on loaded objects (staves, petals)

- 1. Usage of a (100x) stiffer glue between sensors and local supports
 - ♣ Hysol 9396 loaded with Al₂O₃ powder
 - Dispensing studies promising, first stave and petal sides imminent
- 2. Increasing the gap between electronics components
 - Only possible in LS, R4 and R5 modules (to first order)!
 - First two LS modules with wide built, good performance (also, no CN!)
- Usage of thinner hybrids/PBs
 - Coupled to CN mitigation!
 - Only possible to barrel modules
 - Possibly unrealistic copper reduction to have a significant stress reduction
- 4. Modified glue patterns to ensure glue coverage below gaps
- 5. Others: Filling in gaps on top surface, modified thicknesses

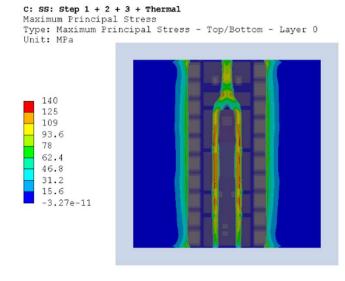
While progressively adding more realistic mechanical parameters, simulations reached the same conclusion: high stress regions coinciding with the observed crack formation regions

High stresses in similar locations for barrel and EC modules

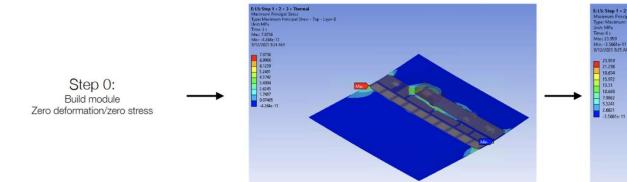
Step 2: Mount on the stave with opposite bow

Assuming sensor breaking at ~120 MPa, incremental impact of each step:

- ❖ Module QC: ~5%
- ❖ Stave mounting: ~ 10%
- ❖ Stave cooling to -35 C: ~ 105%
- Stave cold and powered: ~-10%

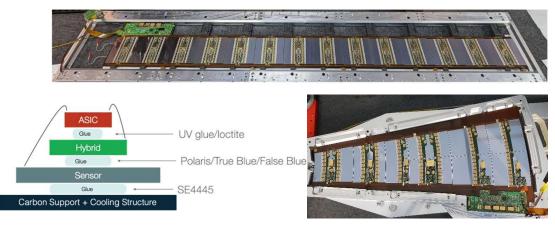
CTE mismatches cause electronics components to bend upwards, which cause sensor regions in between to bend downwards, as SE4445 does not constrain the shape, causing peak stresses

One of the biggest issues appears to be the usage of a "stiff" glue (TrueBlue) above the sensor vs. a "soft" glue (SE4445) below the sensor
