Pac Tech's electroless nickel gold (ENIG) UBM process failed on 5 of 7 CiS dummy wafers

OPTICAL MICROSCOPE PICTURES OF AFFECTED WAFERS

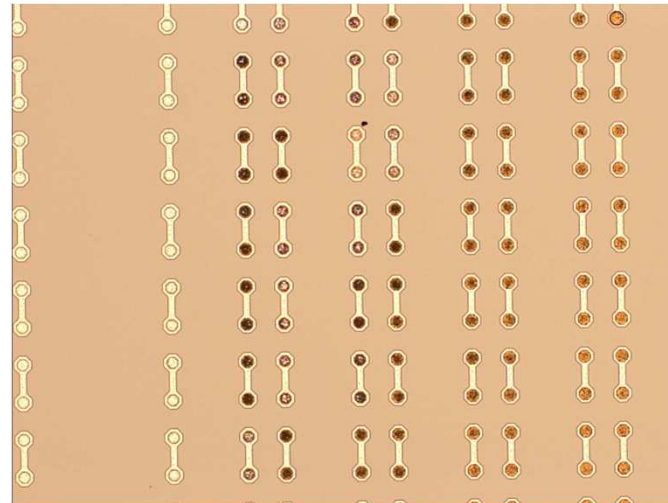
- First 7 AlSiCu wafers processed
- 2 wafers without failures
- 5 wafers show errors in UBM
- 12 unprocessed wafers (9 AlSiCu and 3 AlSi) go back to CiS

Overview after ENIG process

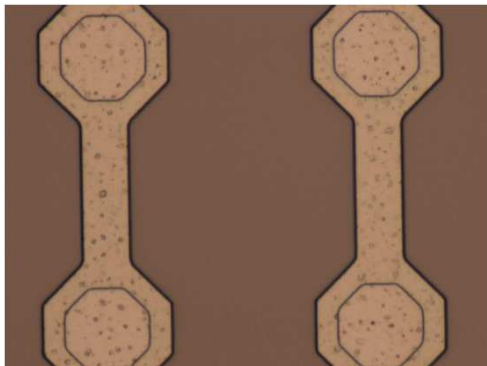
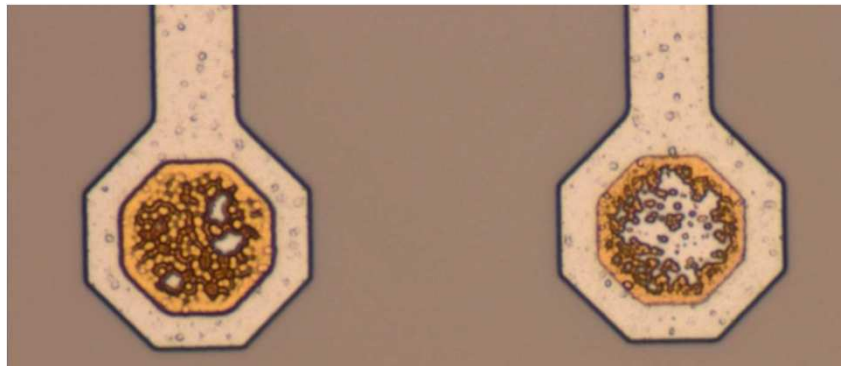
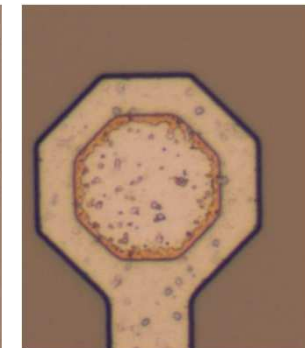
Zoomed views to pads either with missing or partial UBM after processing

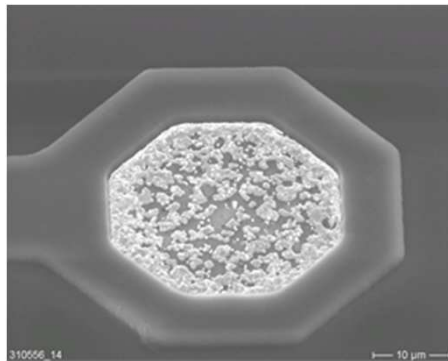
Pad with poor UBM

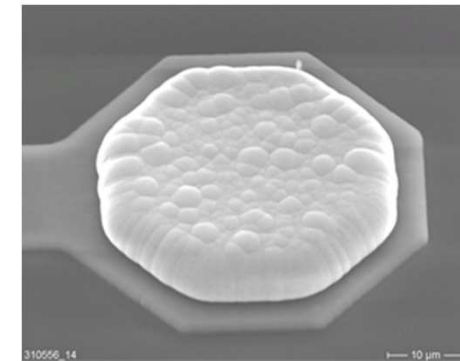
Pad with UBM

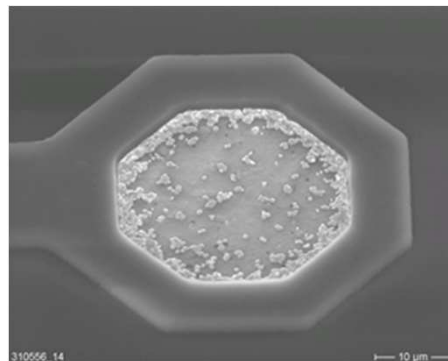
Few UBM islands only

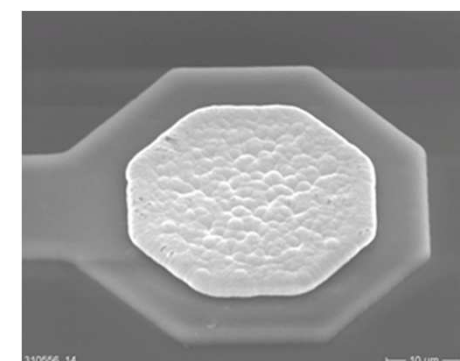
Pad with thin UBM

70 nm residual layer found in SEM cross sectional view

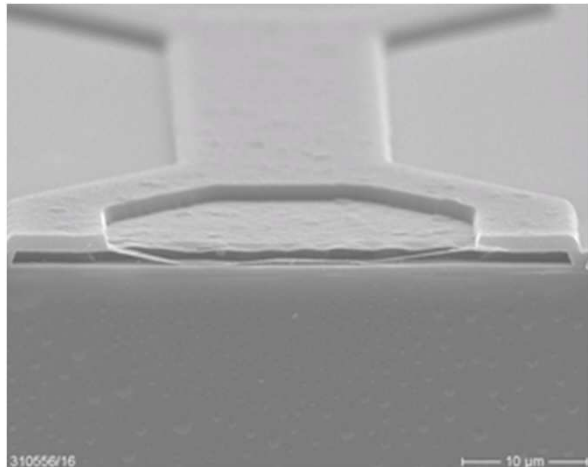
200 nm nitride
1 µm oxide
1.2 µm AlSiCu
200 nm nitride

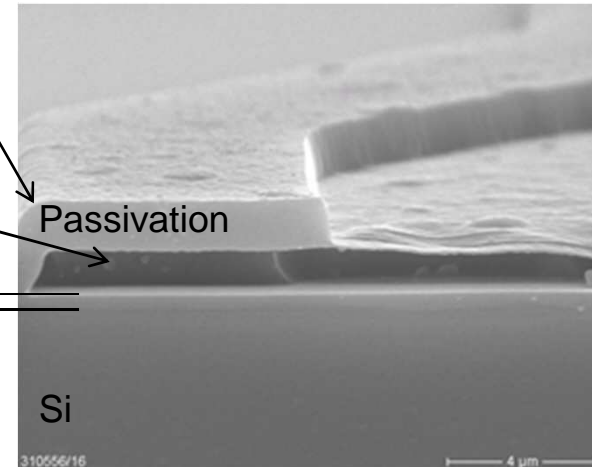
Thin residual
passivation layer
70 nm SiO₂

- was stopped too early
- badly adjusted

Oxide deposition badly
adjusted?

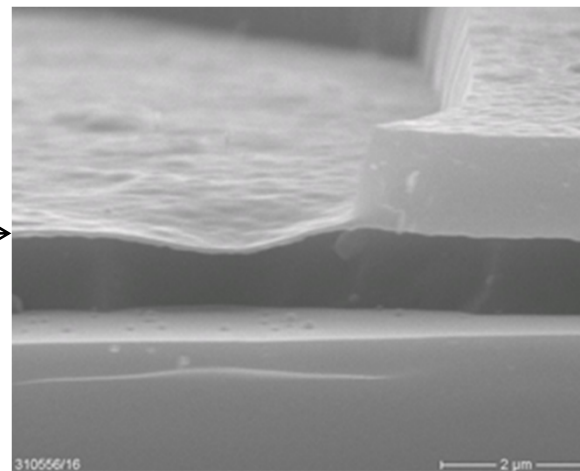
Plasma etch

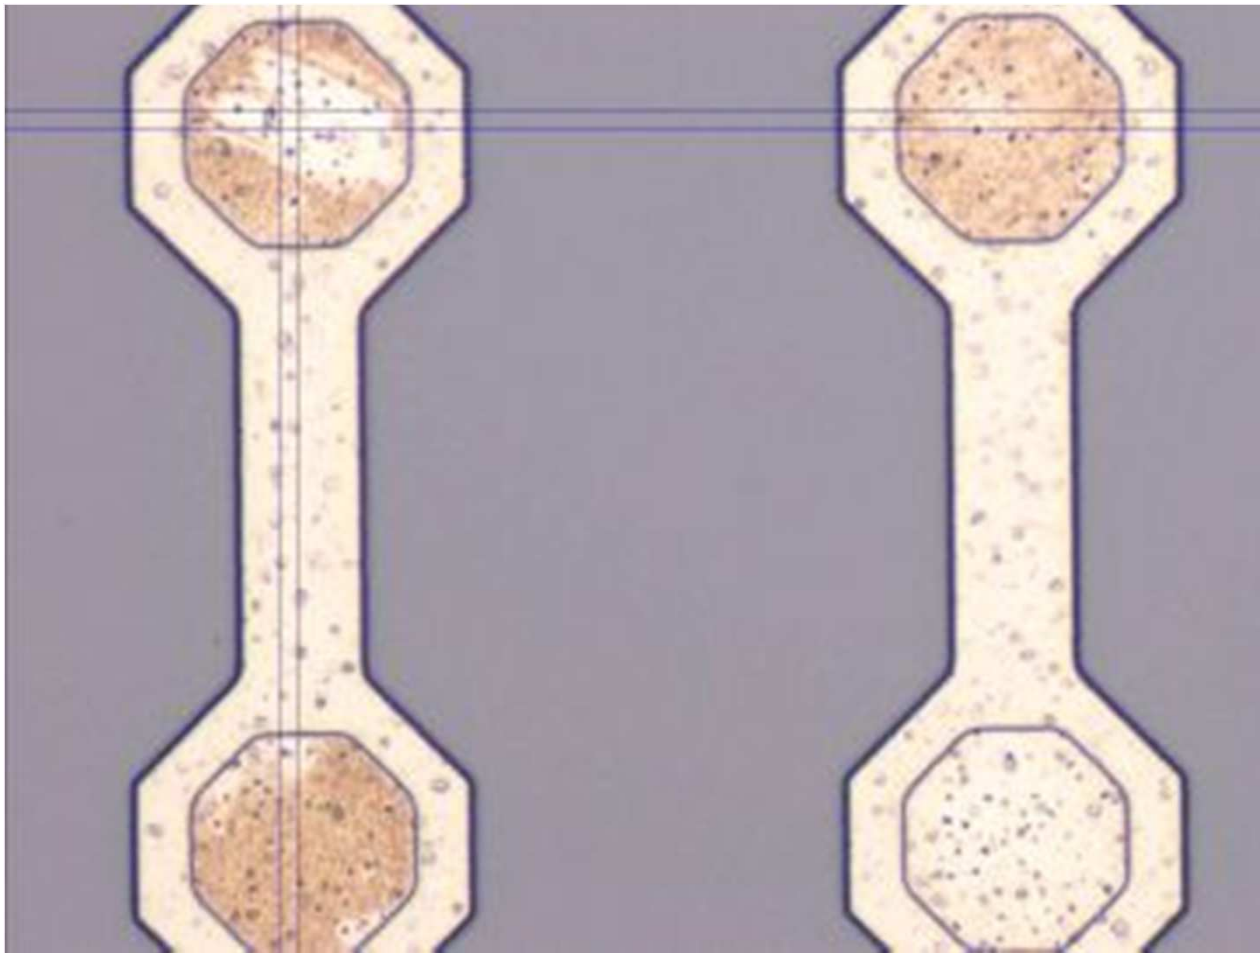
CiS second etch step resulted in discolored pads on both AlSiCu and AlSi wafers

Affected pads:
50 to 70 %

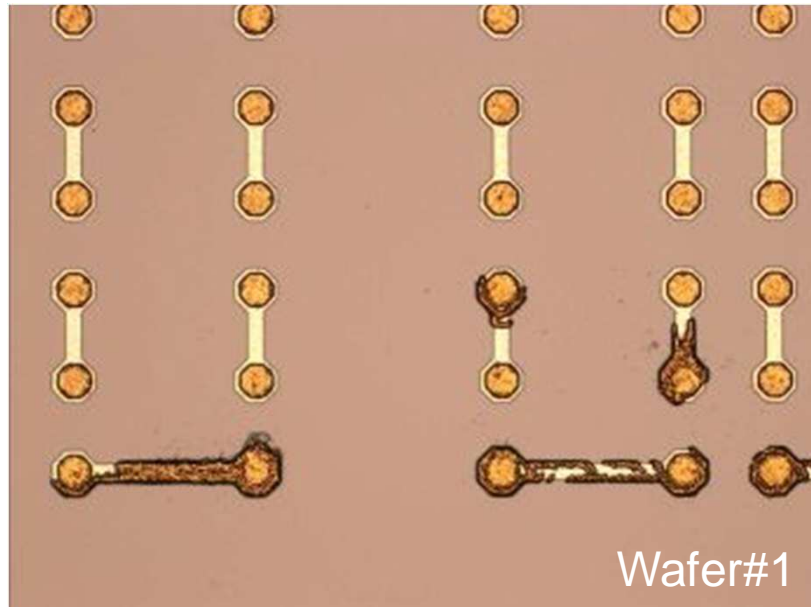
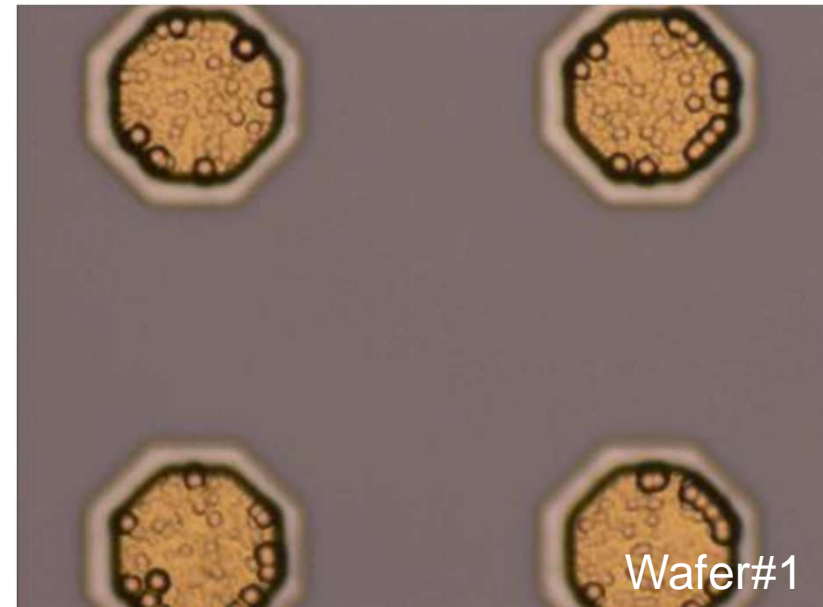
UBM deposition tests failed in shorts and rough nickel surface

- UBM growth also on metal lines → shorts
- Irregular bump growth → rough surface

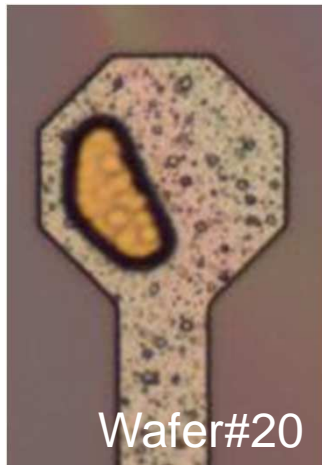
Pads are also still affected by incomplete openings in the passivation layer

Incomplete openings

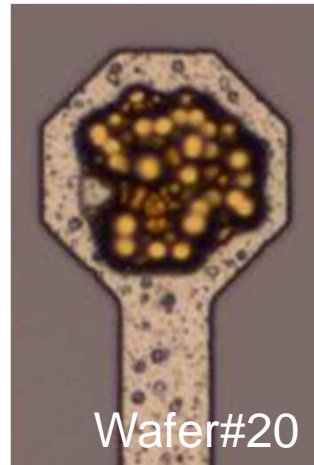
Island like UBM growth

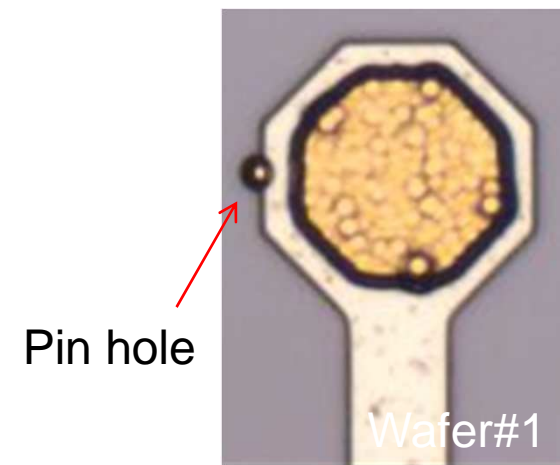
100 % of the pads are affected by failures
