# BCM1F TDCs STATUS

Cms/Fcal Meeting, 07.09.2011

## Read Output Buffer error – new board!

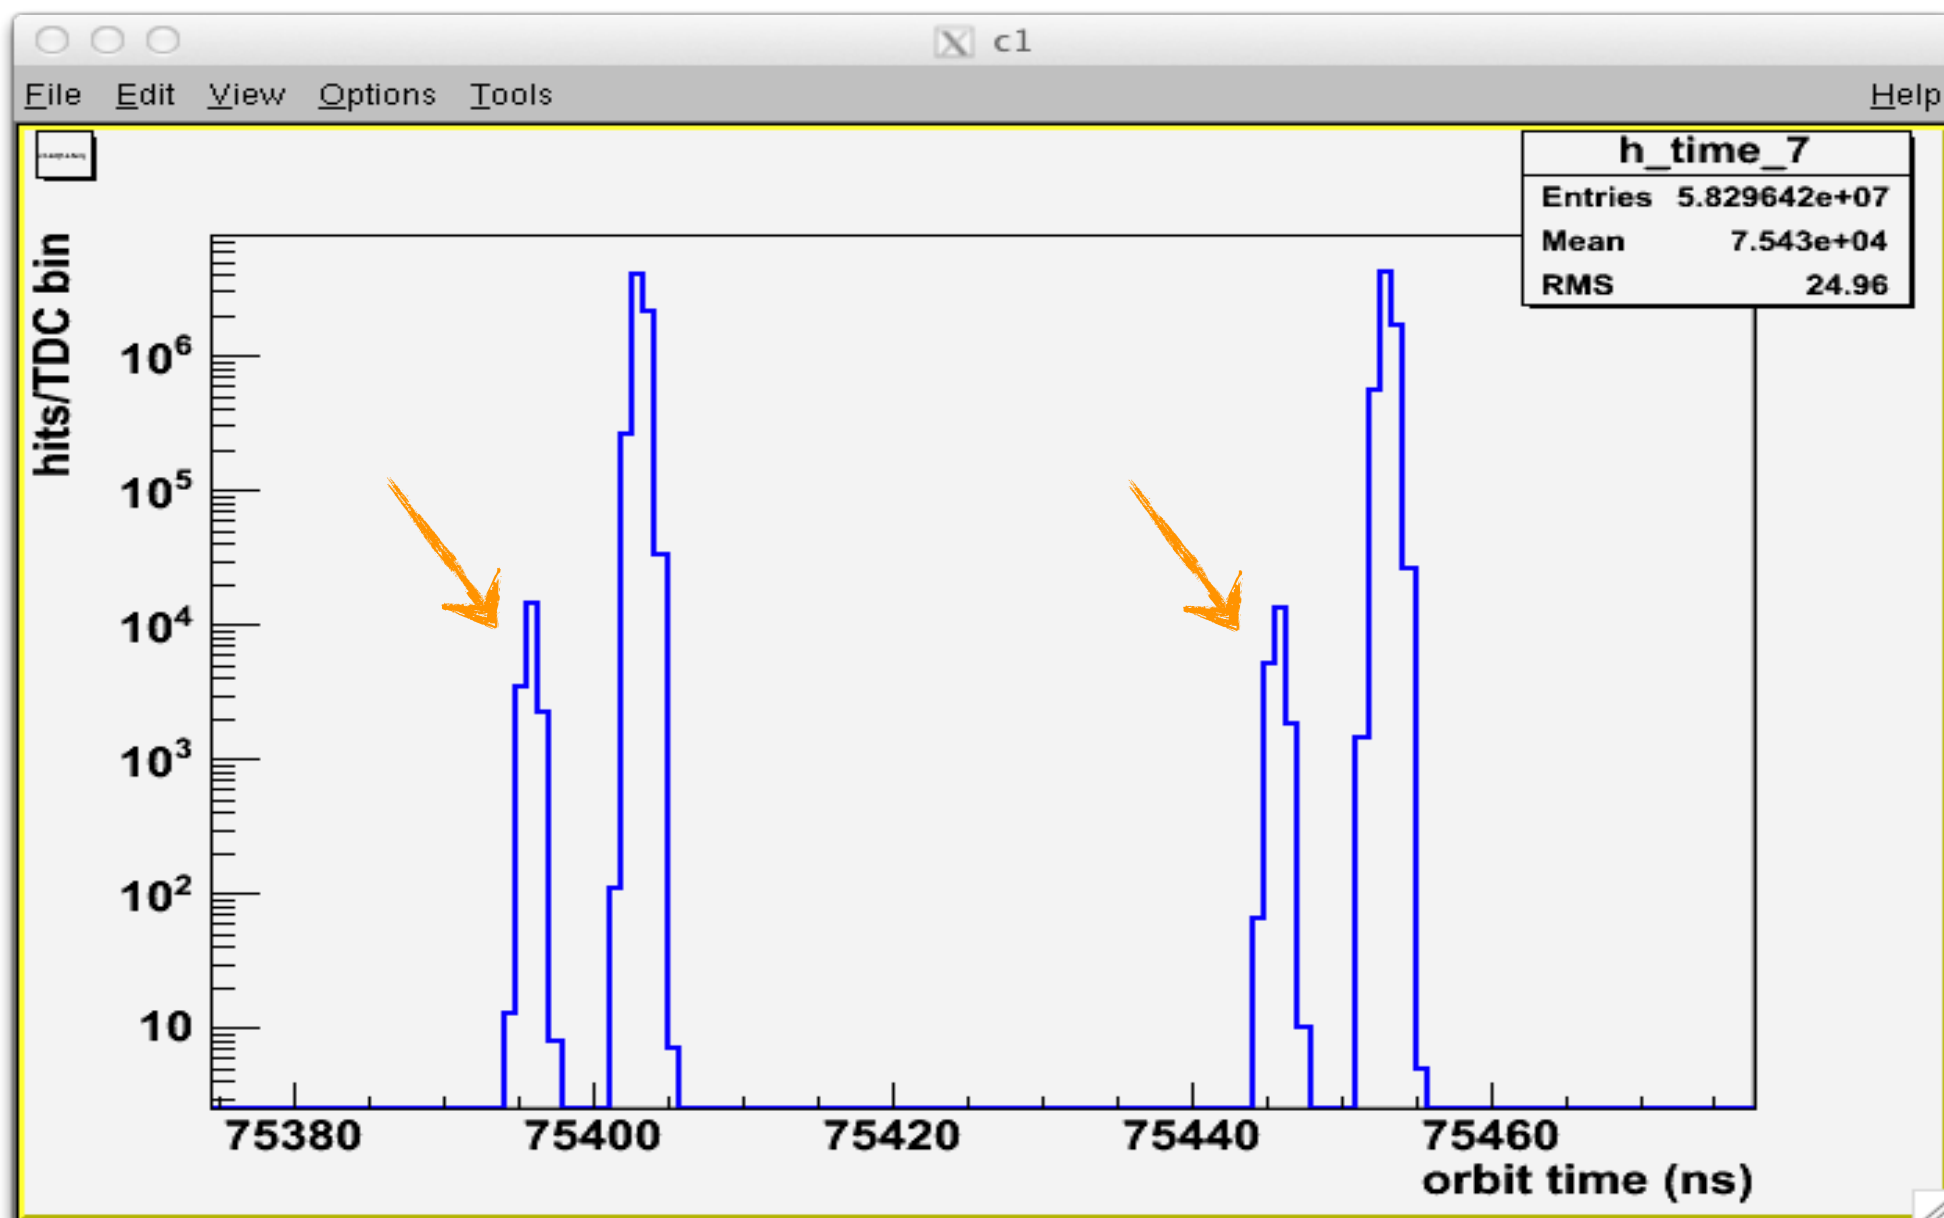
## Pulse generator (II)

- Strange small peaks 10 ns earlier than the main peaks ??? with BOTH TDC boards tested!

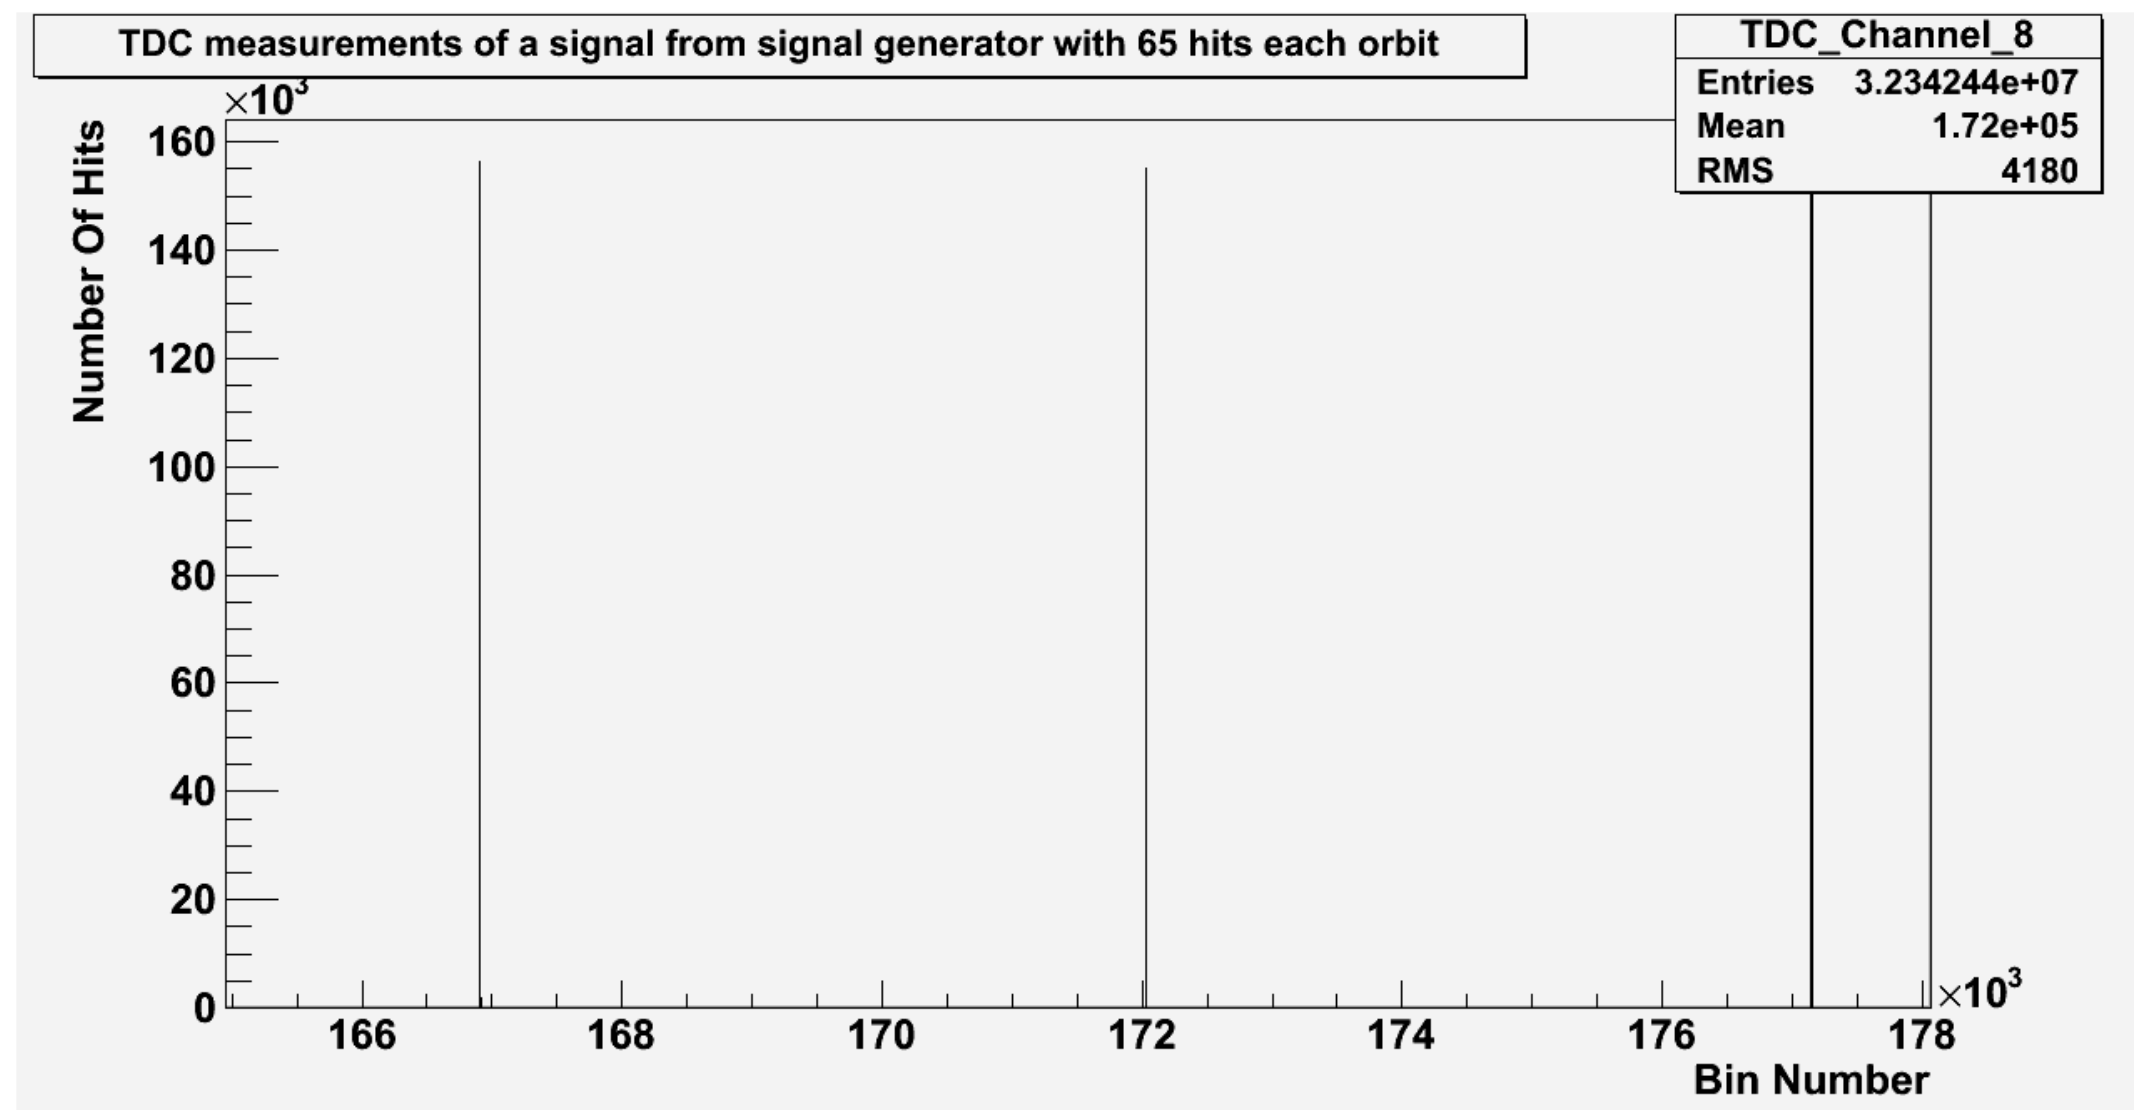
## Pulse generator (III)

- *Strange small peaks 10 ns earlier than the main peaks NOT seen in the gated crate with a TDC 1290 – by Anne et al.*

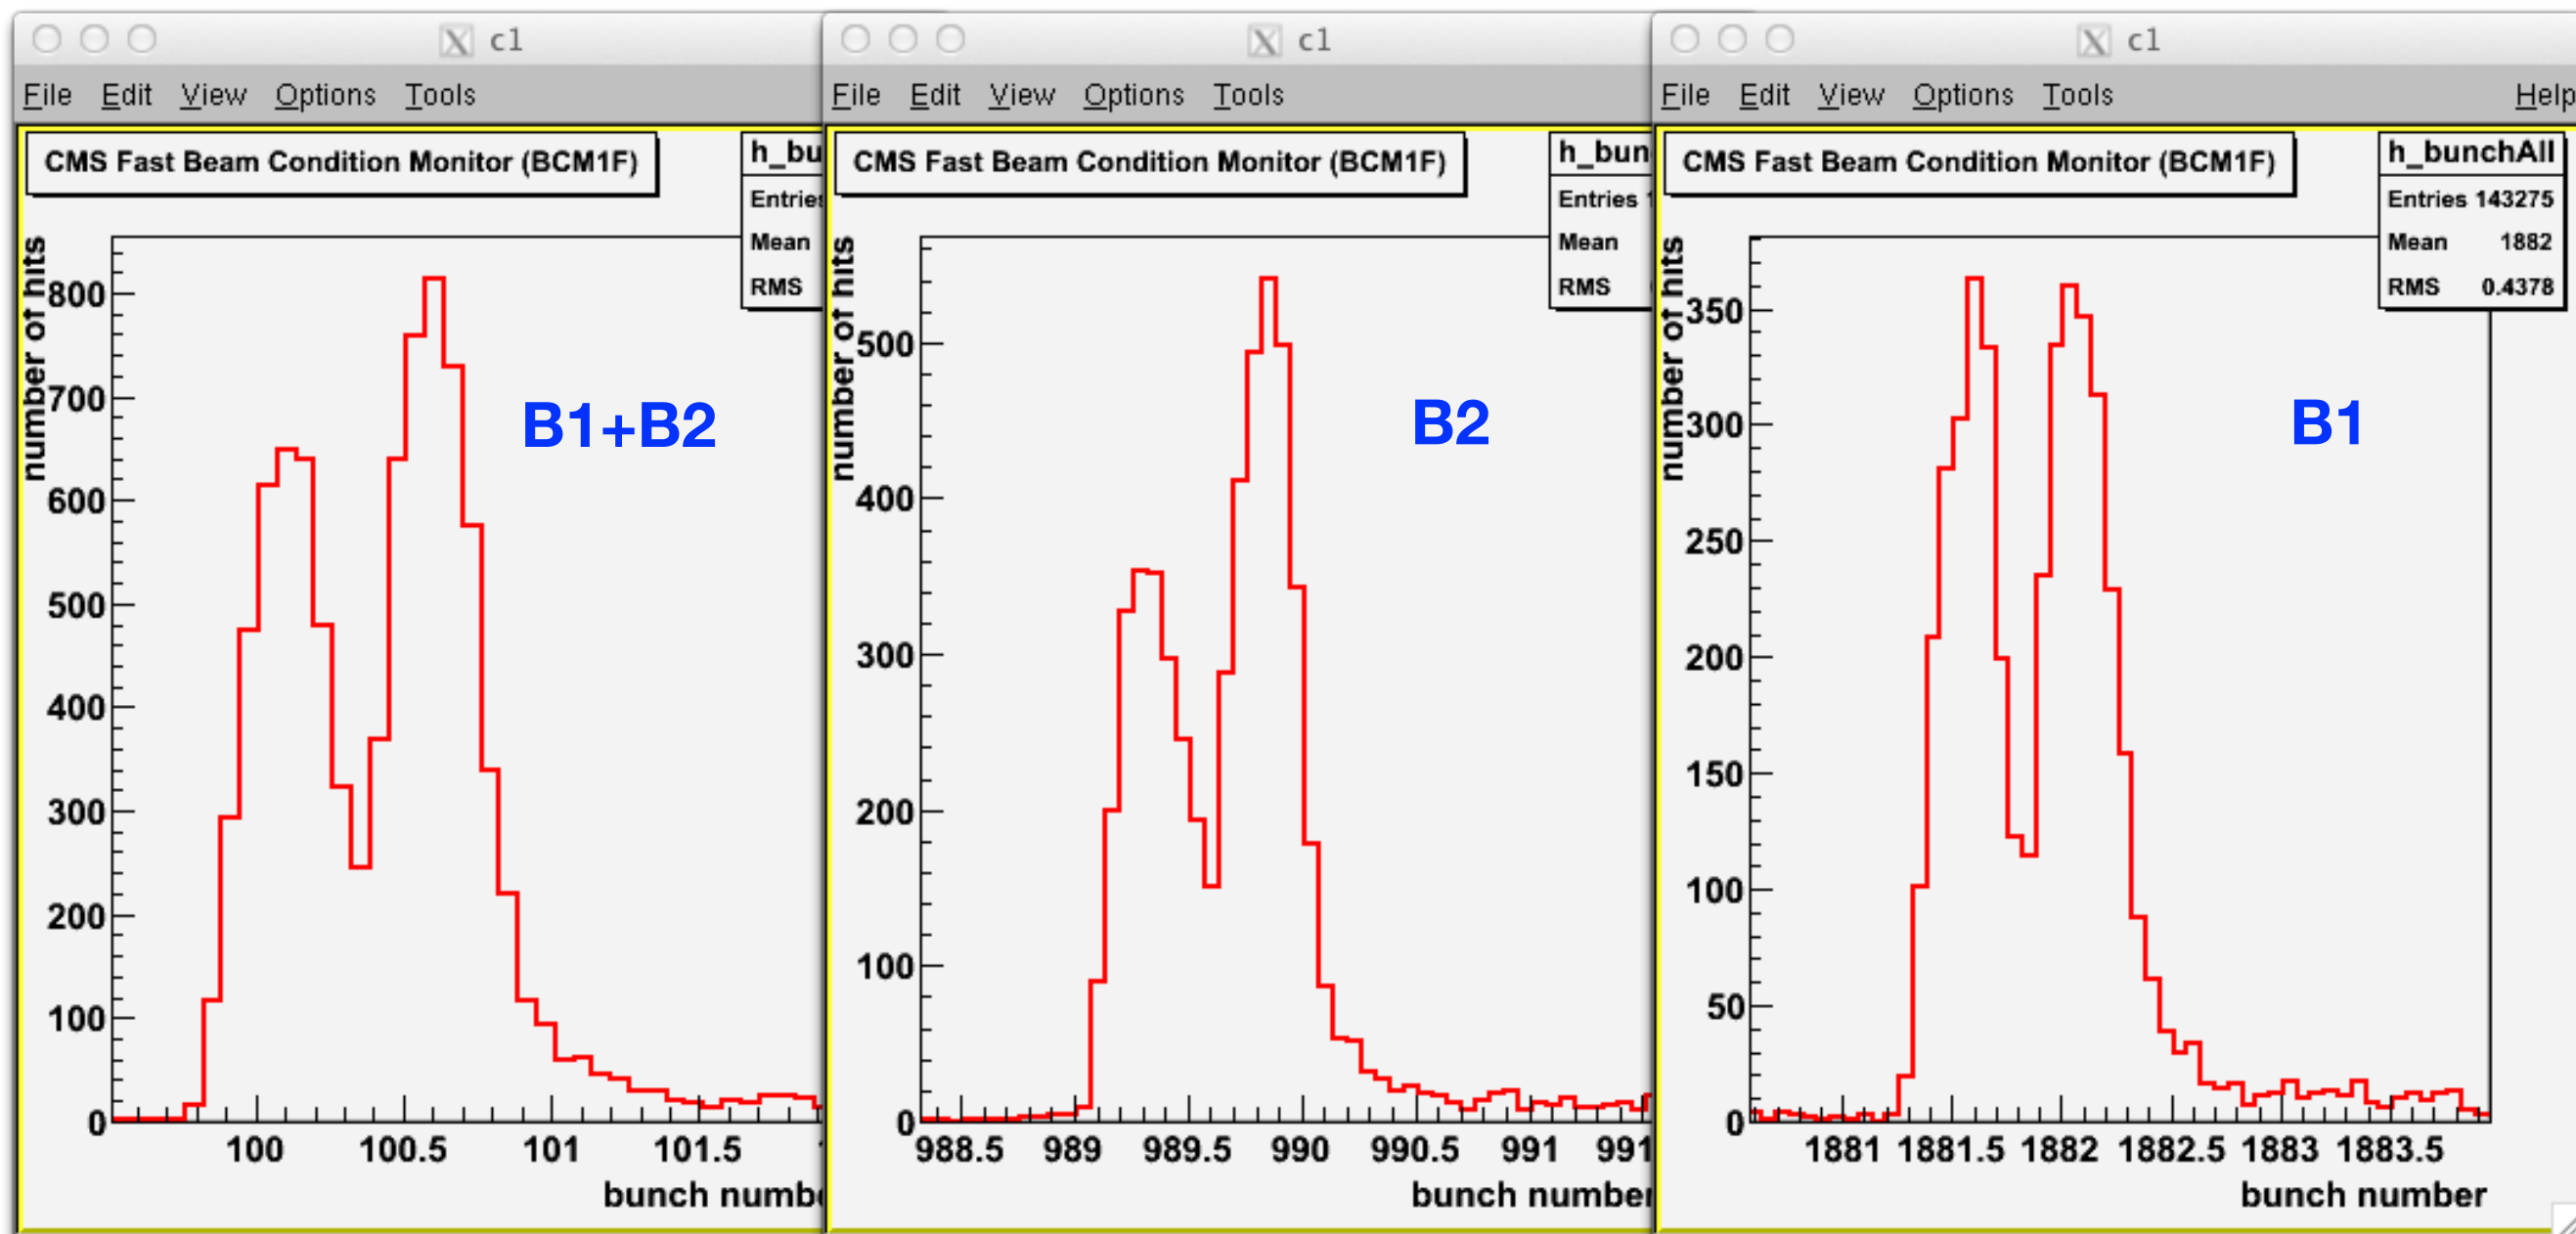
# Data BEAMS (II)

- Zoom... Resolution seems to have improved  $\sim 3\text{ns}$ !

peak position slightly off! need calibrate reference

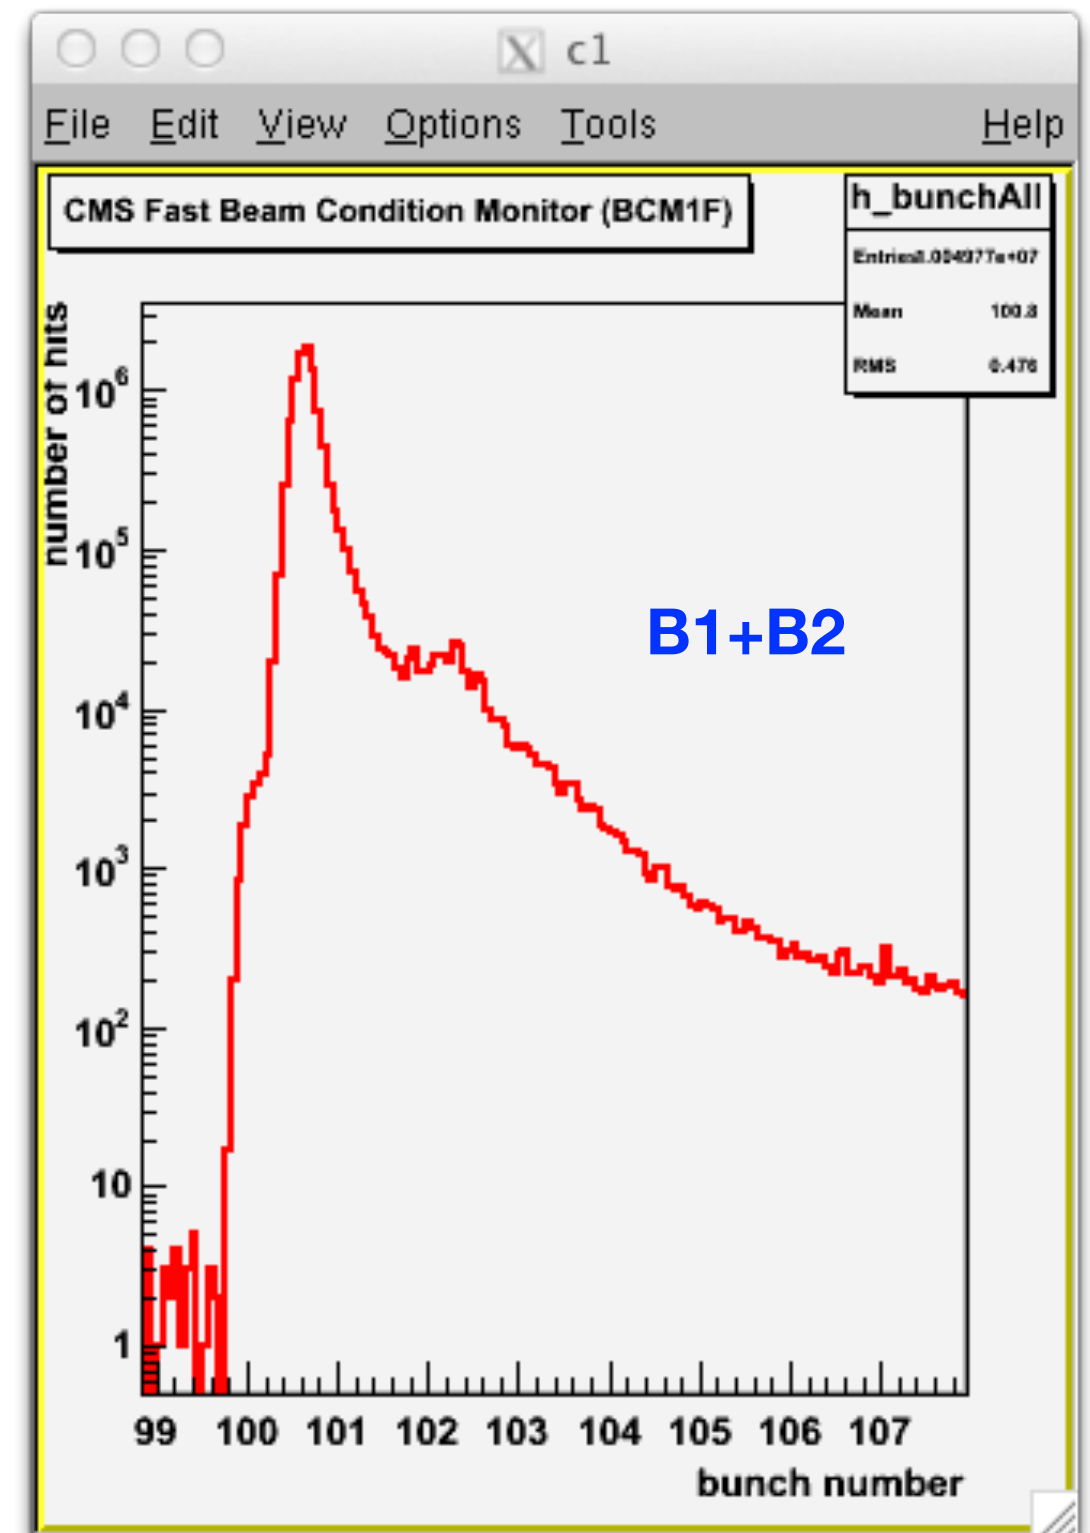
## Beams (IV)

- Strange bumps bumps before and after collision peak.
- Not able to say whether instrumental or from machine studies.
- Not enough raw data (prescaled) to do a scan.
- Seems to affect non colliding bunches too...

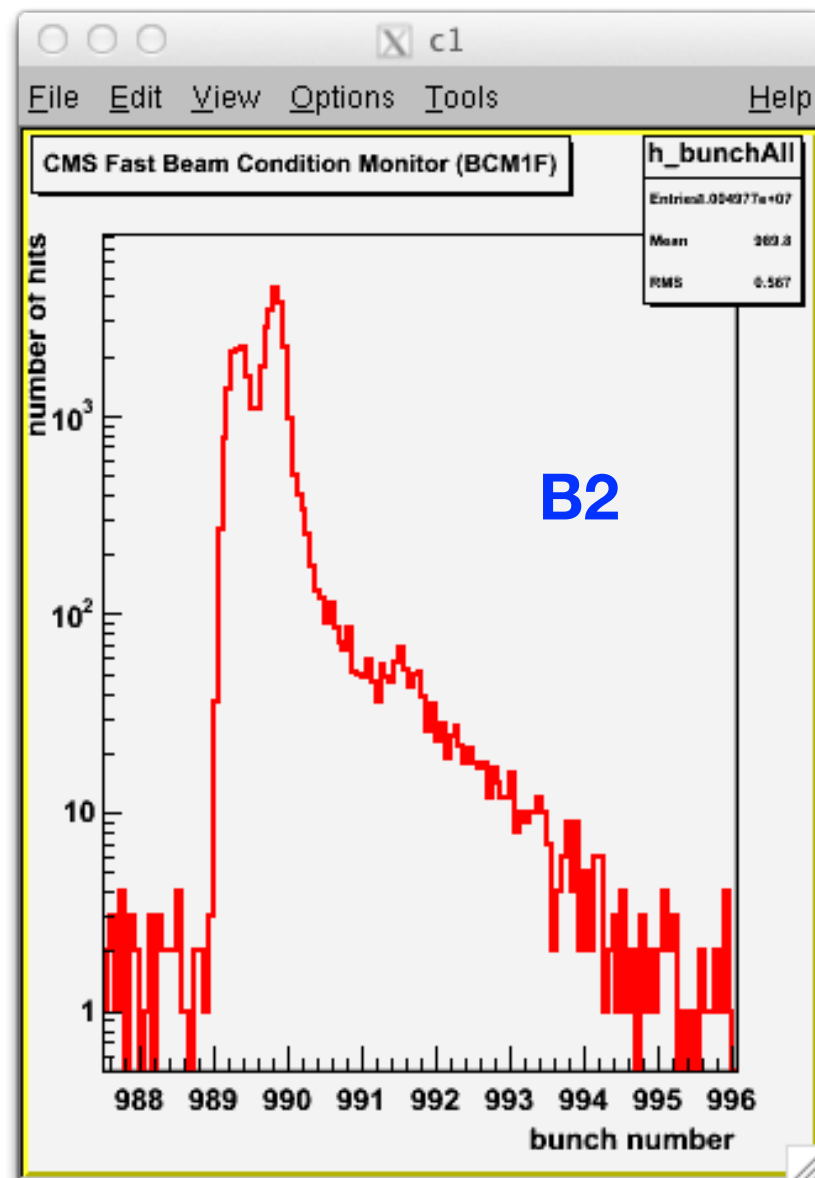
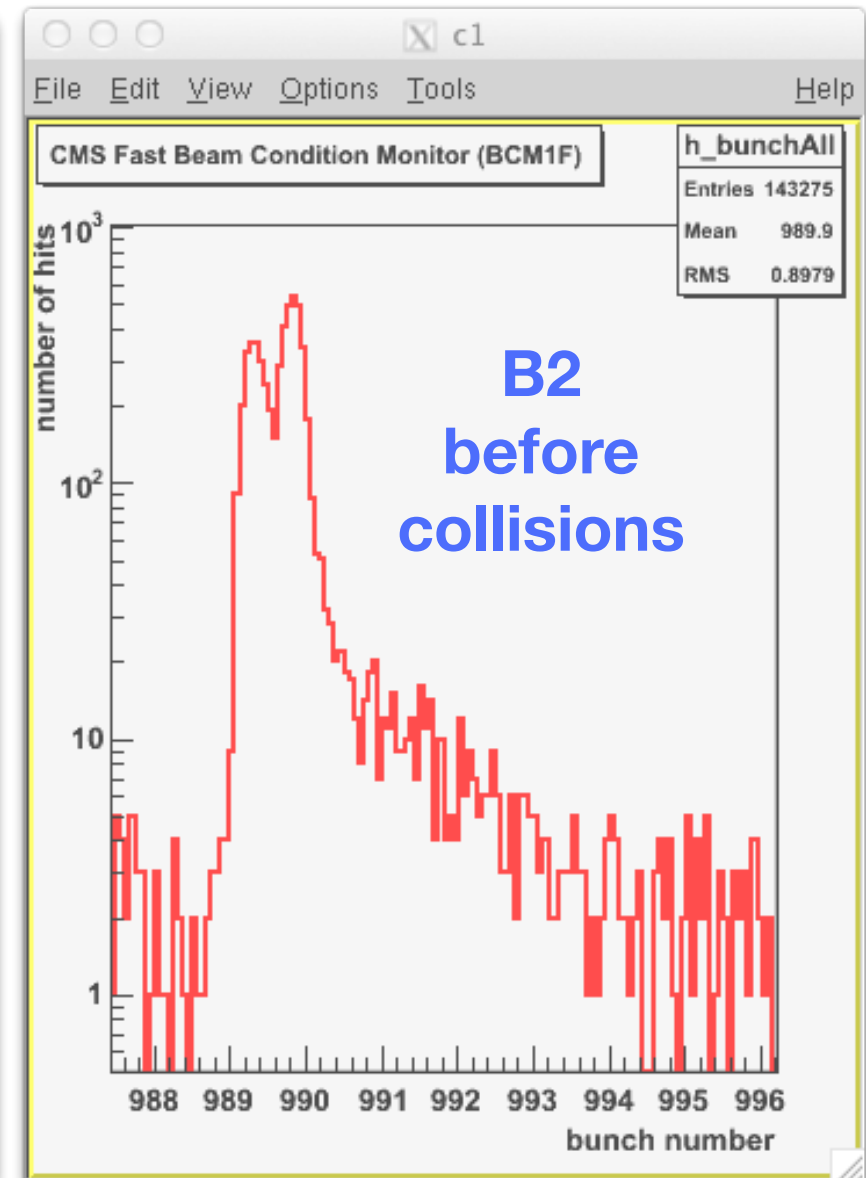
## Beams (V)

- It is difficult to tell if the bump was there before collisions due to low statistics. But notice that the rates were higher during collisions: 1 hour of data during collisions versus 2 hours of data before collisions.

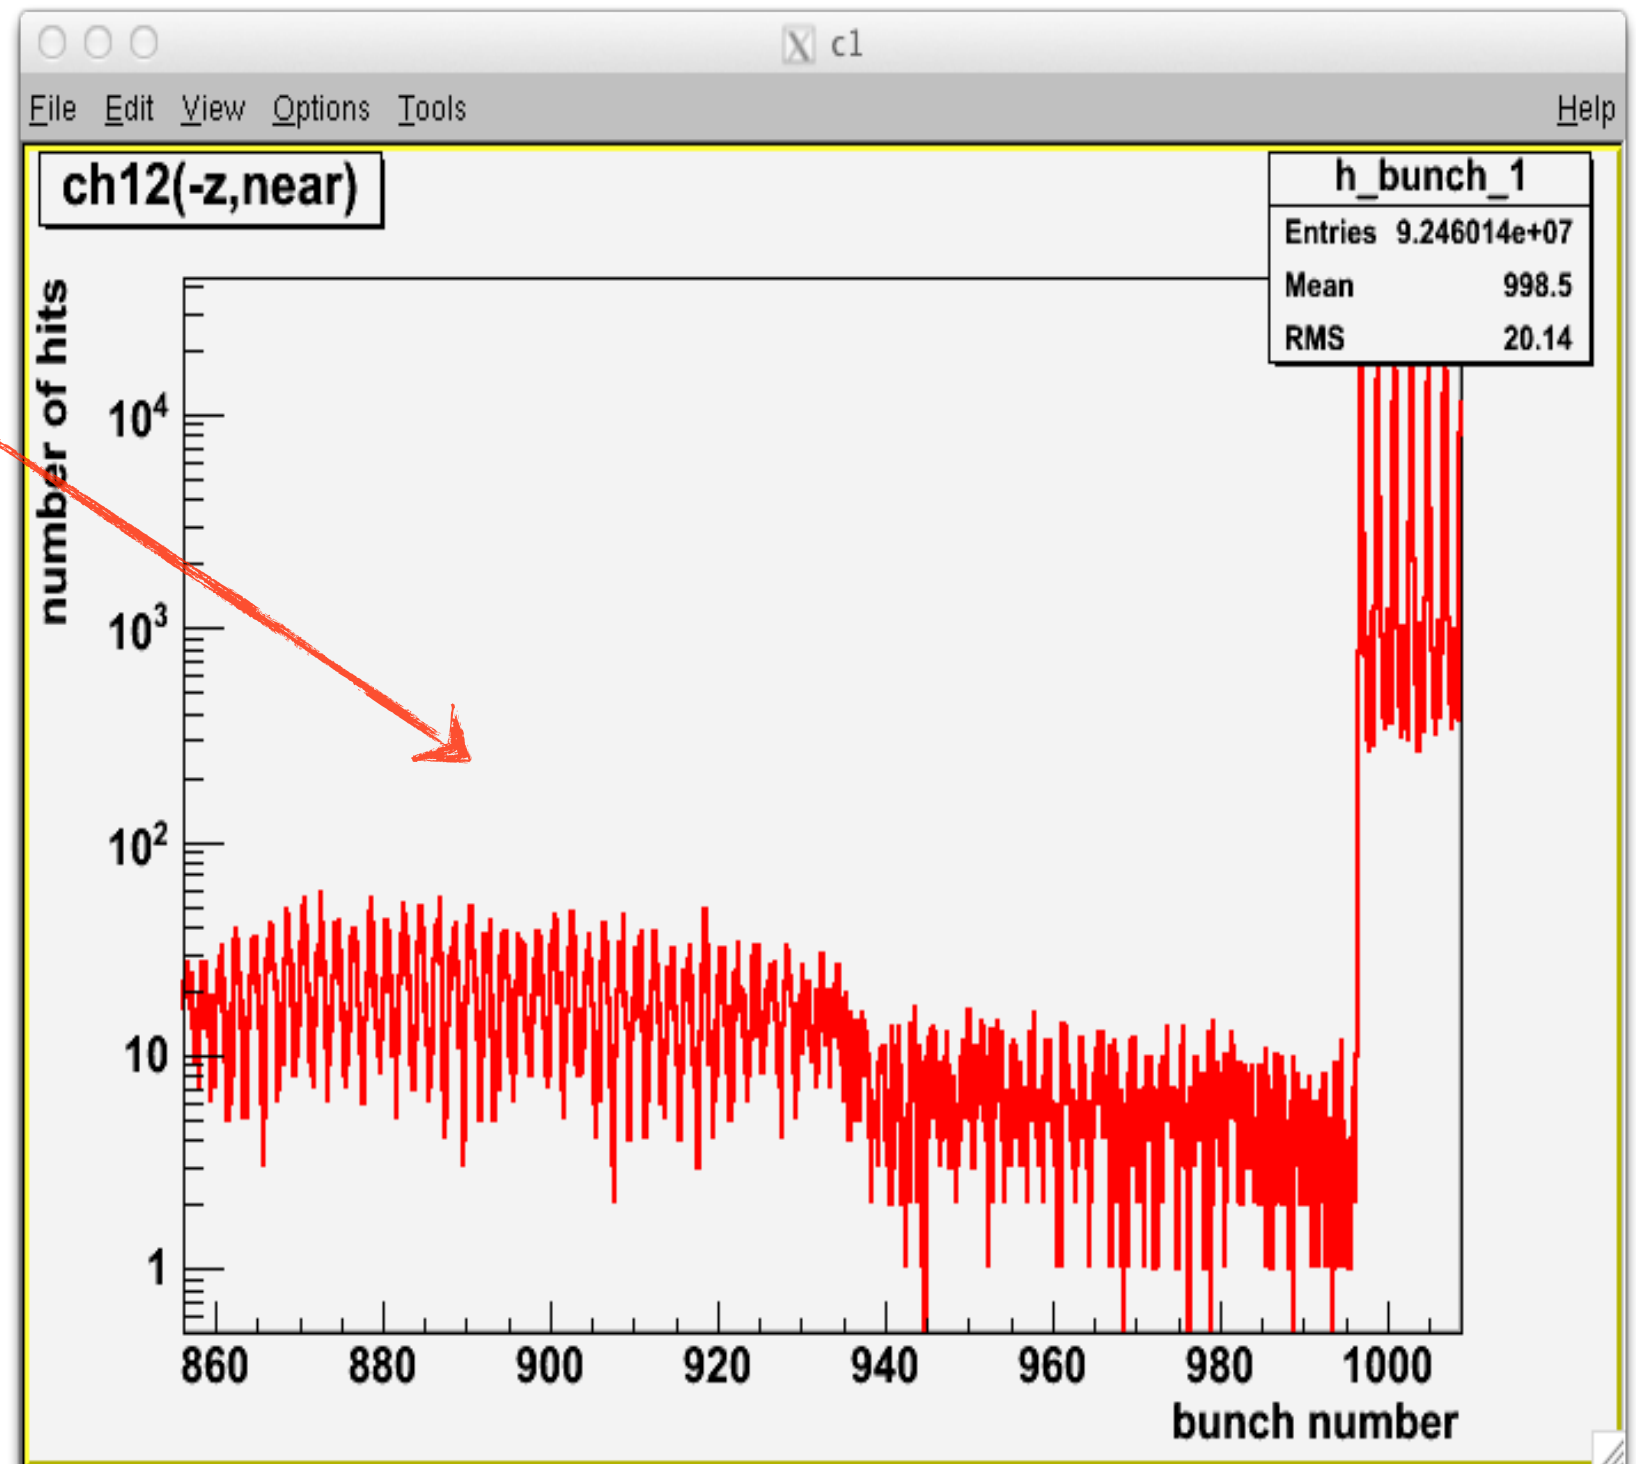
## Spurious bunches

- Spurious bunches re-appearing (08.09.11)

- CH12, CH13, CH22, CH23

- NEW BOARD!!!

- Errors from **chips 1 & 2** at high rates.  
Channels disabled → no errors.
- Spurious bunches in channels connected to **chips 1 & 2** as with previous board.
- **Are both problems correlated?**
- Hit errors in **chips 1 & 2** seen in previous board before being replaced!
- **TO BE INVESTIGATED:**
  - **Damaged cables**
  - **Problems with VETO**
  - **Could chips 0 & 3 handle the 8 channels?**

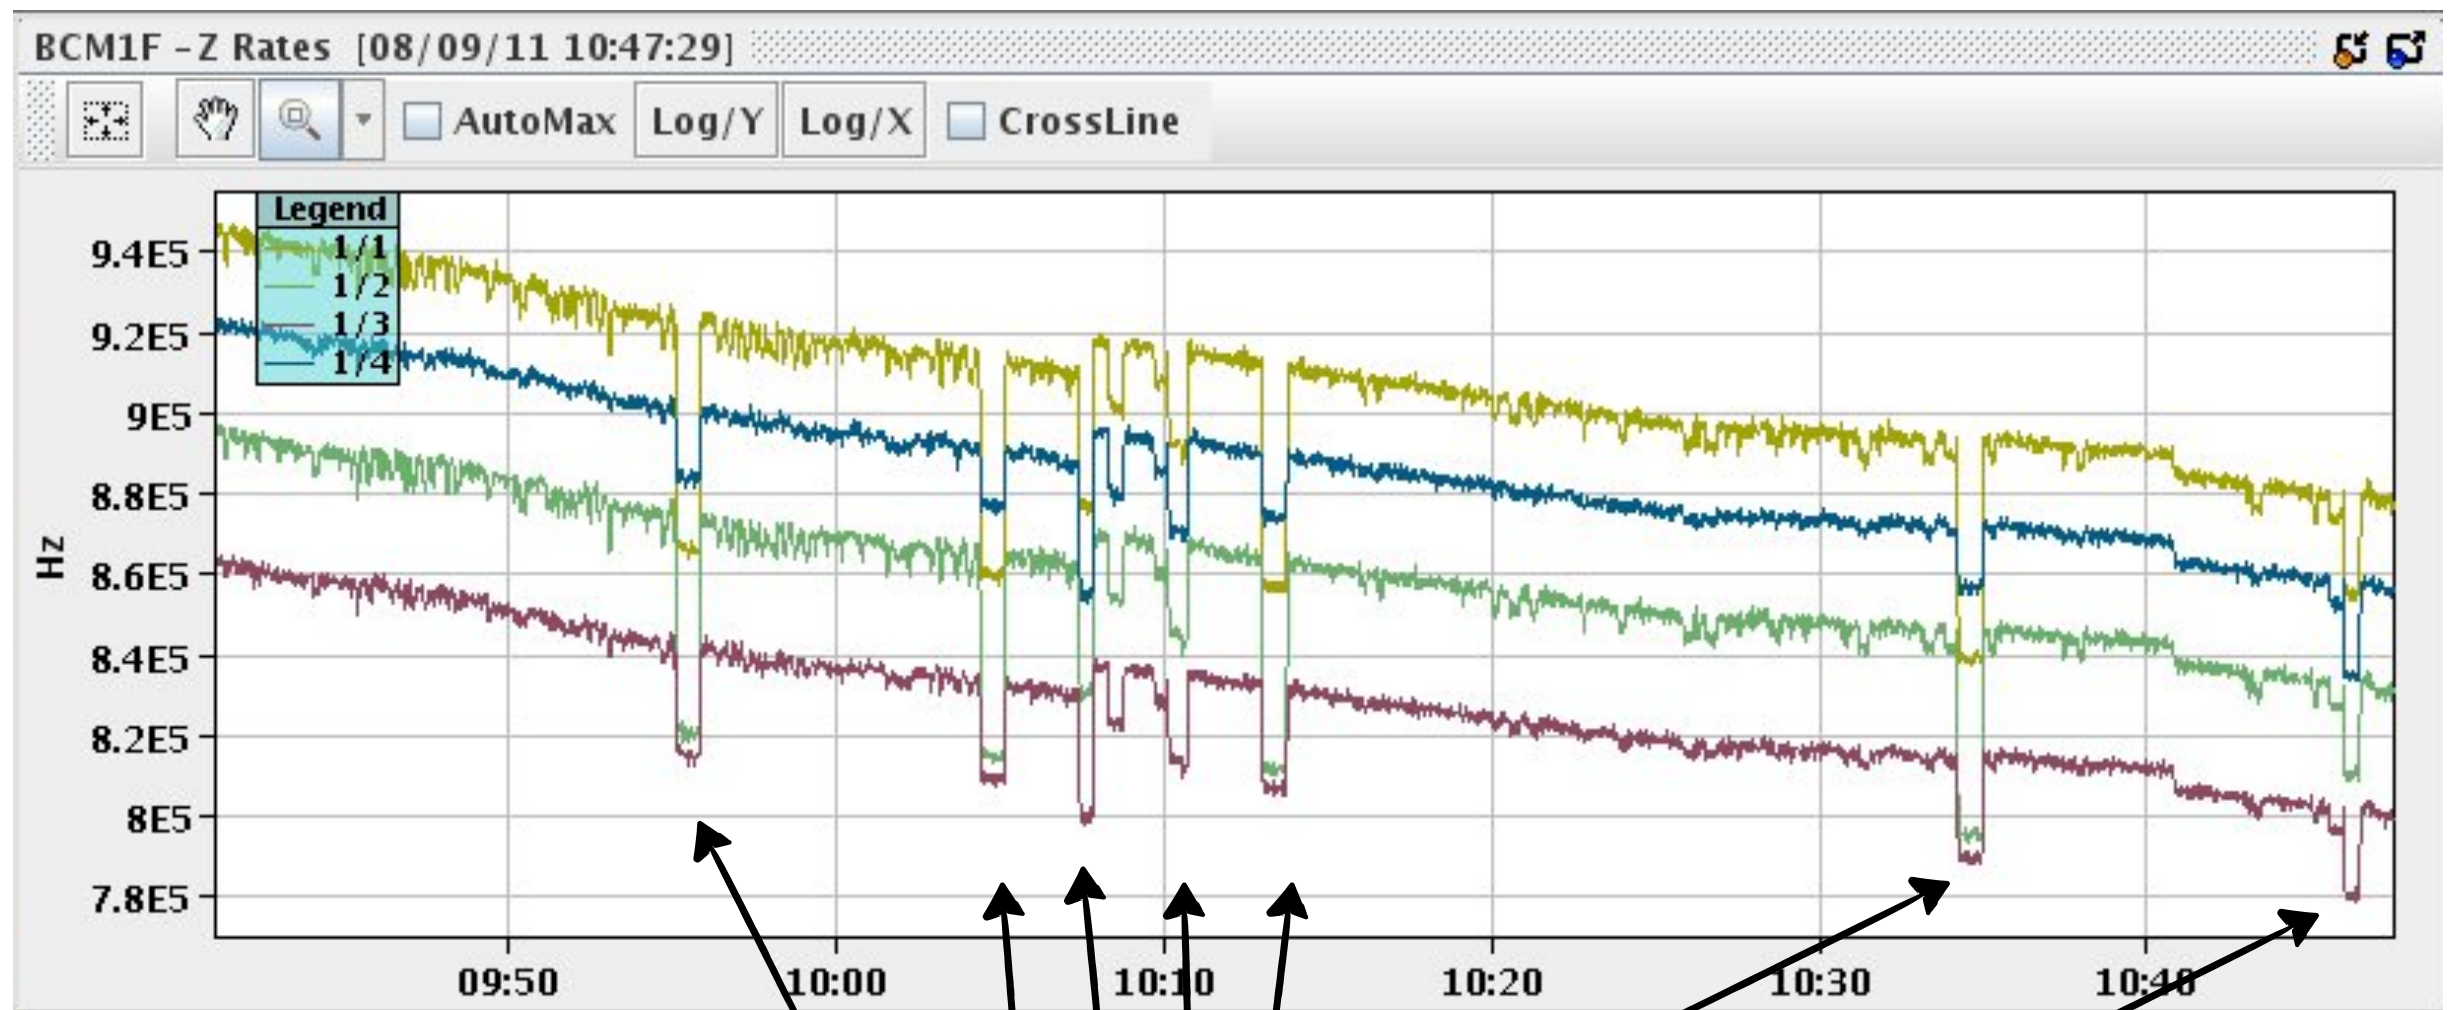
## TDC-SCALER CORRELATIONS

TDCs resets!

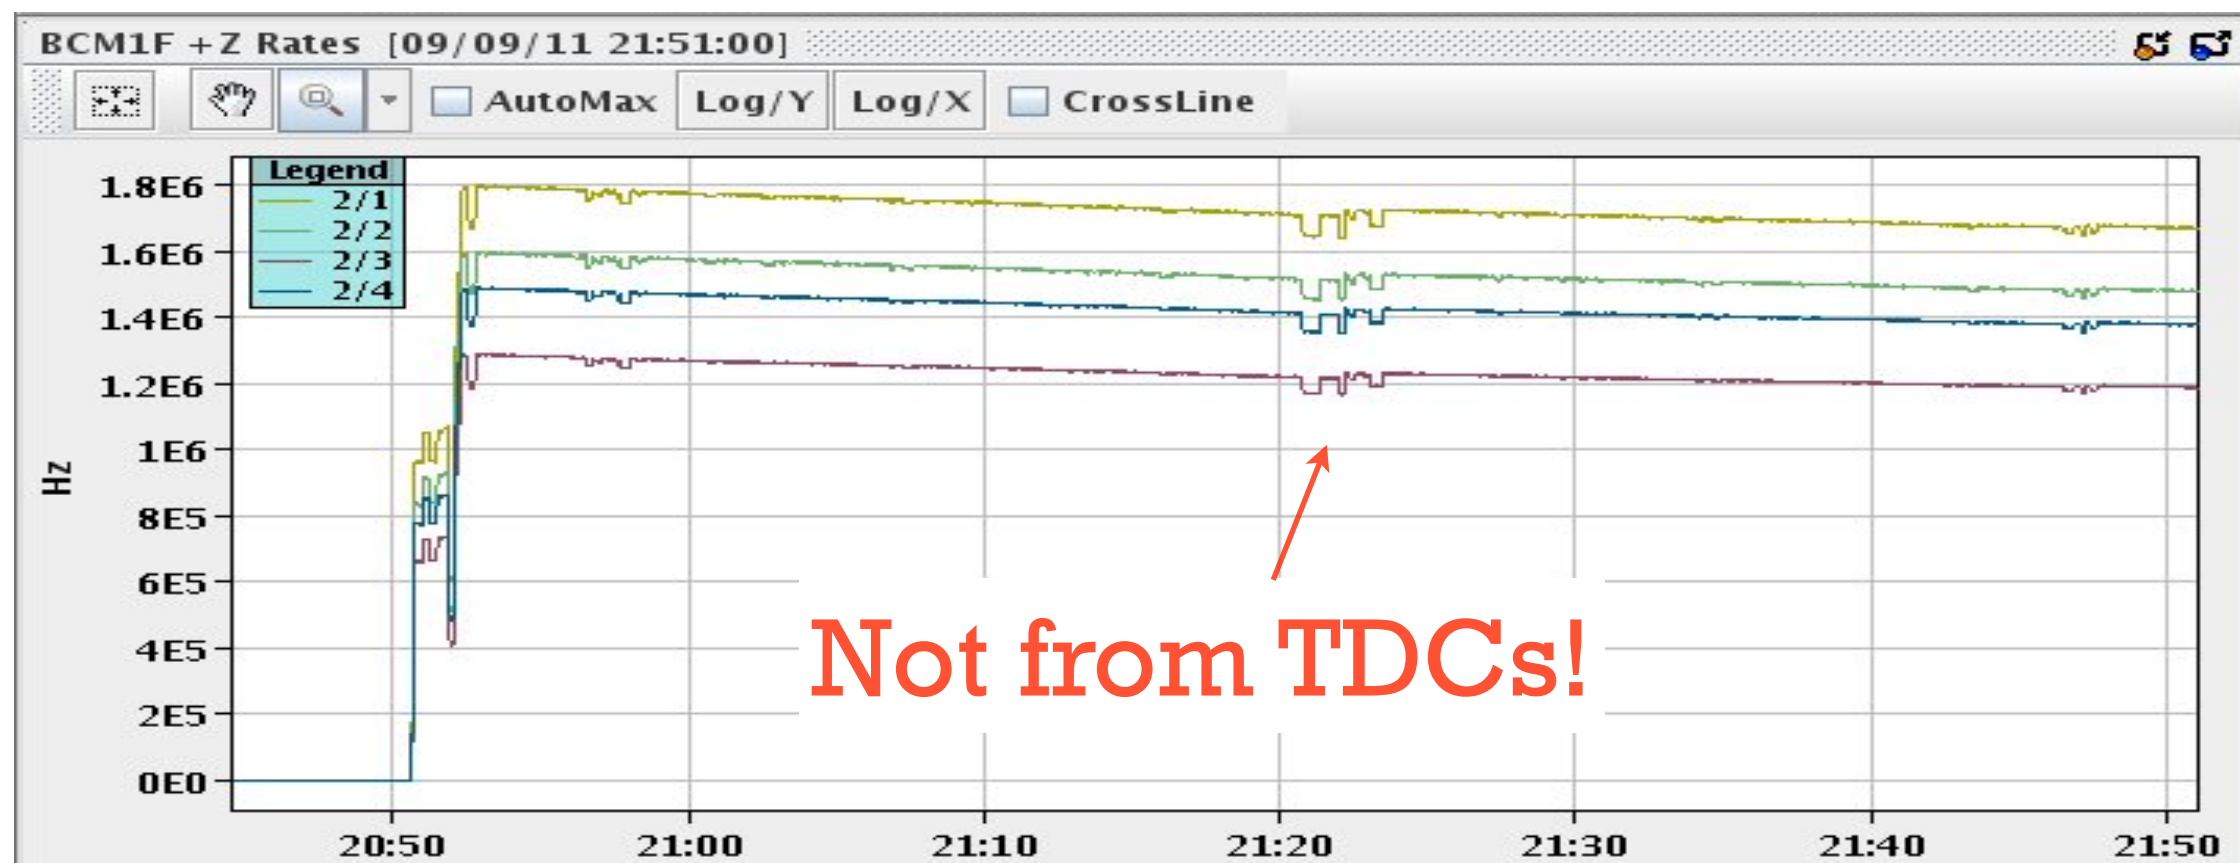
## TESTS

- Channels (CH12, CH22, CH13, CH23) connected to TDC chips 1 & 2, disabled (Fri 09.09)
- TDCs ran smoothly during fill 2092 with CH11, CH21, CH14, CH24 in chips 0 & 3. Rates up to 3 MHz per chip!
