# Successes to rework CBM-STS detector ladders and modules

GSI, for the MT annual meeting

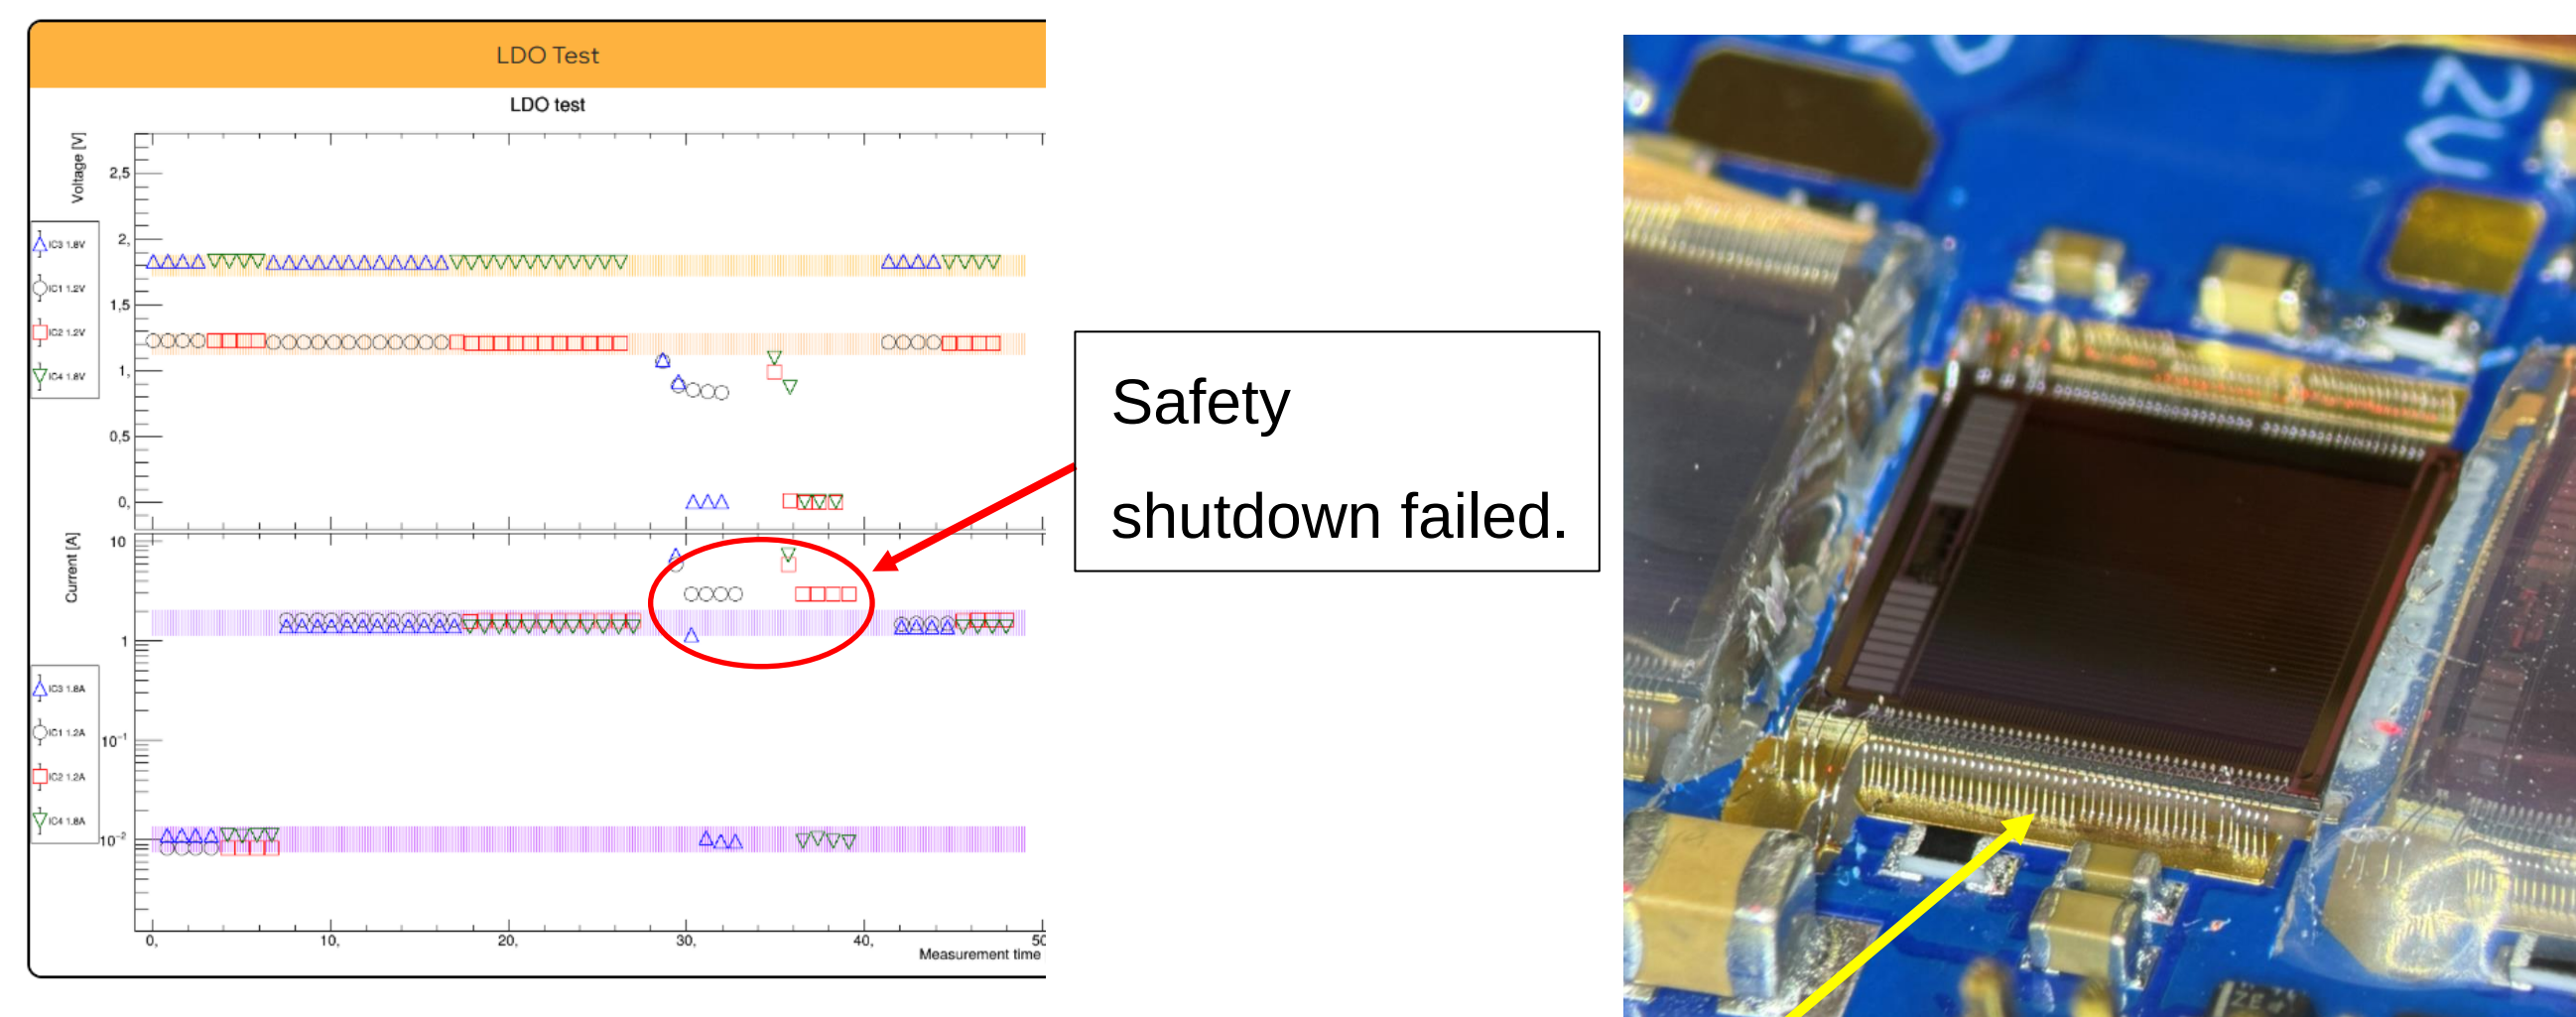
### Removal of LDO

The LDO and readout chips are wire-bonded on the PCB.

The spare chip cable must be installed in a clean pad, replacing the damaged one

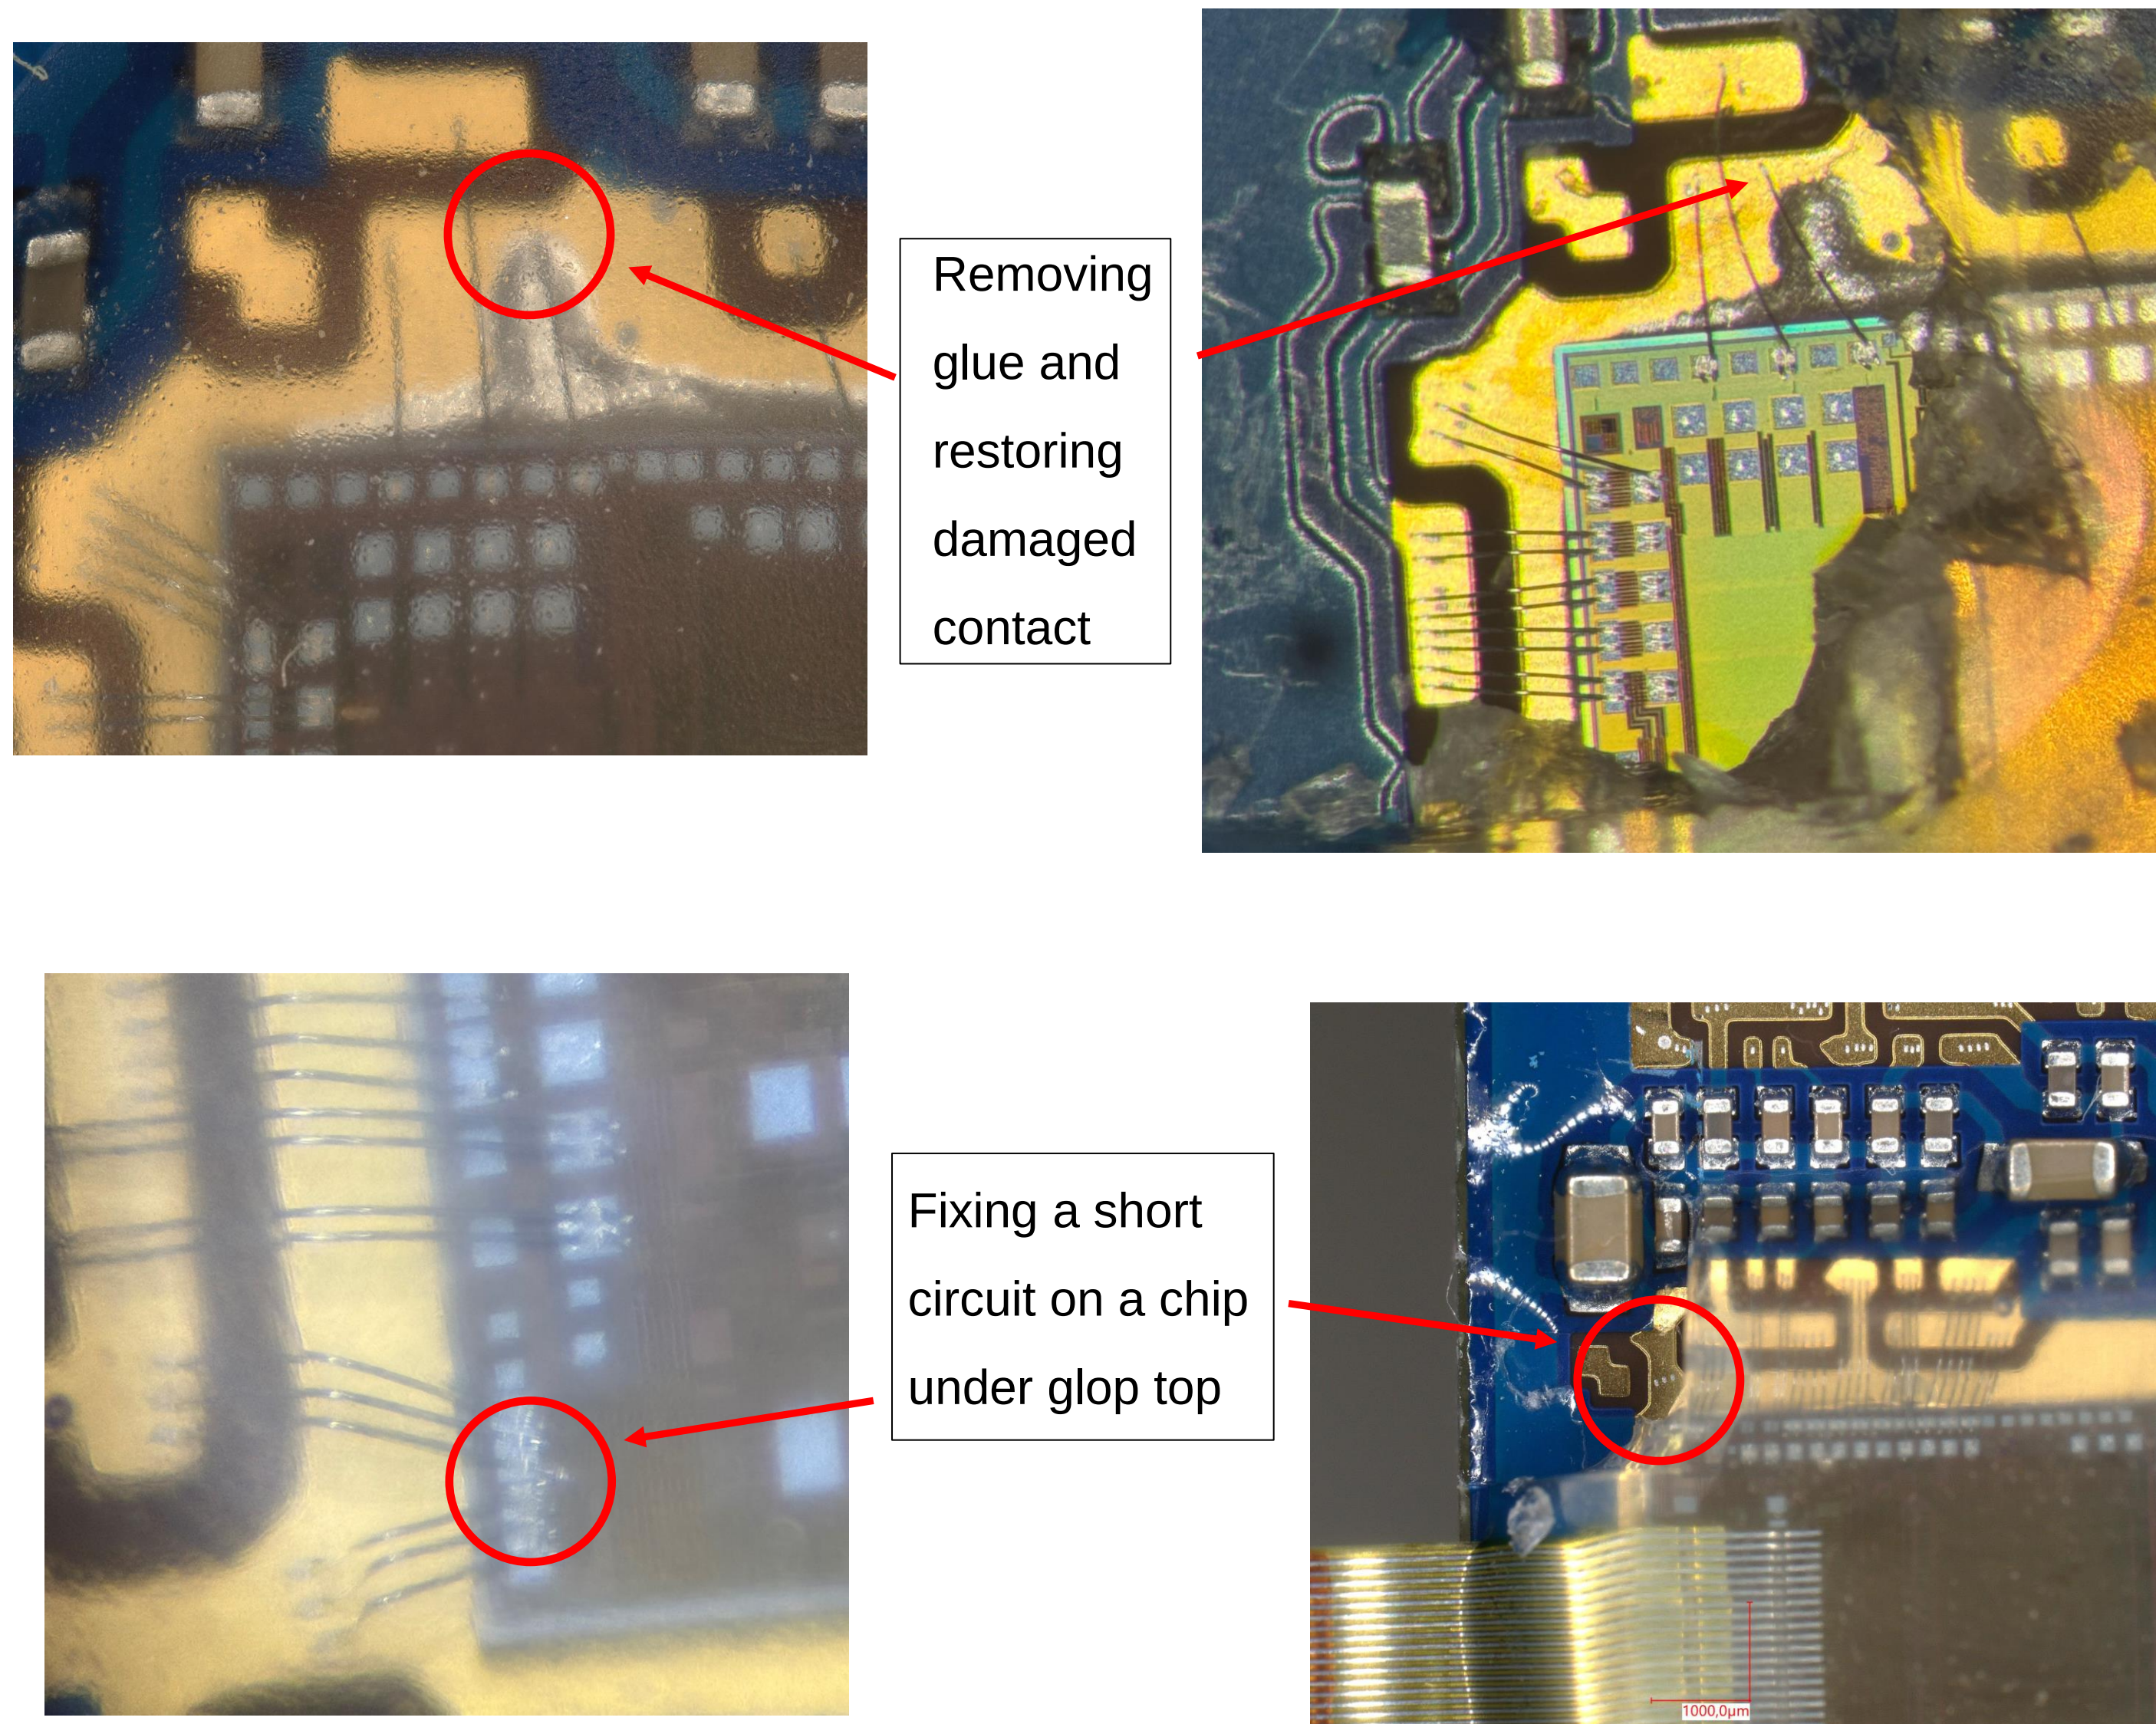
## Repairing damaged connections under the glob top.

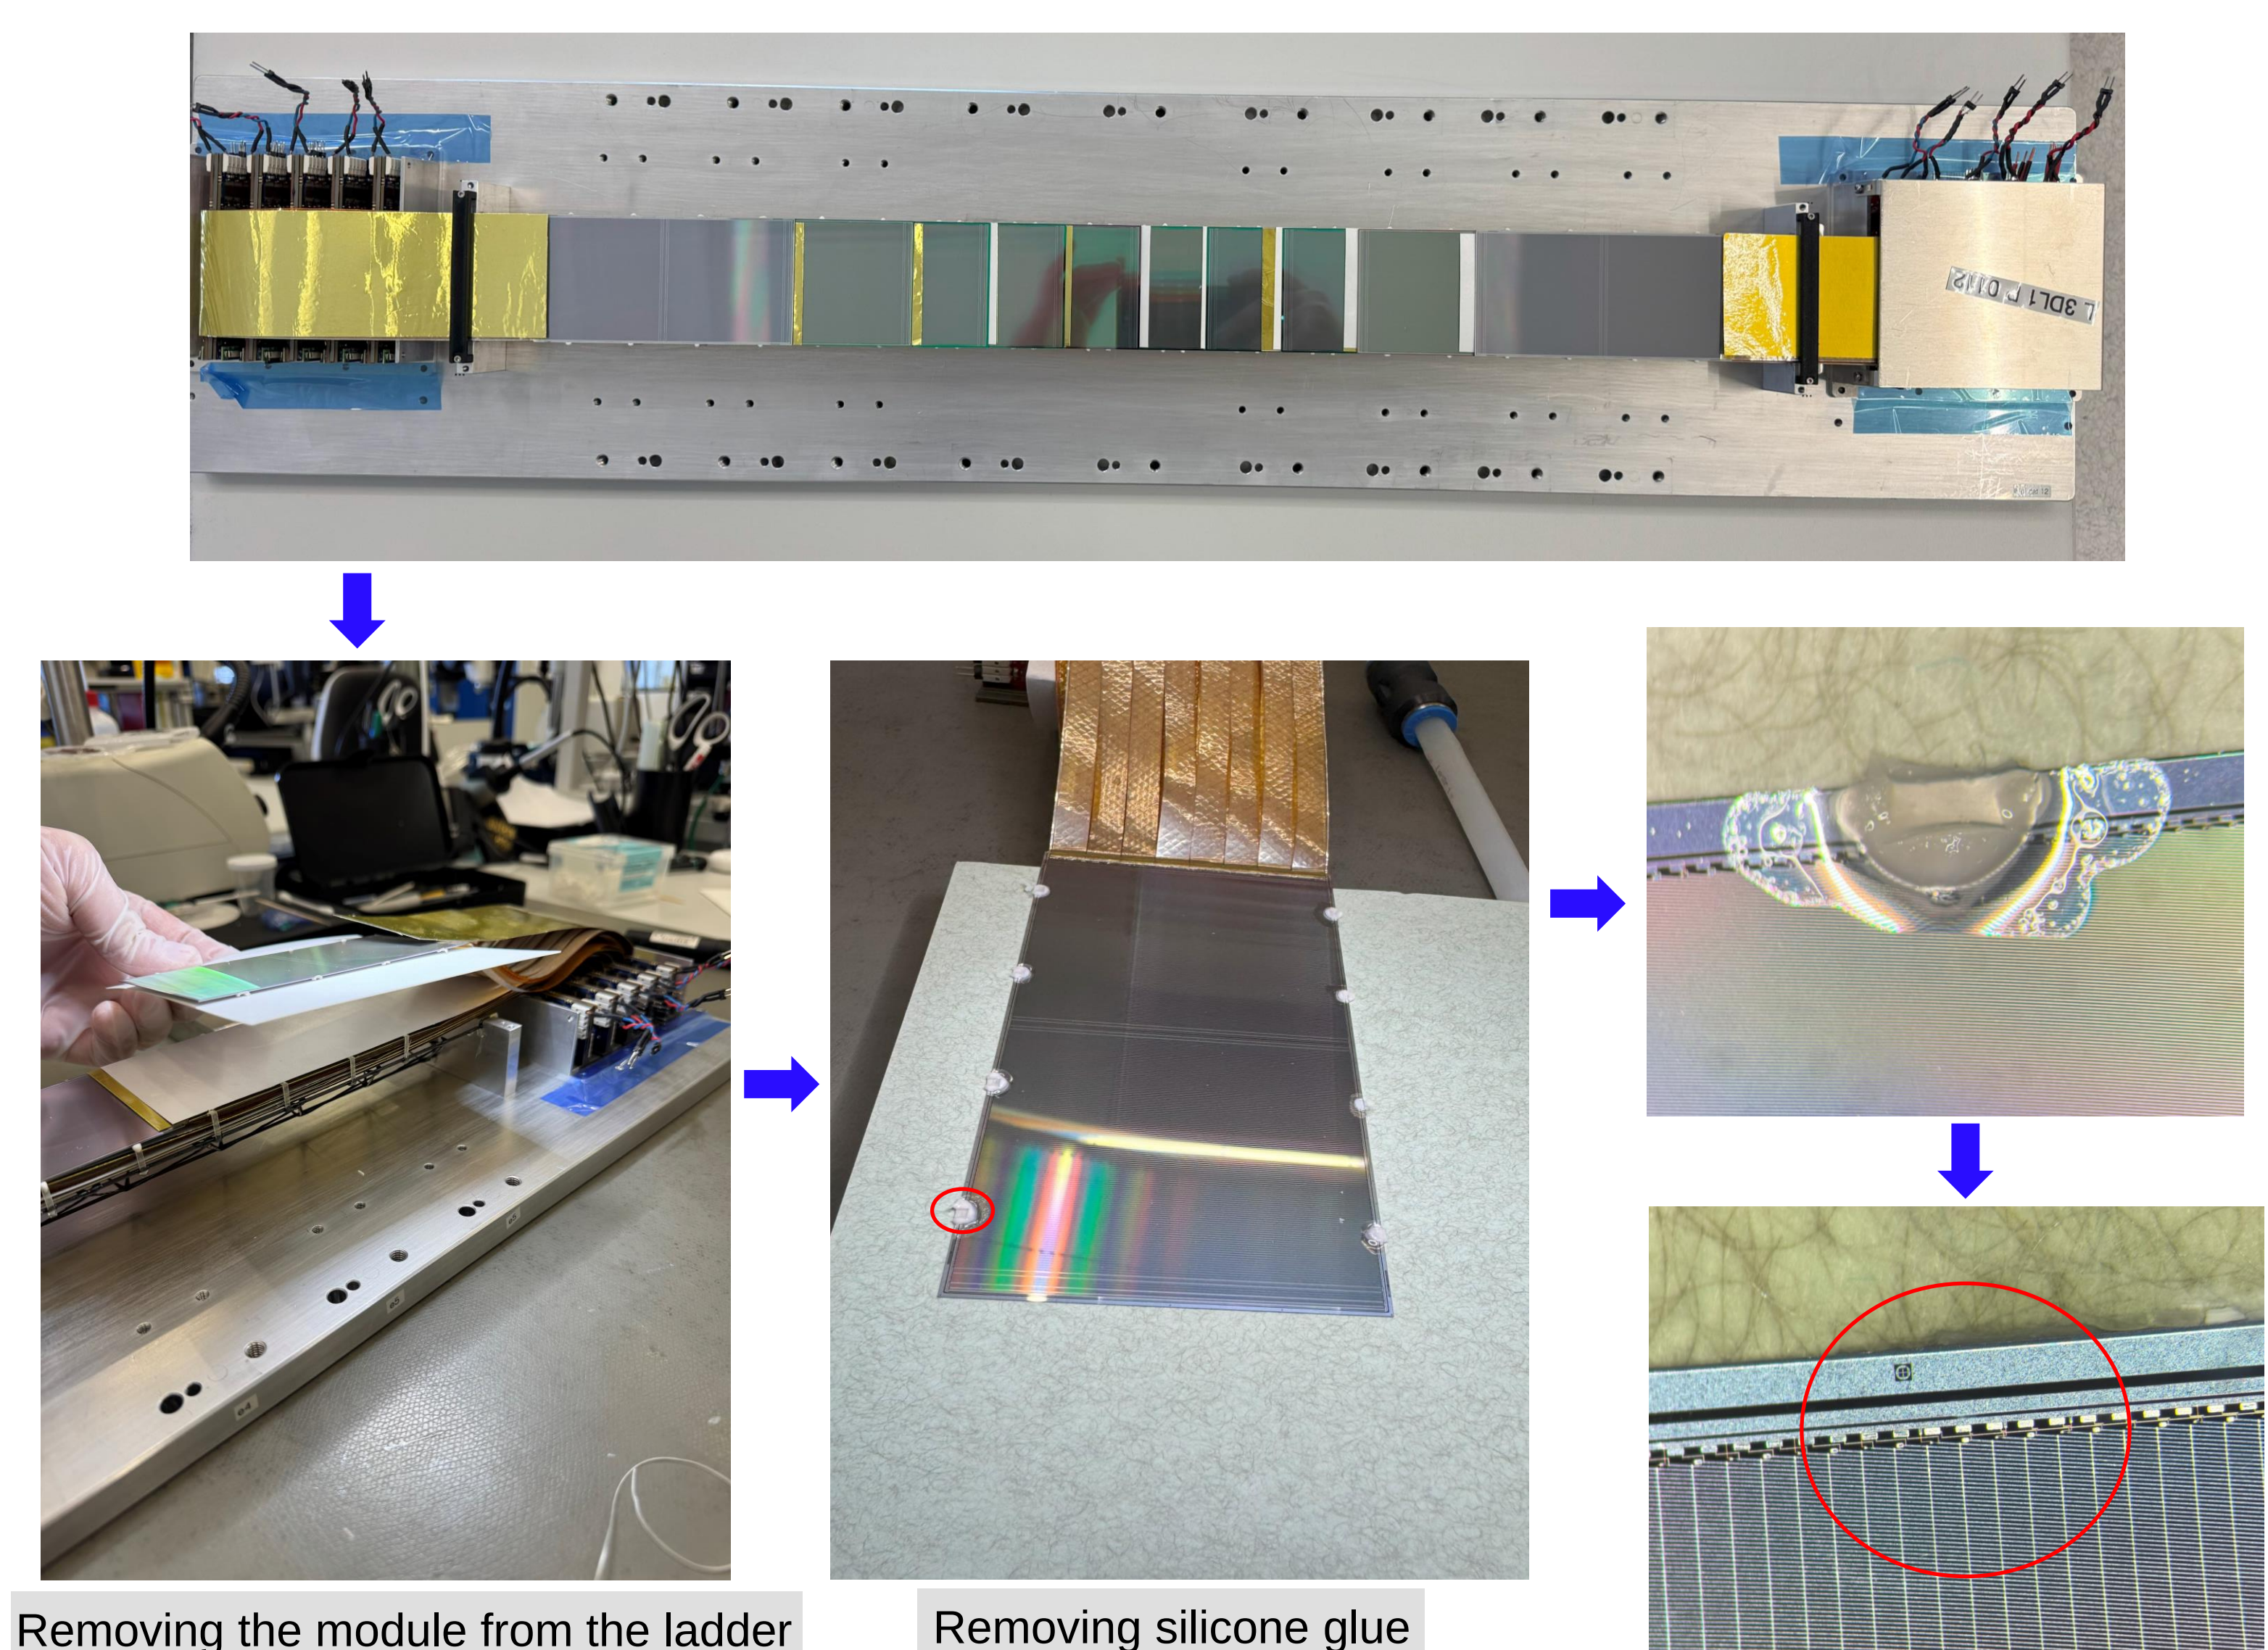
## Removing the damaged module from the ladder and scraping the glue off the sensor surface
