Status report uni Hamburg

Death of a module

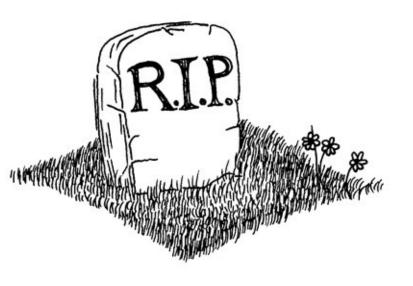
- •Weird peak in the ADC spectra (with no fluorescence target) No full depletion?
- •Problems with the power connector
- Unexpected high leakage current
- •Tested the current behavior disconnecting the sensor from the HDI
- •No apparent damage in the sensor
- No clear cause of the death
