1.3 GHz 9-cell cavity T-mapping and surface inspection results at LANL

**Tsuyoshi Tajima, A. Canabal, G. Eremeev, A. Bhatti,
R. Roybal, F. Krawczyk, J. Sedillo, P. Chacon**

TTC meeting, New Delhi, India, 20-23 October 2008

AES-03 cavity inspection results

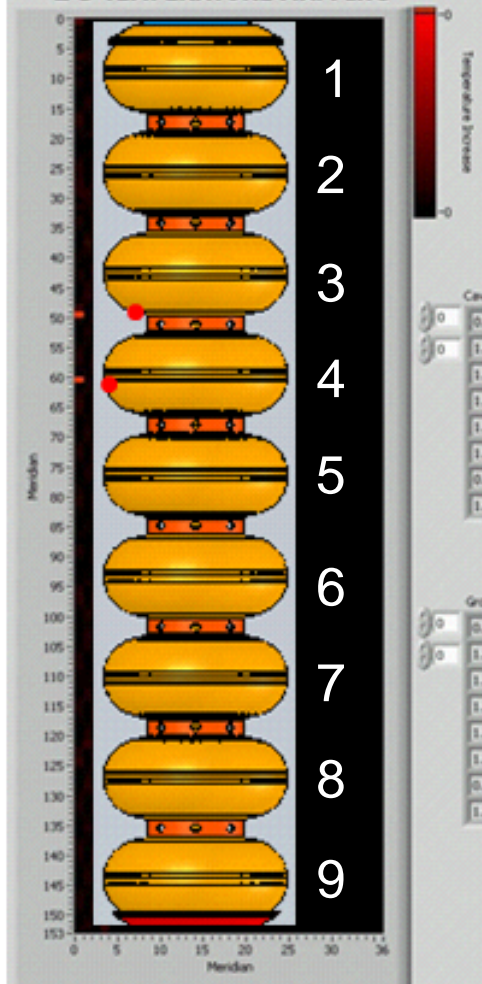
- 1st test at quench
61 @ 120° cell 4 near eq.
75 @ 150° cell 5 near eq.
50+61 @ 160° cell 3 near iris+cell 4 near eq. (X-ray was detected as well)
23 @ 200° cell 2 in the middle
- 2nd test after warming up to room temperature (we did not re-apply grease!)
112 @ 220° cell 7 near eq.
79 @ 230° cell 5 near eq.
112 @ 260° cell 7 near eq.
No X-ray was detected.

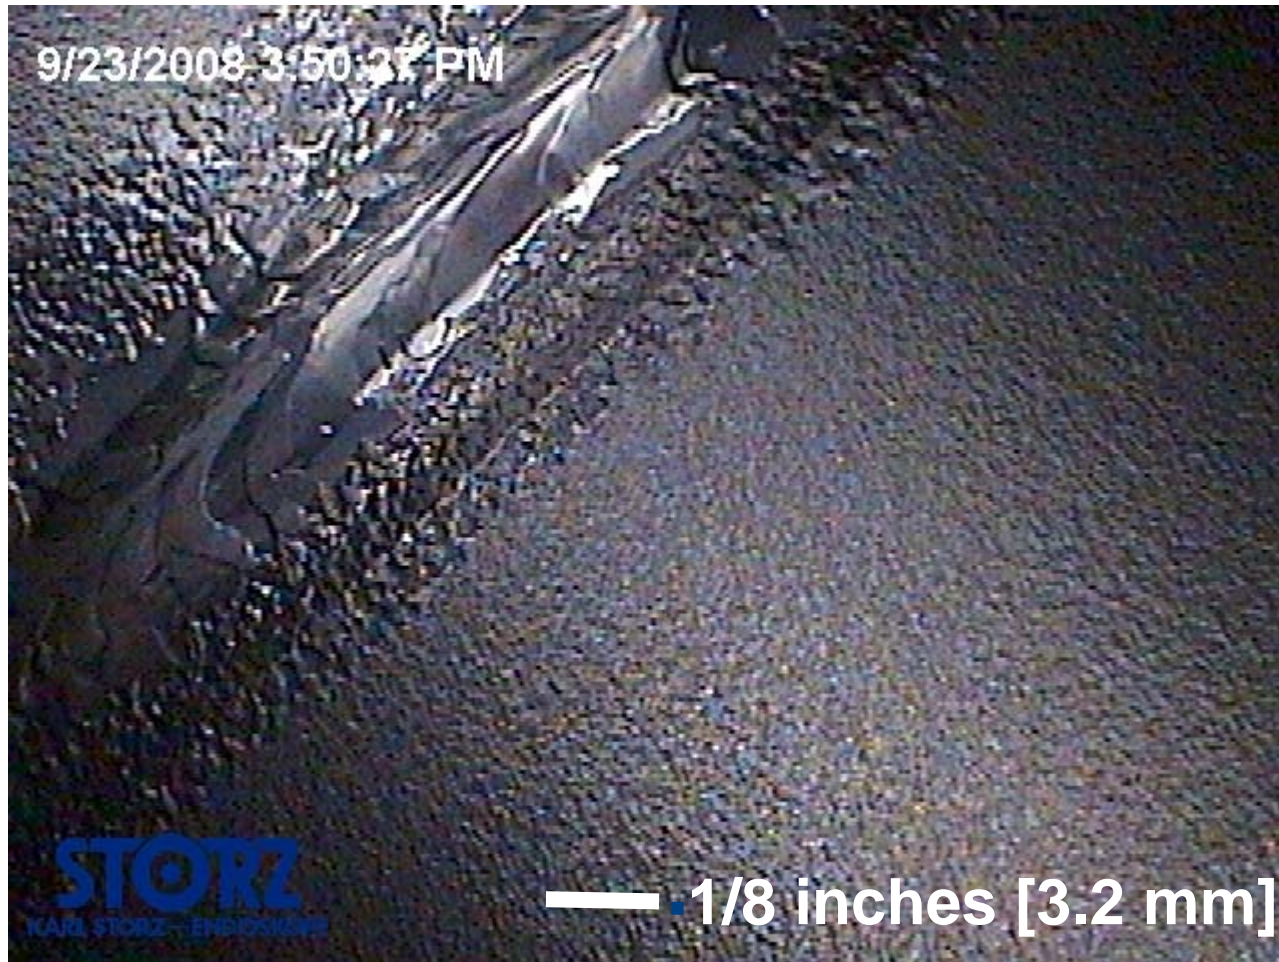
Cell 4, 160°, 1 sensor down from equator X-ray was detected in the first test

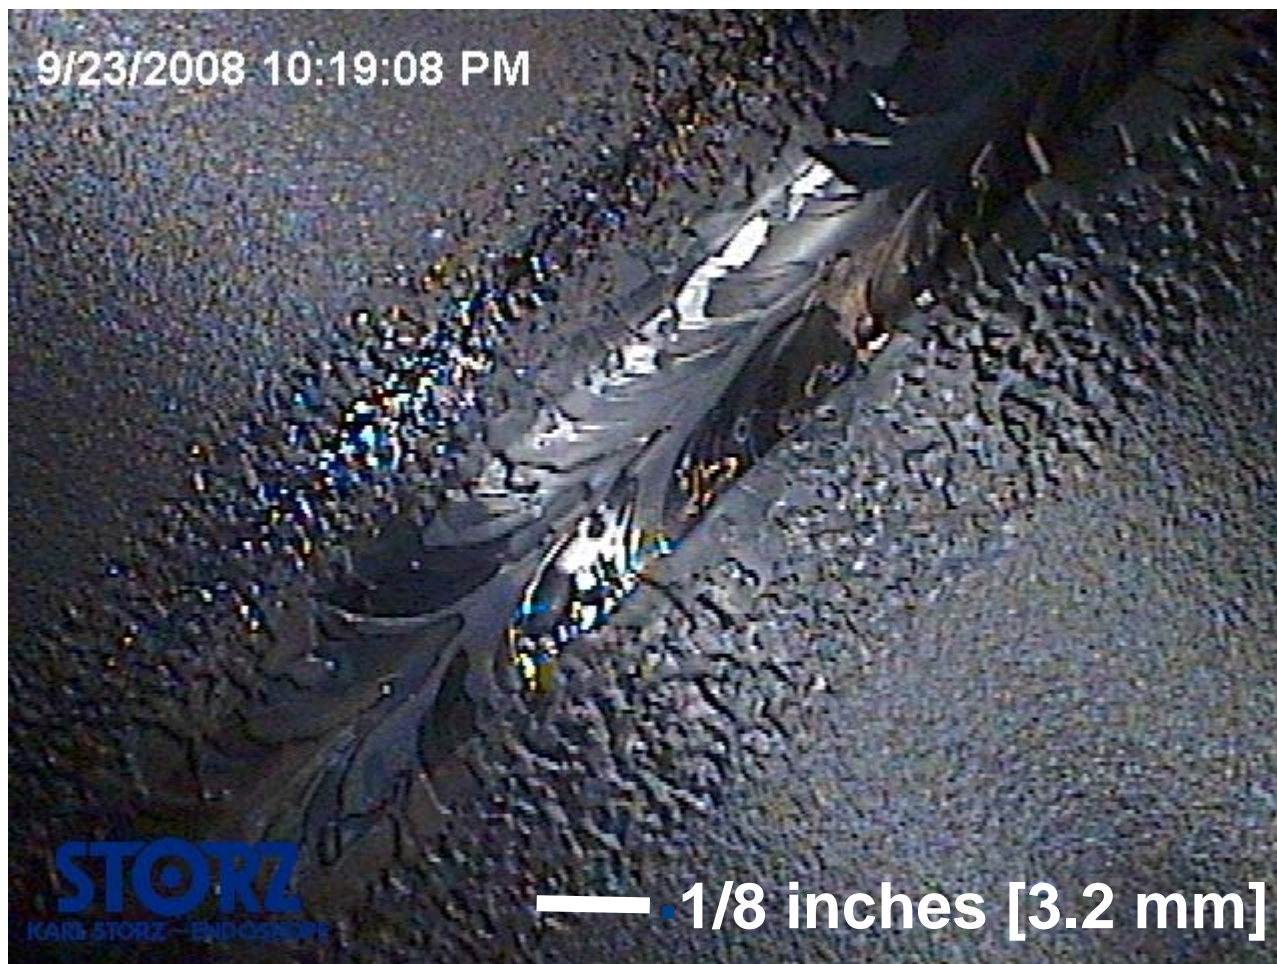
Cell 5, 150°, at the equator, marked on the cavity

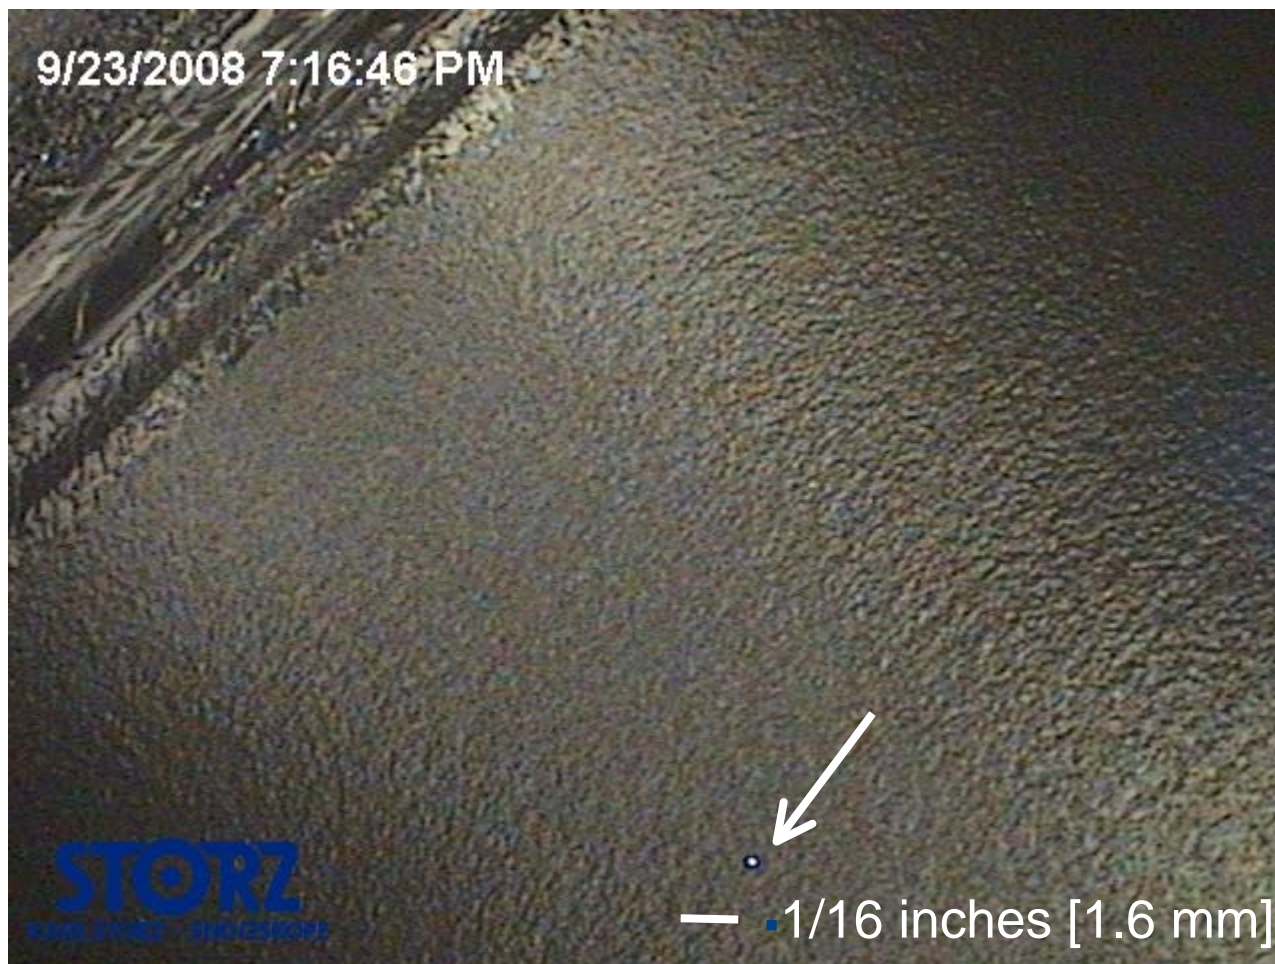
Other imperfections found Cell 9, 160°, below equator

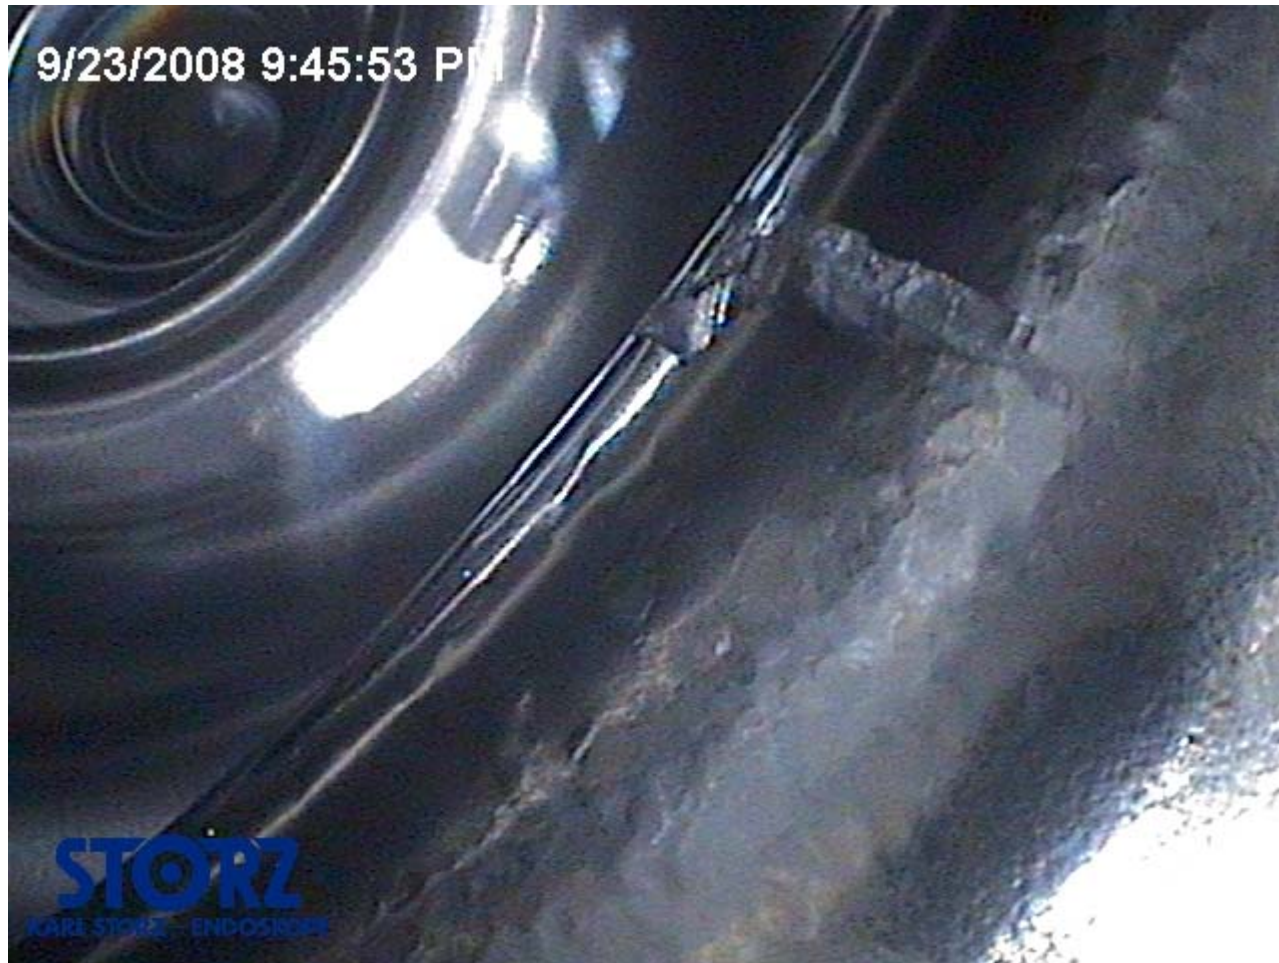
Cell 7 iris to cell 6, approx. 70°. This might have been caused by a screw head of the inspection system.

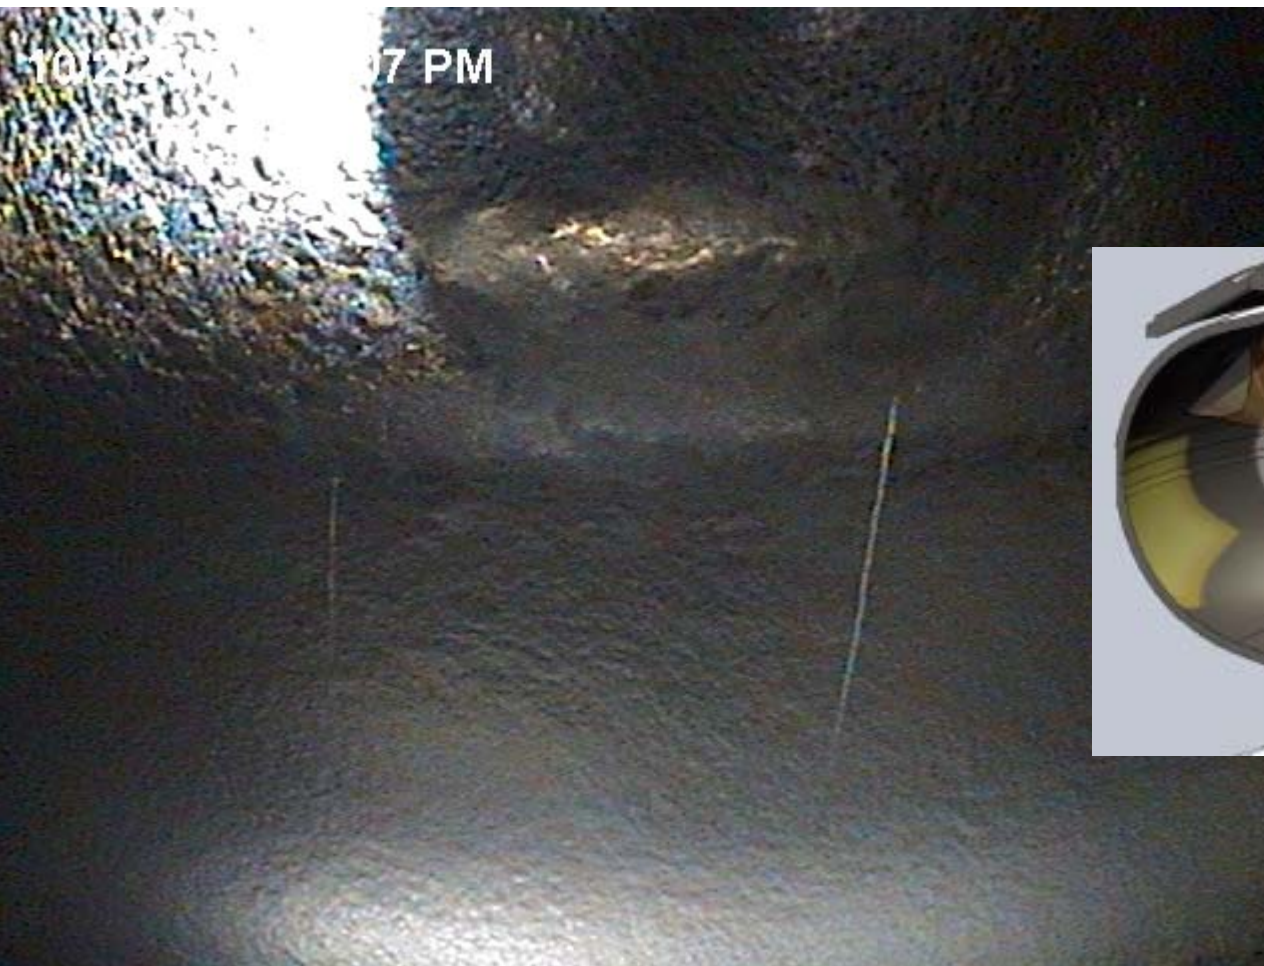
Cell 5, 150° ~45° up, 2 scratches are found

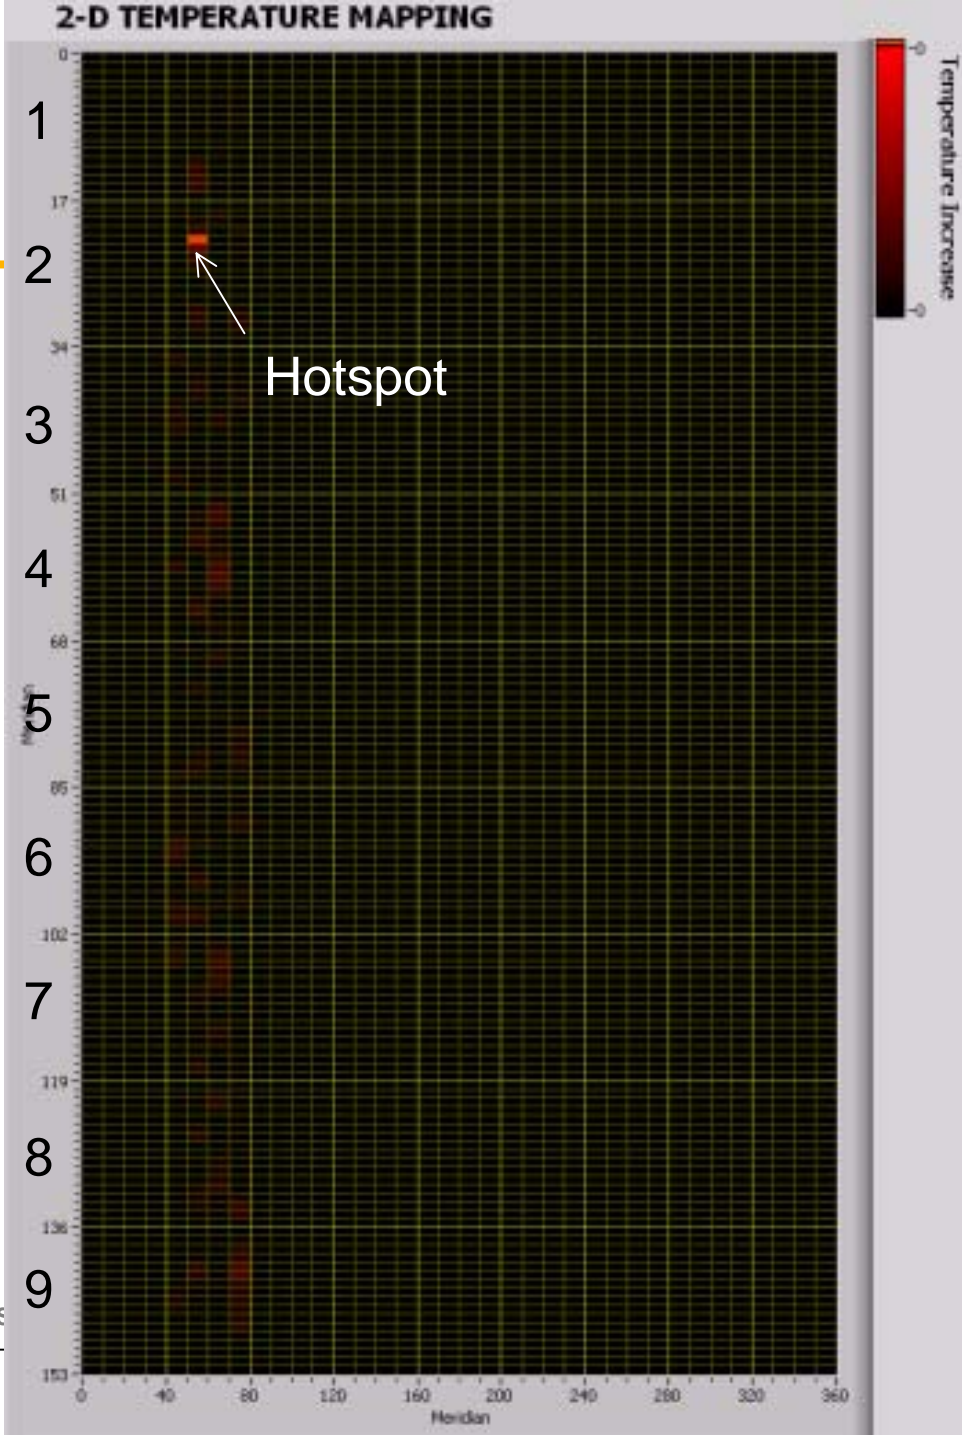
We observed one hot spot. (only 0°-110° were monitored.)

- Cell 2 top half at 50° showed heating
- Only sector 2 (40°-70°) data are shown on the right map.
- Unfortunately, the T-map for 120°-350° range where we found most of the heating in the June 2008 tests did not work possibly due to disconnects at the connectors in the cryostat.

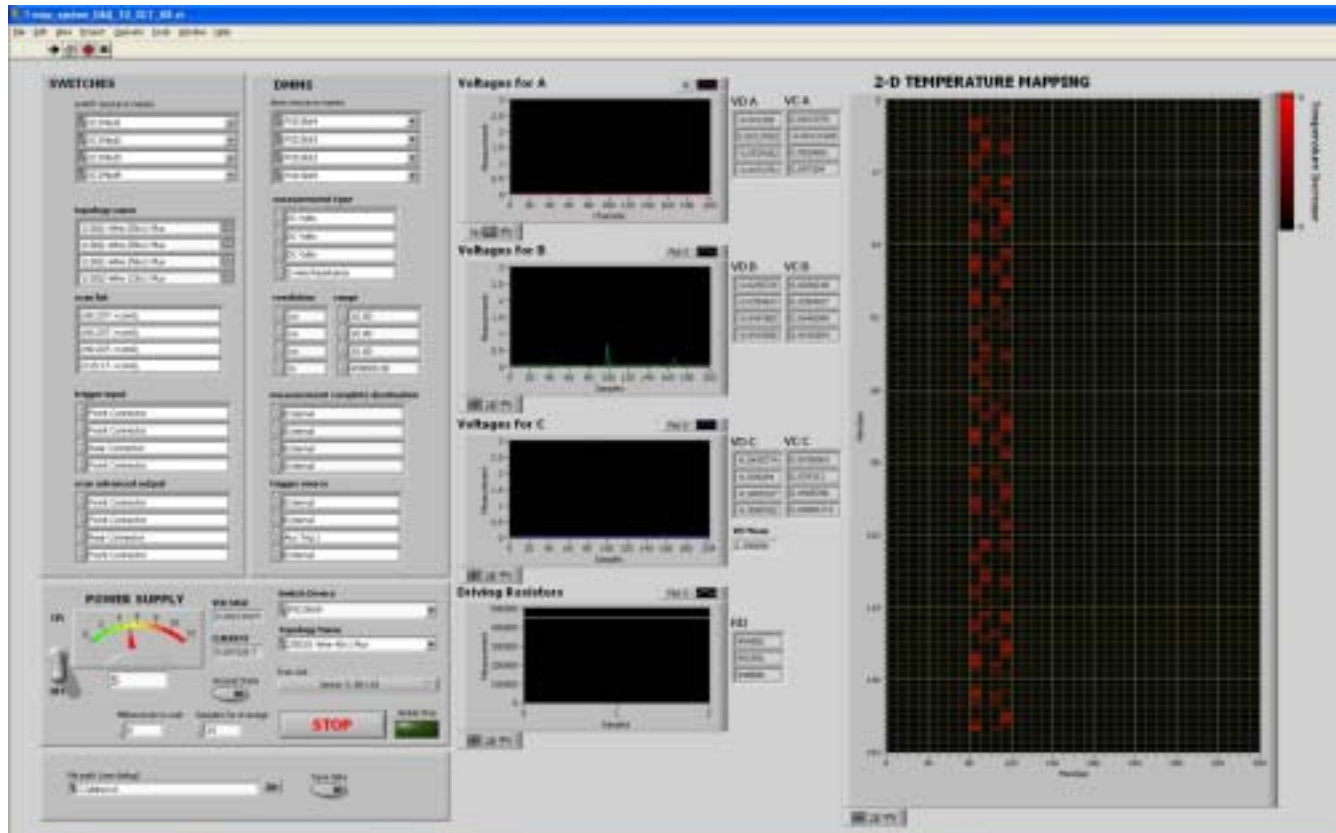
false signals due to 60 Hz noise

This can be seen at high resolution T-mapping.

- The manganin wire connectors are sometimes loose without a means to secure it.
- Strain on the cables attached to the connectors at the ends of long (83 ft.) cables connecting the cryostat and the control room.
- The signal shows 60 Hz noise. Electrical shielding needs to be done.
- Noise when switching power from one sector to another. We had to do the mapping sector by sector without fast switching.
