## Copper plating on XFEL couplers

### Real defects, examples and classification

DESY-Hamburg, March 25<sup>th</sup> 2014

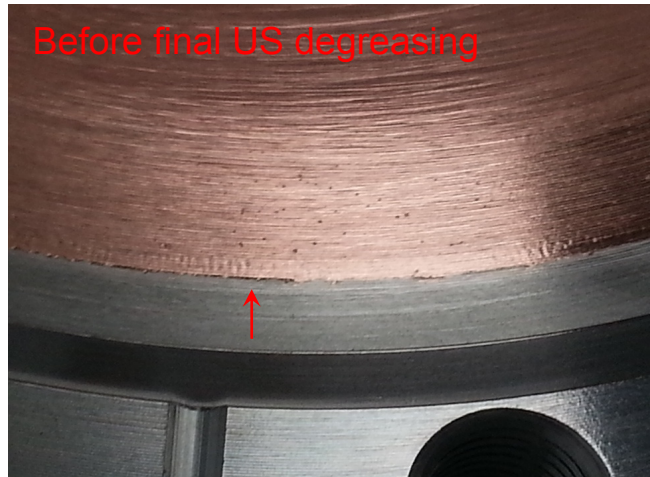
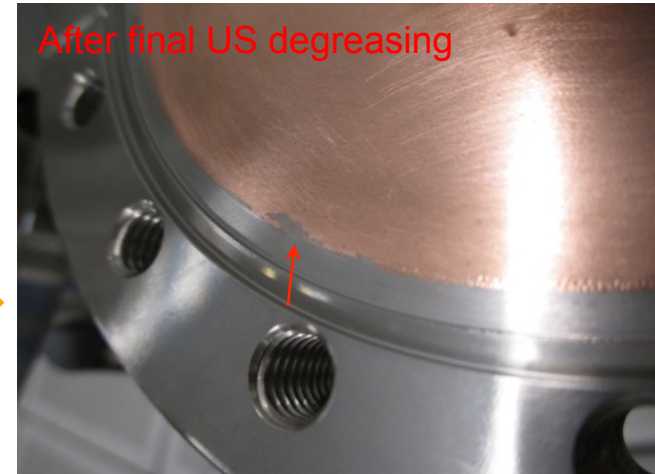
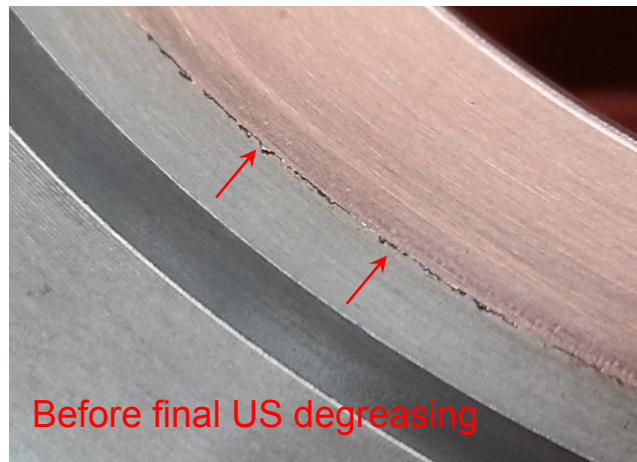
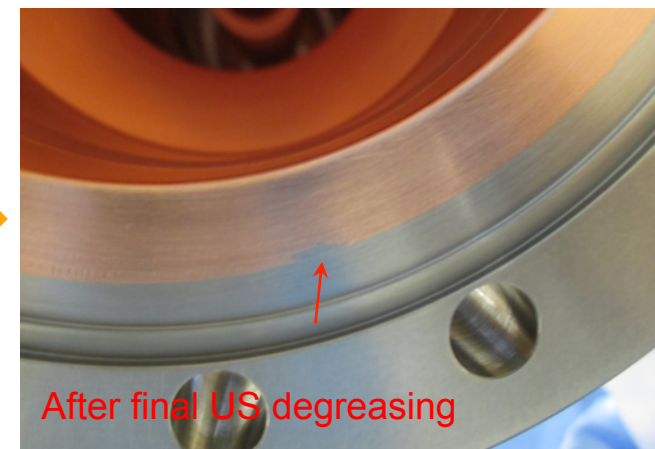
Copper coating edge peeling on CF100 flange:

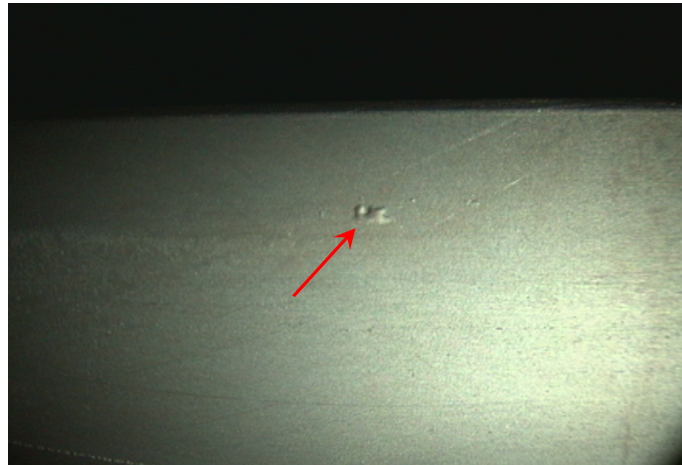
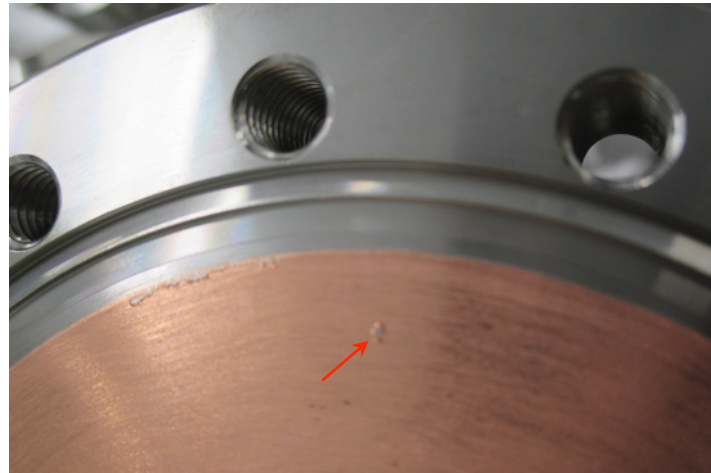
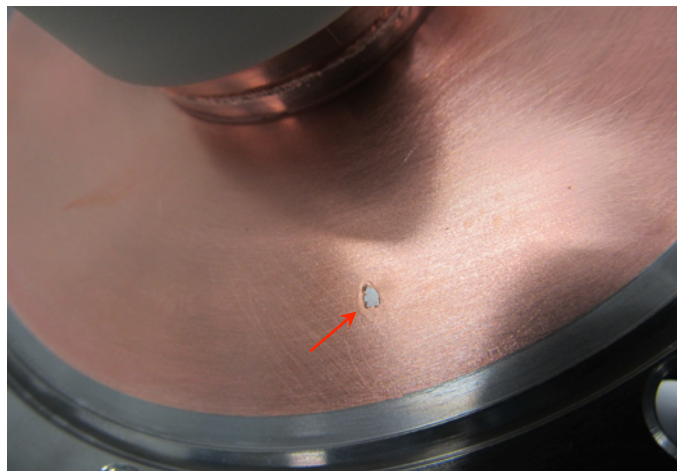
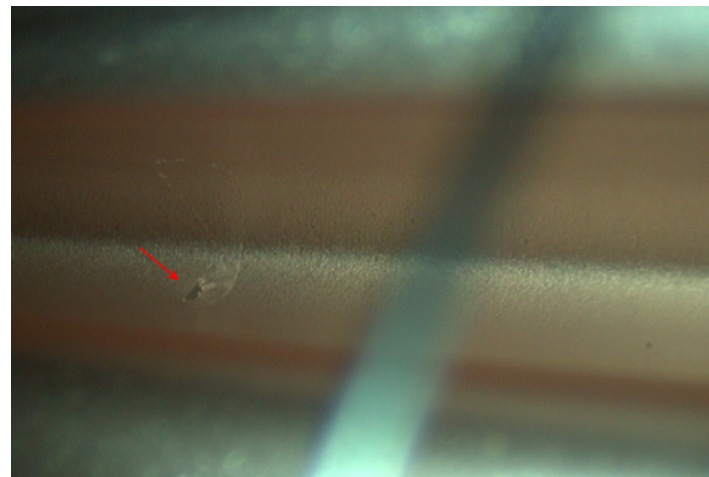
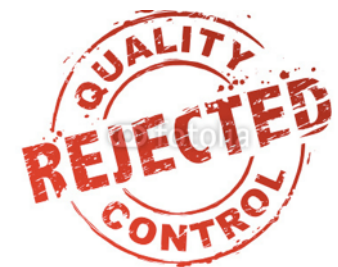
Blisters, bubbles and lack of copper in the coated surface:

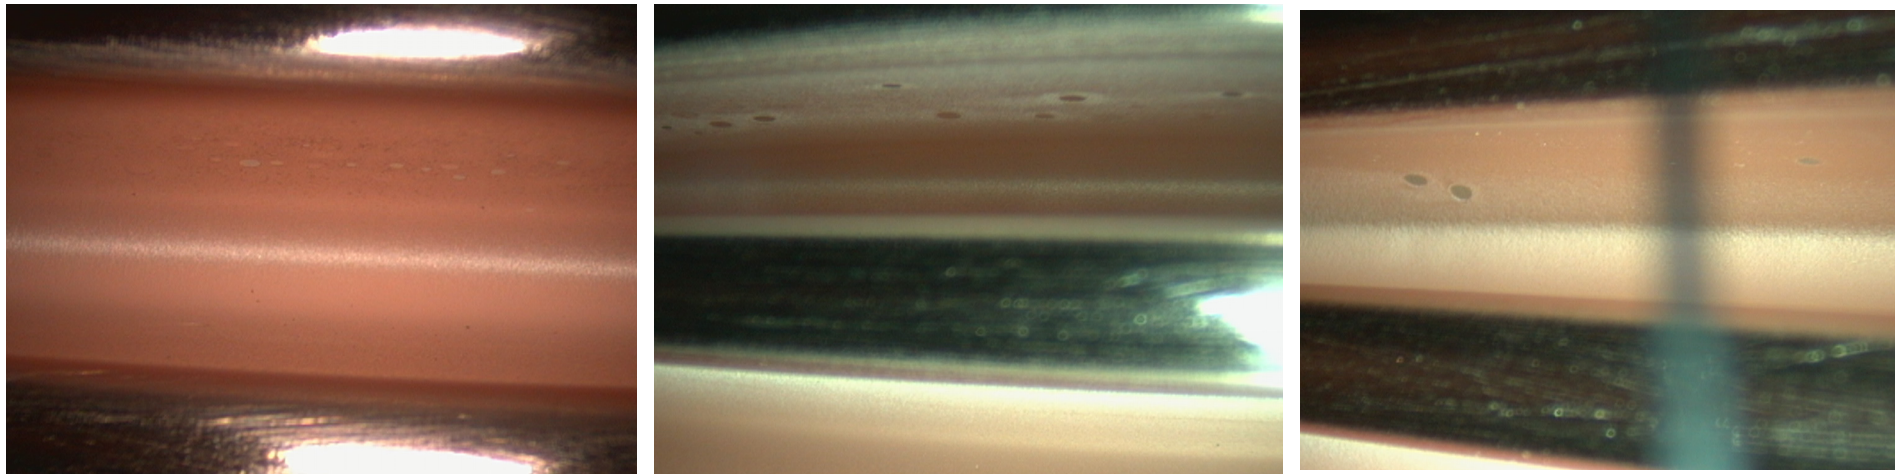
Circular spots in bellow valley upper surface:

- Diameter of the circular spots varies from 0,1 to more than 0,5 mm,
- The colour of the spots varies from copper like to light grey,
- The number of spots varies from 1 to some tenth per wave,

- Spots diameters must be  $<0,2\text{mm}$ ,
- The number of spots per wave must be  $<10$ ,
- Only the valley spots valley are concerned by this deviation, spots in the bellow hill are not accepted,
- The copper like spots are not concerned by this acceptance criteria,

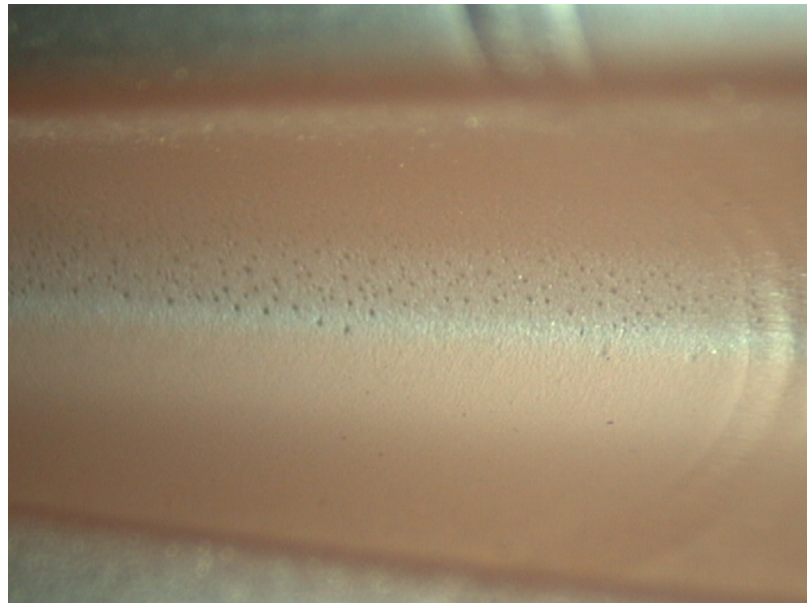
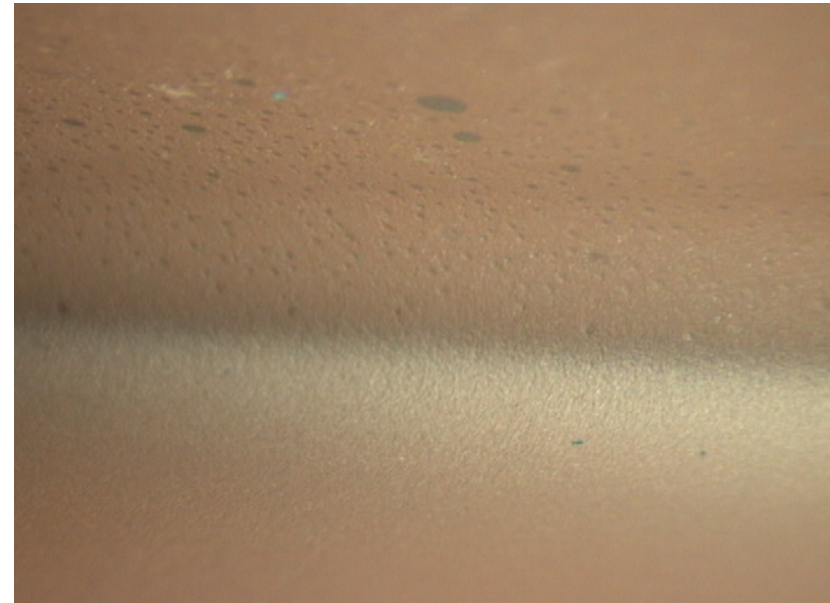
Pitting in the bellow valley: Many very small spots in the bellow valleys:

Accepted with NCR after a case per case discussion.

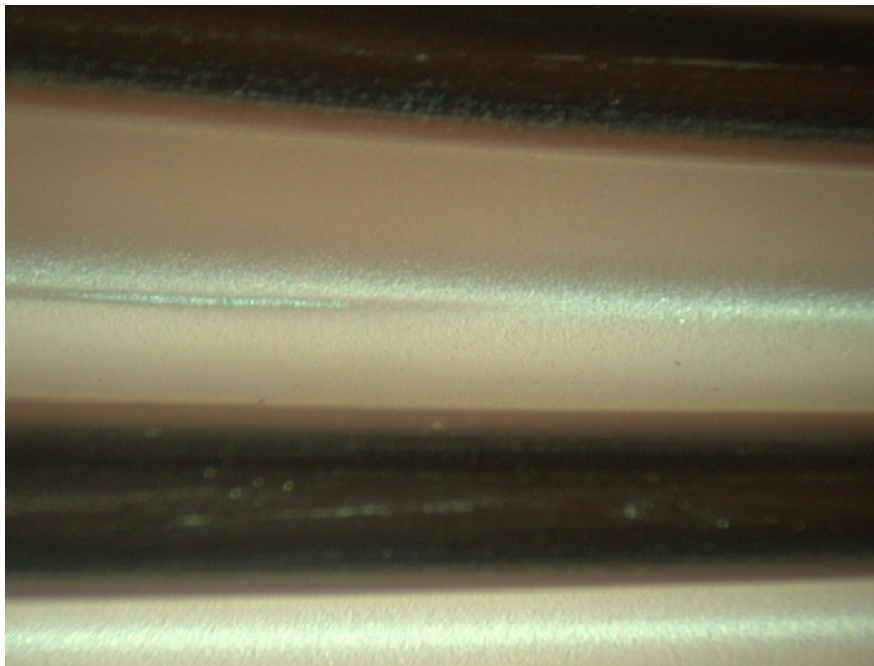
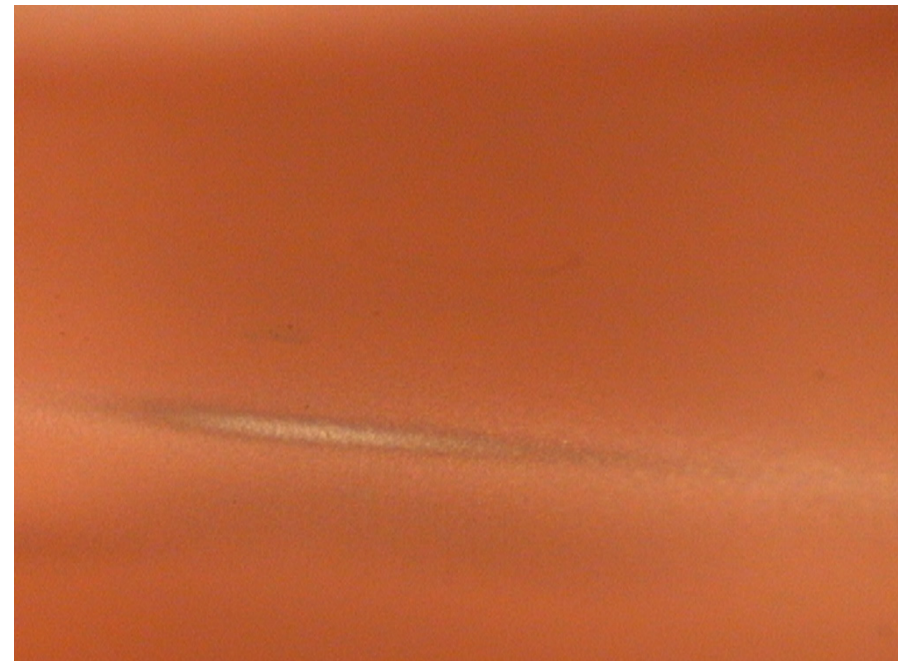
Long thin barely in the bellow valley (1,5 x 0,1mm):

Accepted only for warm part with NCR after a case per case discussion.

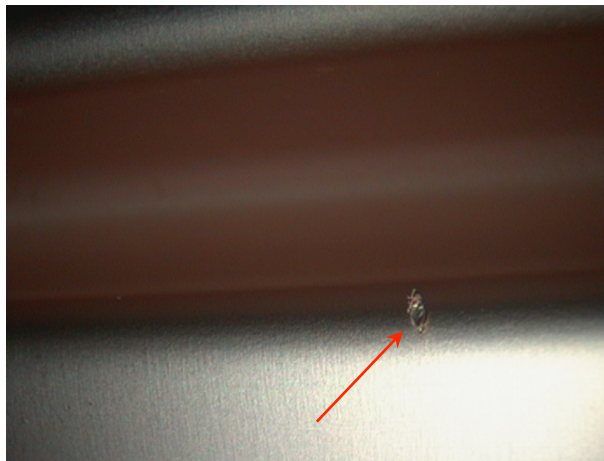
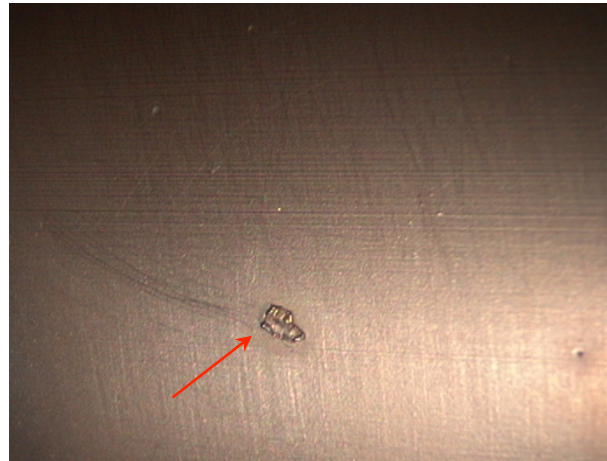
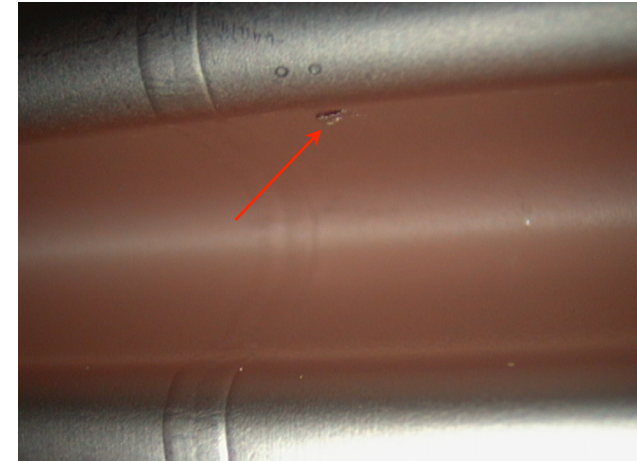
Copper particles in the coated surface:

- Must be removed from the surface with a copper tool,
- Surface must not show sharp tips after particle removal,
