Experience with defects in copper plating at HTS/FNAL

TTC Workshop, DESY 2/22/2014

Ken Premo FNAL
Acknowledgments:
Tug Arkan FNAL
Jeff Tice SLAC
Chris Adolphsen SLAC

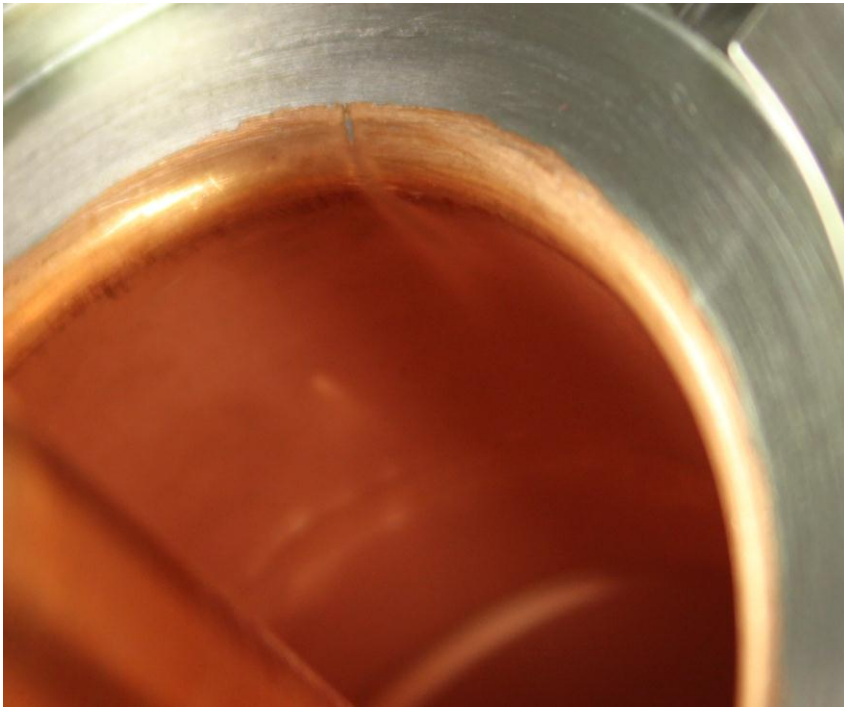
2 Coupler failures at HTS, low gradient quench induced by field emission.
Both couplers had been reworked by CPI in the areas of failure.
It is possible the rework process caused damage to the effected areas.

FC01, vapor trail, missing Cu

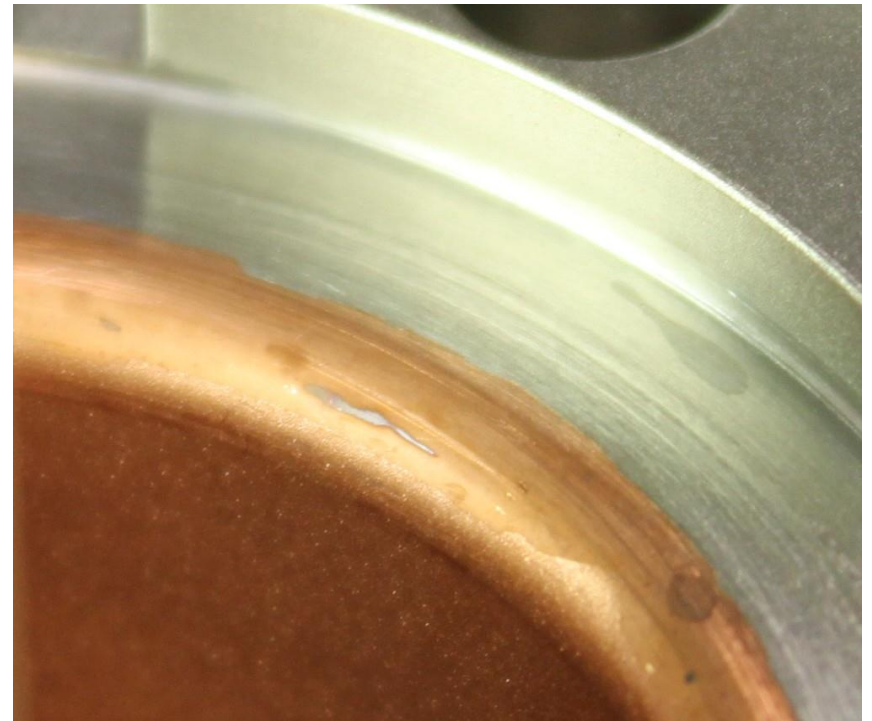
FC10, uneven/missing plating, Cu flakes were found on antenna tip

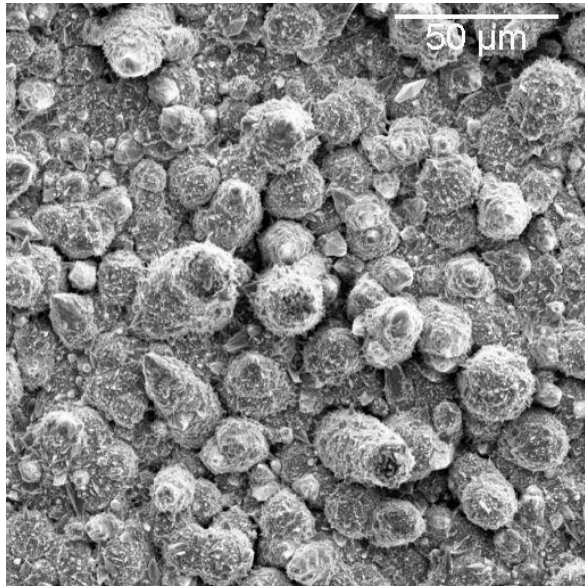
CPI not post bead-blasted coupon

The vendor non-bead blasted surface is much rougher than that resulting from the SLAC plating process. This is likely the result of SLAC doing a periodic-reverse polarity change during the plating (25 seconds 'forward' plating followed by 5 seconds of 'reverse' plating), which the vendor does not do. The vendor bead-blasted surfaces are smoother, but crevasses and sharp edges are produced. Inspection after ultrasonic cleaning did not show significant difference, which suggests the ultrasonic cavitations are not too strong as to significantly erode the surface.

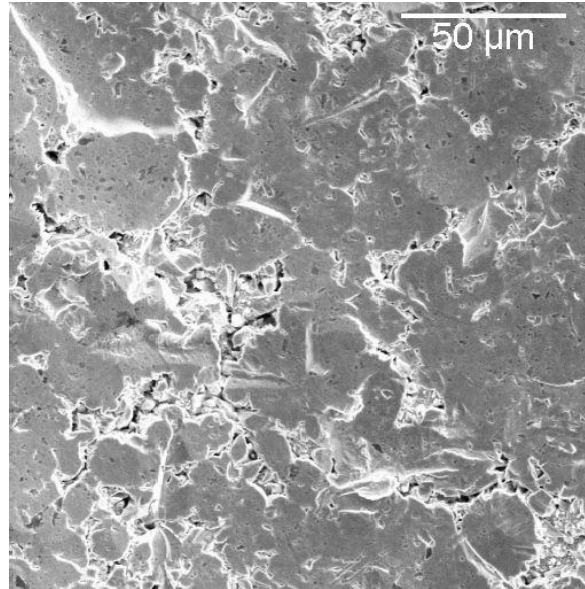
CPI post bead-blasted coupon

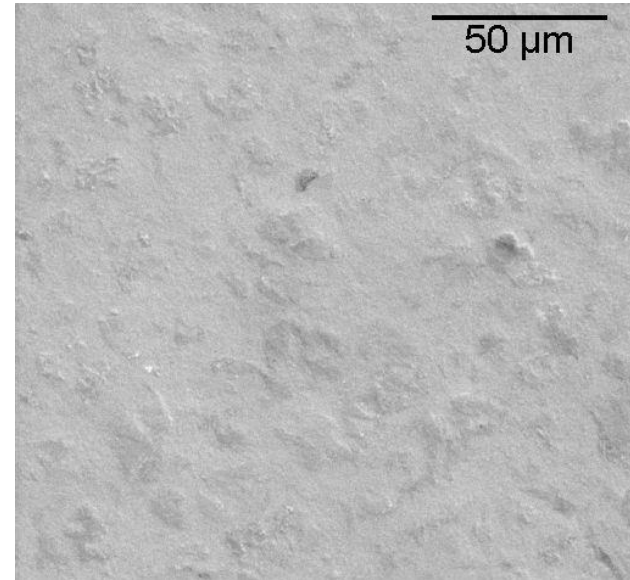
SLAC not post bead-blasted coupon
