Typical problems with EBW welding observed with OBACHT

Aliaksandr Navitski
aliaksandr.navitski@desy.de

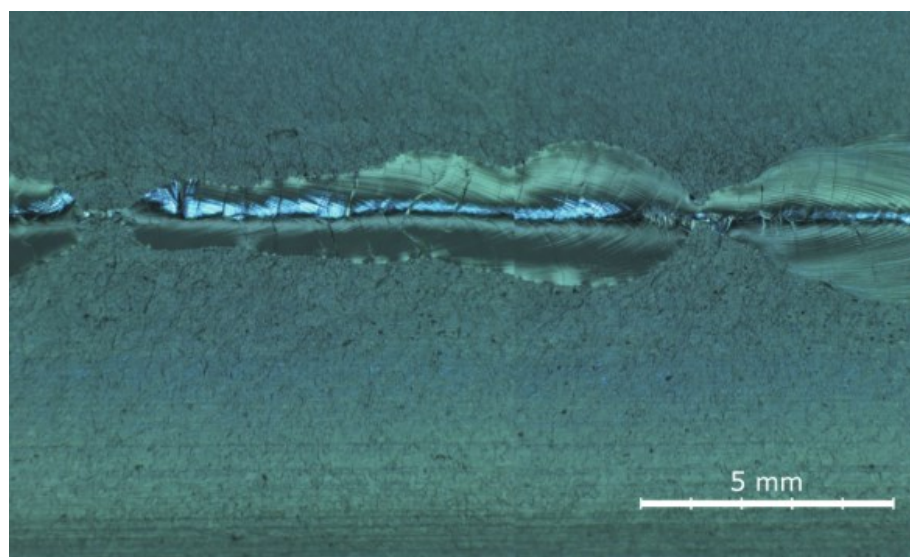
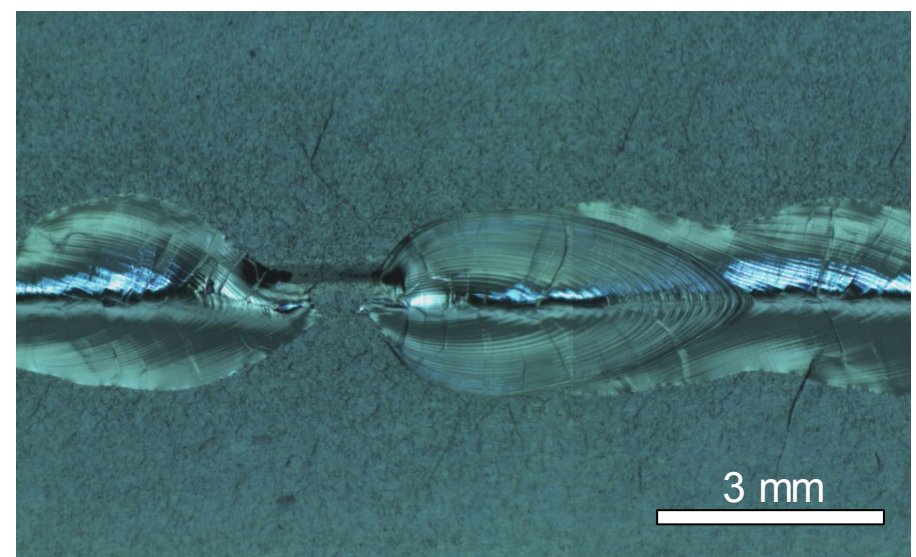
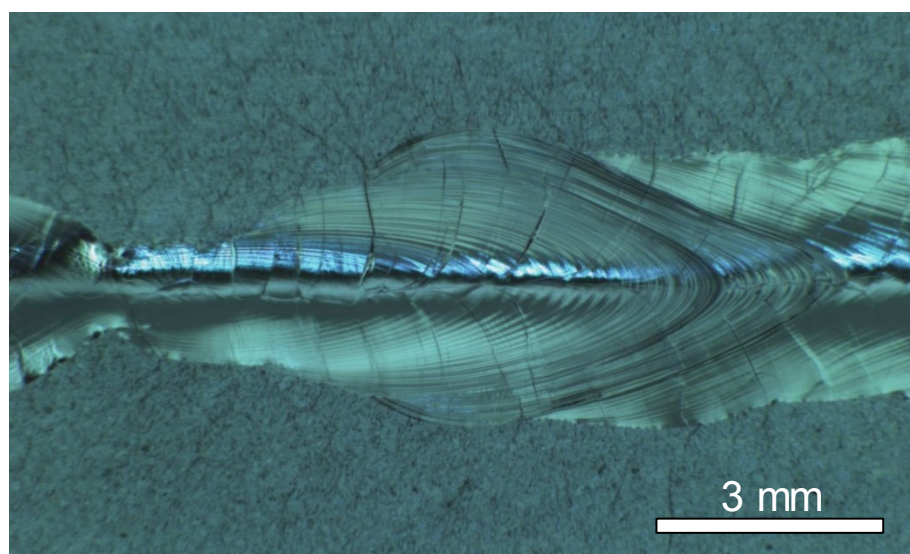
- welding seam **not penetrated** everywhere
- **strong variation** of the seam-width
- **repair** procedure to be established and commissioned
- is it an issue of PED?

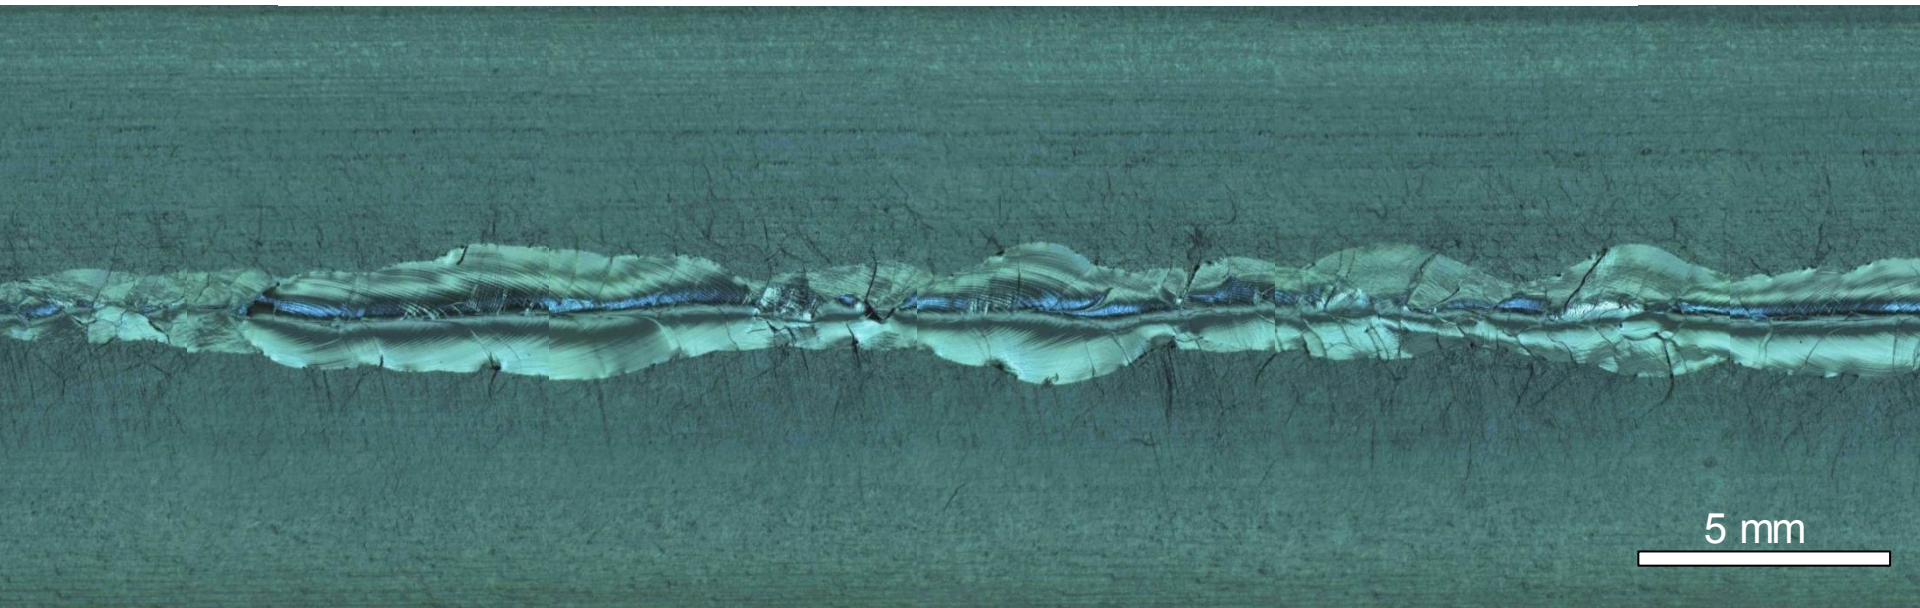
→ At least factor of 2 variation of the welding seam even after a repair attempt

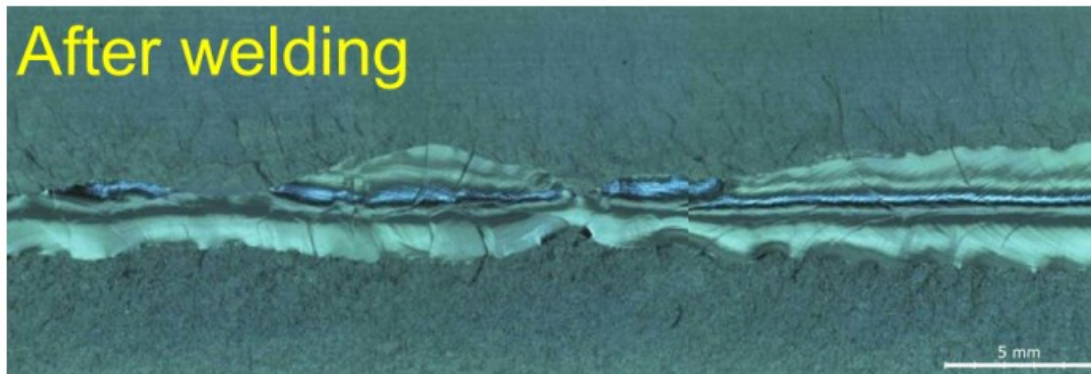
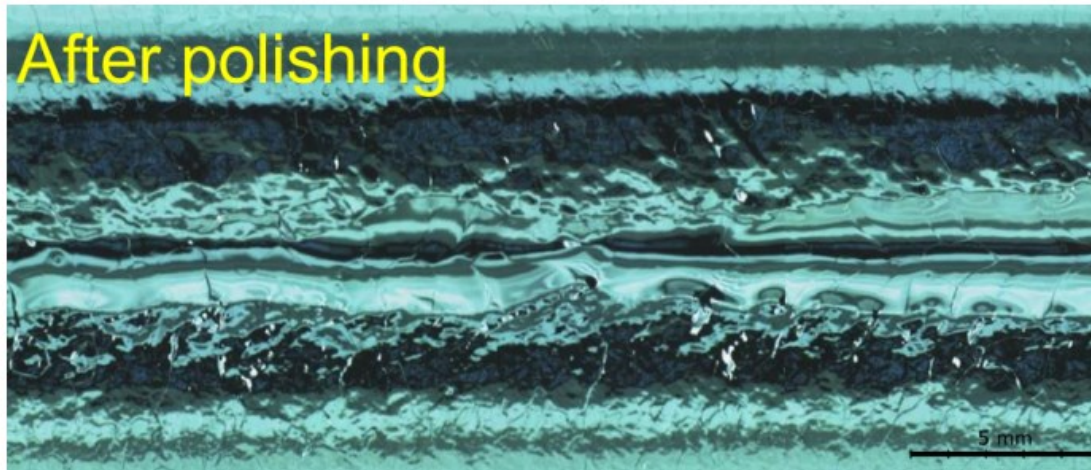
- > Unsuccessful cold RF test result with quench at **22 MV/m**, **no FE**
- > OBACHT indicates defective welding as a possible quench reason

→ **2nd Sound** & **T-map** will be applied for the quench localization and further clarifications

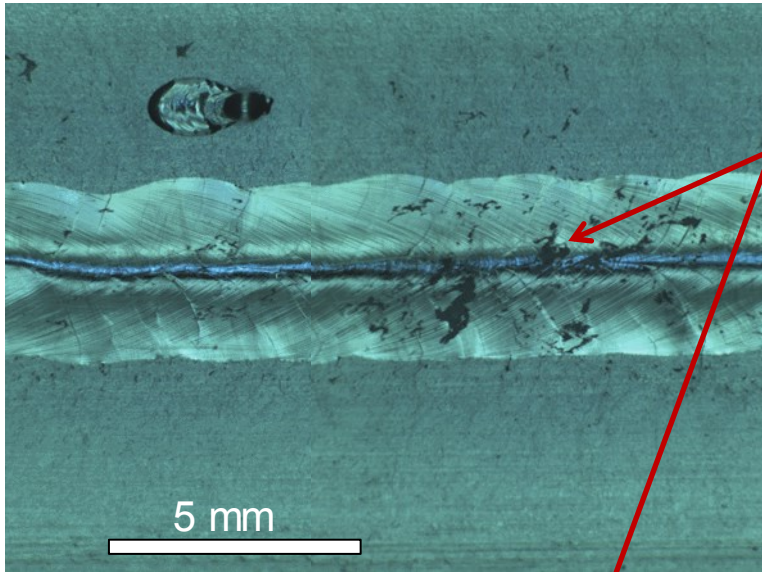
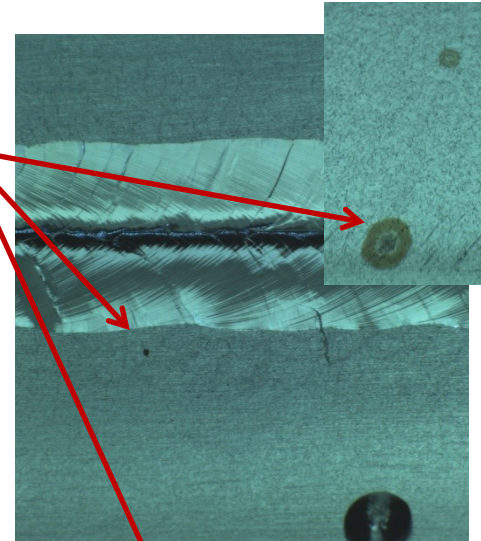
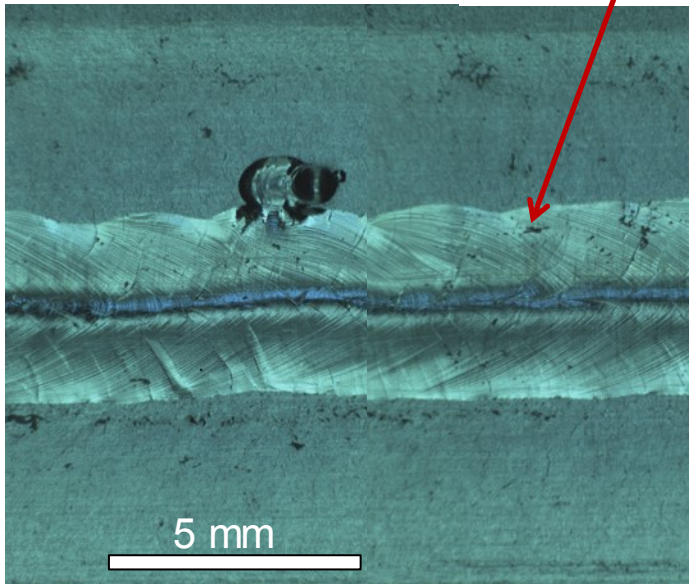
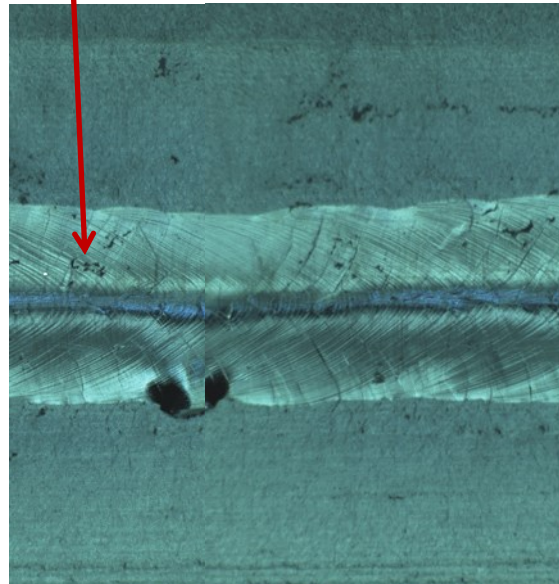
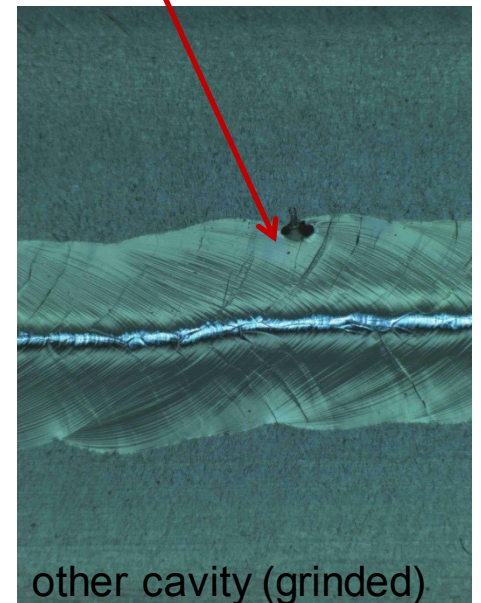
Endoscopes & OBACHT discover some “**spatters**” occasional occurring during the welding:

- is this dust responsible for the spatters (present only in this region, esp. for big spatters) or is it just a product?
- Is a cleanliness issue or e- beam stability?

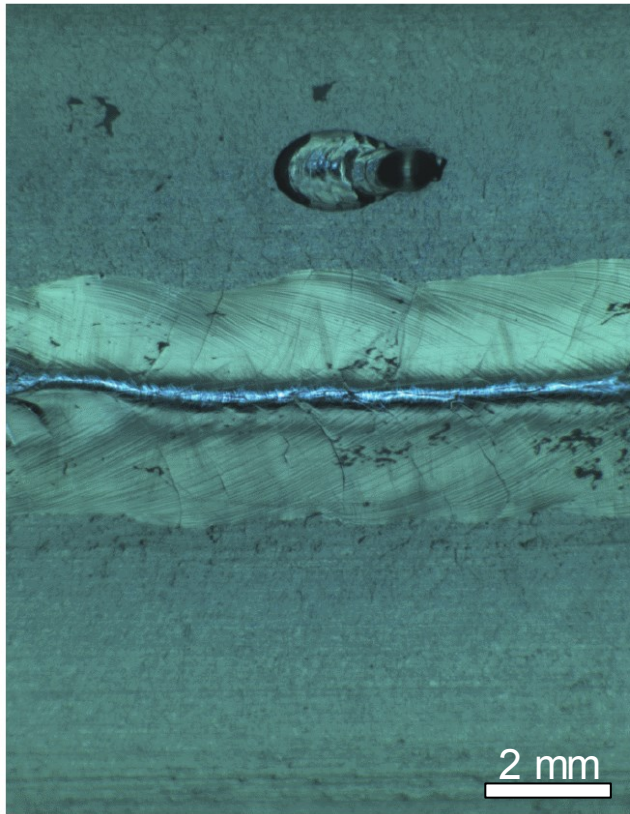
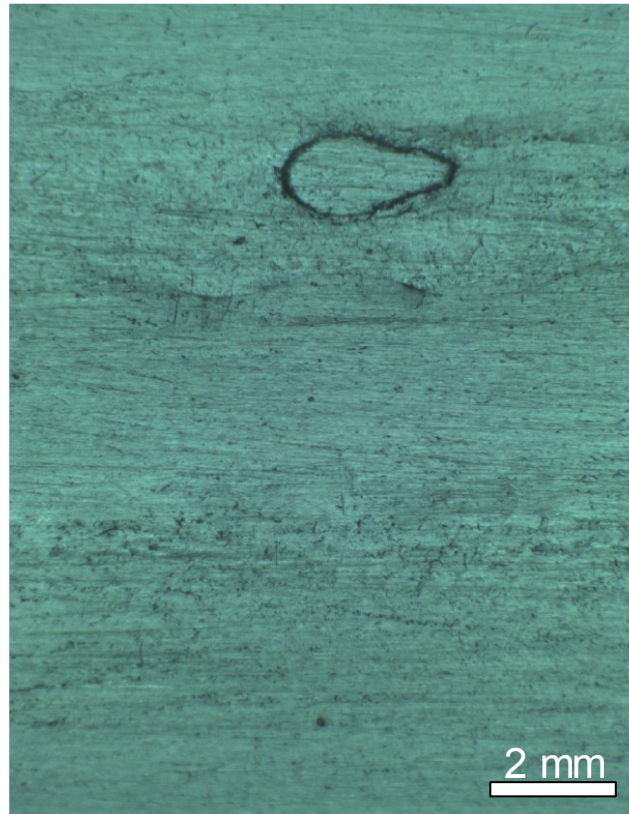
After final polishing:

→ max $E_{acc} = 30.5 \text{ MV/m}$
 → no FE

- reason is under investigation
- an **additional grinding/repair** is required
- optimum repair procedure (here shown a manual one) is under study

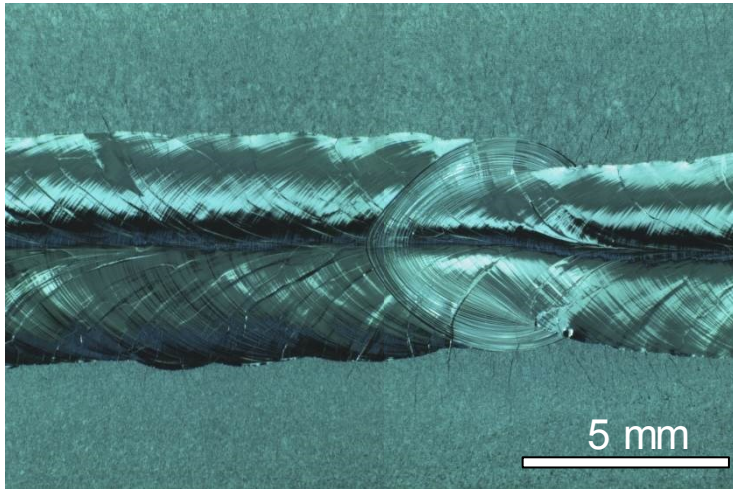
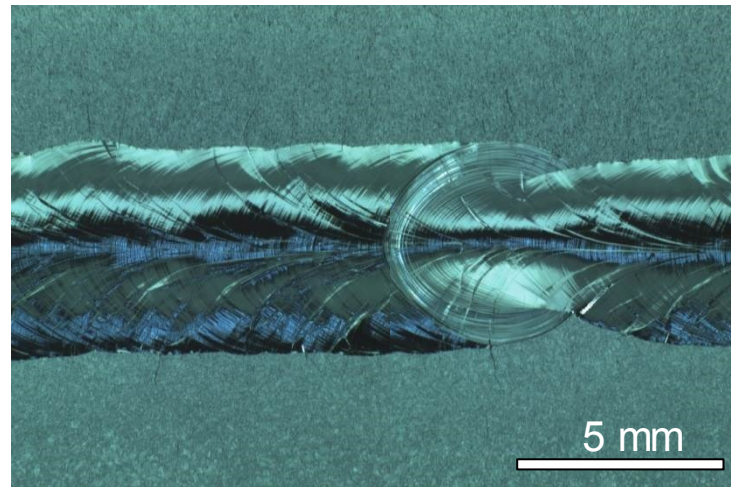
-> Optically the seam **looks fine**

-> Another cavity after such event (not OBACHT tested) showed **good** result with $E_{\max} = 33 \text{ MV/m}$

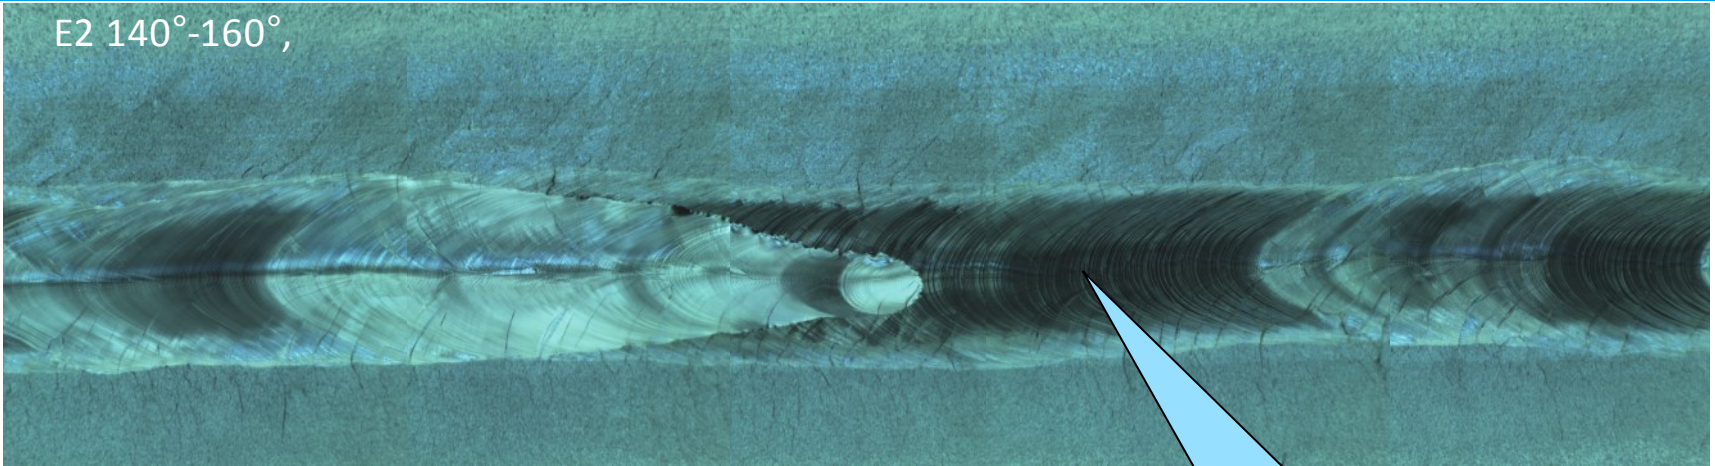
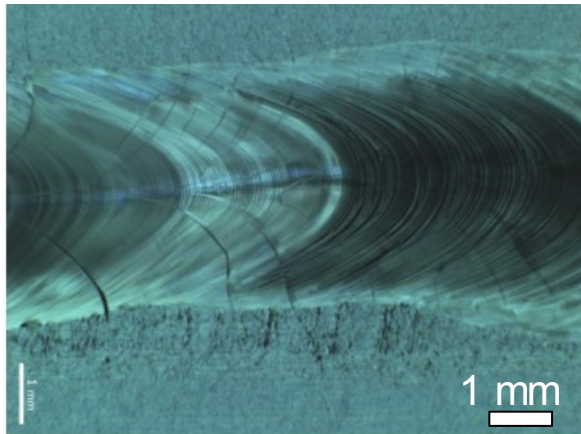
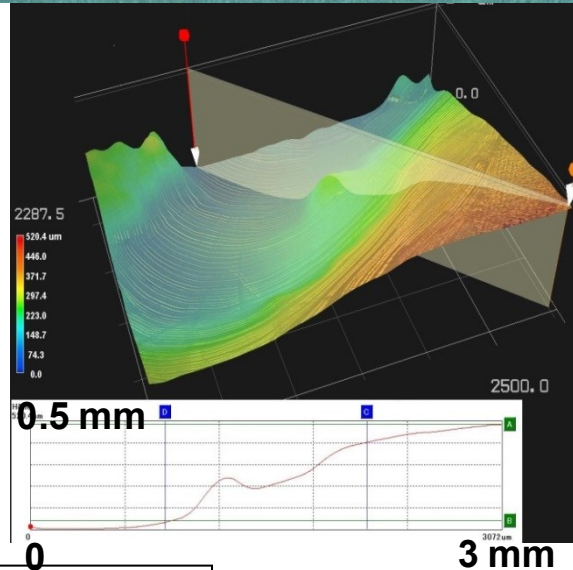
E2 140°-160°,

→ The whole welding seam (right) **protrudes >500 μm** (<300 μm specified)

After final assembly and polishing:

→ max $E_{acc} = 34.3 \text{ MV/m}$, BD limited
→ no FE

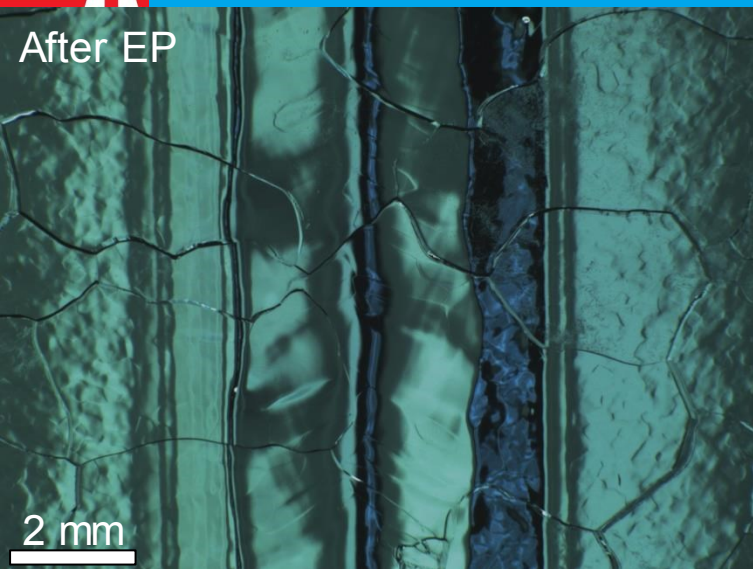
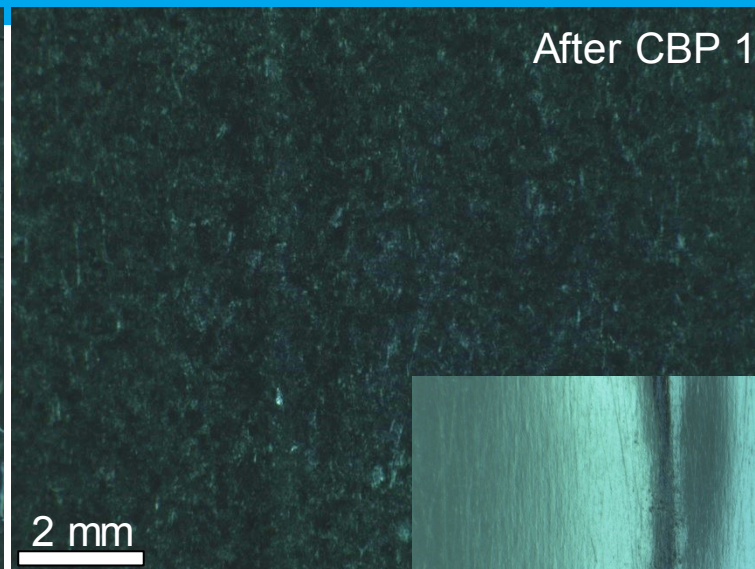
Z110_E1, 14.4°
 $E_{\text{max}} = 14 \text{ MV/m}$
 despite of add. EP

Porosity close to welding seam
 even after ~200μm CBP polishing

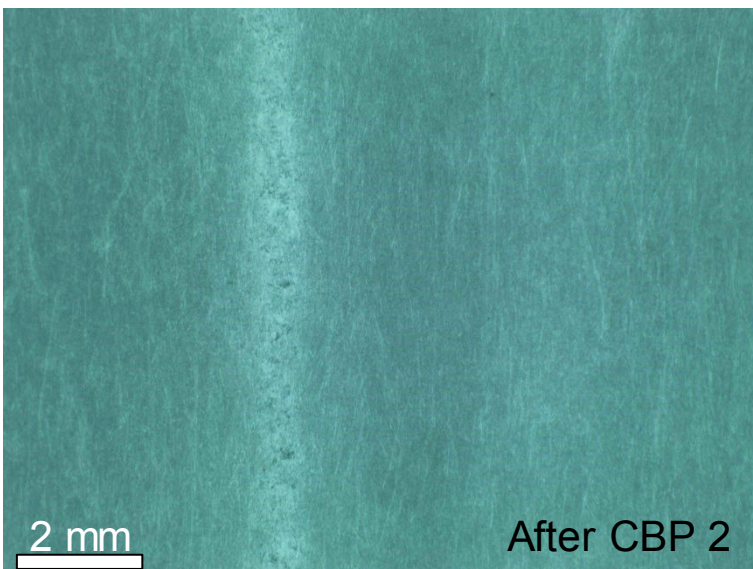
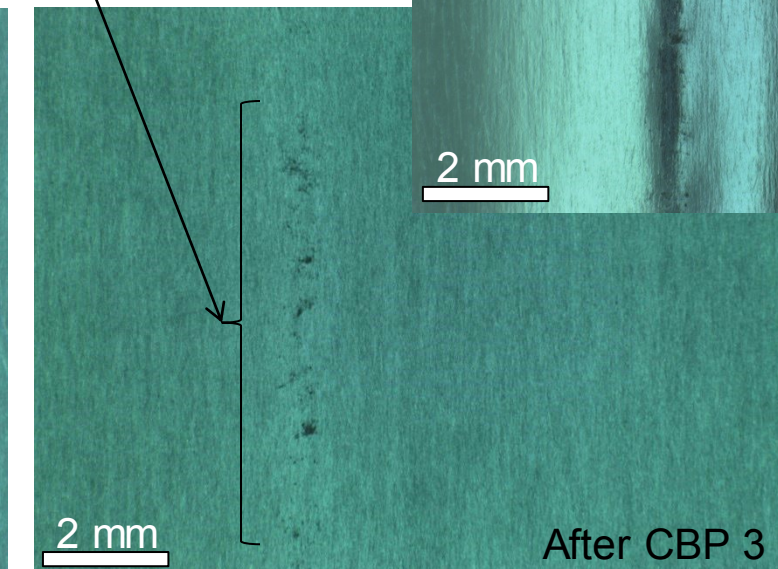
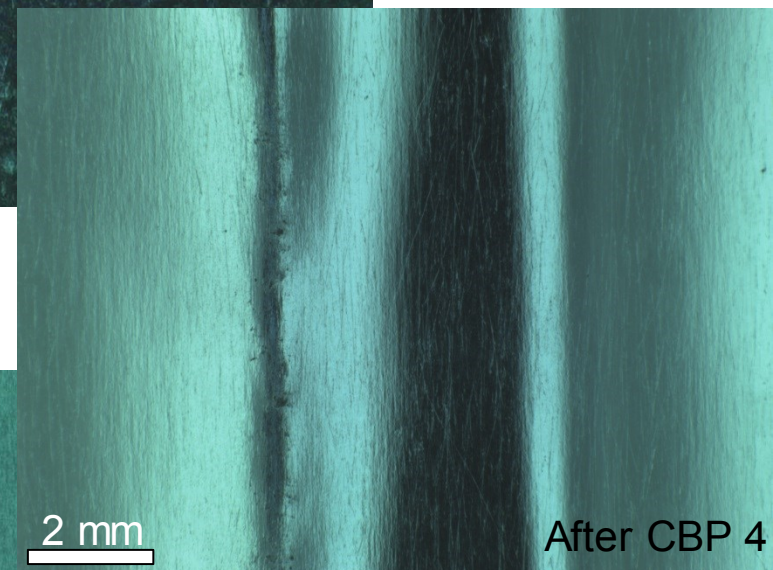
Porosity close to the welding seam

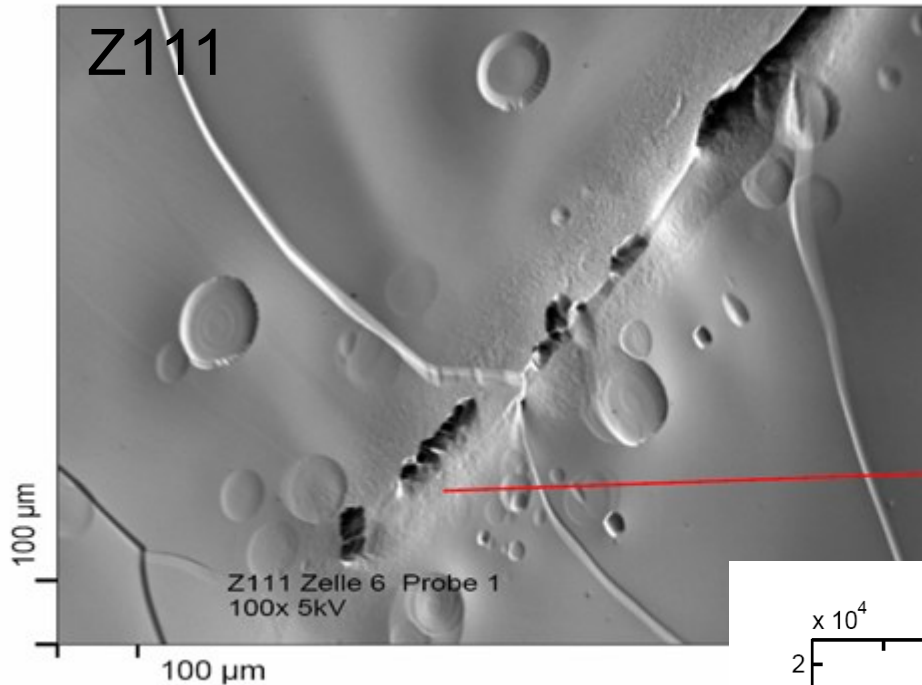
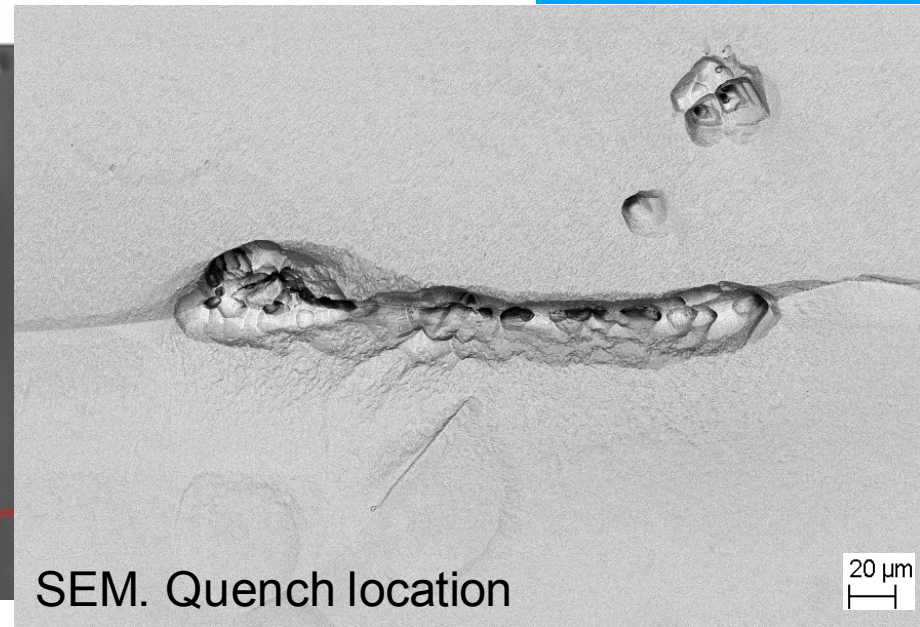
The Z111 cavity from the same campaign:

- deep pores even after additional 88 + 20 μm BCP, no foreign inclusions
- max $E_{\text{acc}} = 14.8 \text{ MV/m}$, BD limited
- It is hardly possible to cure such defects

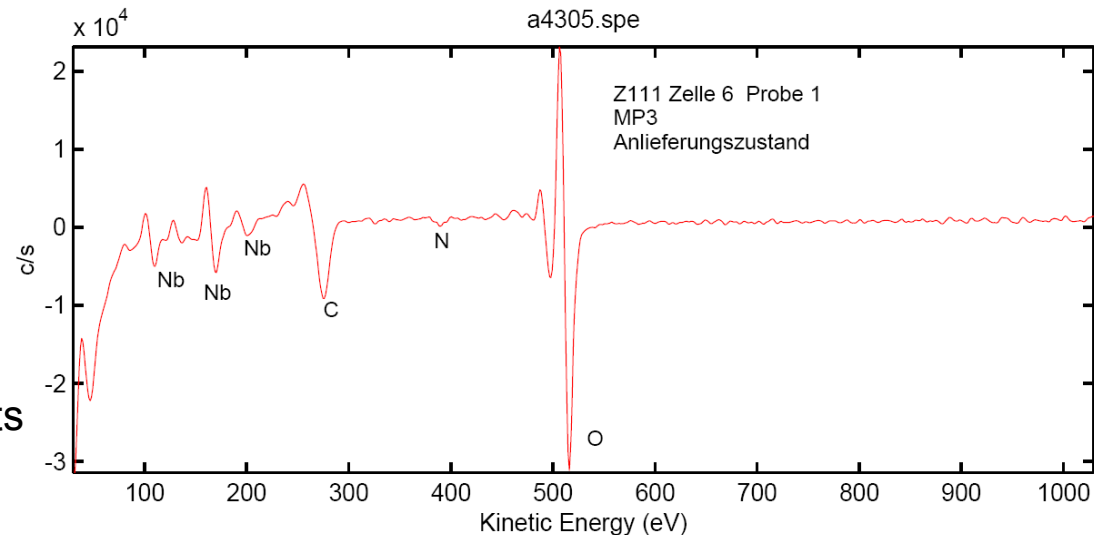
Auger analysis of the quench area (no foreign elements)
