# Optical inspection by OBACHT (DESY) and other inspection elsewhere from other laboratories

Aliaksandr Navitski  
aliaksandr.navitski@desy.de

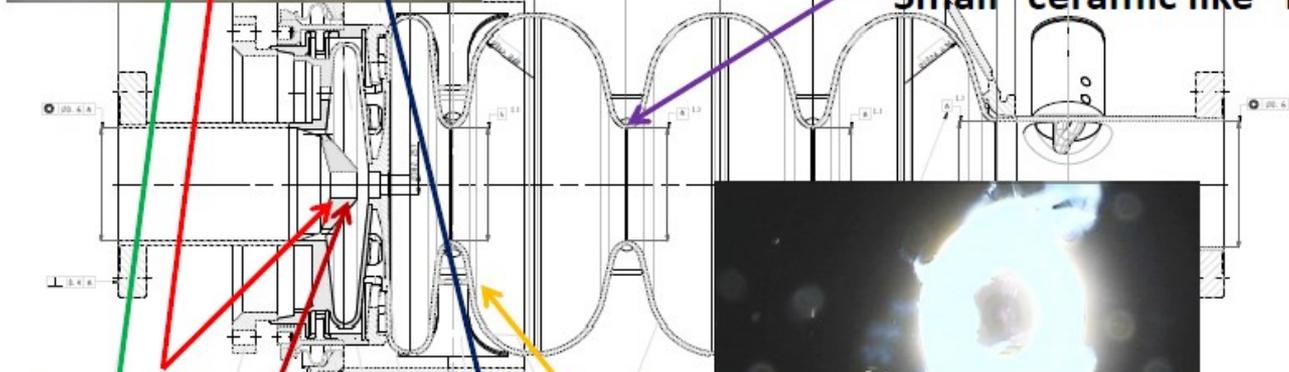
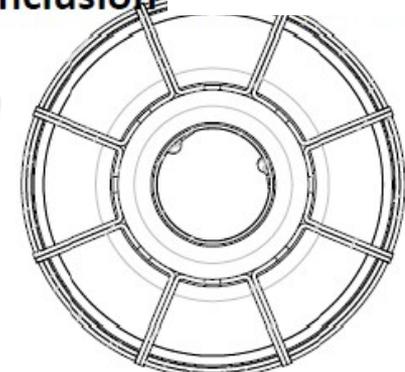
Small "ceramic like" inclusion

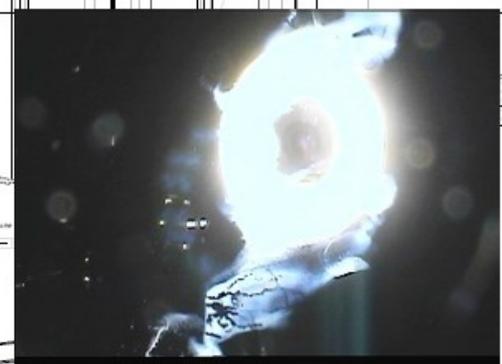
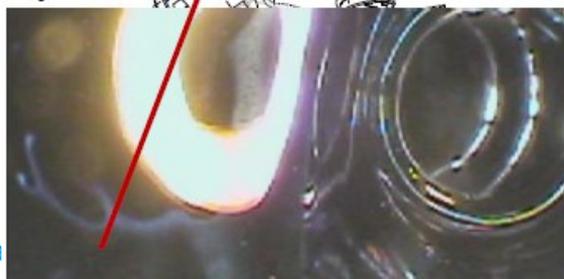
- a) HWP rinsing wand-marks
- b) Iris overheating marks
- c) Large grains boundary
- d) Chemical stain

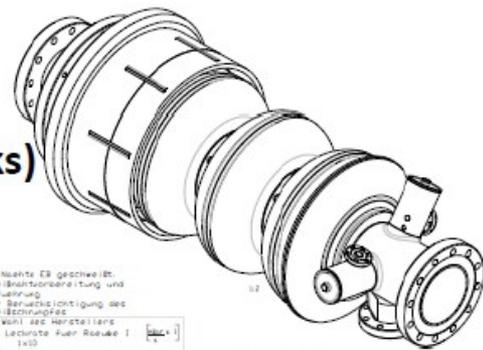
NB surface exfoliated (peeled off, cracks)

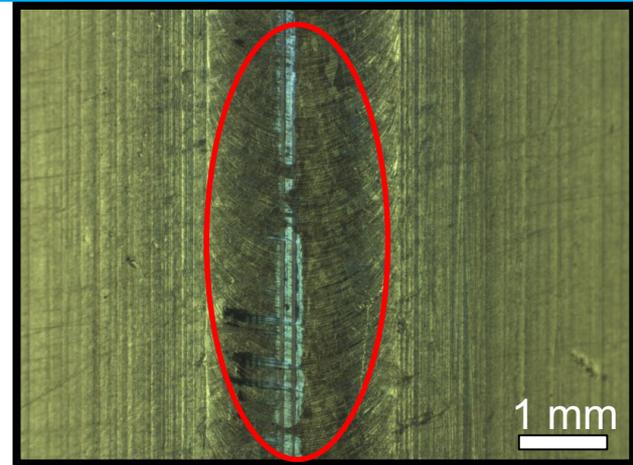
*Defect during SPL mock up assembly*

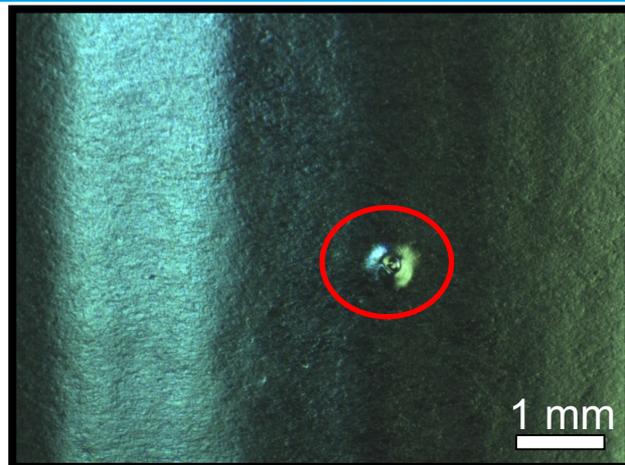
*Cat eye defect on coated cavity (HIPIMS)*

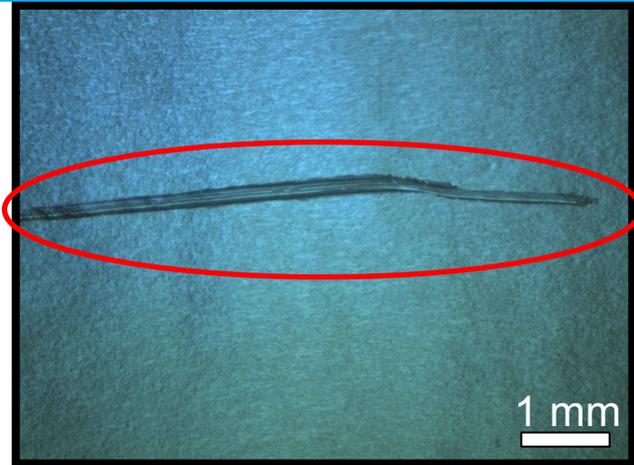
*Scratch coated cavity (HIPIMS)*

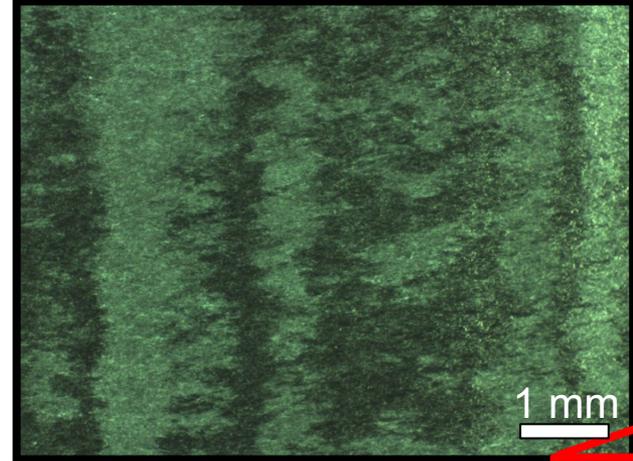
*Black marks on coated cavity (HIPIMS)*

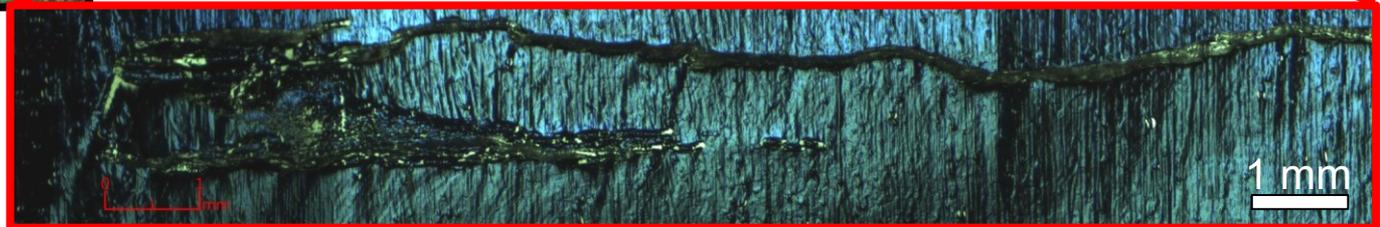
*Crack on SPL01 Nb cut off*

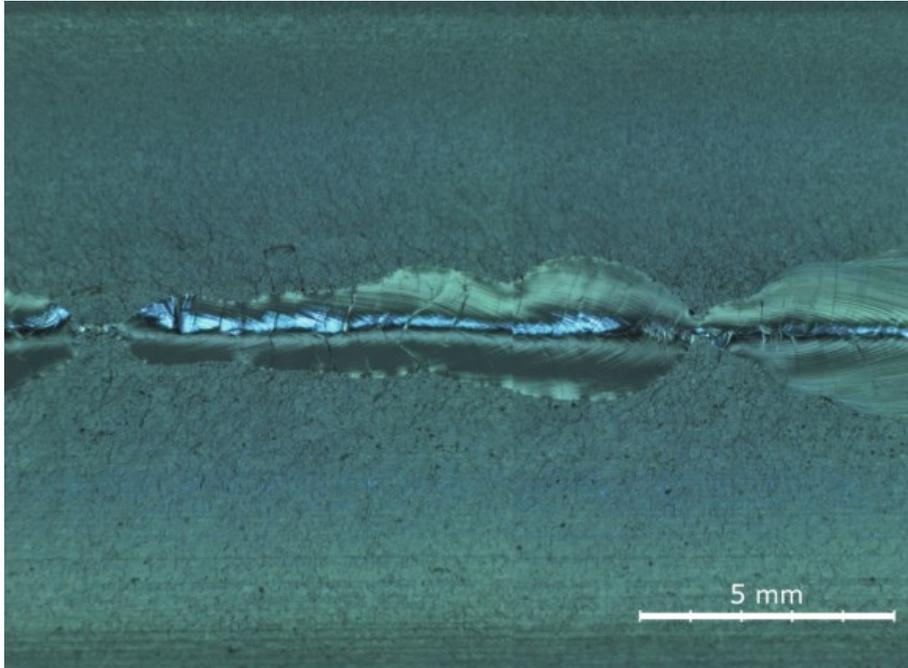
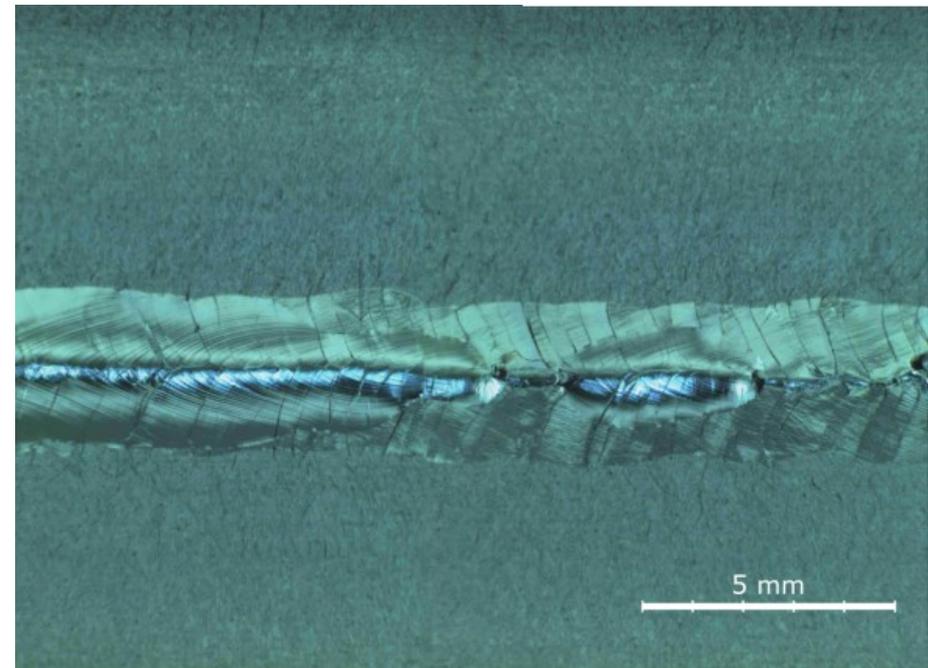
Initial, **not optimized**  
 → e<sup>-</sup>-beam **not penetrated** everywhere  
 → **strong variation** of the seam- width  
 → **repair** procedure to be established

Final, **optimized**  
 → e<sup>-</sup>-beam **fully penetrated**  
 → **homogeneous** welding seam

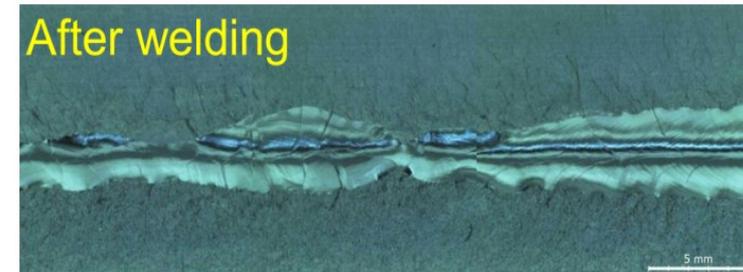
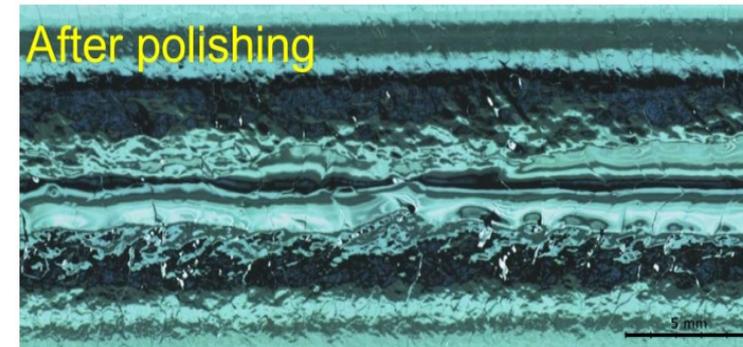
**CAV00518:**

→ Unsuccessful cold RF test result with quench at **22 MV/m**, **no FE**

→ OBACHT indicates defective welding as a possible quench reason

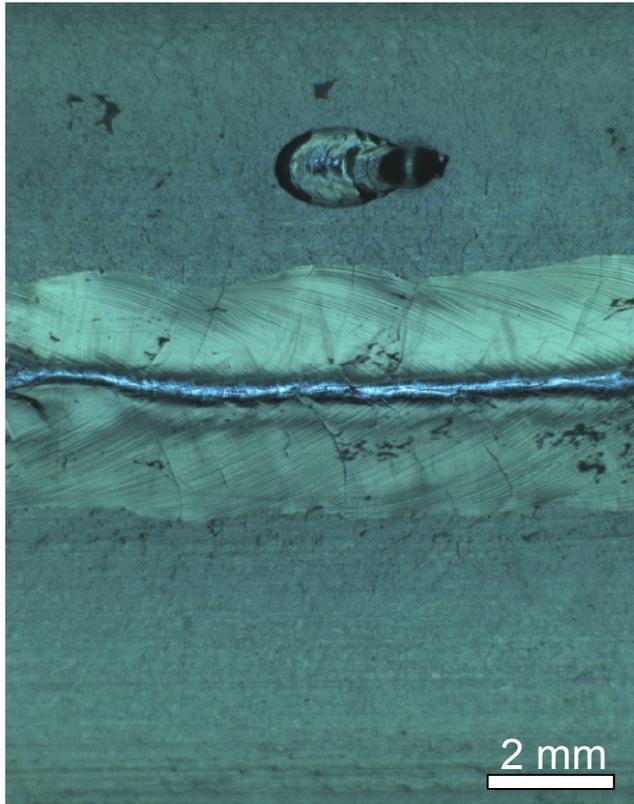
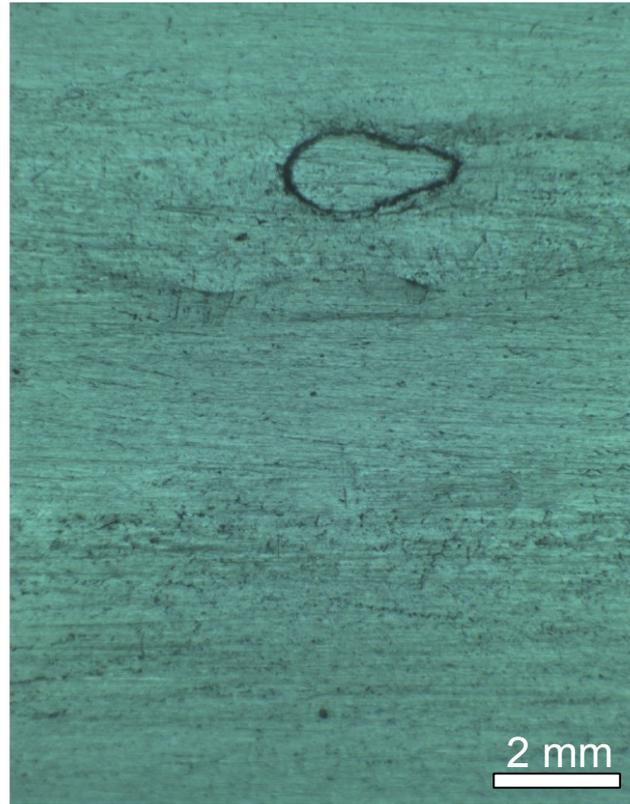
Endoscopes & OBACHT (shown here) inspections discover some “spatters” occasional occurring during the welding:

→ max  $E_{acc} = 30.5$  MV/m  
→ no FE

→ reason is under investigation

→ an **additional grinding/repair** is required

→ optimum repair procedure (here shown a manual one) is under study

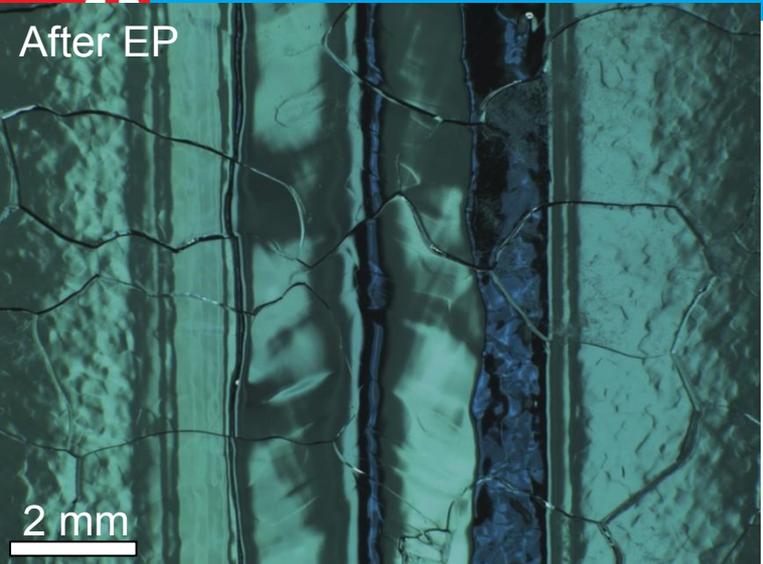
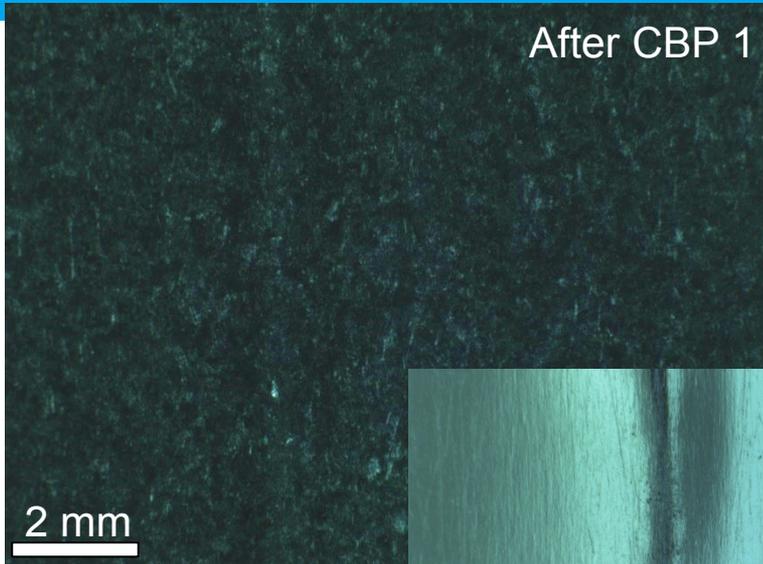
Z110\_E1, 14.4<sup>0</sup>  
 $E_{\max} = 14 \text{ MV/m}$   
despite of add. EP

Porosity close to welding seam  
even after  $\sim 200\mu\text{m}$  CBP polishing

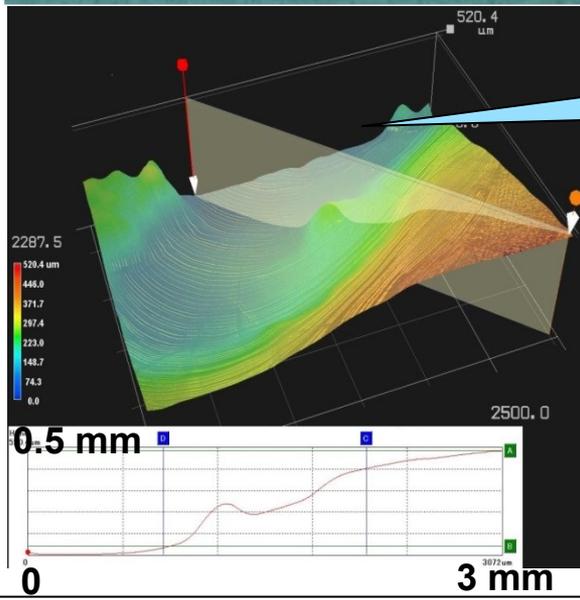
→ “snake head” at e-beam welding exit is **not protruded** as it seems from the OBACHT images

→ The whole welding seam (right) **protrudes >500 μm (<300 μm specified)**

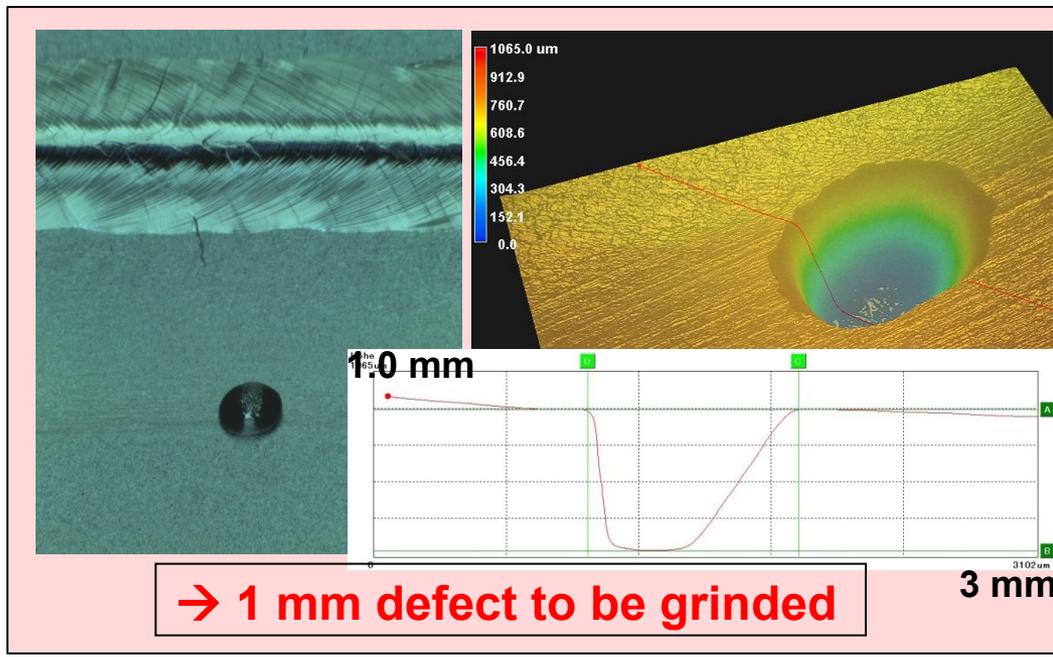
→ 1 mm defect to be grinded

After final assembly and polishing:  
 → max  $E_{acc} = 34.3$  MV/m, BD limited  
 → no FE
