TTC Cornell Talks

1-cell test results from new vendor
cavities

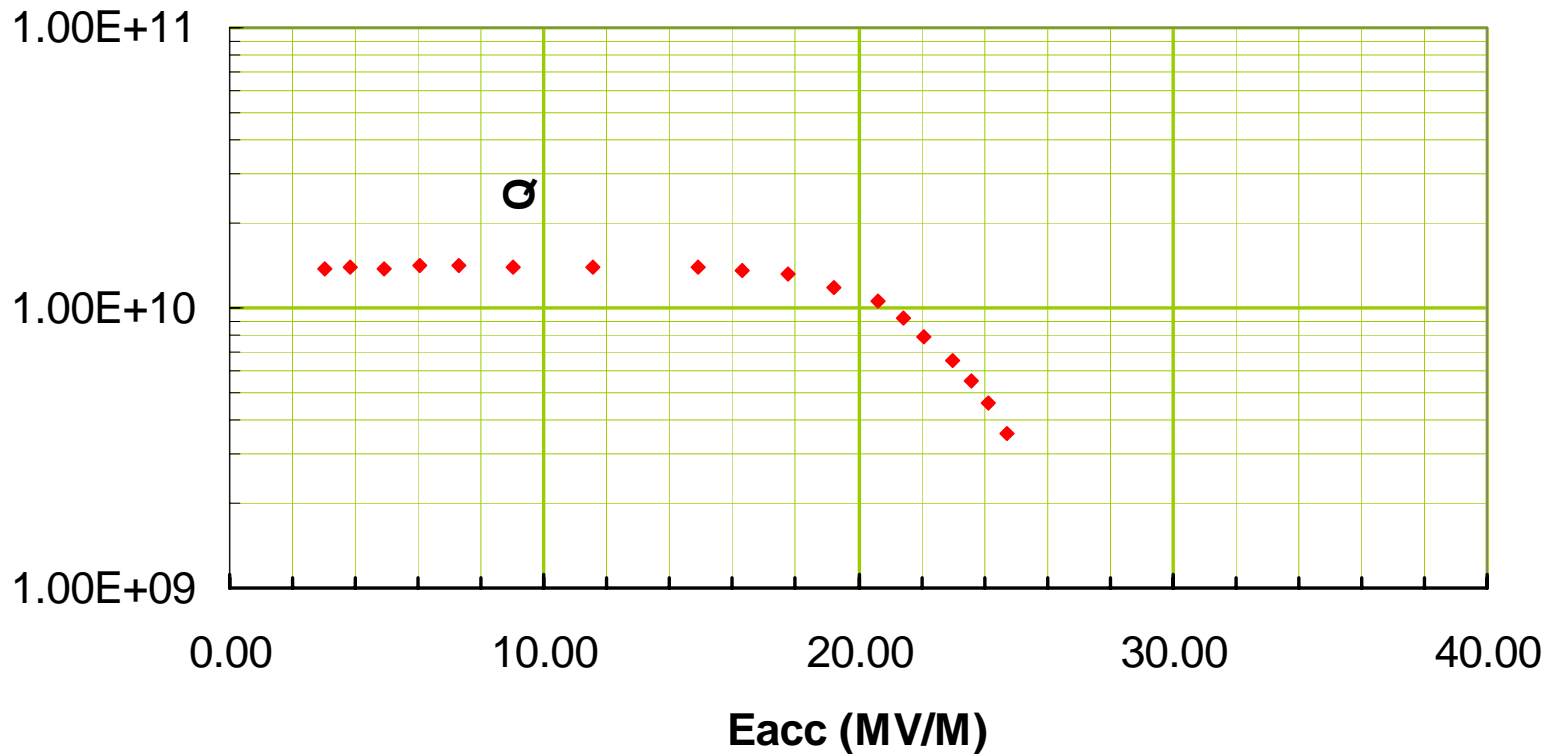
Cavity 4 (Q-slope + Quench)

- optical microscopy with Questar shows bump (s) –see figure
 - (but not on weld)
- Cavity 4, BCP total 150 mm
 - Q-slope to 25 MV/m. then quench
 - Quench location identified with 2nd sound

- Preliminary analysis, location near weld (different from others)
 - Optical inspect coming this week
- Summary
 - Gradient > 25 MV/m possible
 - Quench is not in weld

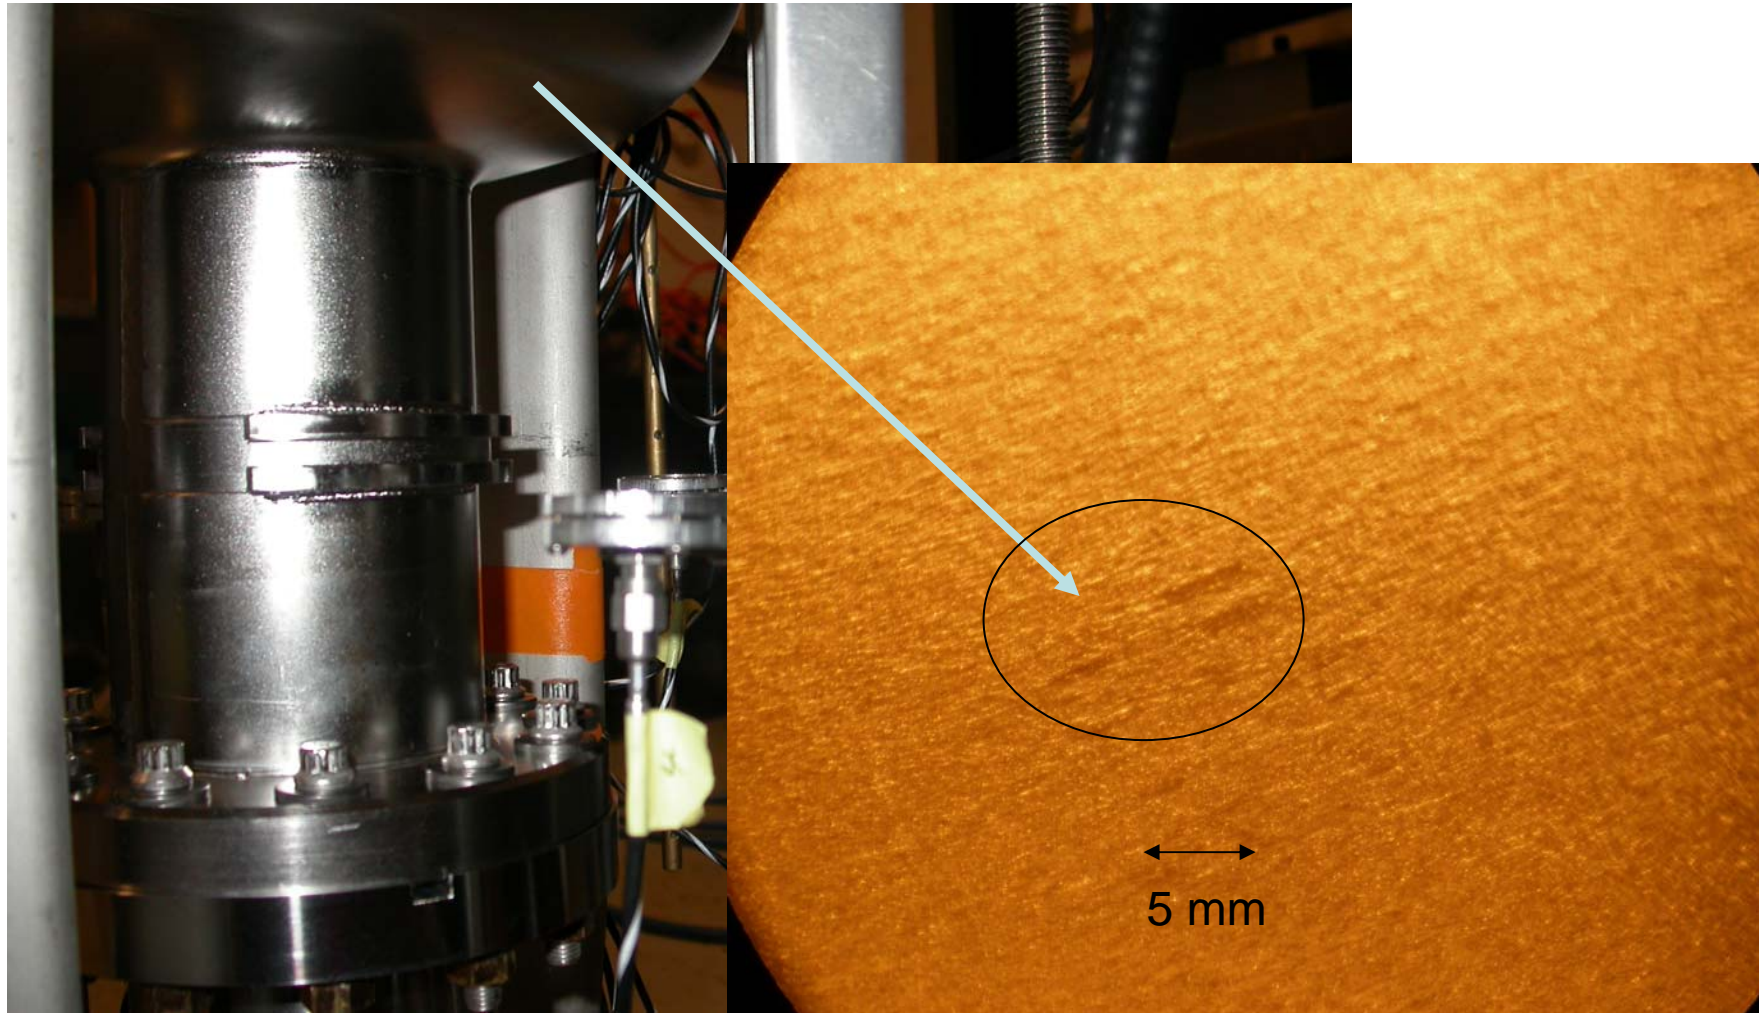
Defect Found in Cavity #1 with 2nd Sound Detection and Questar Inspection

- Quench location identified with 2nd sound
 - optical microscopy with Questar shows bump (s) –see figure
 - (but not on weld)
- Cavity 2' BCP Total 180 μm

- Q-slope to 29 MV/m, then quench
 - Same location, only one bump remaining
- Cavity 3, BCP 60 mm
 - Q-slope to 24 MV/m, then quench
 - Quench location identified with 2nd sound

- But fabrication technique leaves bumps on material
