# *Status of the HVStripV1 testing*

Luigi Vigani  
University of Oxford

# *MB03 Failure*

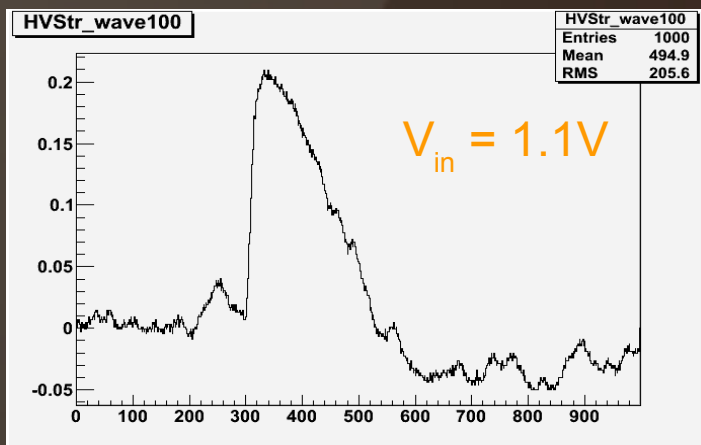
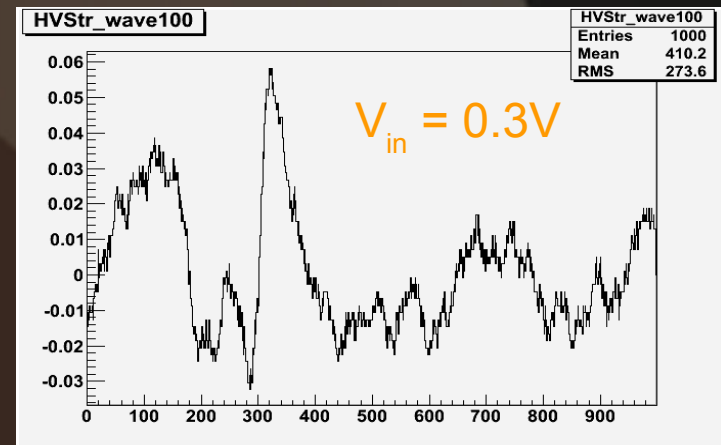
- “Usual” injection study,  $-10^{\circ}\text{C}$ :
  - Inject voltage in
  - Read voltage out
  - Plot mean signal height vs voltage in
  - Fit with straight line
- Fact: output seems very noisy now:

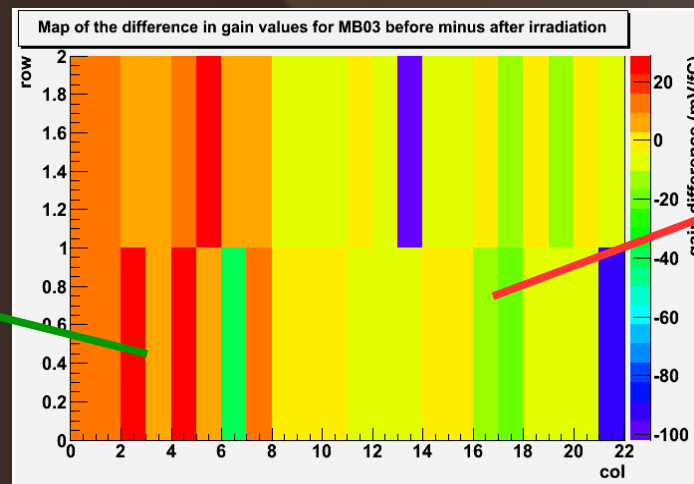
This is the difference between the two:

Gain decreased

Gain increased (?)

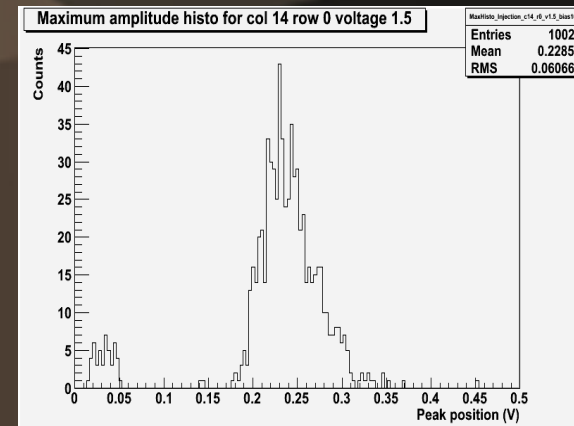
After irradiation:

Huge increase in noise!

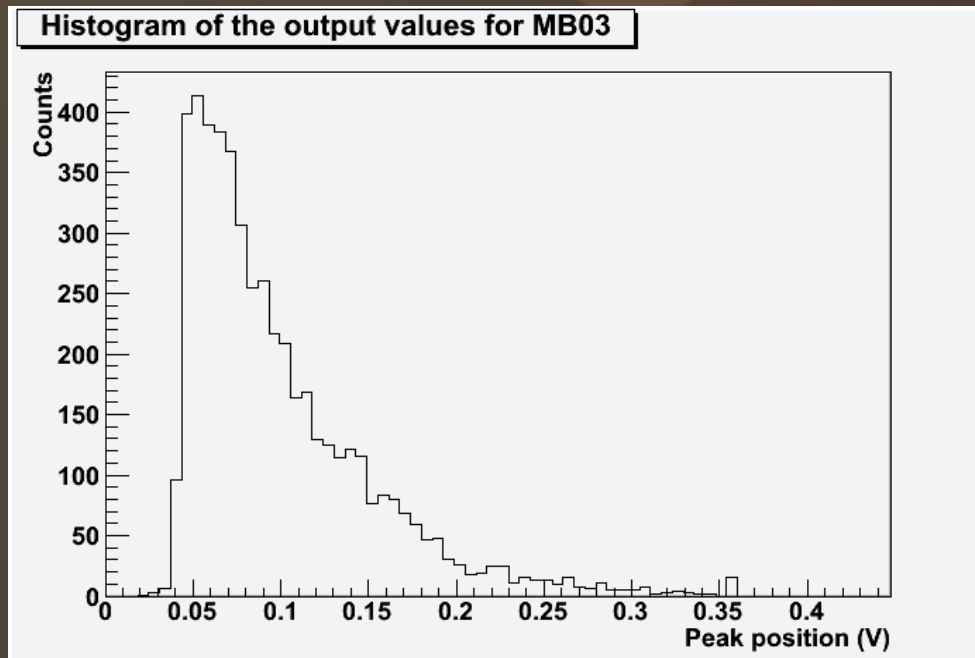
We tried to check the gain with an Iron55 source as well, but given the high noise we couldn't see anything, even at -20°C:

**Triggering on the output signal gives us a lot of background, we couldn't get rid of it.**

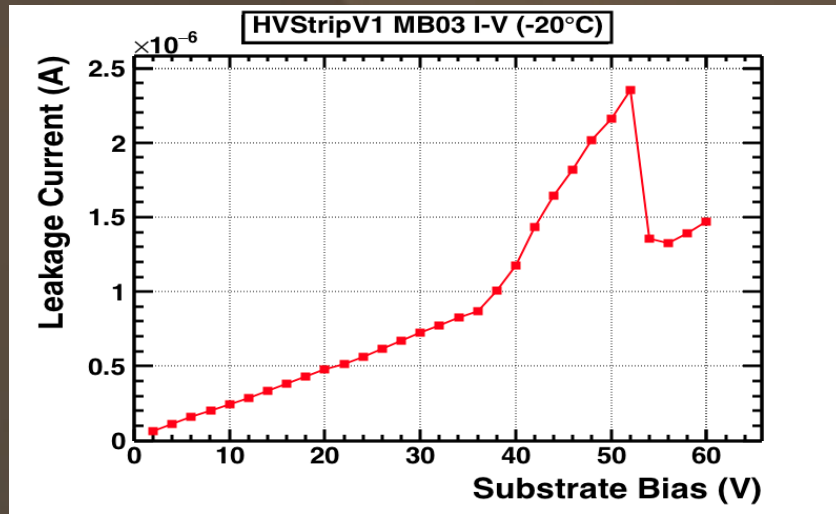
Really strange behavior, especially if compared with an unirradiated chip:

It could be also the case that we didn't wait enough at each step before the leakage current got stable.

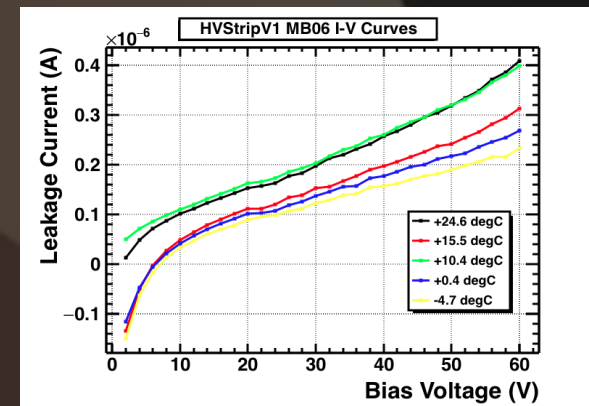
Also, on the unirradiated device, the changes in the curve on increasing temperature are not regular: environmental chamber working badly?

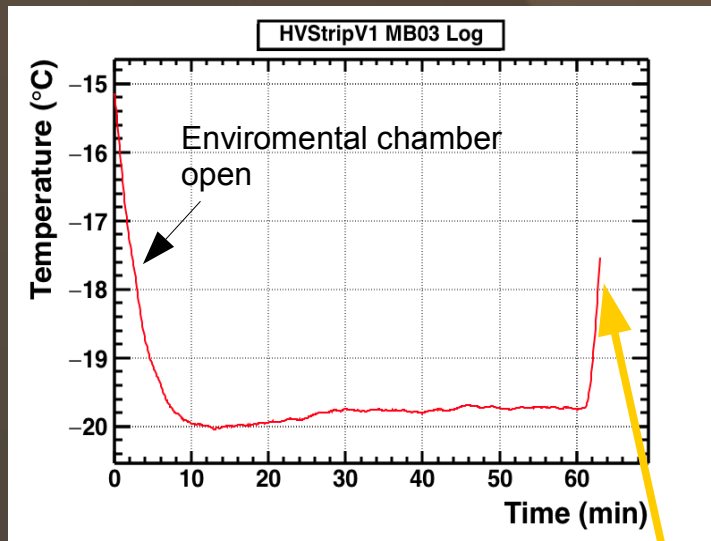
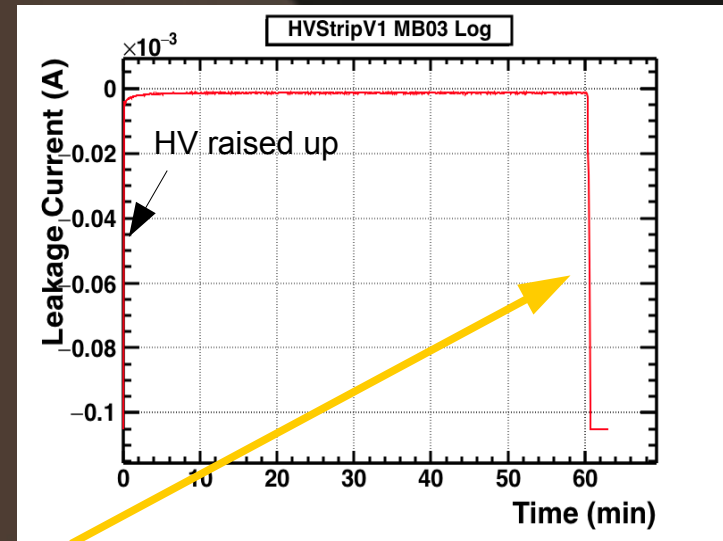
- While measuring the passive element characteristics on MB03 (PMOS structure, using a Keithley machine) the device stopped working:

**Temperature and leakage current increased (up to compliant) at the same time**

Unfortunately it seems to be impossible to recover...

Possible causes:

- Since HV was on, could be HV circuit failure (it wasn't necessary, but it shouldn't affect the measurement)
- Loose connections on Keithley machine (after unscrewing and screwing back some components it got back working)
- Condensation: humidity not kept low enough (need for Nitrogen bottles )
- Some combination of the three above.

- Improve the working conditions for the devices
- Study MB04 and improve the Iron55 calibration
- Use Strontium90 source (better signal)
- Annealing
- Test beam at DESY
