# GEM Modules Assembly for TPC Group Test Beam.

GEM Module Assembly,

TPC Test Beam Preparation, 29.08.2016

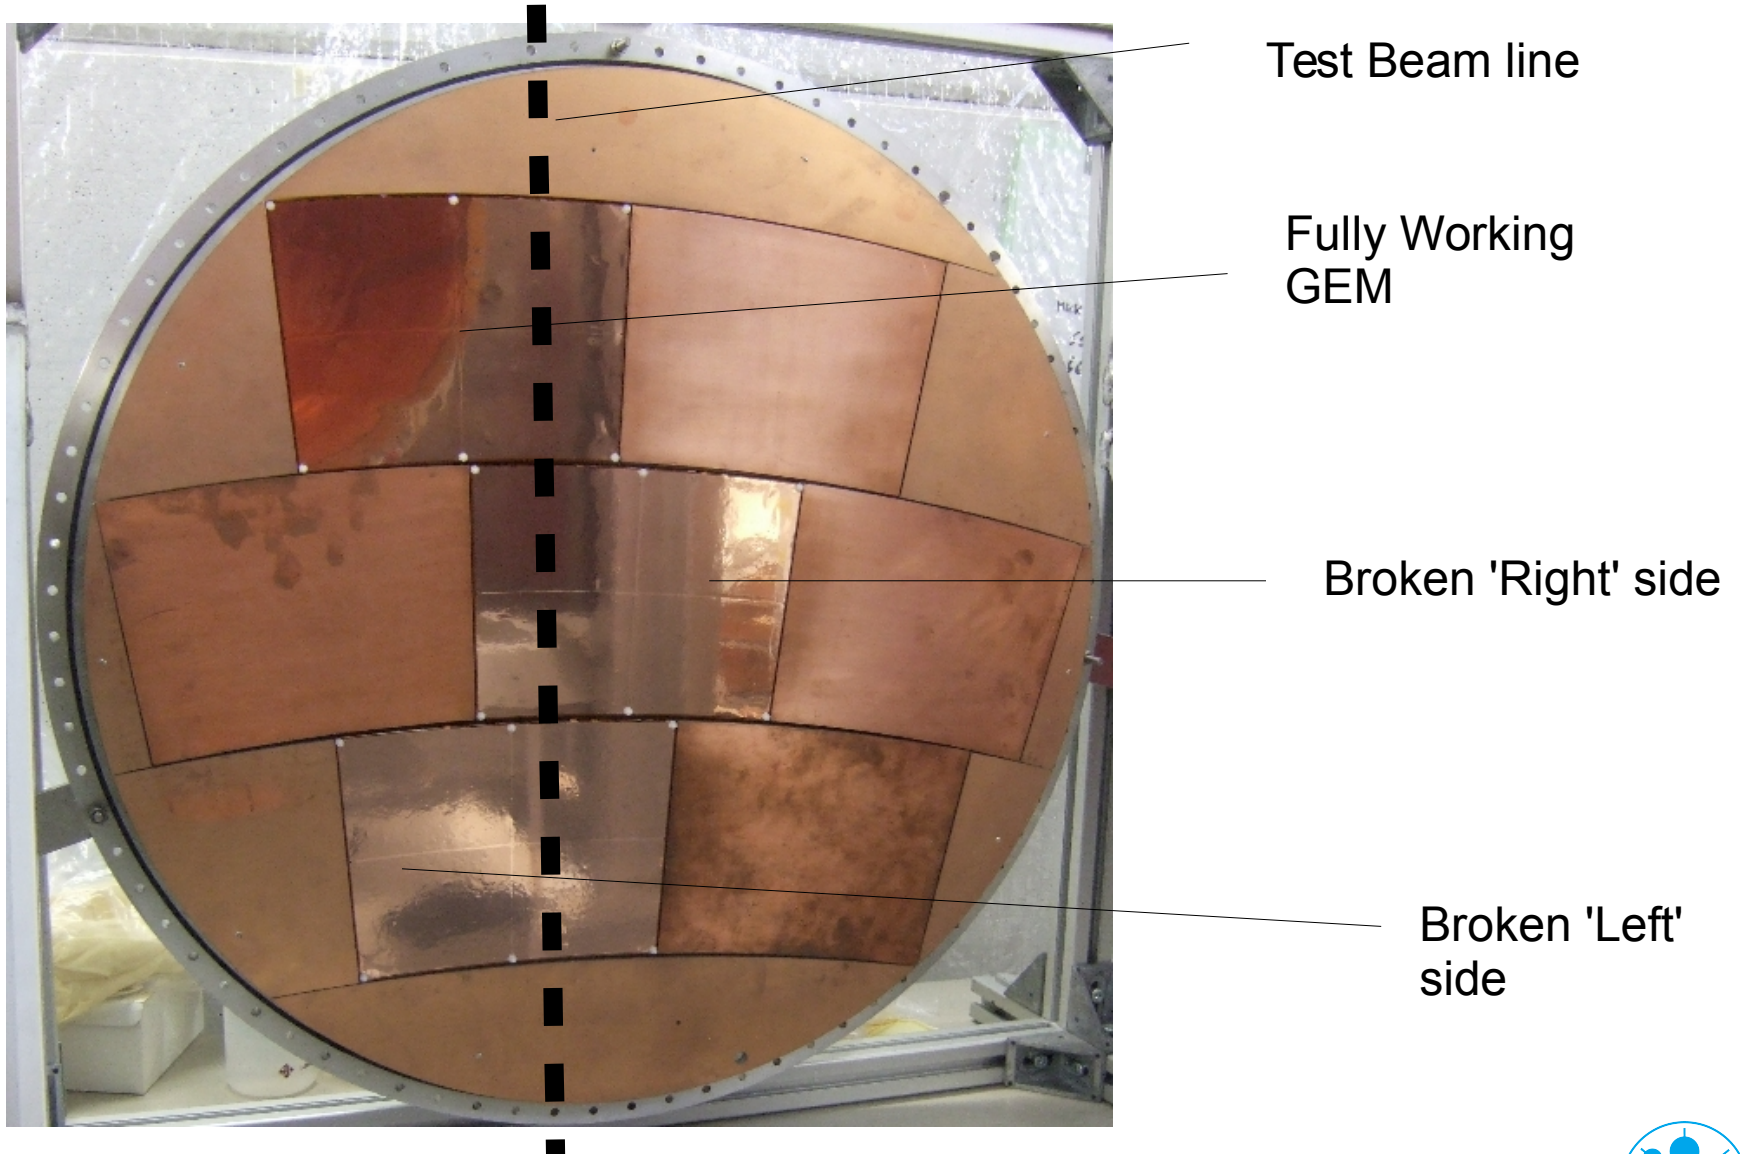
# Final Configuration in test Beam

- 1 GEM module is fully working for the test beam time.
- 2 GEM modules will be placed such that their broken sectors are outside the test beam line.
- Broken sectors are shortcuted to common side to keep it at the correct voltage.
- In total we had 6 broken sectors. With 3 In one module on 'left side' and 3 On 'right side'.
- Still need to test one last GEM Module.

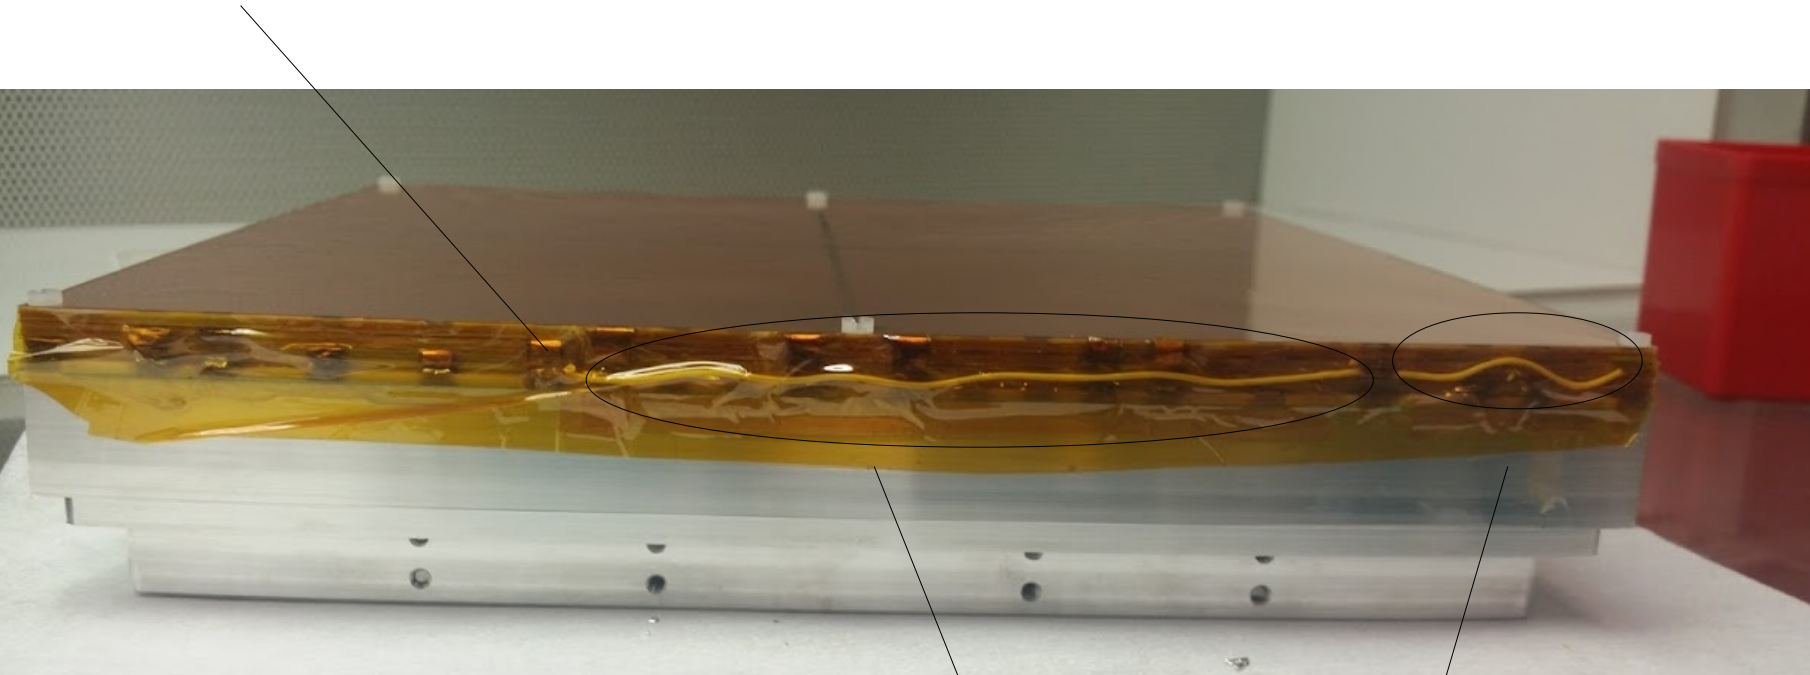
# Shortcutting of a Sector

Connection to common side

Shortcutting Wires
