ONSEN SC, RC, IPMI – Status and Issues

Björn Spruck, Uni Mainz

Belle2 PXD Workshop, DESY
23.1.2018

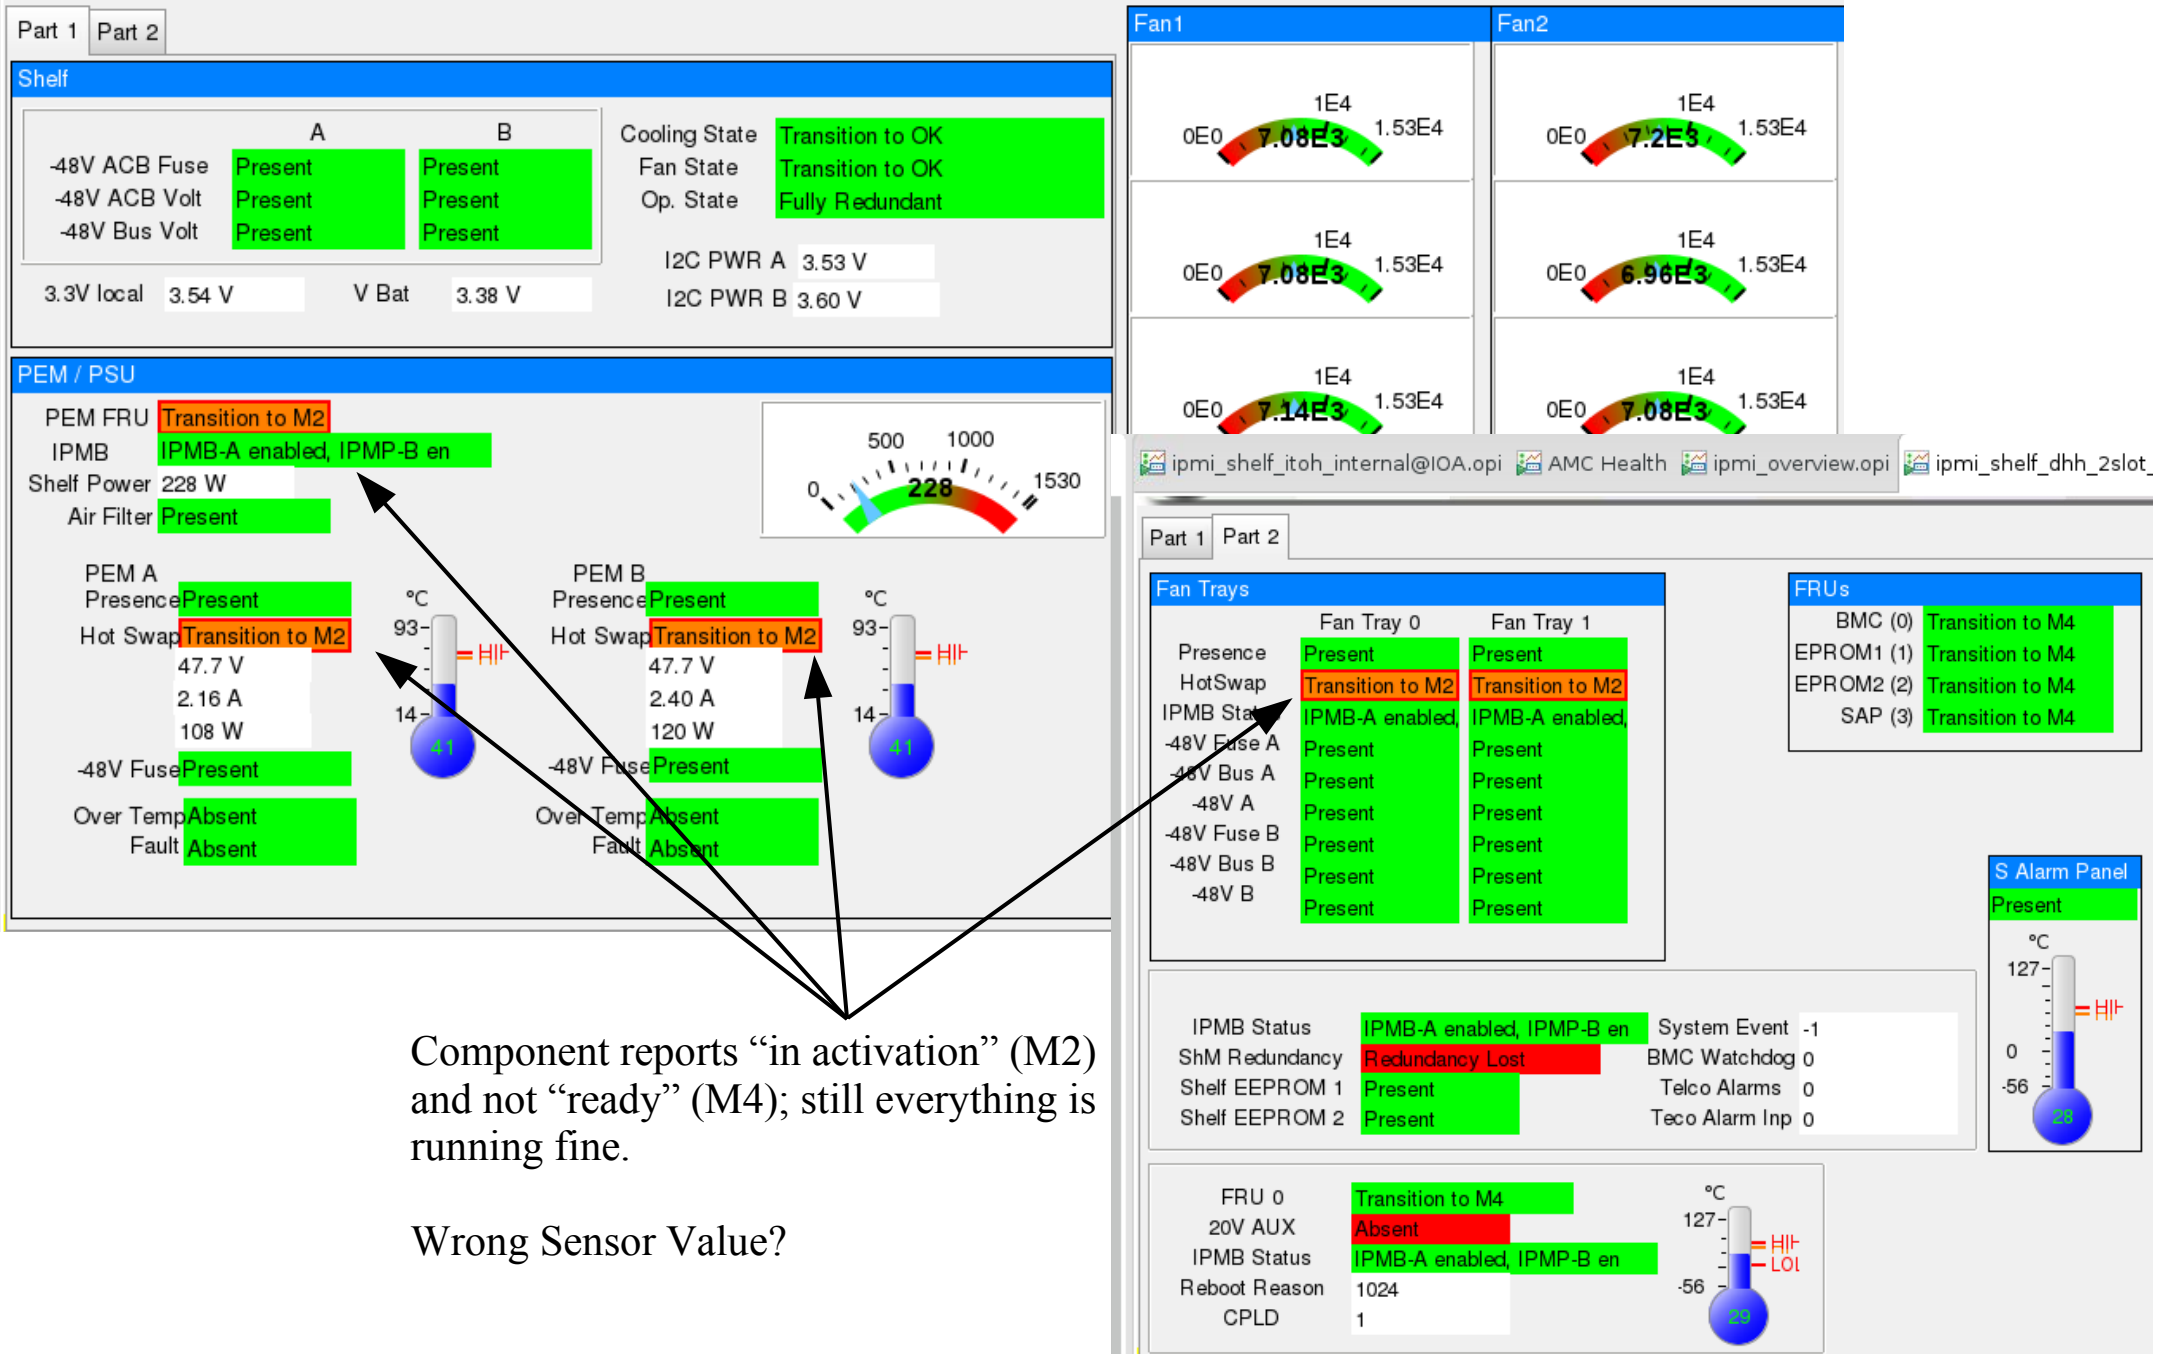
(IPMI) Hardware Issues – DHH Shelf (2Slot)

Sensor reading ("Mask") tells M2, but Shelf Manager reports M4 state. (ShM keeps Track of Messages; but IPMI ioc uses sensor reading)

Clearly a firmware problem (or a questionable implementation) on the FRU ...
But on several at the same time???

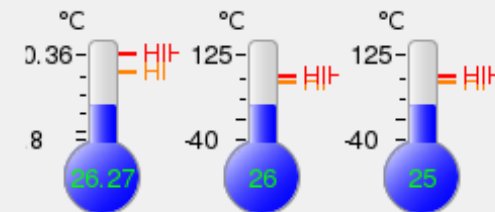
No Power Supply, that is strange.

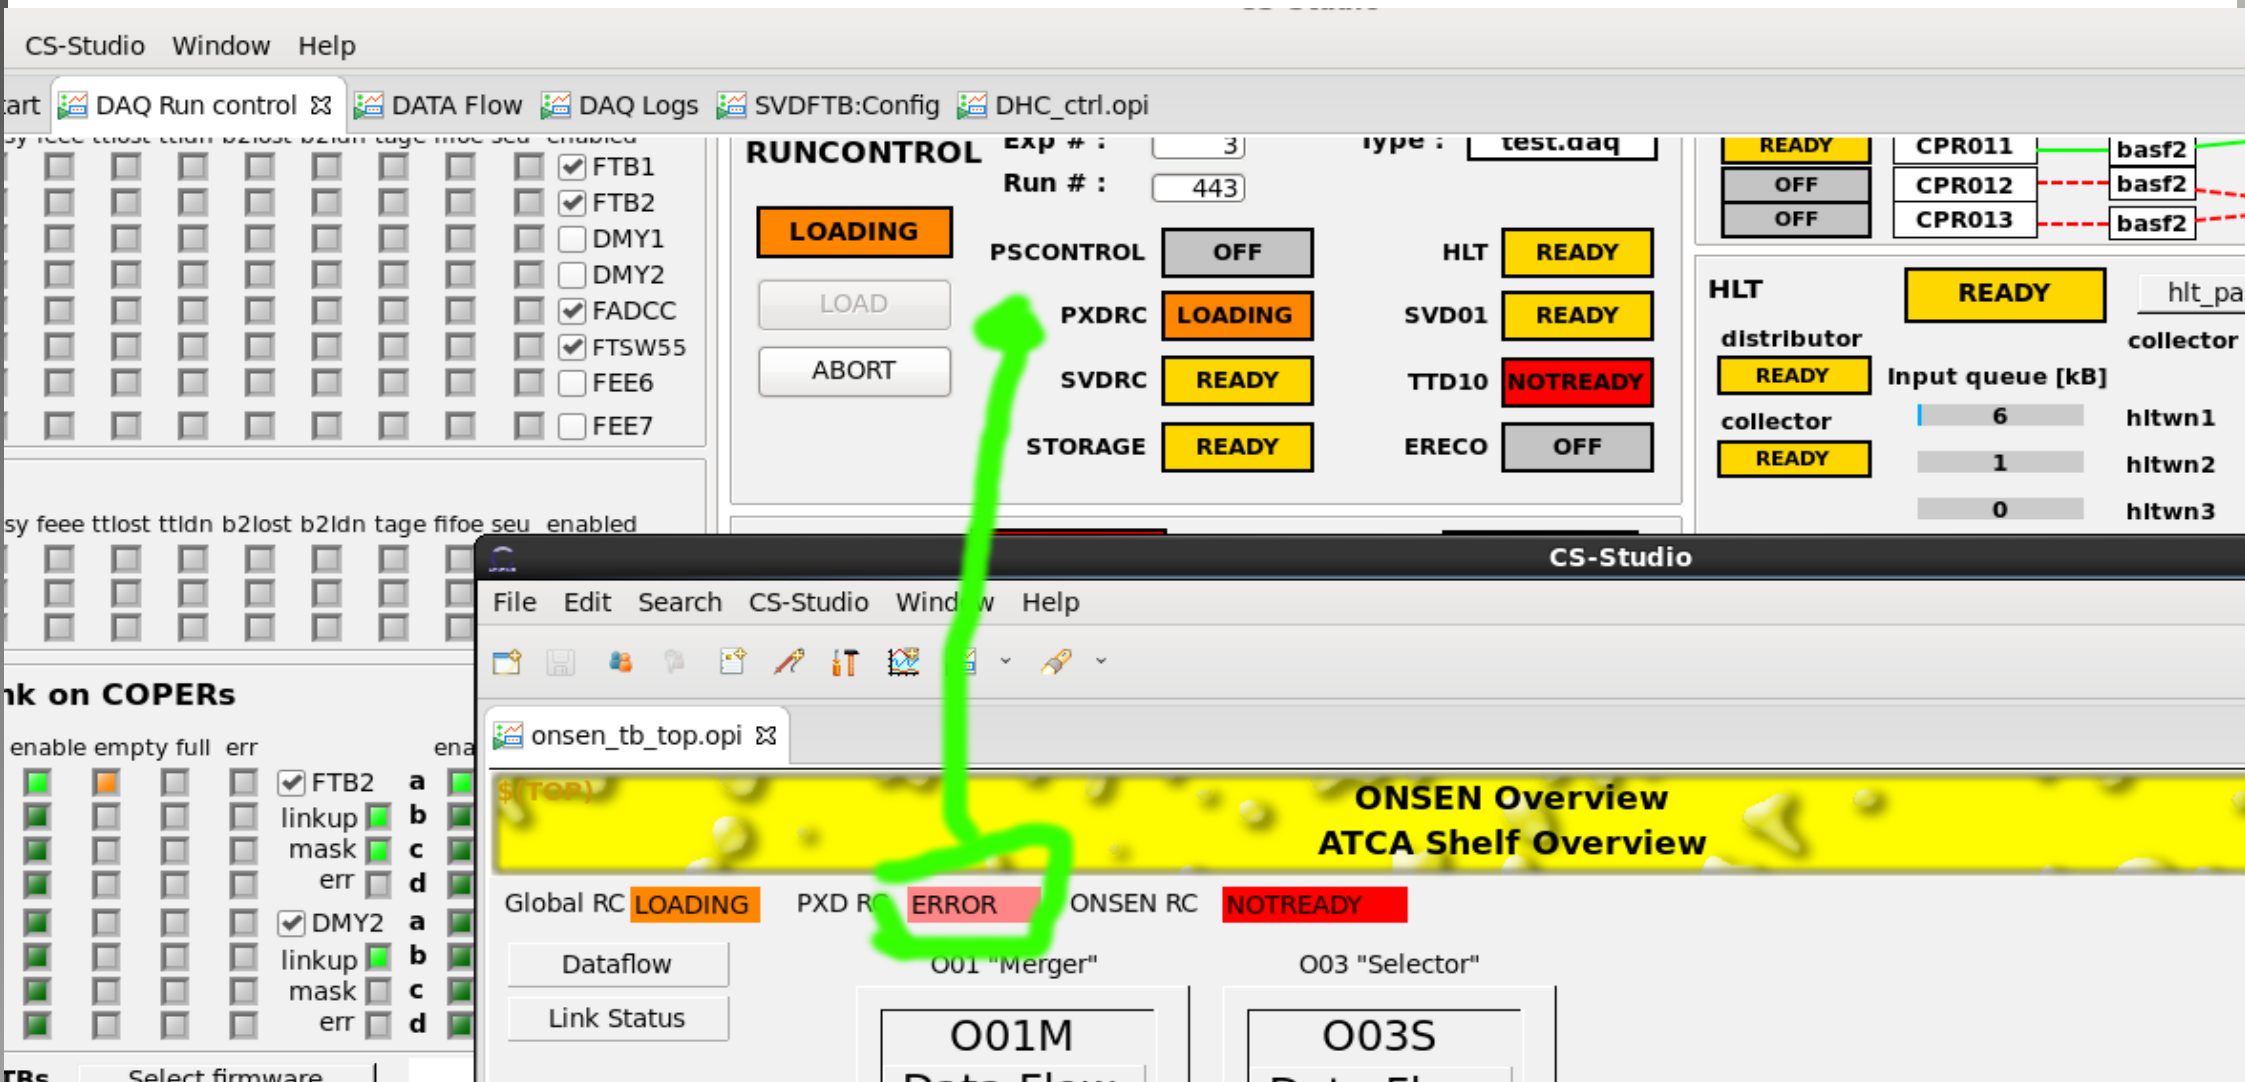
NSM Gateway: Hidden Local State

Old picture, but „problem“ can be reproduced in current setup.
Remark: Its only a (cosmetic) GUI issue.
