Module and Ladder Testing at MPP

Philipp Leitl phleitl@mpp.mpg.de

Max Planck Institute for Physics

2018-01-23

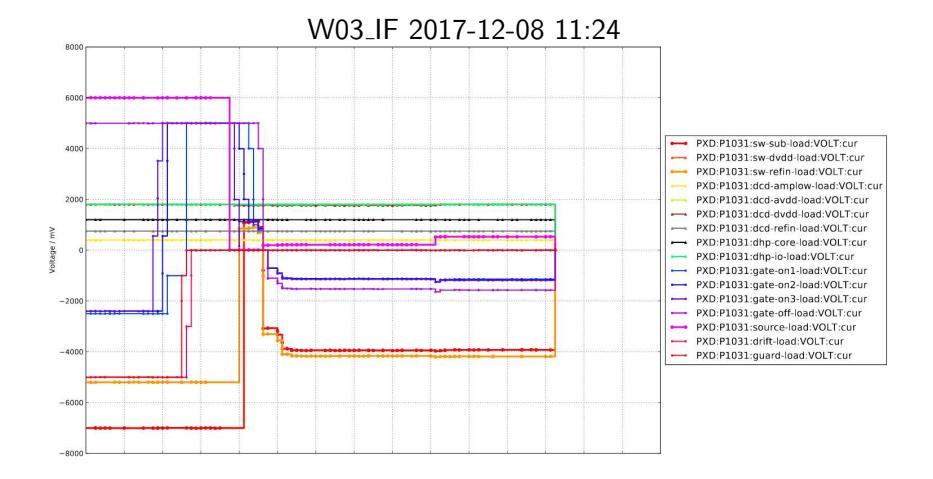
Ladders are tested after gluing to verify nothing broke. L1_019 was working fine, but encountered a problem during power down.

Powerdown issue or switcher incident

At the step when ramping down the source voltage several lines went into the current limit and the corresponding voltages were pulled away from the nominal values. sw-sub and sw-refin have been positive for a short time (5-6 s).

The Power Sequence was adapted by Felix to slow down the ramping of the source voltage. Also all current limits are set now at the first step to provide proper operation of the regulators.

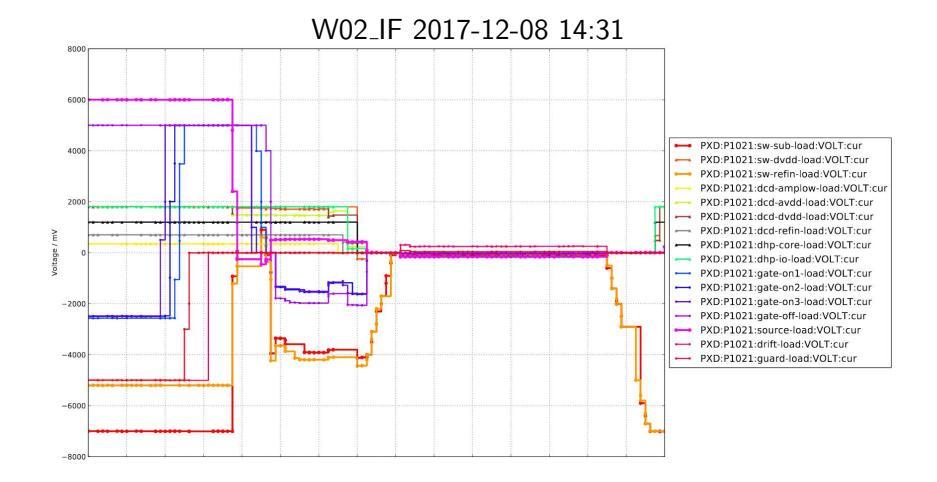
Powerdown issue or switcher incident

Only a few hours later the same behavior was seen on the module W02_IF on pxdtest8. Both modules show increased clear-on and clear-off currents after this incident.

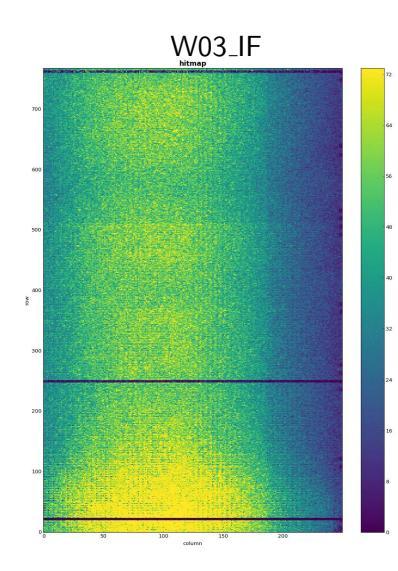
Powerdown issue or switcher incident

- Source scan reveals 3 damaged gates.
- Clear currents stay at high level:

| 19355 mV | 19003 mV | 89 mA | clear-on |
| 4690 mV | 4997 mV | -67 mA | clear-off |

L1_019 is running stable for several days now. So far no degradation has been observed. Every 5 minutes pedestals are taken. Those will be analyzed if there was a change in time.

The failure mechanism is still not known.
