PXD Modules

- January 2018 -

Flip Chip II – Report from IZM

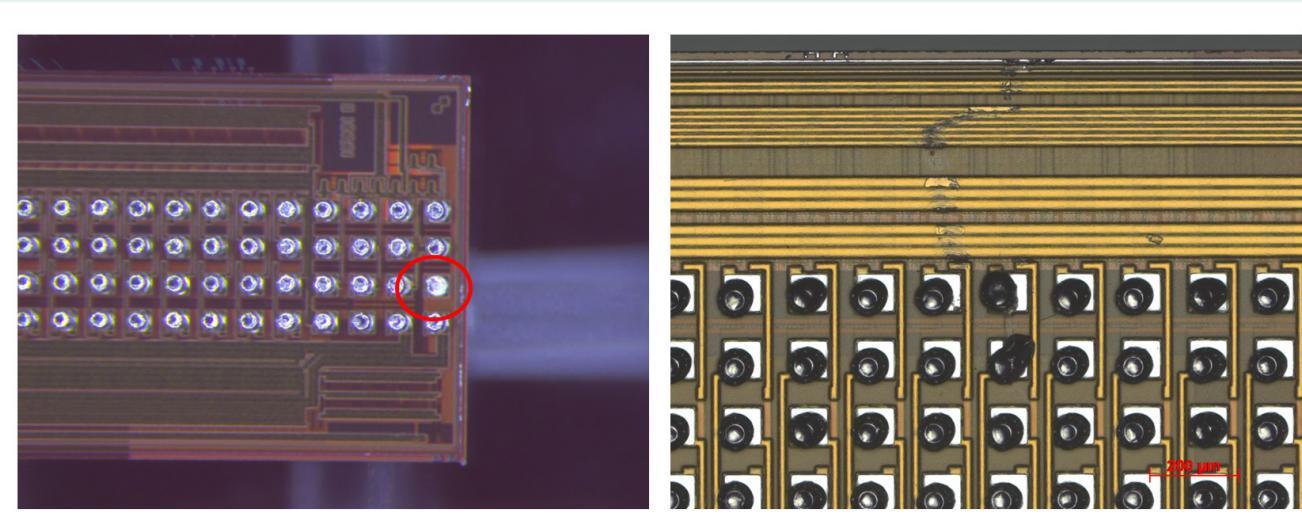
Fehlender <u>Bump</u> auf <u>eienem</u> <u>Switcher</u>

Paddefekt und Kratzer auf einem Switcher

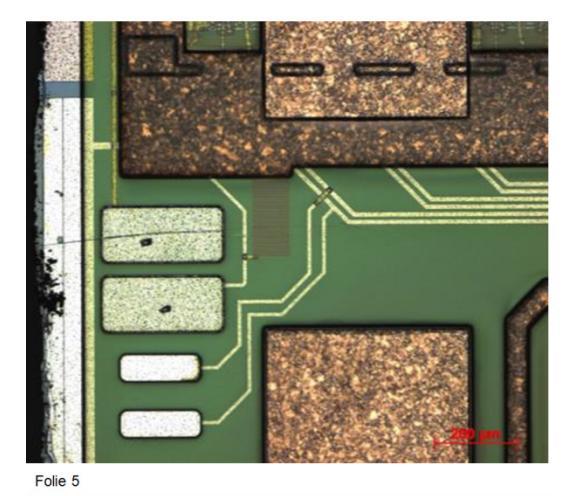
Modul W31-IB

Eingangsinspektion

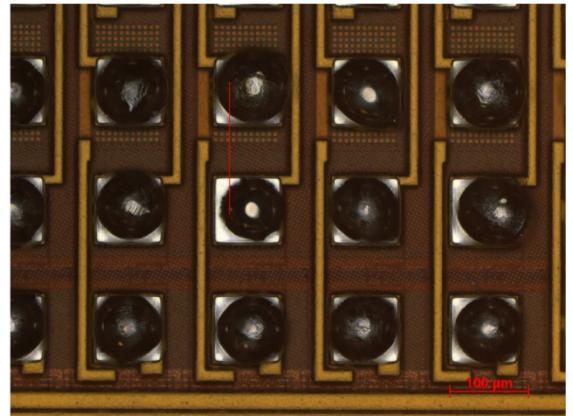
Höhendifferenz zwischen Balls: bis zu $25 \mu m$

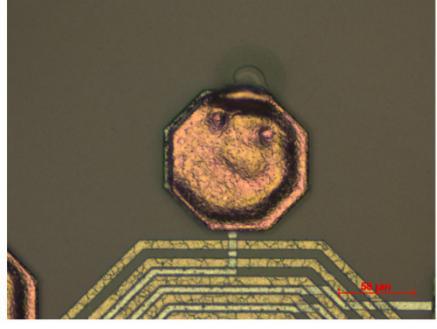
evtl. Lackrest unter dem Pad

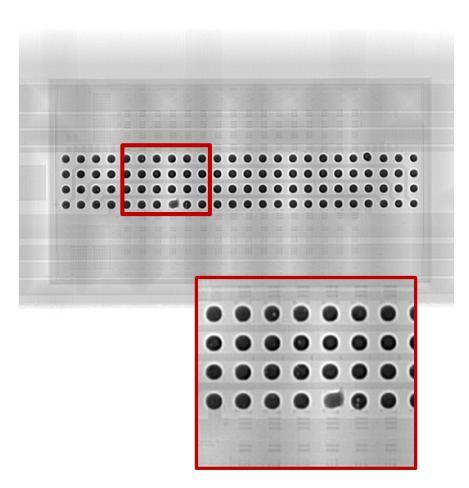
Ausgangsinspektion

Bump wahrscheinlich nicht verbunden

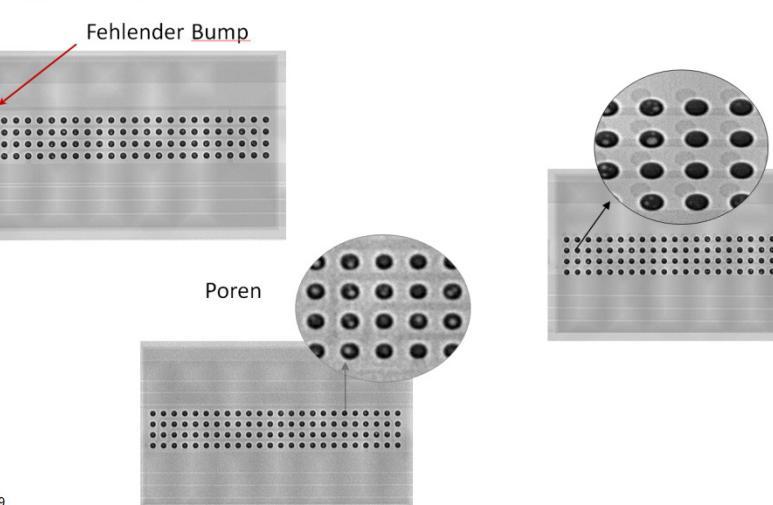
Ausgangsinspektion

Versatz

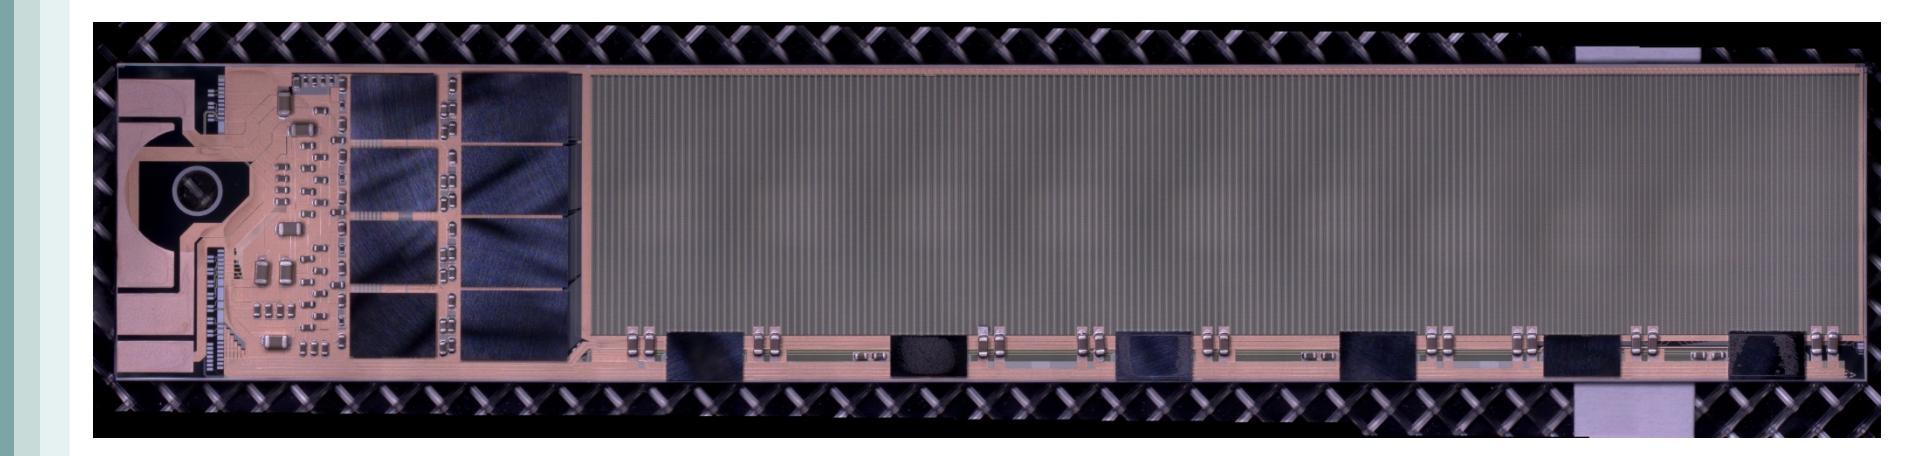
- \triangleright inhomogeneous rad damage due to x-rays
 - \mapsto shields/masks used, but the alignment of the mask was not ideal
- \triangleright deltaVth in damaged area ~150mV, ~few tens of krad (tbc)
