DHH Related Issues and DHE Firmware

Igor Konorov

PXD Workshop 8-10 October 2018

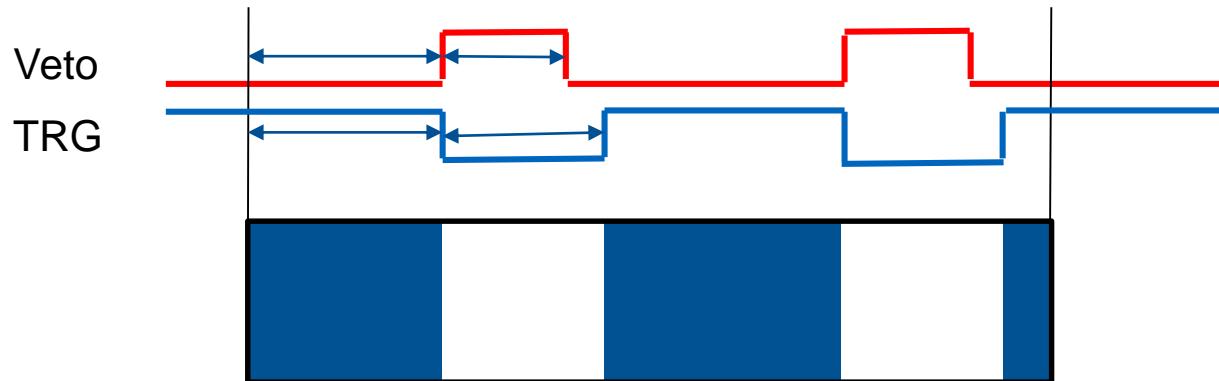
Frame length counter, Revo length counter, Veto length counter, TRG length counter

DHI firmware was losing synchronization => GCK clock quality ?

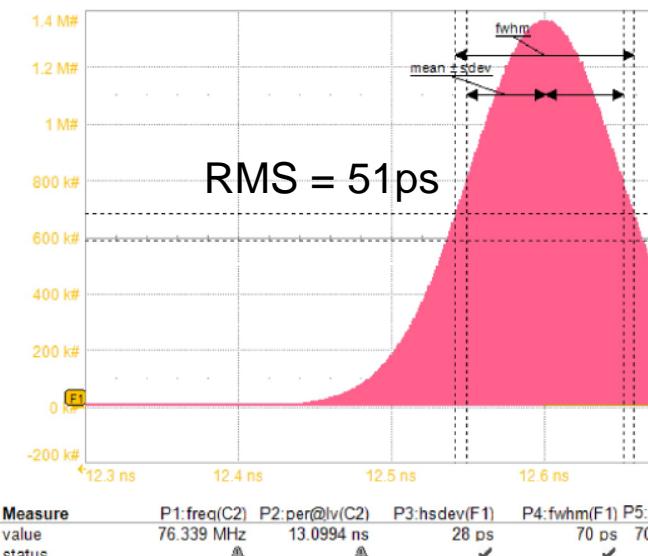
DHI in ATCA shelf

GCK period jitter

Problem was originated in DCDC converter in DHI

Additional 47uF capacitors at DC-DC inputs reduced jitter to 30 ps

All DHIs at KEK were modified accordingly

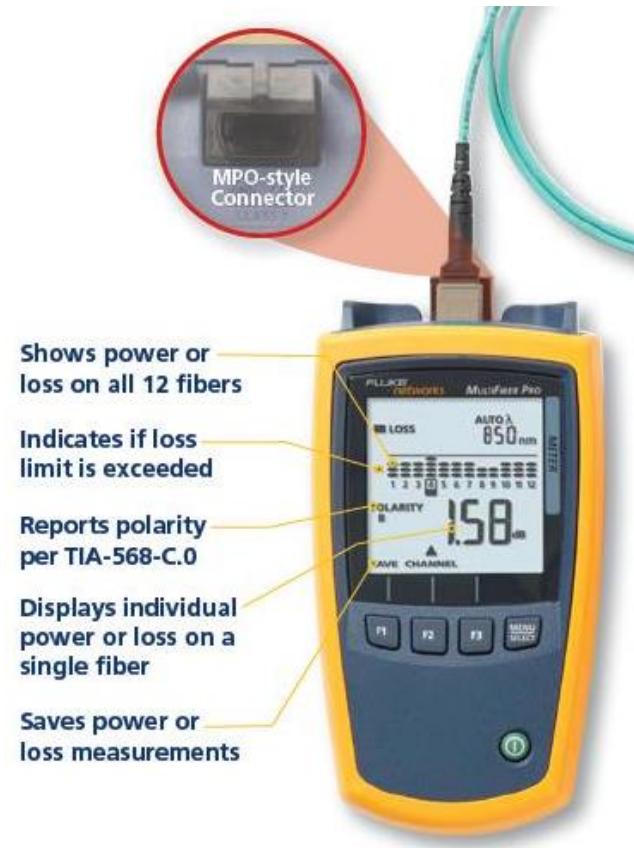
- 37 links have expected value of 0.2-0.3 mW
- 3 links were below 0.1mW and required replugging of fiber to improve value to above 0.2mW

Quality of optical connection is a point of concern

Glenair offers PULL-PROOF “P” type connector and not PULL-PROOF “N” type.

Pool-proof does not provide locking of connector

For final installation quality of optical contacts to be measured!!!

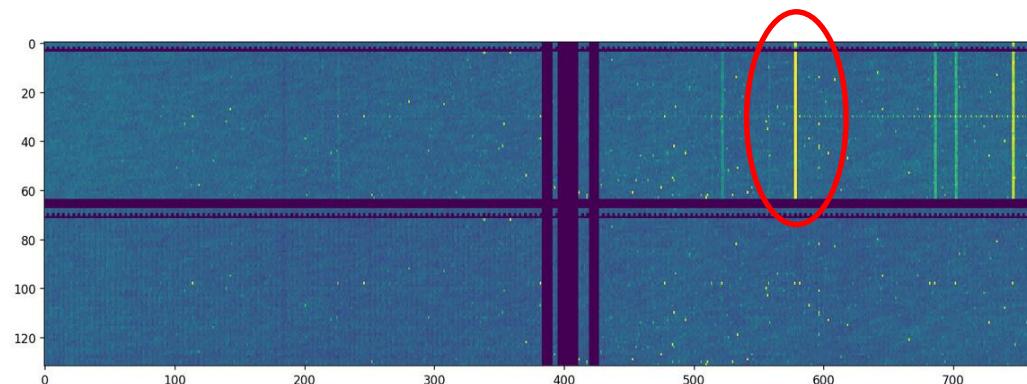
A problem was observed:

Top part shows all hits.

Second half is the same DHPT data but without last hit in frame.

Firmware test to be continued.

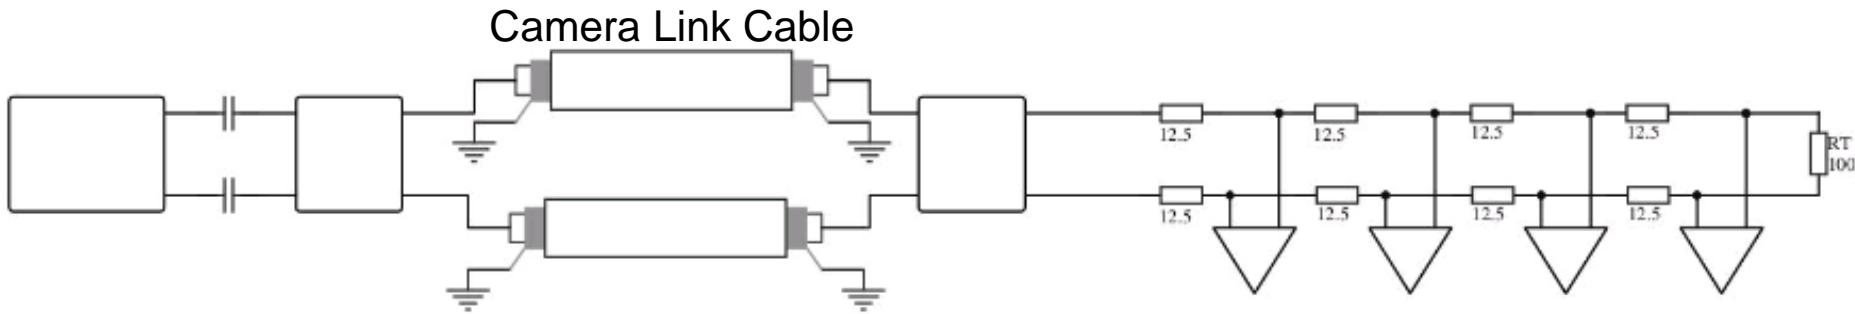
EMCM module.

GCK line has additional serial resistance of about 100 Ohm in EMCM

Real detector module is improved but still additional serial resistance is about 50 Ohm

Due to serial impedance of wiring on detector module transmission line is terminated with wrong impedance and cause reflections.

1. Reduce serial resistance of traces for GCK signal on detector module
2. Match line impedance
 - increase termination resistor to 200 Ohm => increase signal swing and reduce effect of serial resistance
 - Add 170 Ohm resistor to match resistance to 100 Ohm of transmission line
