Belle II Module and Ladder Failure Analysis and Repair

after Flip-chip and SMD mounting (using Probe Card)

Belle II PXD Meeting - DESY 08.10.2018

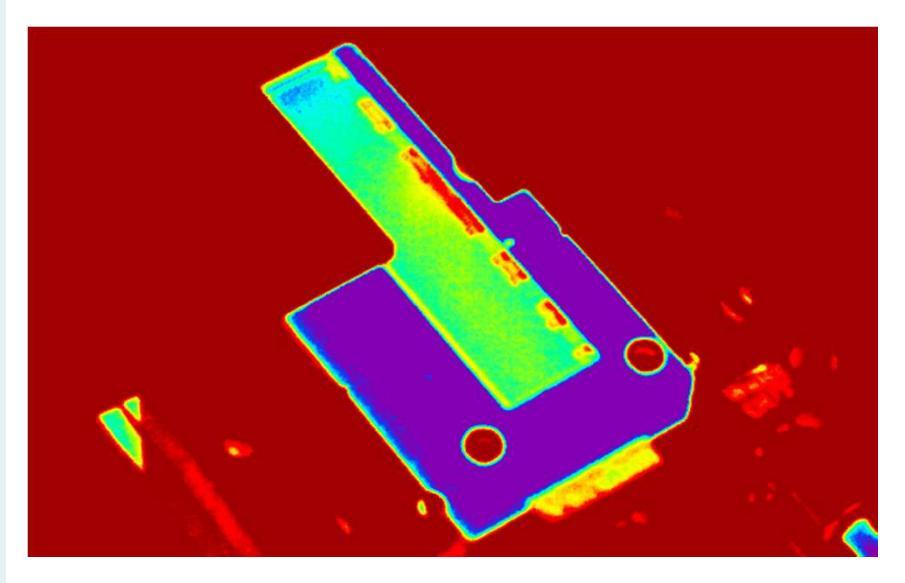
- Caused by faulty switcher
- Switchers could be identified using a thermal camera
- 4 (+2) Switchers successfully replaced

Module	Fault	Action	Result
W31_OB1	SW	SW replaced	ClearOn/Off Used for proto type ladder L2_010
W31_OB2	SW	SW replaced	OK @ KEK
W38_IB	SW rotated	SW replaced	OK Was part of L1_013
W43_OF1	SW4	SW4 replaced	OK, grade A Running in GOE
W44_OF1	SW	Matrix cracked. Mo	odule broken.
W44_OF2	SW6	SW6 replaced	ClearOn/Off in SW3 (Elog ID 7586)
W09_0B1	SW2	SW2 replaced	OK, grade A

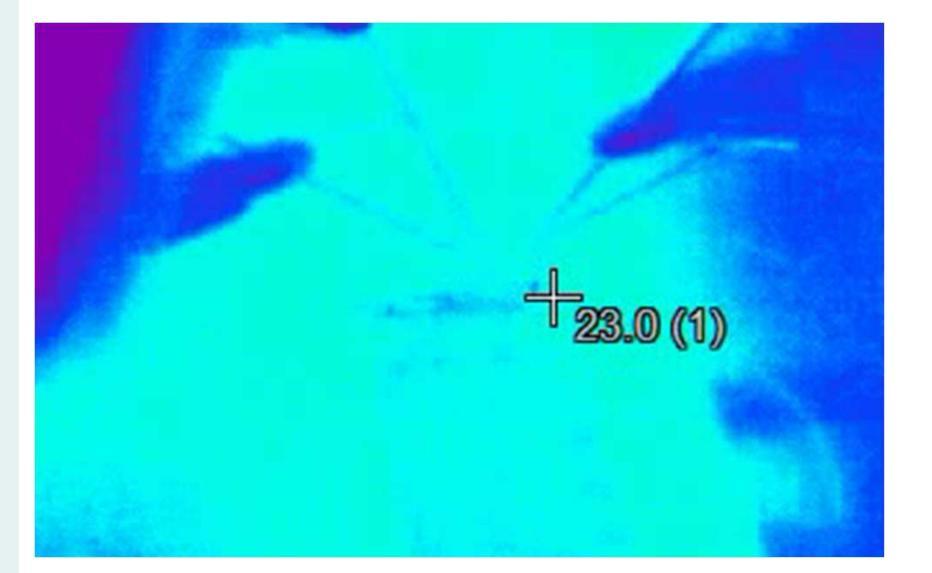
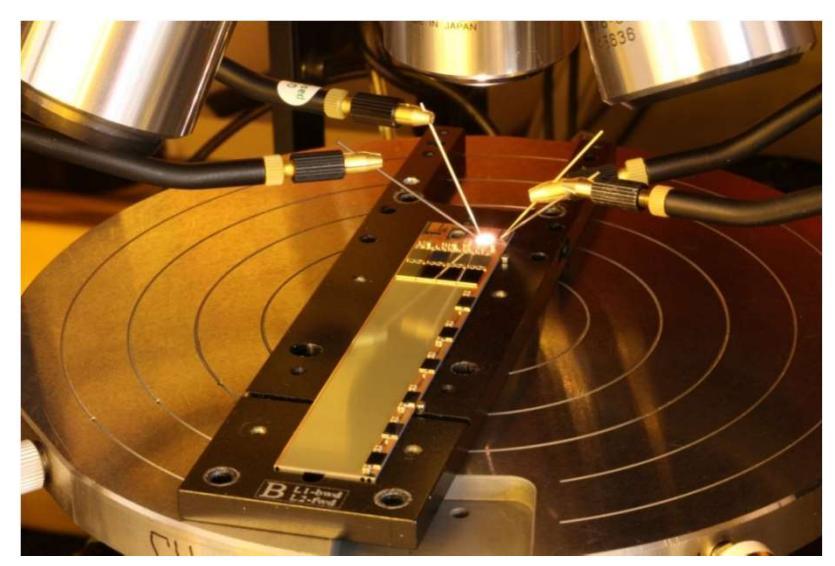
Module passed the probe card test after DHPT3 was replaced

Module	Fault	Action	Result
W38_OB1	ASIC not identified	None yet.	None yet.
W45_OF2	DHPT3	ASIC replaced with high temp.	OK.

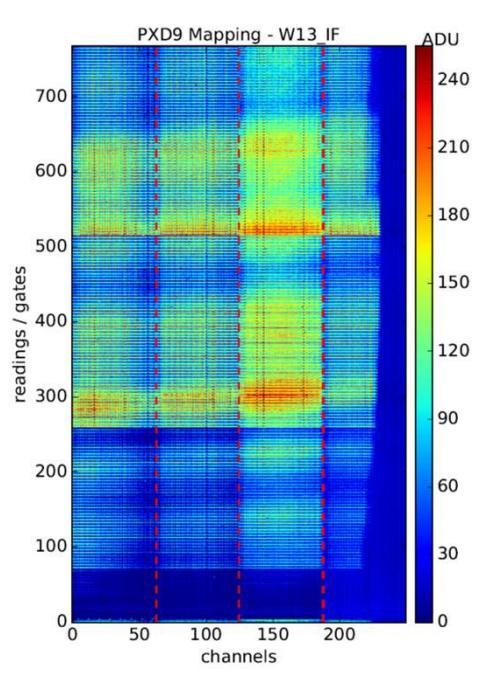
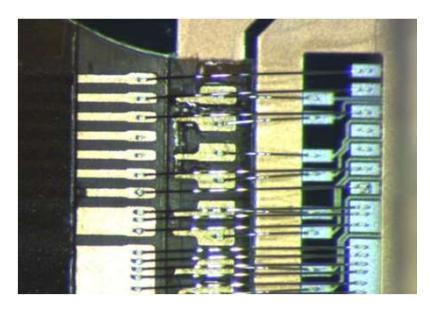
### W13\_IF – Fault in Kapton

- Module passed the probe card test including taking pedestals https://elog.belle2.org/elog/PXD-Mass-Testing/7531
- ASIC digital domains show an increased current consumption at the module test after the Kapton assembly
  - Already after JTAG configuration the current consumption of DHP\_core and DCD\_DVDD are increased compared to reference modules (by ~ 100mA)
  - When the DCDs analog parts are enabled (via JTAG) the currents of DHP\_core and DCD\_DVDD are increased dramatically
- DHP control lines (GCK, TRG) are okay (probed on the termination resistors on the module)
- ASIC supply voltages show strong dependence Amplow voltage

- Short on the Kapton between DGND\_Sense and Amplow\_Sense (60hms measured at the pins of the SAMTEC connector after those two wirebonds were removed)
- Output voltages of all the regulators (for the digital nets) were enlarged due to the wrong sensing
- When the DCDs analog part is off, the voltage regulator (current sink) of Amplow is not working in a proper way (the regulator needs some sink current). Therefore the Amplow voltage is not at the set values (but less)
- Passed the testing procedure (grade B) after Kapton was exchanged, part of L1\_036

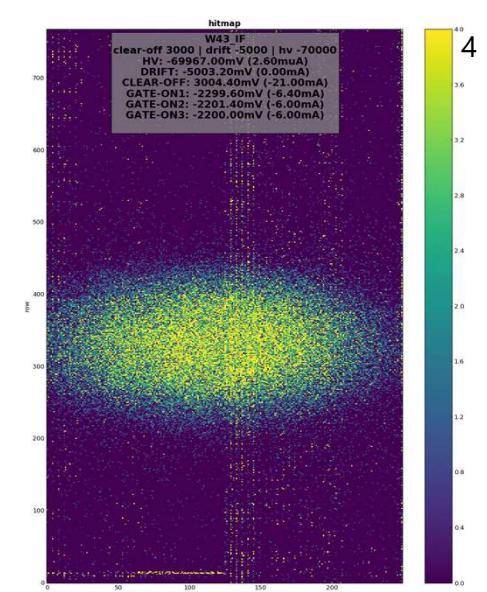
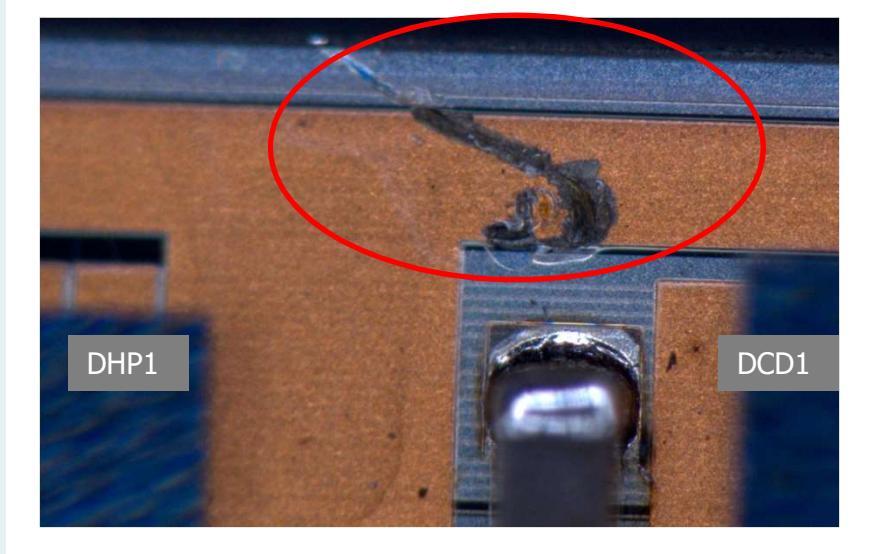
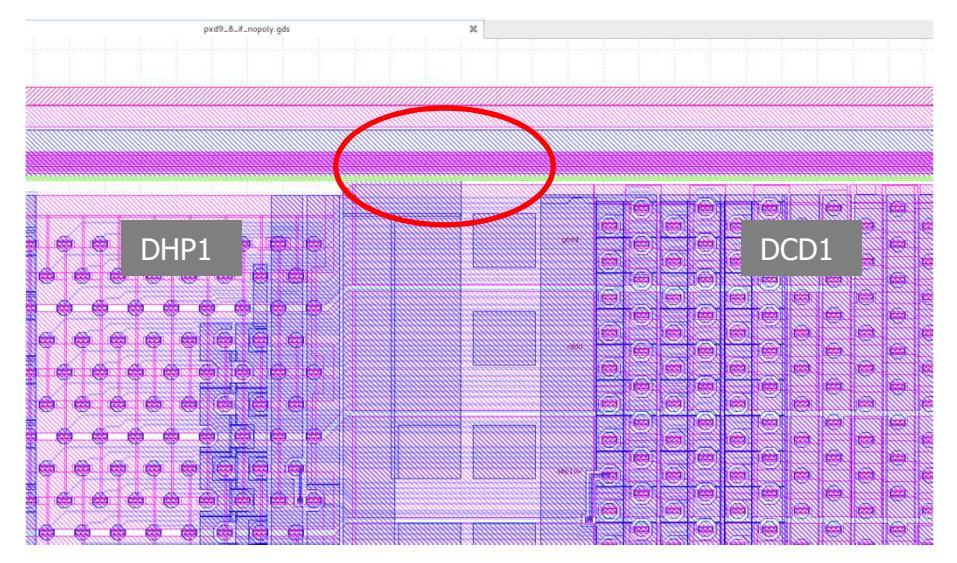
### • W43\_IF – Broken VBP Trace

- DCD1 and module damaged after Probe Card testing
- DCD successfully exchanged by IZM
- Operation of the ASICs possible
- Module shows only very few hits in the Sr90 radioactive source measurement
- V\_BP was measured correctly on the wirebond pad on the PXD9 module, but there is no current flowing (no current when the matrix is illuminated too)
- The V\_BP trace is running below the scratch between DCD1 and DHP1
- Probably the V\_BP trace was damaged (cut), neighboring traces Source\_Sence,
  V\_Guard, CGG1-3 may be affected too

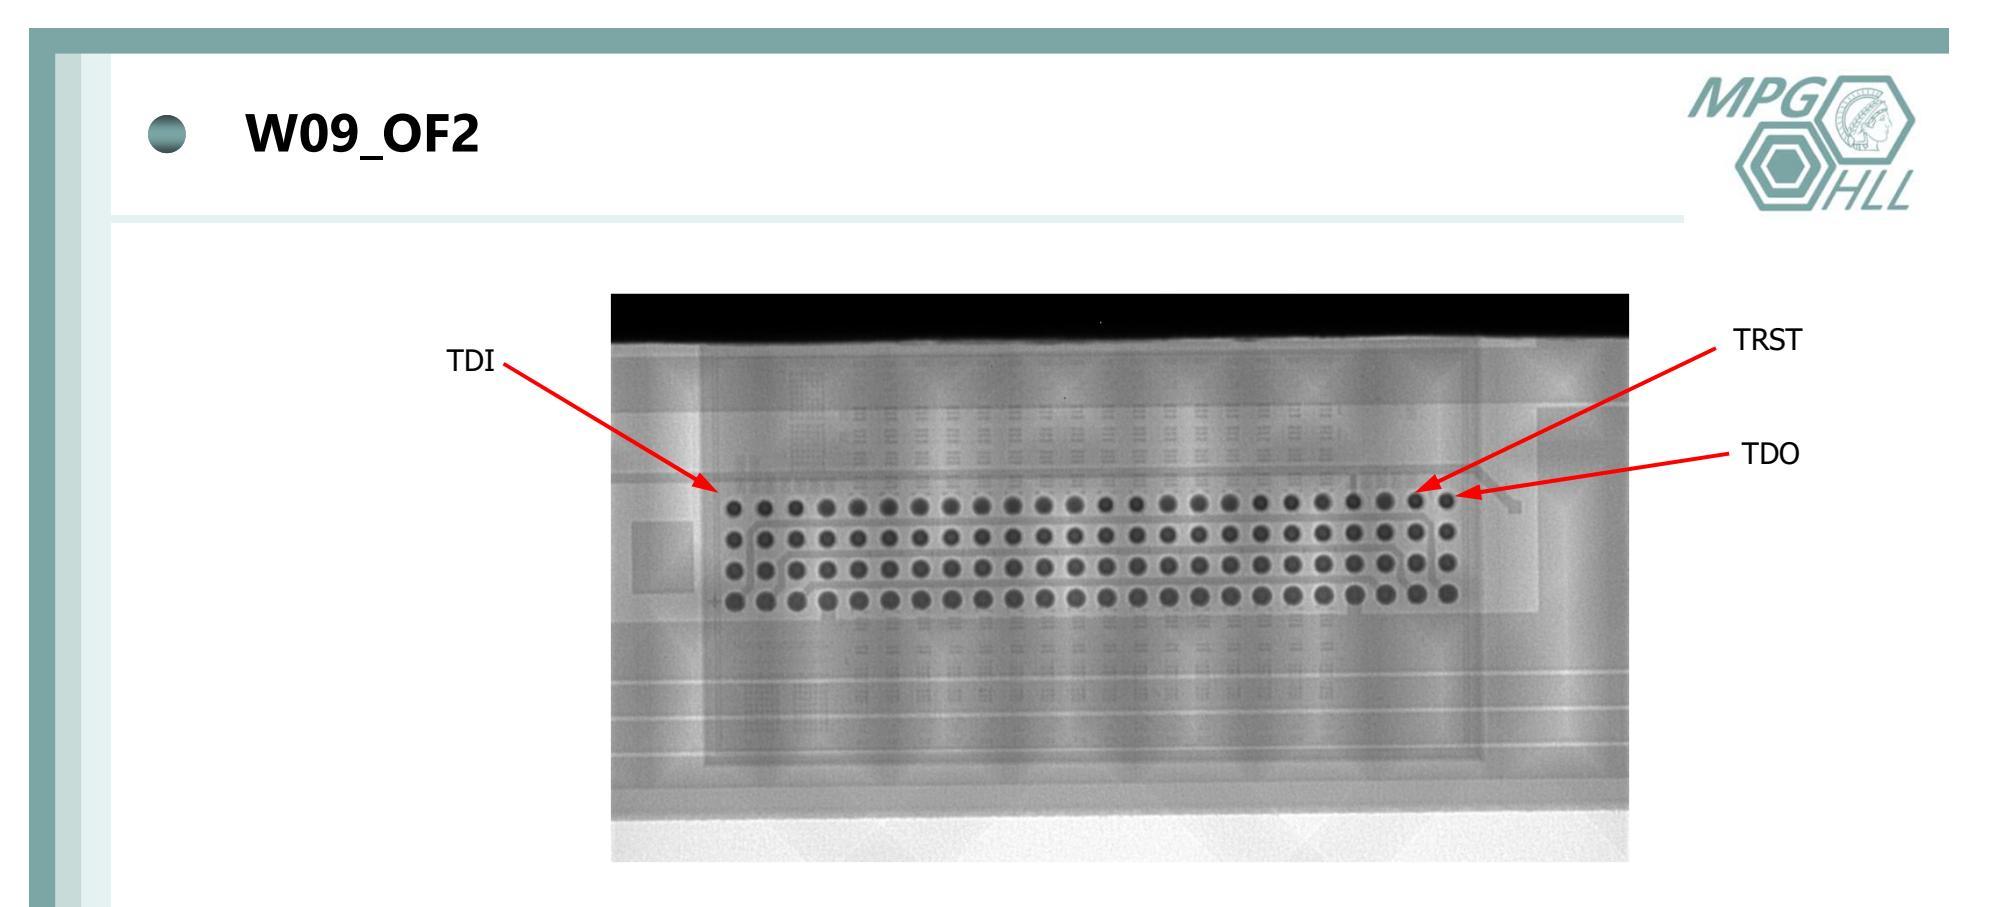
- JTAG configuration fails when Switchers are included into the JTAG chain
  - DCD1 still get's the JTAG commands (e.g. enable analog part or test pattern)
- SW5 showed suspicious bumps in the upper bump row
- Re-solder (exchange) of this Switcher5 was done at HLL (with the Kapton attached)
- Afterwards JTAG configuration works fines with all ASICs
- Sanity check (pedestals) ok, now at MPP for full test

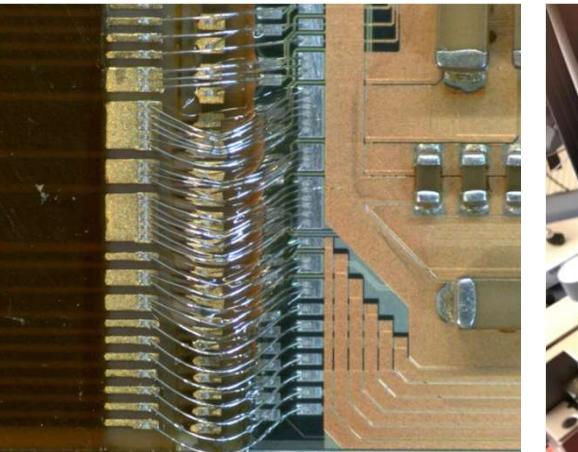
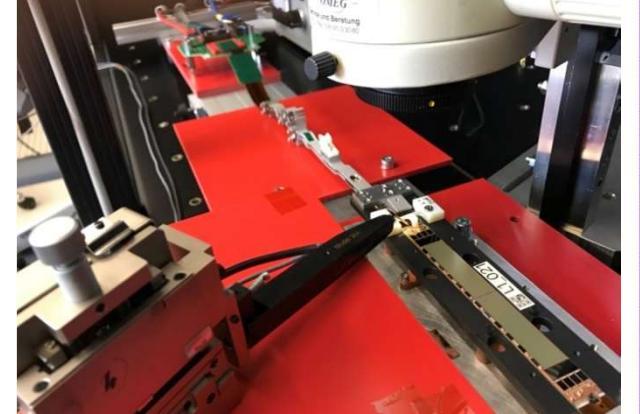
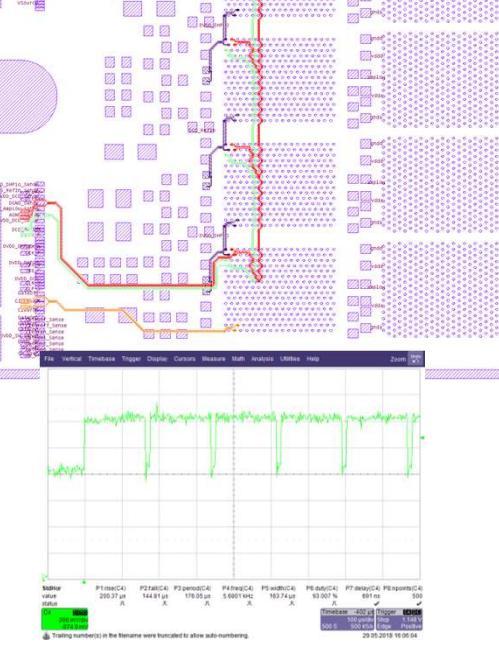
## L1\_021 (W46\_IF)

- Ladder was operated without proper thermal contact to the cooling block
- Kapton on the IF side shifted and bent the wirebonds upwards
  - W46\_IF electrically okay, but could not be mounted on SCB
- Wirebonds were covered with glob top and bent down at HLL
- After this JTAG initialization failed, nevertheless the first analog voltages (bulk, ClearOn, ClearOff) were applied at MPP
- Since the JTAG initialization failed the ladder was sent back to HLL
  - Optical inspection indicated that TDO and ClearOff wirebonds could touch each other
  - To exclude broken wirebonds all bonds were removed (including the ones below the glob top) and re-bonded
  - All JTAG signals and DHPT control signals were measured on the EOS
    - TDO of DHPT4 does not show any sign of life (no bits toggling, both TDO\_N and TDO\_P show GND level only)

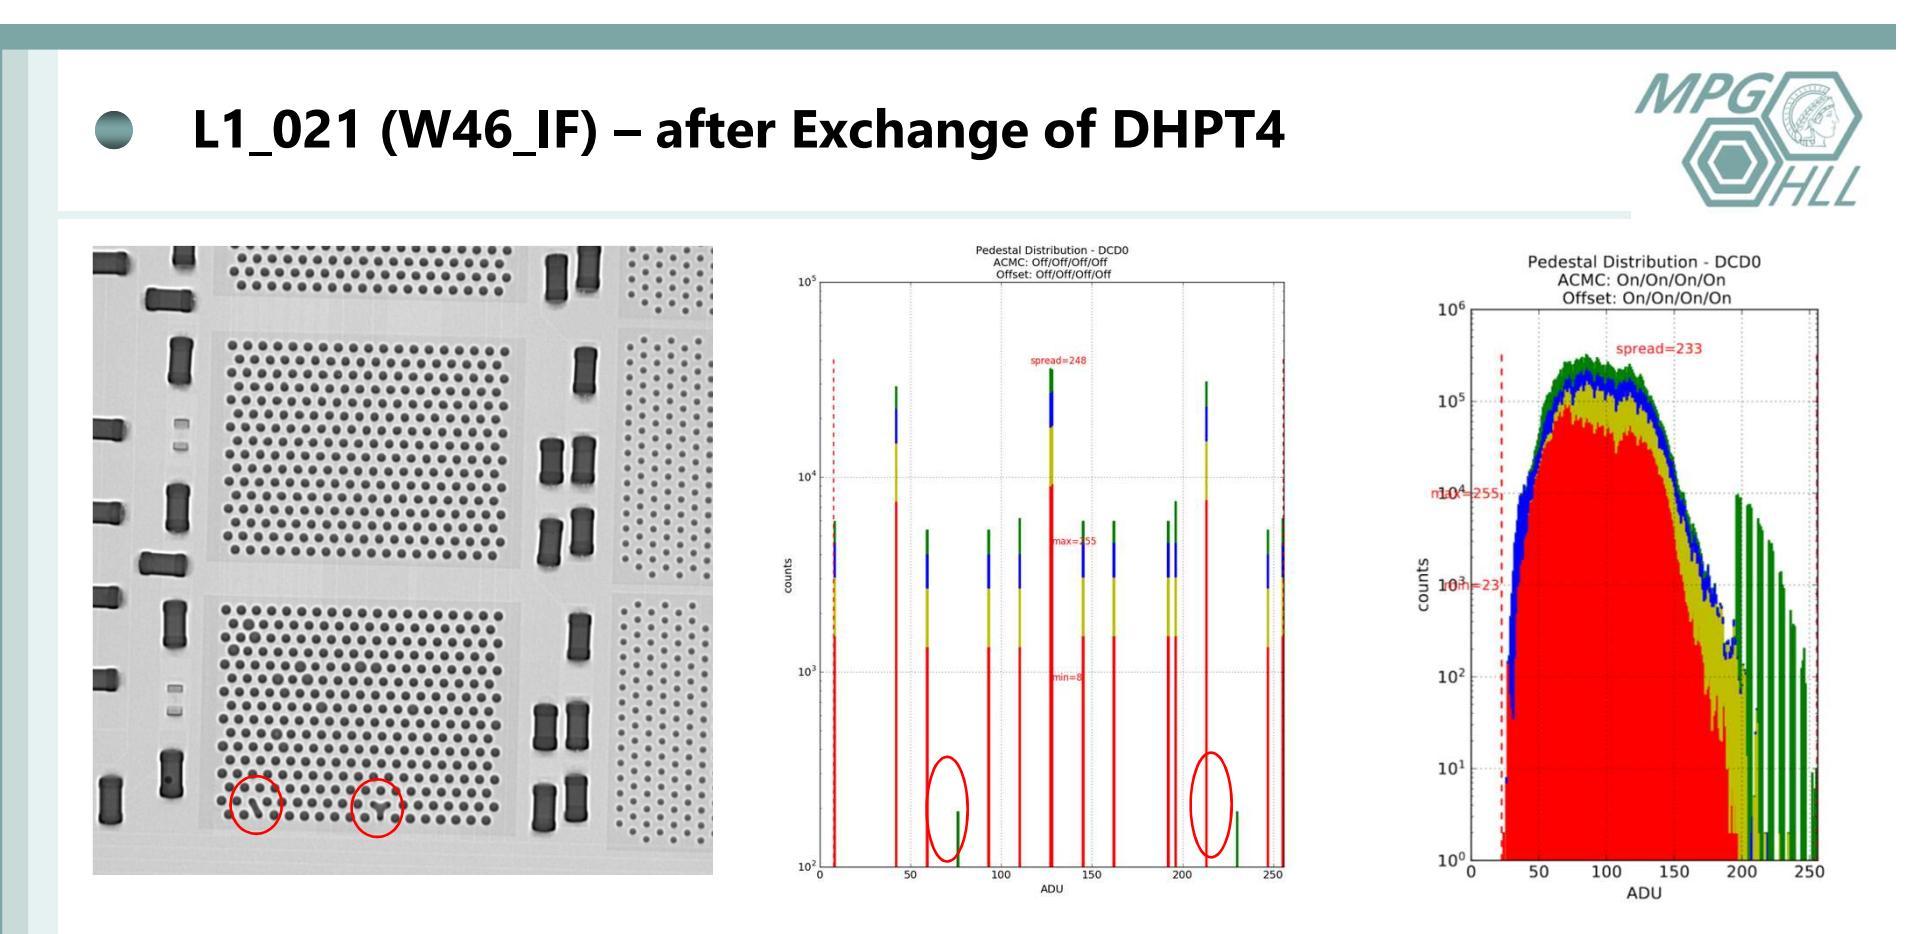
- Shorts after exchange of DHPT4
  - Two DHPT input lines to DHP-IO (stuck bits)
  - TDO\_P to SW\_StrC\_N (two DHPT outputs)
- Basic operation possible (JTAG configuration, pedestals taking), but Source measurement failed due to corrupted data
- Stable operation not possible 2<sup>nd</sup> exchange of DHPT4?

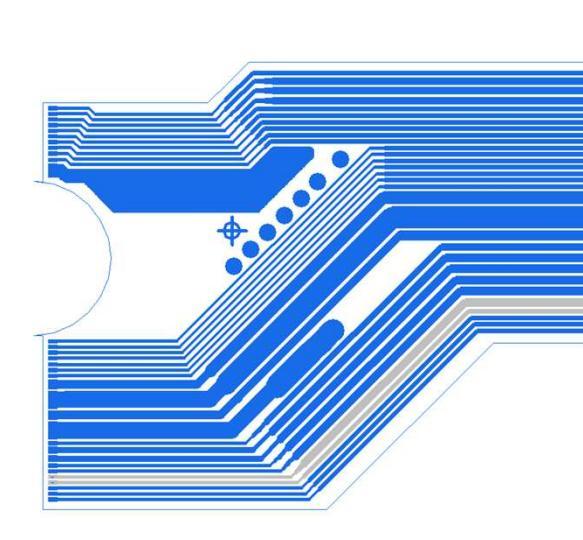
# **W09\_IB** with Kapton L1bwd\_V30\_401\_104

- Short between GateOn3 and SW\_DVDD\_Sense lines on the kapton L1bwd\_V30\_401\_104
- Unknown stress to SW1-2 due to overvoltage
- Kapton exchanged with L1bwd\_V30\_401\_102
- W09\_IB passed the testing procedure and is part of L1\_030

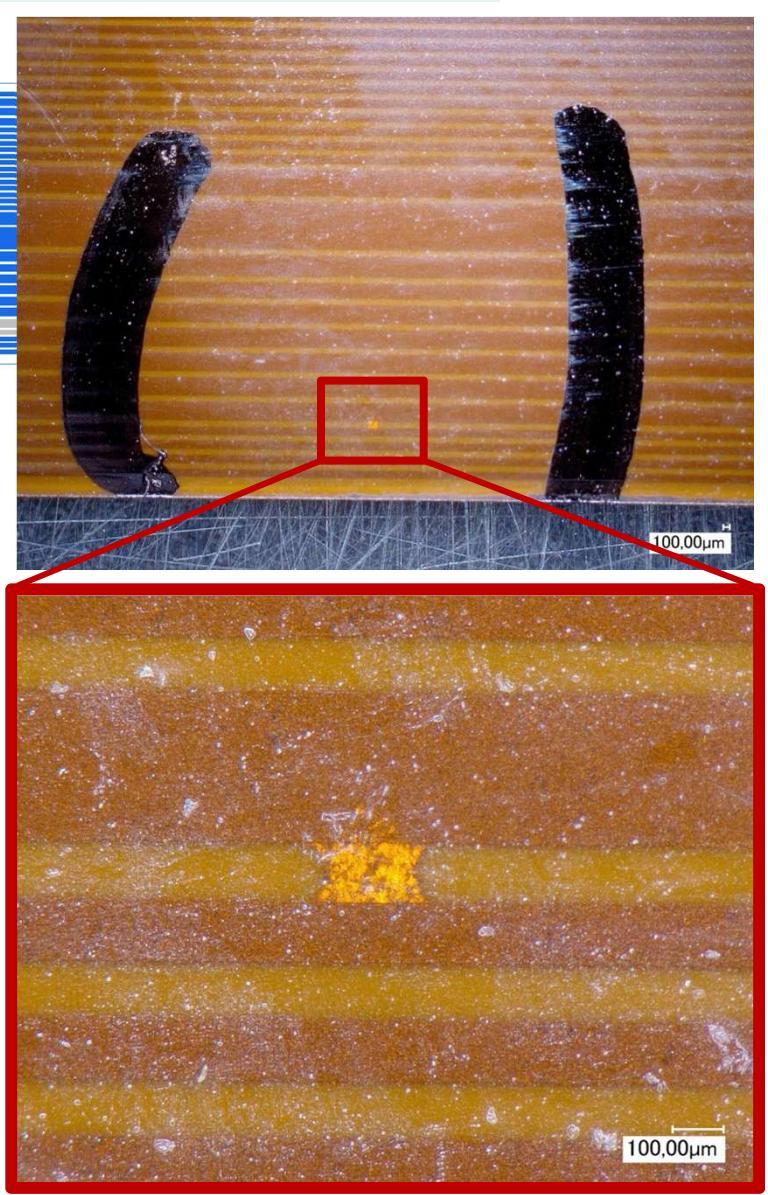
- Short on matrix region after ladder gluing on OF and OB regions
- First time that the damage due to particles in the ladder gluing procedure was noticed
- Trying to repair the short; it remains a short between Source and V\_BP (which is likely due to the mechanical damage of the thin silicon

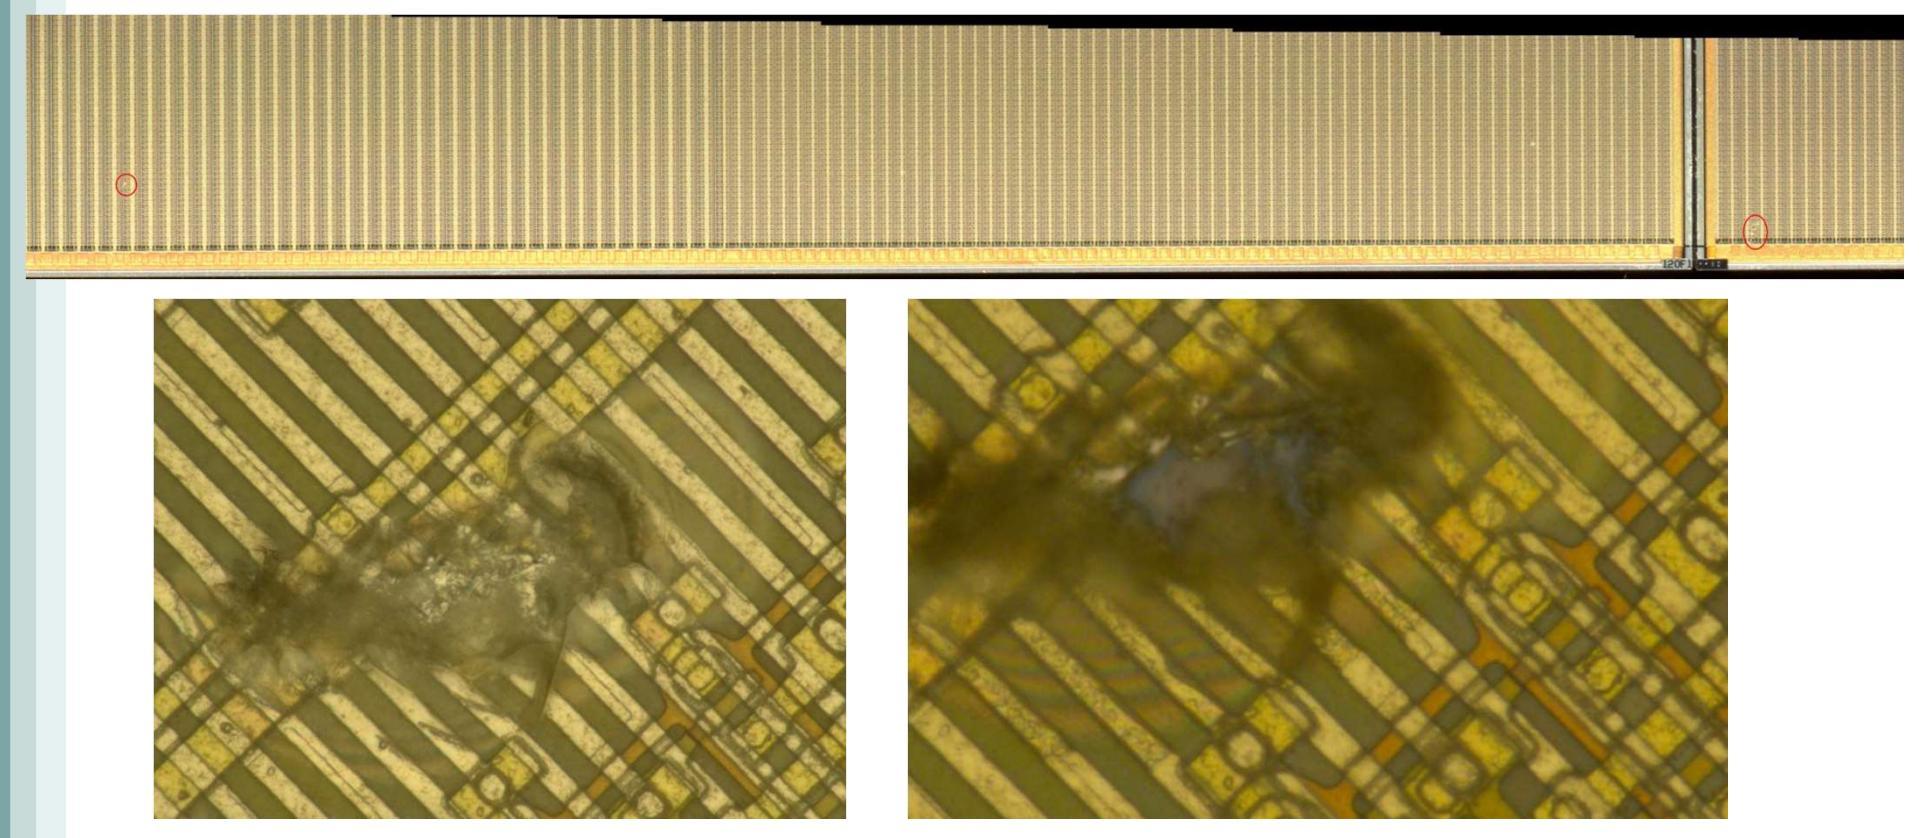
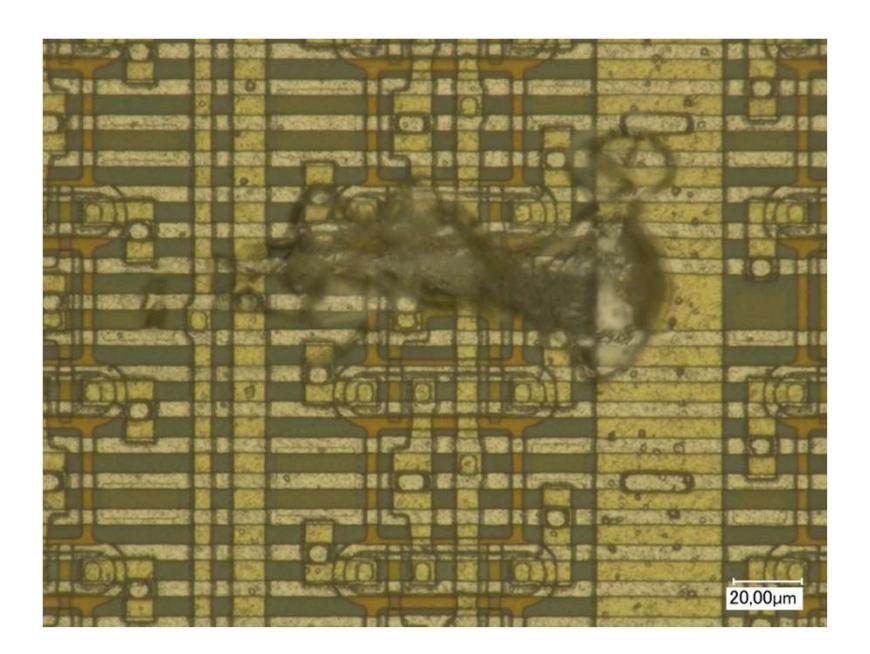
## **L1\_016** – W47\_IB

- High value drain lines observed after ladder gluing
- Gluing was done in Oct. 2017 but testing only in March 2018
- Damage of the matrix region visible at the peculiar drain lines
- "long-term" pedestal scan to see if number of effected drain lines increases... seems to be stable

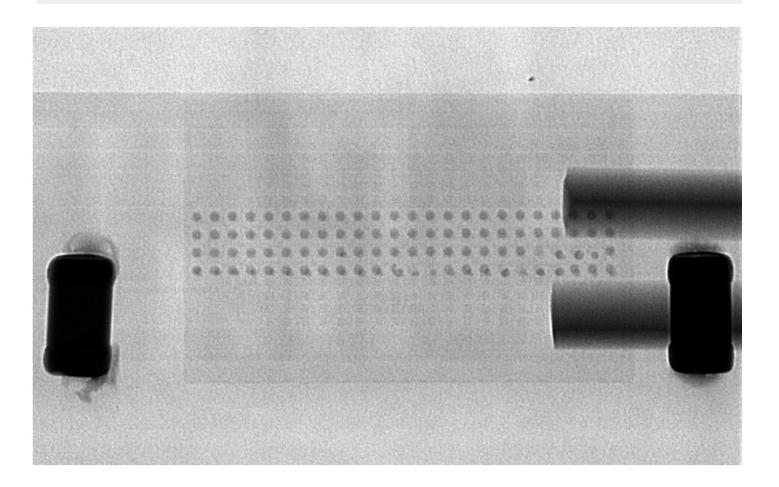
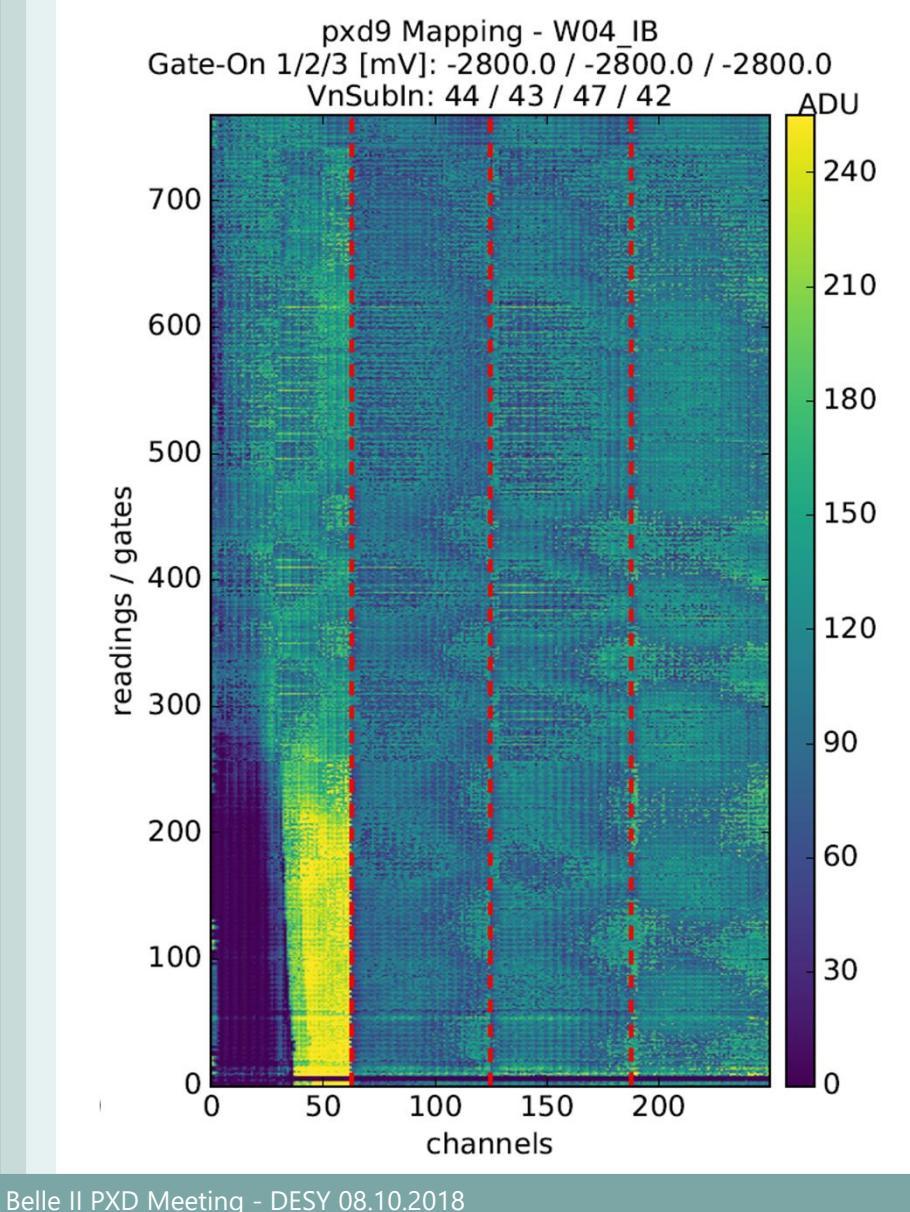
## • **L1\_035:** W04\_IB and W04\_IF

- Replaced SW1 some bumps not connected
- Configuration okay
- Pedestal change in region of of SW1&2 after re-soldering

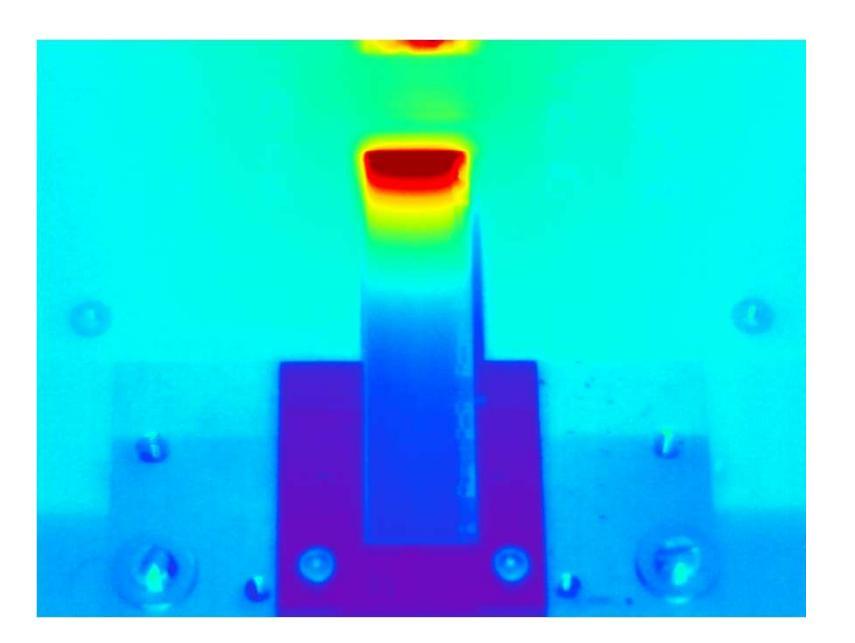
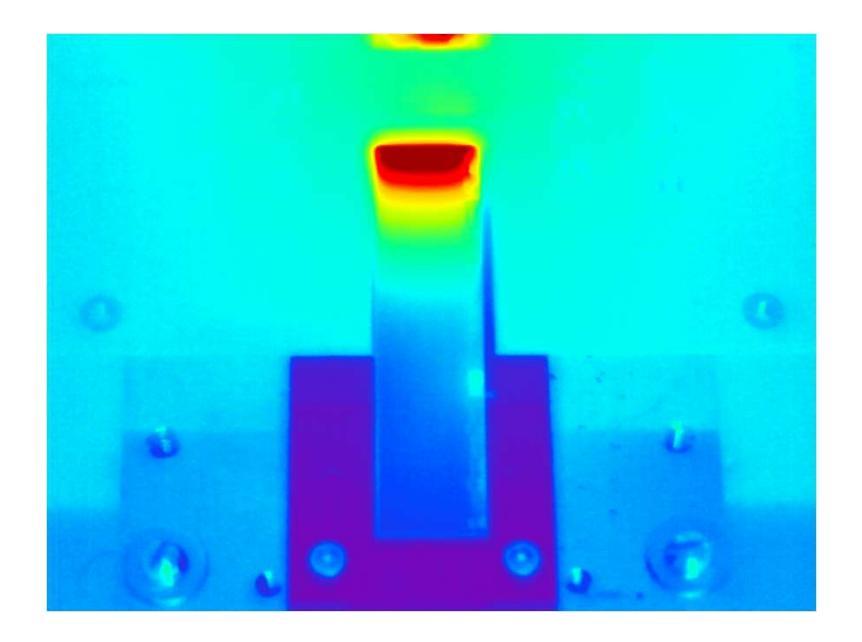
### W44\_OF2

- Faulty switcher could be identified by thermal imaging
- Module broke during the rework @ IZM

Module	Fault	Action	Result
W31_OB1	Not identified.	None taken.	Module glued to L2_010
W44_OF2	Switcher3	Replace Switcher3.	Module broke during rework.

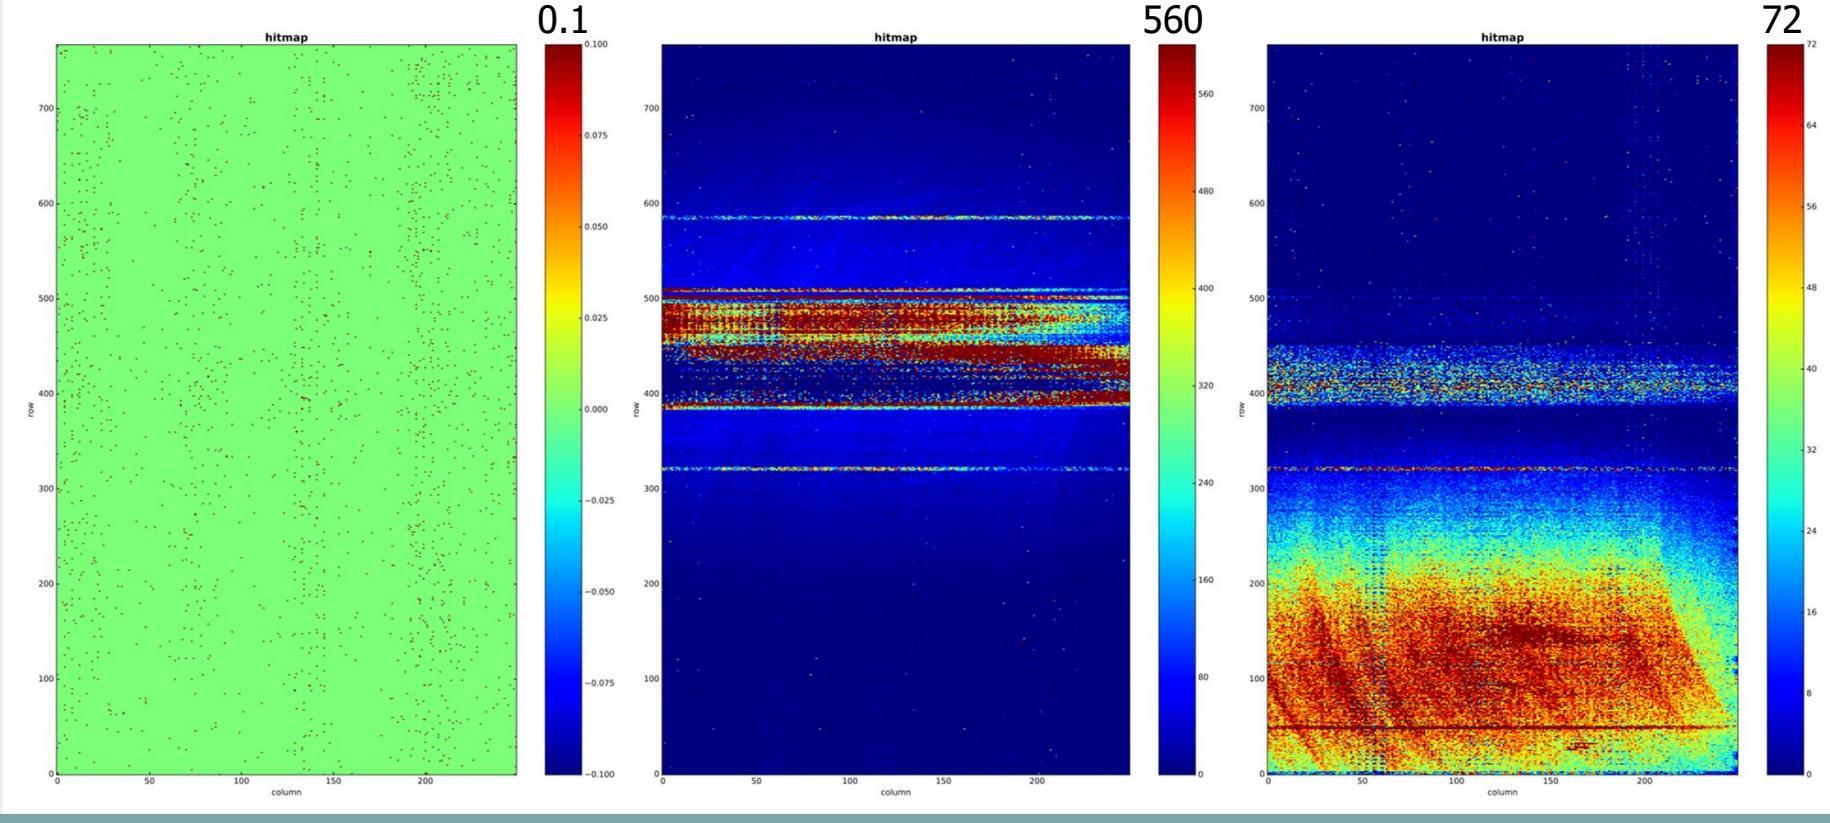
### • W08\_IF Fails during Source Scan

- Without a source over the matrix: no sign of the affected area
- With a source over the affected area: about 10 times as many hits as expected; distribution with no apparent link to the source geometry
- With a source somewhere else over the matrix: about half of the affected area (the part of the region that showed less/no signal before) shows hits

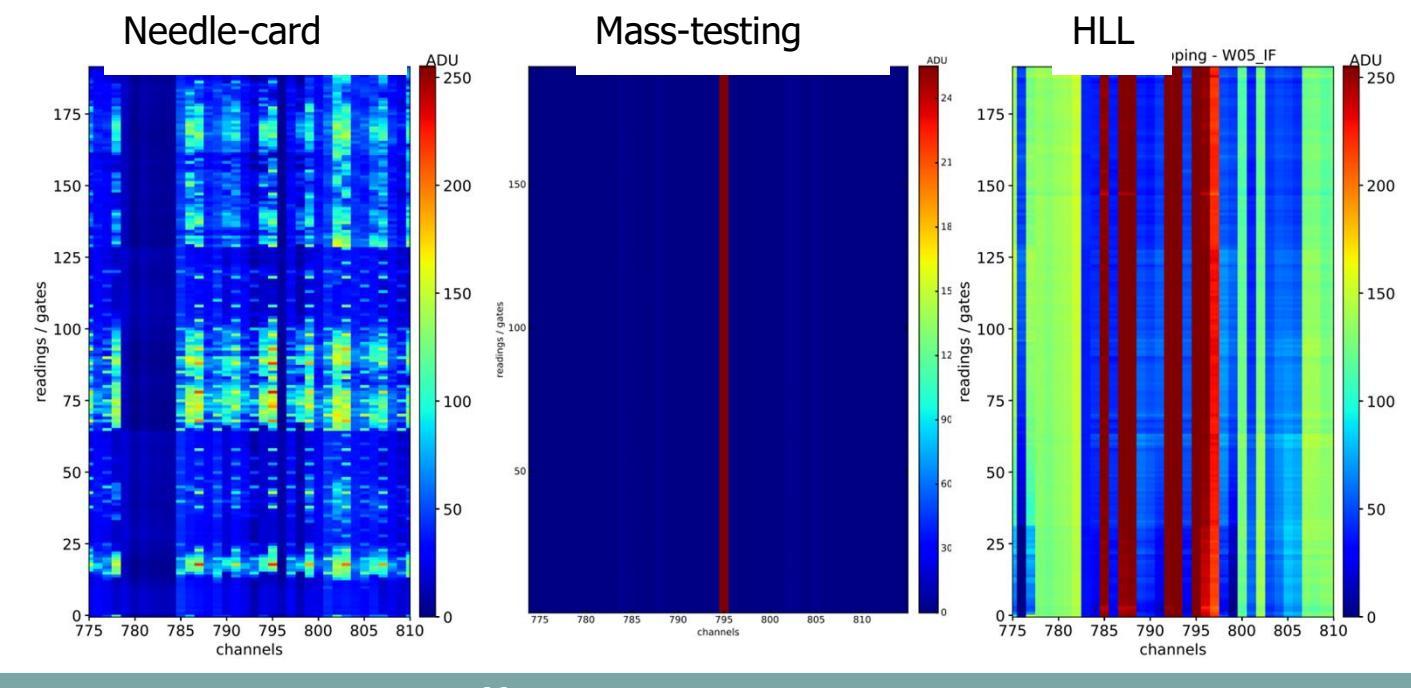
### • W05\_IF (with Kapton)

Module has short between Drain and Source:

- Short was not caught during production QA due to unexpected measurement value (currents O(+10^22A)), was flagged as open instead of short
- Appeared as a single missing electrical column in needle-card test
- First found as single hot line during mass-testing (MPP)
- Damage appears to be growing over time, compromising electrically neighboring lines on DCD4

- $\Rightarrow$  Cut drain line between DCD and matrix
  - Possible damage on neighboring lines during cutting (very narrow region)
- $\Rightarrow$  Removing DCD4 and disconnecting the bump-ball of the affected channel A0<27>
  - Replacement of DCD4
- Module used to check power-up/-down sequence at MPP

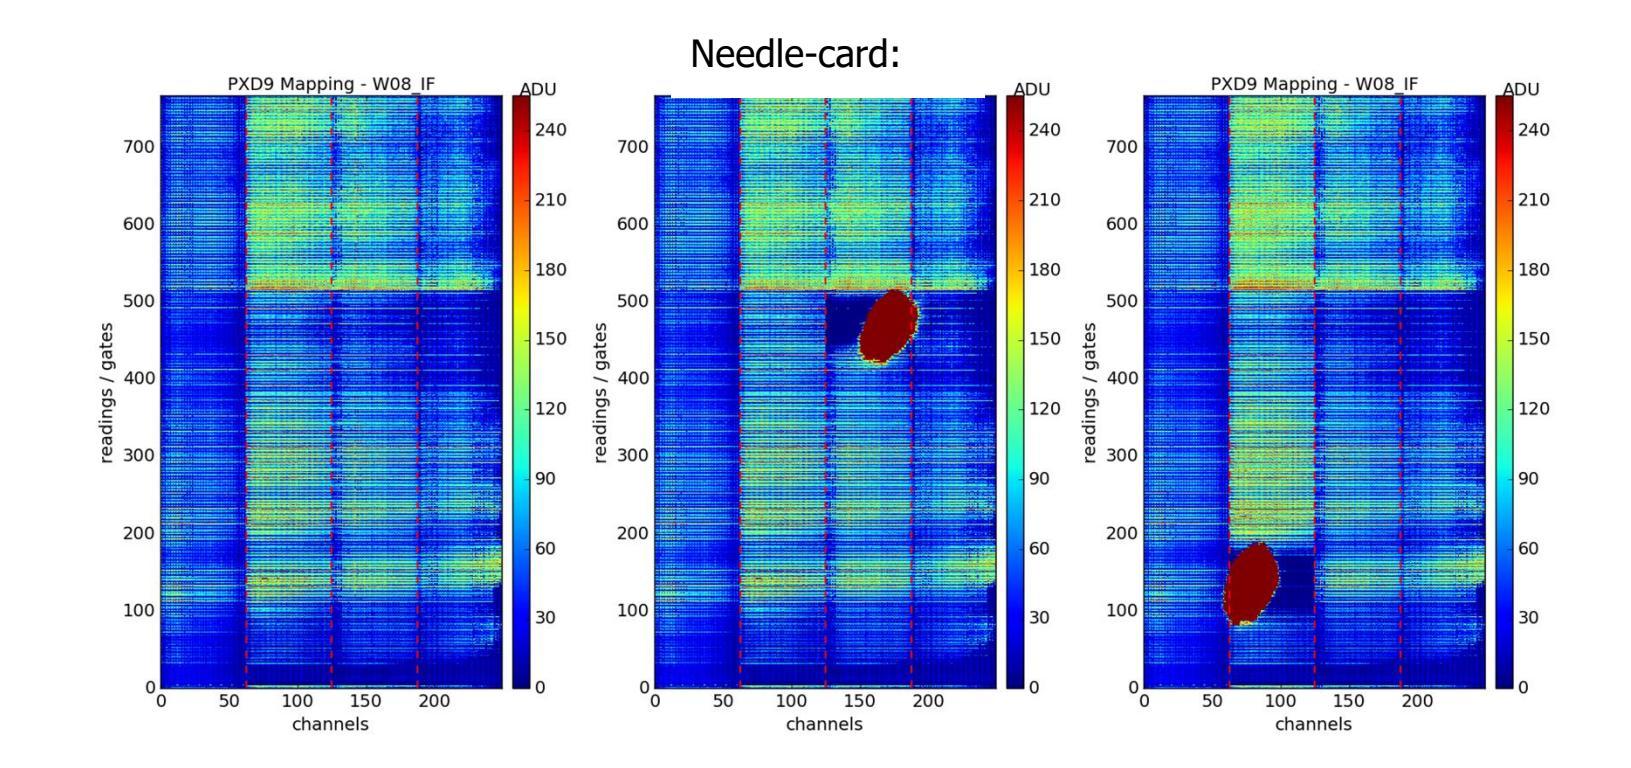
### • **W08\_IF** Laser Spot during Probe Card Tests

- MPG HILL
- No sign of the problem could be seen during needle-card measurements as it is not visible in pedestals (even with laser spot)

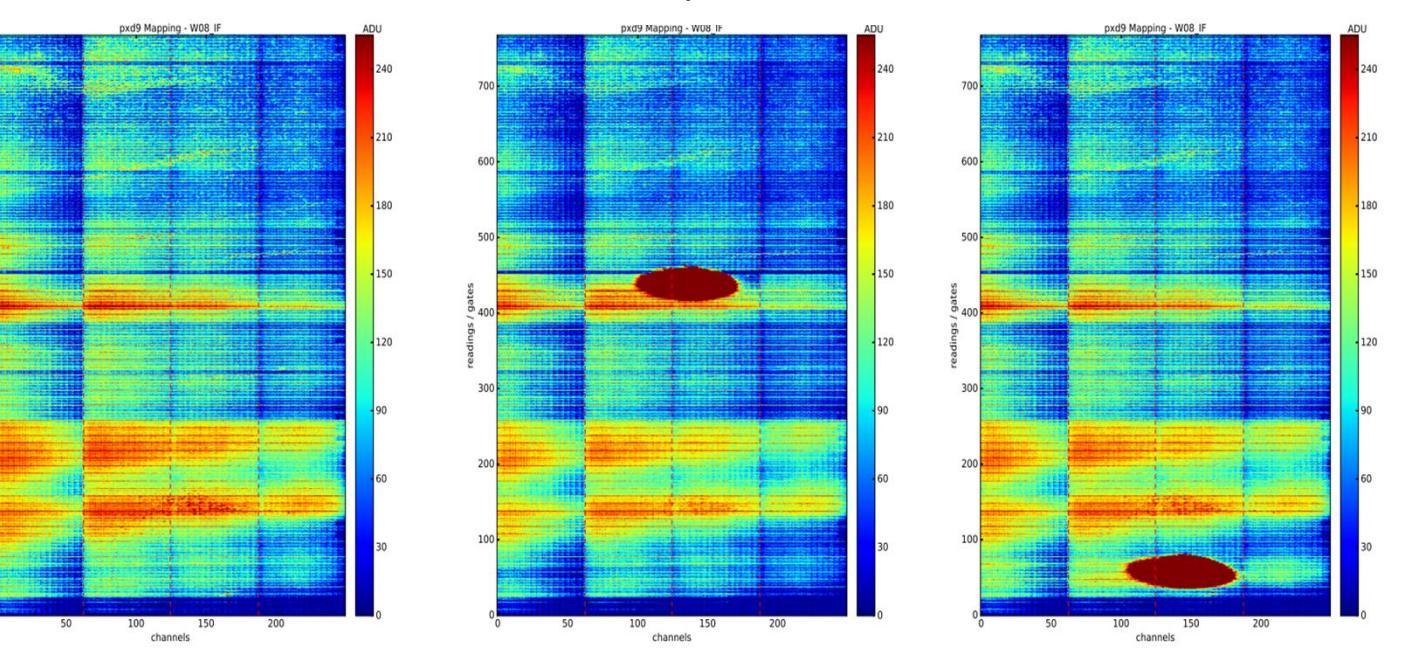
## • **W08\_IF** Laser Spot @ pxdtest5 (w/ kapton)

• Nor during pedestals measurements (with laser spot) during with kapton

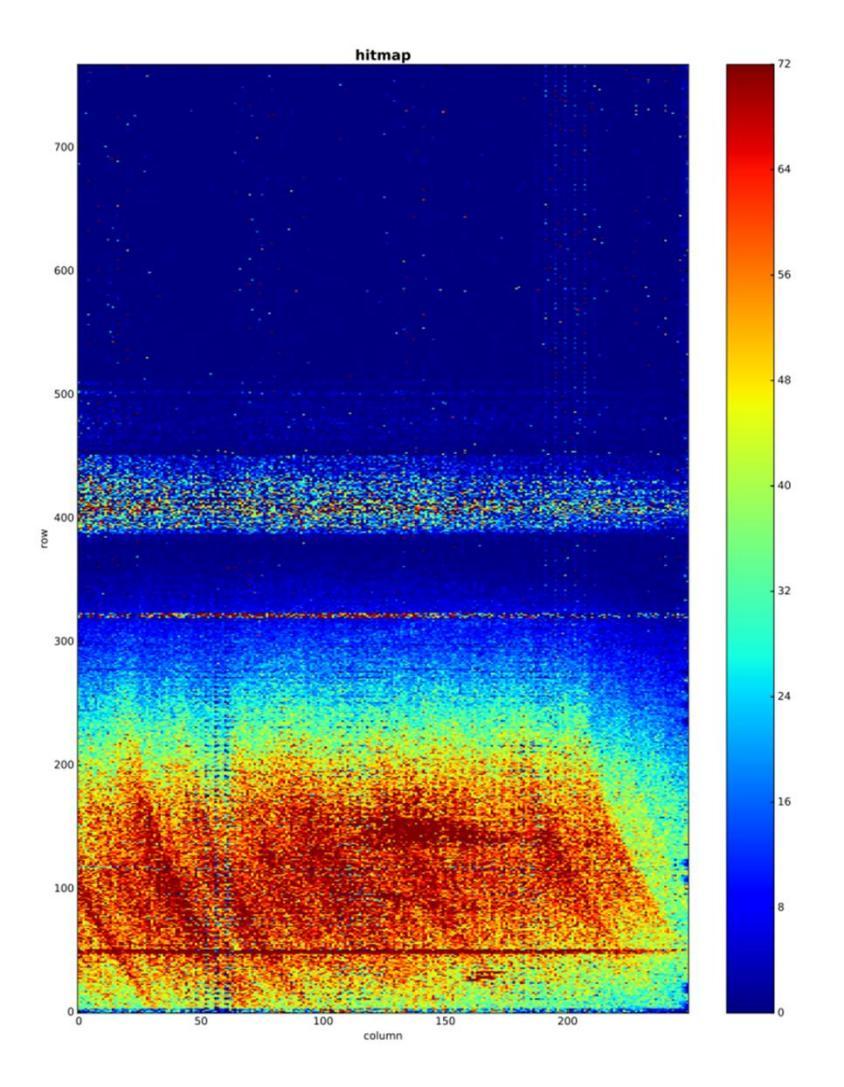
### Failure mode is not understood

- Ghost hits only in rows connected to SW4 (exchange of SW4)
- Debugging could be continued using a laser (small spot, controlled timing)

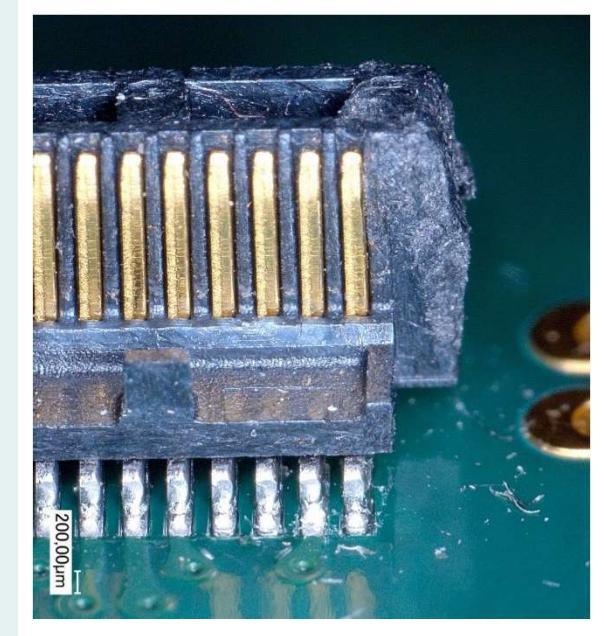
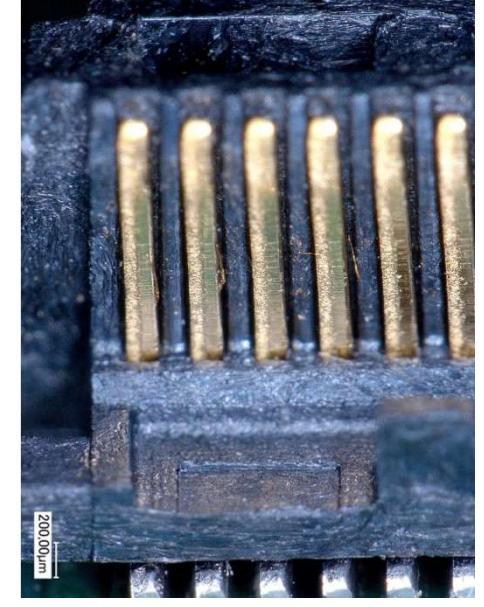
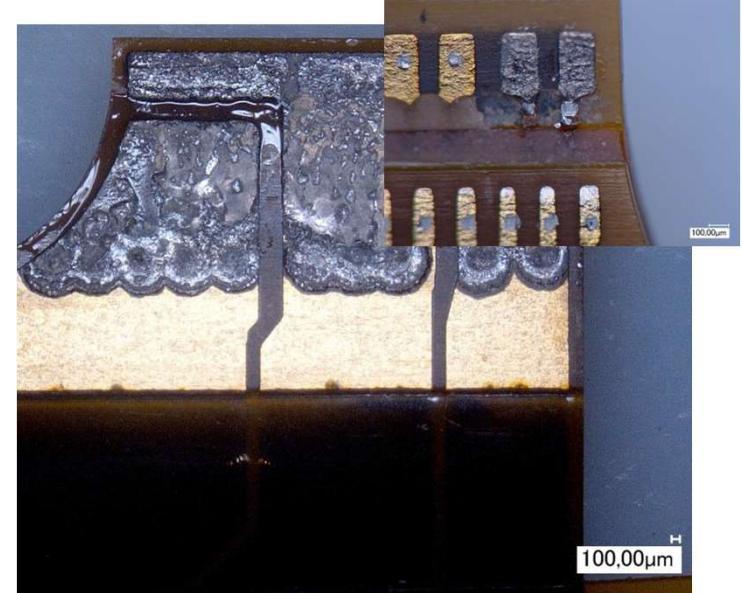
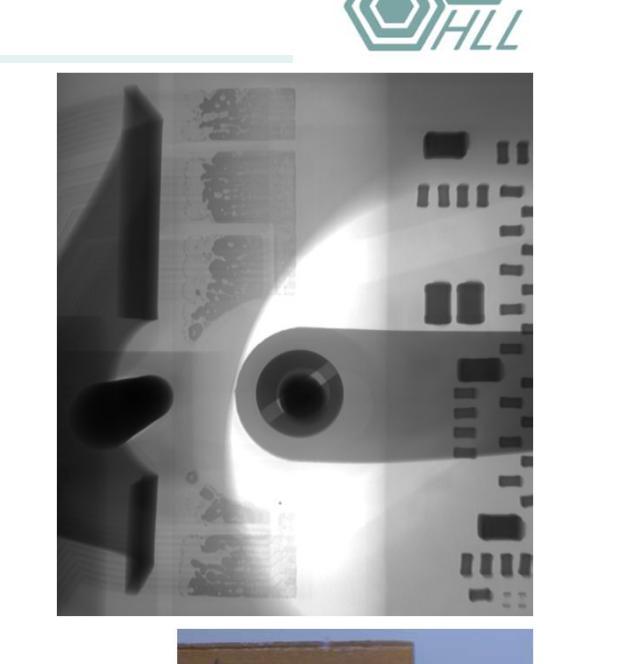
### Photos of kapton L2fwd\_V30\_200\_027

- No clear evidence for the short between GND and DCD\_AVDD
- Possible failure mechanism:
  - Connection between the solder pads (AGND and DCD\_AVDD are neighboring pads on the bottom of the kapton), x-ray image (on the right side) not suspicious
  - Damaged/misplaced connection of the SAMTEC connector to the Lab Patch Panel
- Kapton was exchanged and module W09\_OF1 passed the testing with kapton L2fwd\_V30\_200\_041
