Ladder Assembly

Series gluing of 11 ladders using
improved gluing procedure

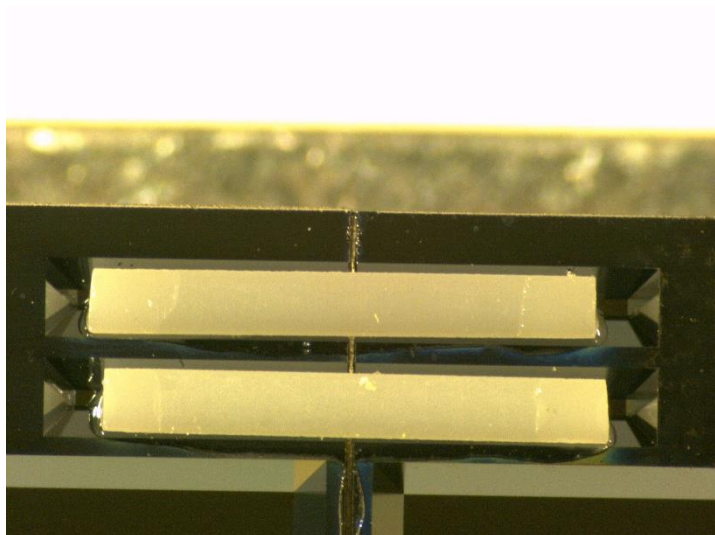
LK 42: glue did not spill out, difficult to judge which area is glued
(nevertheless, the joint is well glued)

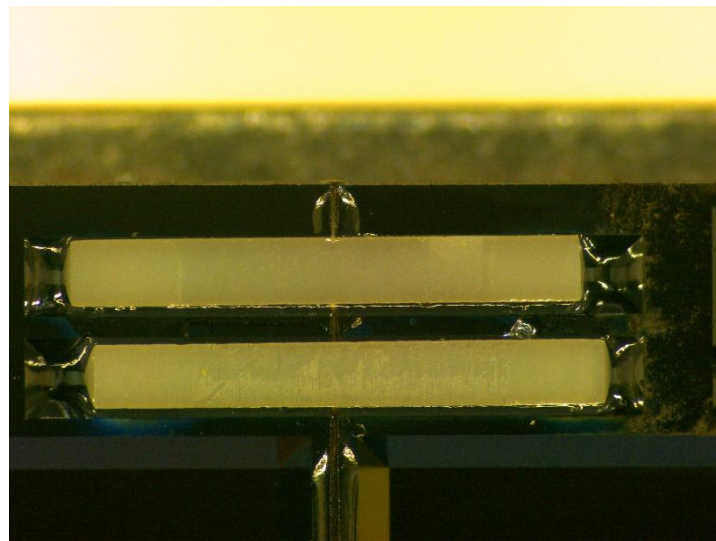
LK 51: Excess glue essentially visible everywhere (tolerances of slot)

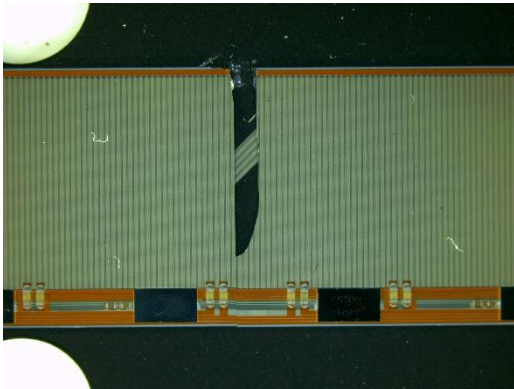
High speed links of our ladder setup were unstable: not possible to test ladders reliably after gluing. Indirectly this lead to a loss of one ladder during inspection (LK-43, hit by a microscope lens which detached itself (fixed)

Had to use module setups for testing => no module characterization in parallel

Turned out to be a grounding problem in the ladder setup (two branches), understood, ifxed (need DHH)

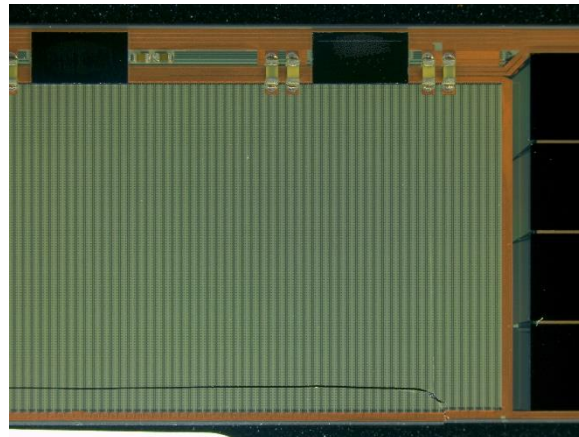
One module (W12_OF1) failed the electrical test before gluing (high currents). Turned out that had a crack.

Had already been tested im May and was ok then. Stored with other modules and not touched since. Not known what happend.
