Status at MPP

Belle II PXD Workshop 21 January, 2020

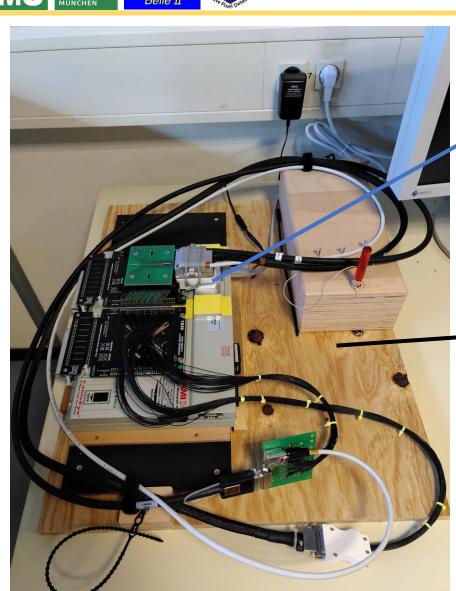
3D printed structure for easier plugging

wooden structure for fixation

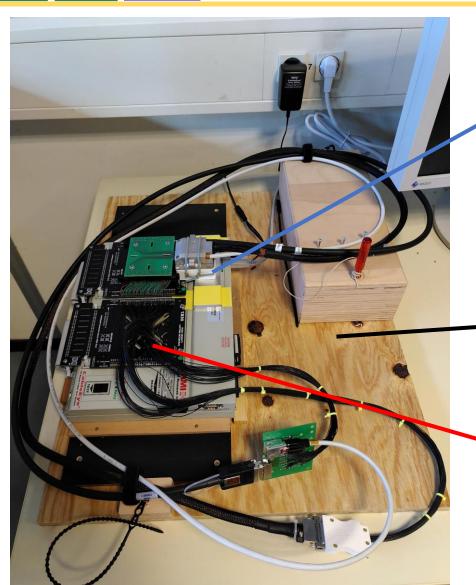
3D printed structure for easier plugging

wooden structure for fixation

new adapter PCB currently designed

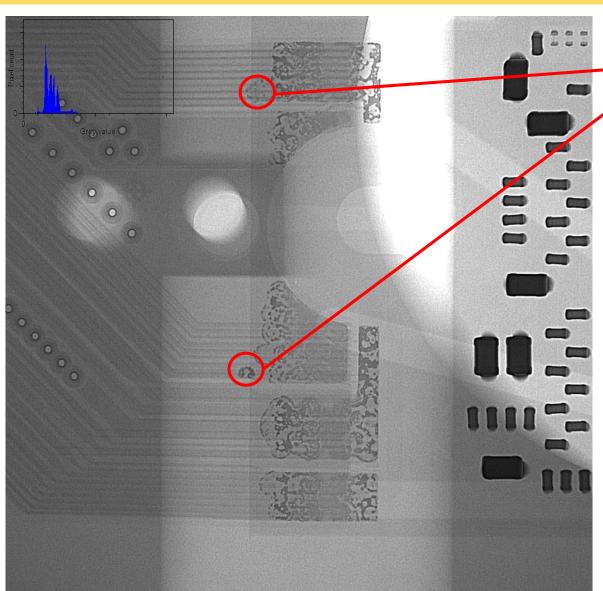
suspicious 'outrunners' on module W10_IF

- probably due to new charge of soldering tin (lower viscosity)
- no effects during module testing
- > one dummy module (looks good)
- > continue kapton attachment
