# Available Femto test bond stage was too small for the entire module

# One of two dummy module bonds was successful

# Bond test samples presents bad bond joints due to production failures

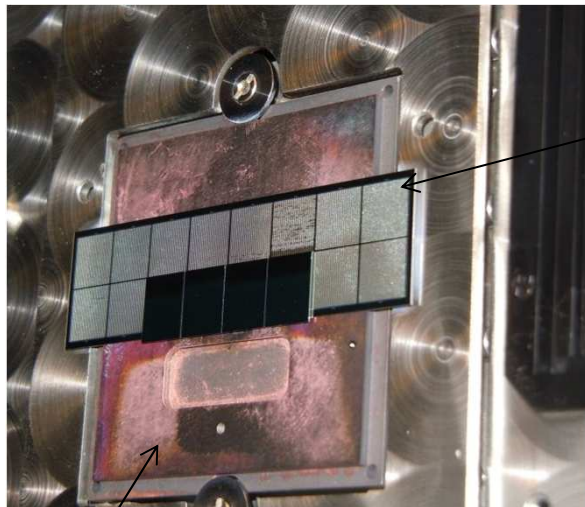
Bumped dummy sensor with  
4 tacked ROC

Heated area (W-Cu chuck)

- Heated chuck was 50x50 mm<sup>2</sup>
  - Four ROC areas protrude over chuck size
- Only 12 ROC could be bonded

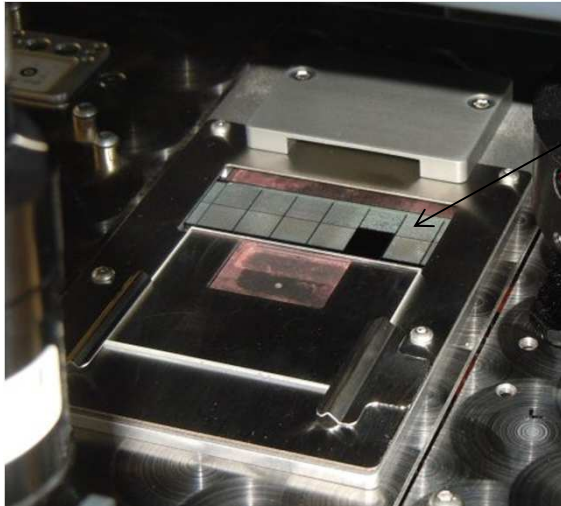
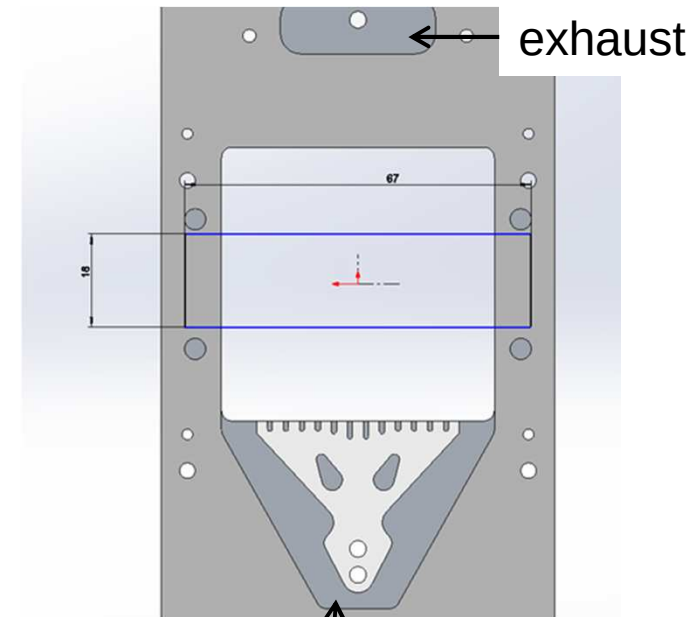
Dummy sensor in formic acid chamber with opened glass cover

- Formic acid chamber was modified to accept sensor
- Protruding sensor area was cut out
- Chamber was still sealing completely

N<sub>2</sub> and formic acid inlet

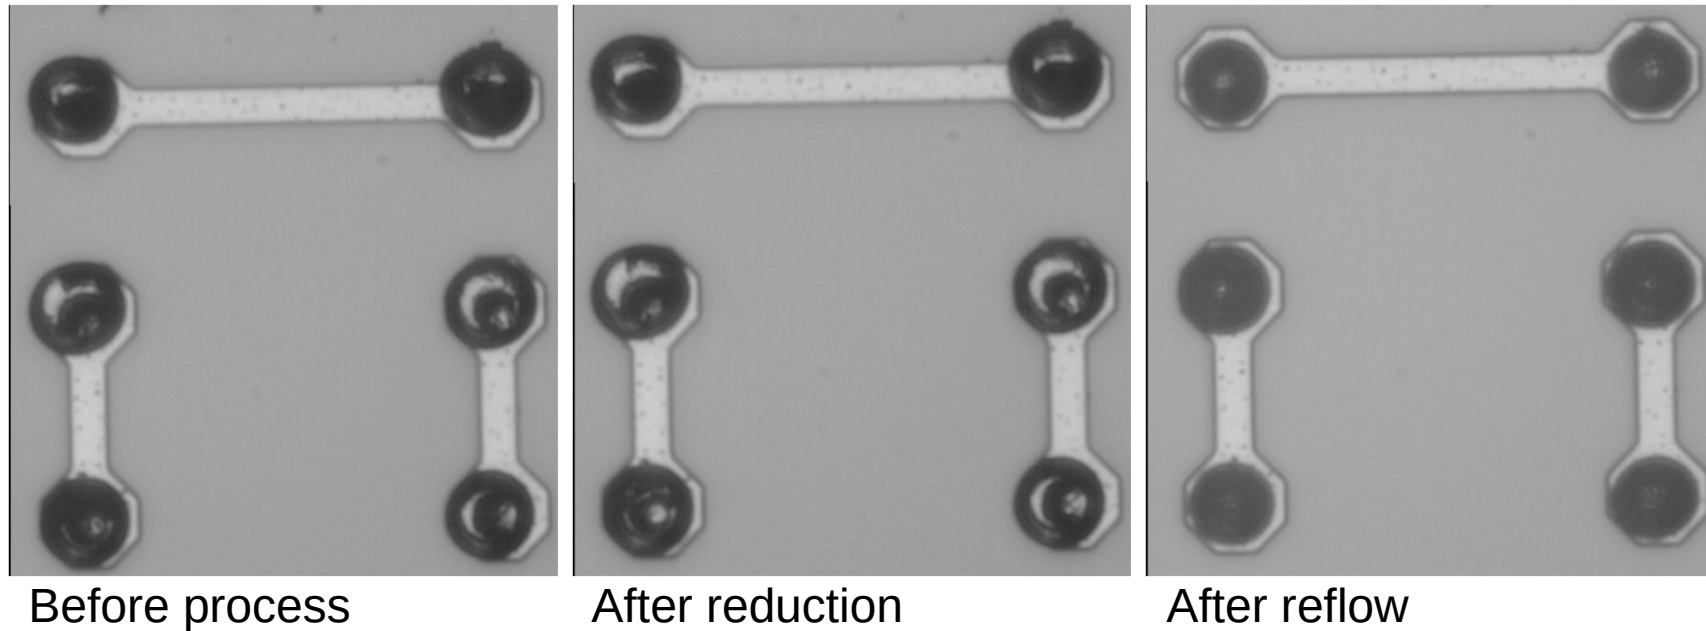
Dummy ROC bond#2  
Finetech 31.01.2012

Reduction: at 145°C for 180 s

Reflow: ramp from 145°C to 240°C by 2 K/s

stay at 240°C for 15 sec

ramp down (4 K/s)

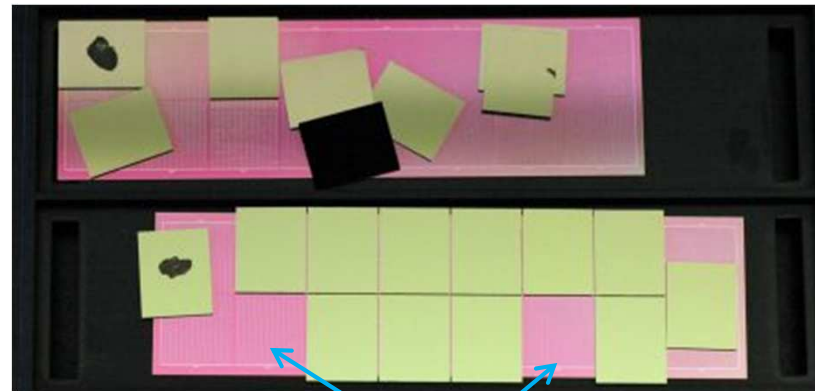
ROC to ROC bond#2  
Finetech 31.01.2012

Modulebond#1

Modulebond#2

No chip remained in  
place

Two ROC broke apart

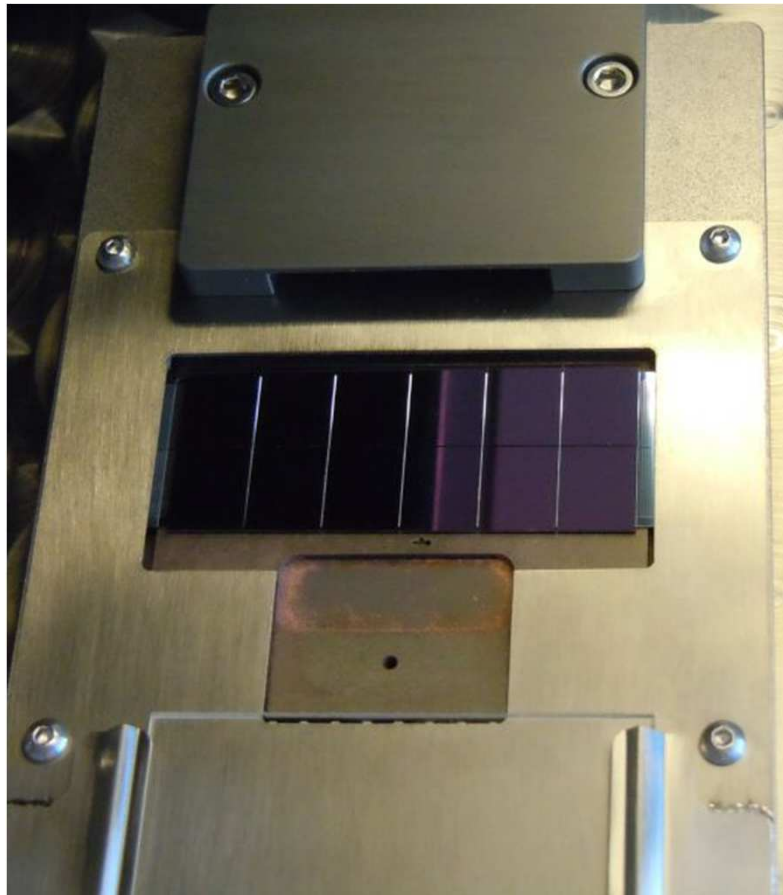
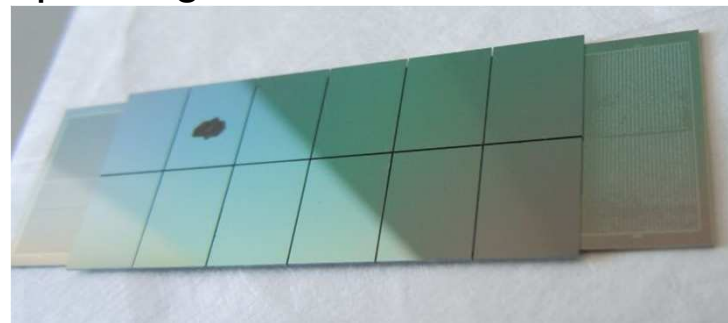
12 ROC on sensor in formic acid chamber on Femto stage

Demounted bare module before packing

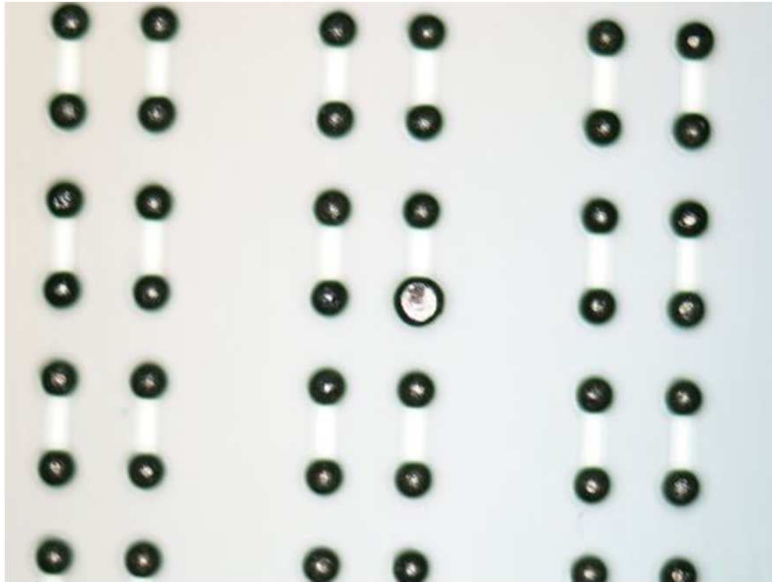
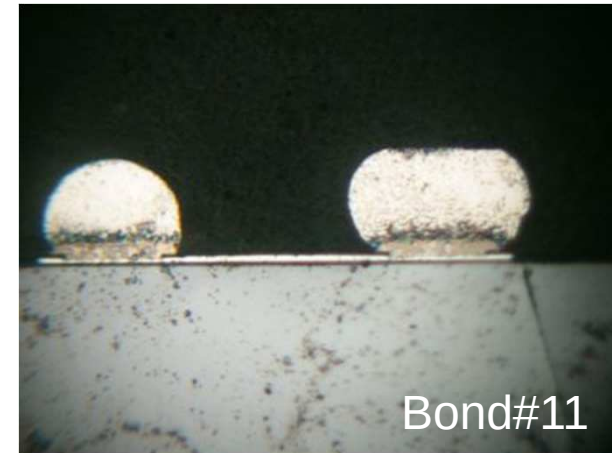
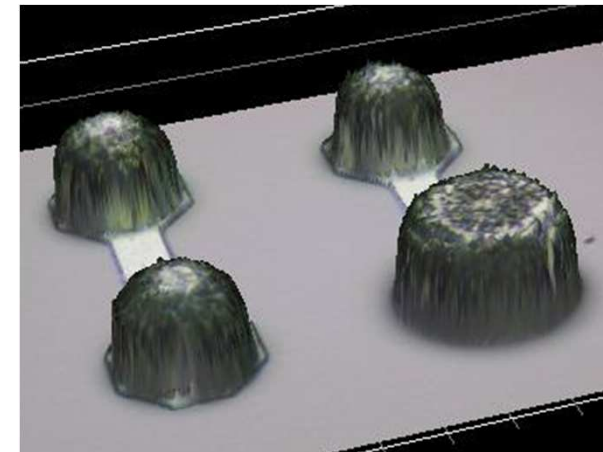
Dummy module#2 bond#1  
Finetech 01.02.2012

# Tacking force was too low to coin makro bumps sufficiently

5 macro bumps were flattened  
All other bumps remained spherical

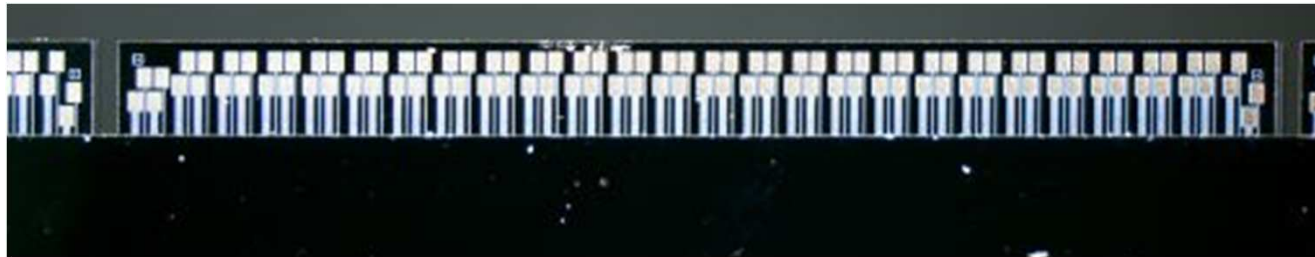
104 pads on each bonded dummy ROC allow 4 wire resistance measures on each of the 26 double columns

All daisy chain resistance measure paths of this sample were open 😞

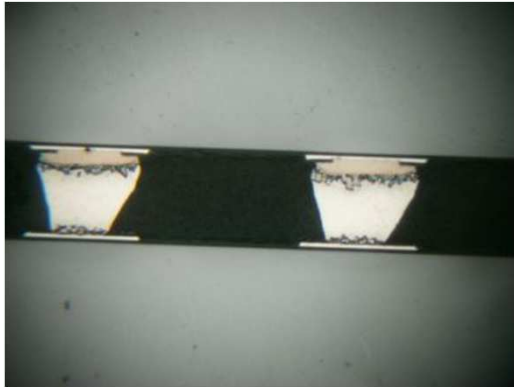
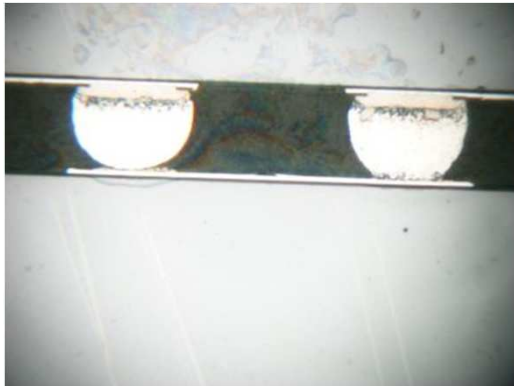
Dummy module#2 bond#6 and #14  
Finetech 01.02.2012

Too few UBM

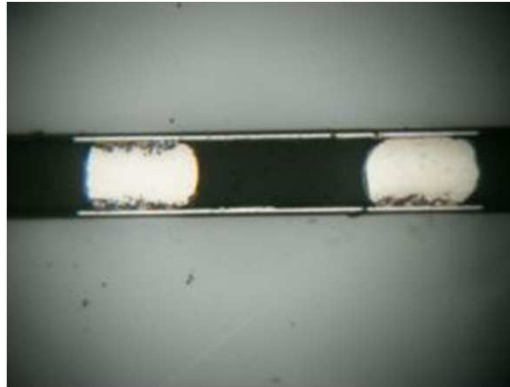
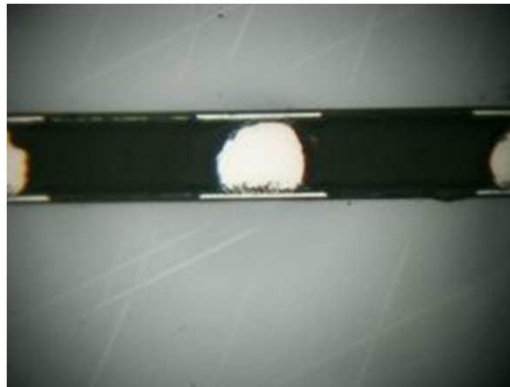
ROC to ROC bond#1  
Finetech 01.02.2012

Missing UBM / Pad openings

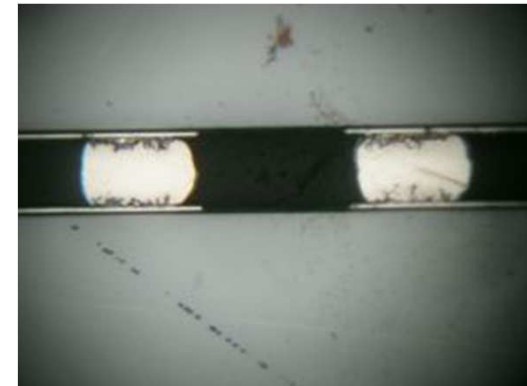
At least kind of bond

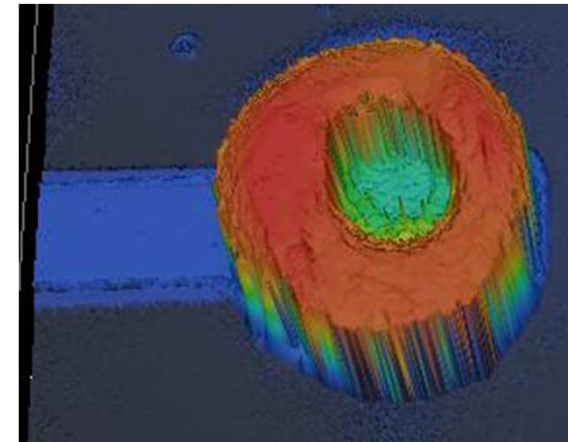
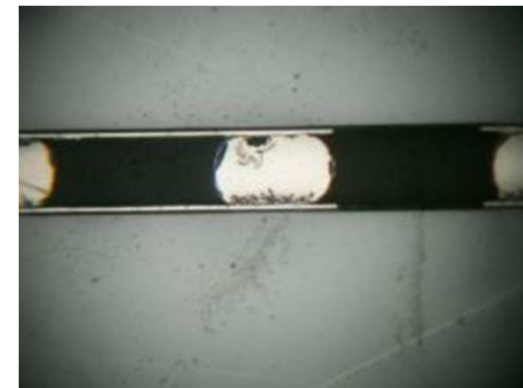
ROC to ROC bond#3  
Finetech 31.01.2012

- ductile bump fracture 😊
- voids within solder volume are found ☹️

Shear strength: 183.69 N

~ 70% soldered bumps

→ 0.6 N/bump

Problem originates from the solder jetting process

Pac Tech suggests different UBM material
