Experience with Optical Inspection

Bob Rimmer

TTC meeting, October 20-23, 2008

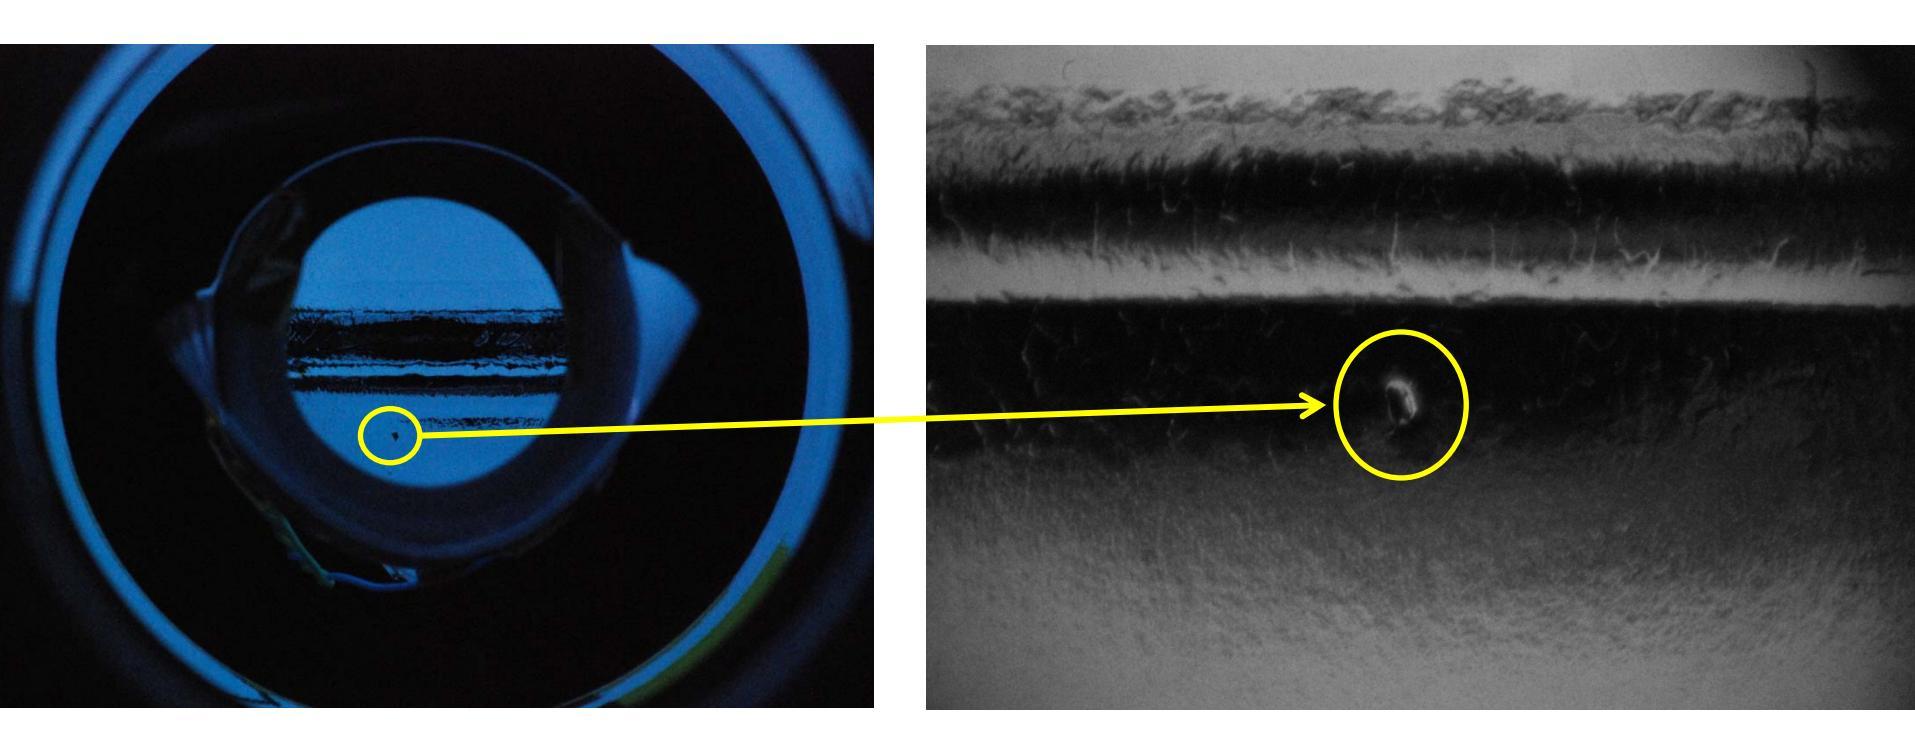
1st Example of Finding Defect in Equator Region

- A15 hard quench limit 17-19 MV/m
- Pass-band measurements pointed to cell #3/7
- T-mapping found hot spots correlated to quench
- Optical inspection found defect near hot spot
