# XFEL cavity production tests and comparison before/after module assembly

TTC Meeting KEK Dec 2-5, 2014

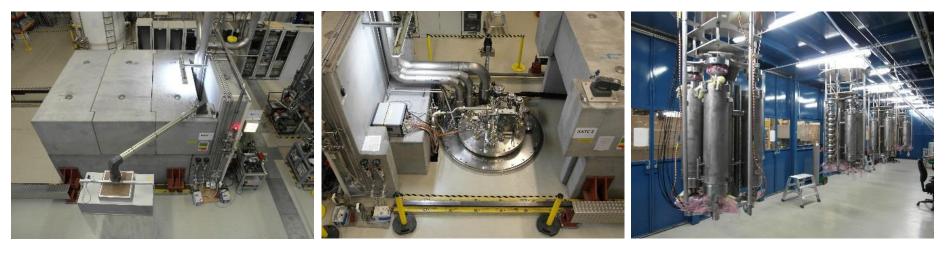
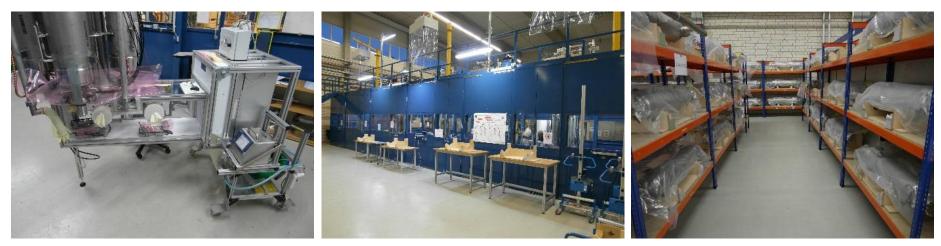
# EuropeanXFELVertical tests at AMTF

ALL vertical acceptance tests counted (incl. hall3 + cavities with limited acceptance + return from Saclay + ...)

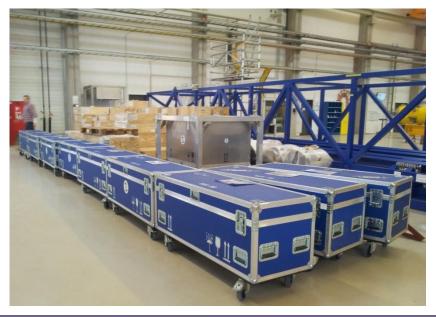
### **XFEL** Vertical test => string assembly

- **Sorting of cavities for string assembly** according to
  - gradient
  - mechanical constraints
  - => string proposal
- routine weekly transport in boxes to Saclay => very reliable, but shock log data still not fully understood
- Cavities up to XM31 at Saclay

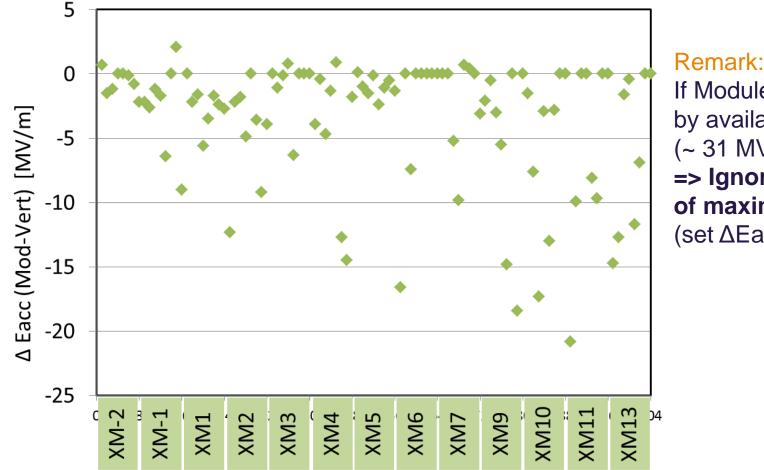
- Hans: "too often we are disappointed by a decreased gradient of single cavities"
- Difference of maximum gradient from module test and vertical test ΔEacc(Mod-Vert) vs. Module

If Module Test is limited by available RF power (~ 31 MV/m) => Ignore the decrease

of maximum gradient (set  $\Delta Eacc = 0$ )
