Tobias Haas  
Technical Meeting  
21 Oct 2016

# Damage of Accelerator Infrastructure during Pressure Test

During the pressure test of a Helium exhaust line severe damage to accelerator infrastructure happened late night on October 11, 2016.

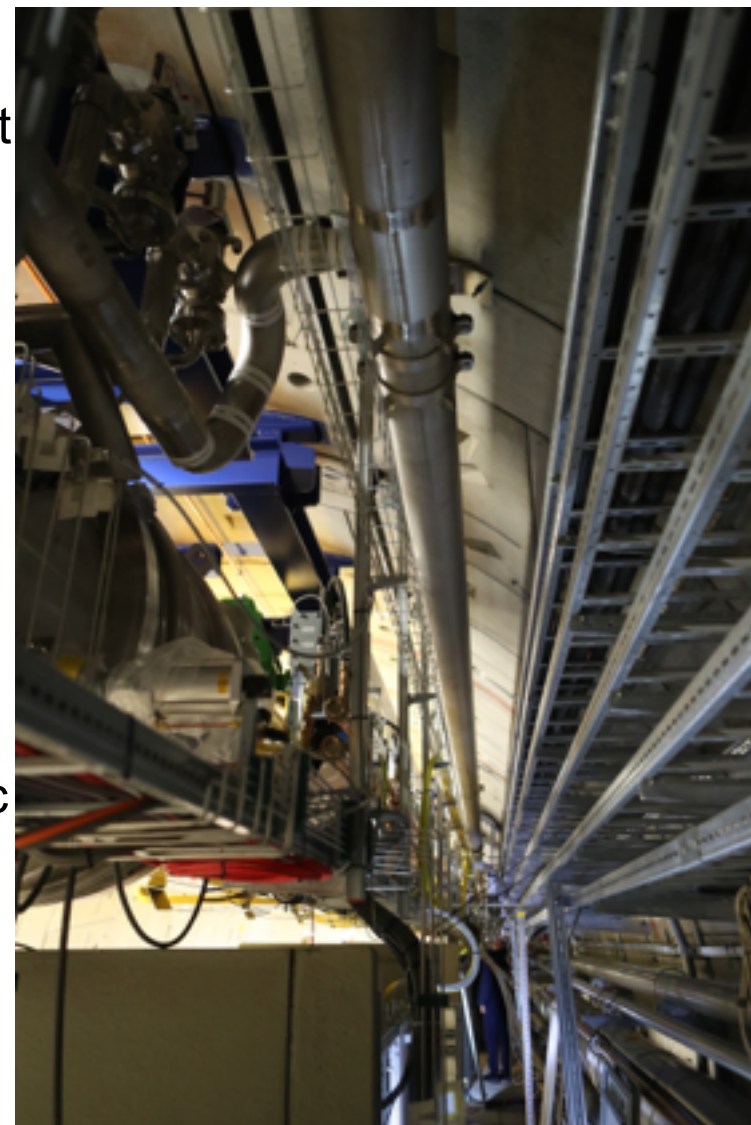
- DN200 exhaust line all along the linac to collect He in case of abnormal operation conditions in the process lines of the accelerator modules. Safety valves with short hoses connect the cryogenic string connection boxes to the exhaust line.
- Exhaust line was designed, constructed and installed by an external company. Installation finished in 2014 with an acceptance test including full pressure check without any apparent problems.
- After completion of connections to all cryogenic boxes a final pressure test was needed to prepare for the upcoming cool-down of the accelerator.

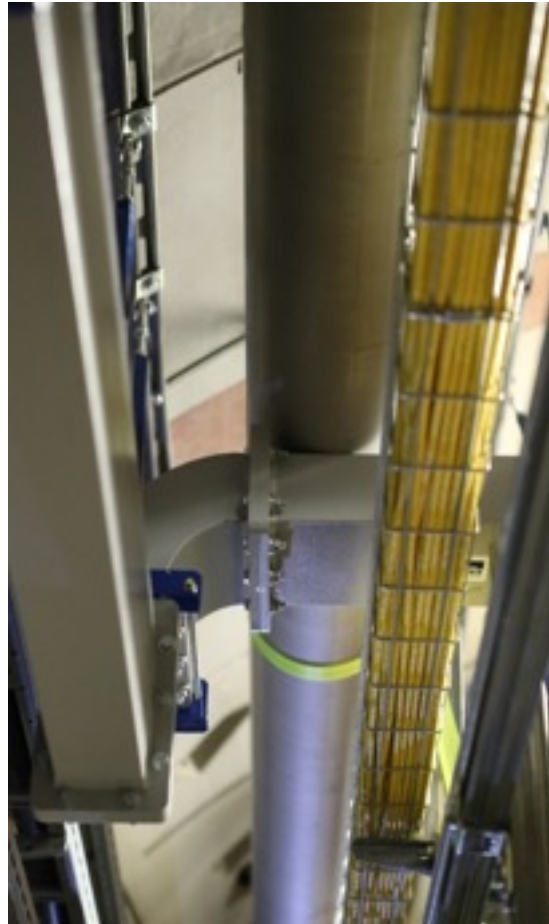
- Along CS9 and CS8 the line came to a halt on some of the wave guide sections which are 0.5 m below the original position of the pipe.

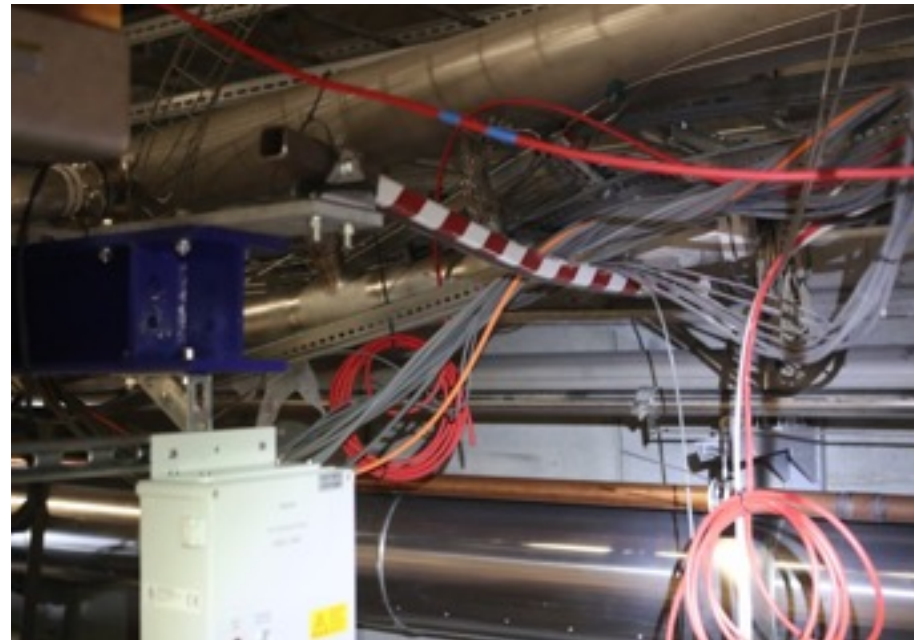
- At the cryo end box and also at the string connection box connecting CS8 to CS9 all connections to the DN200 pipe broke.

- At present the exhaust line is secured in its current position. Together with the piping company all still existing forces in tunnel direction have to be compensated by appropriate fixtures.
- Access for others to the XTL is not possible yet.

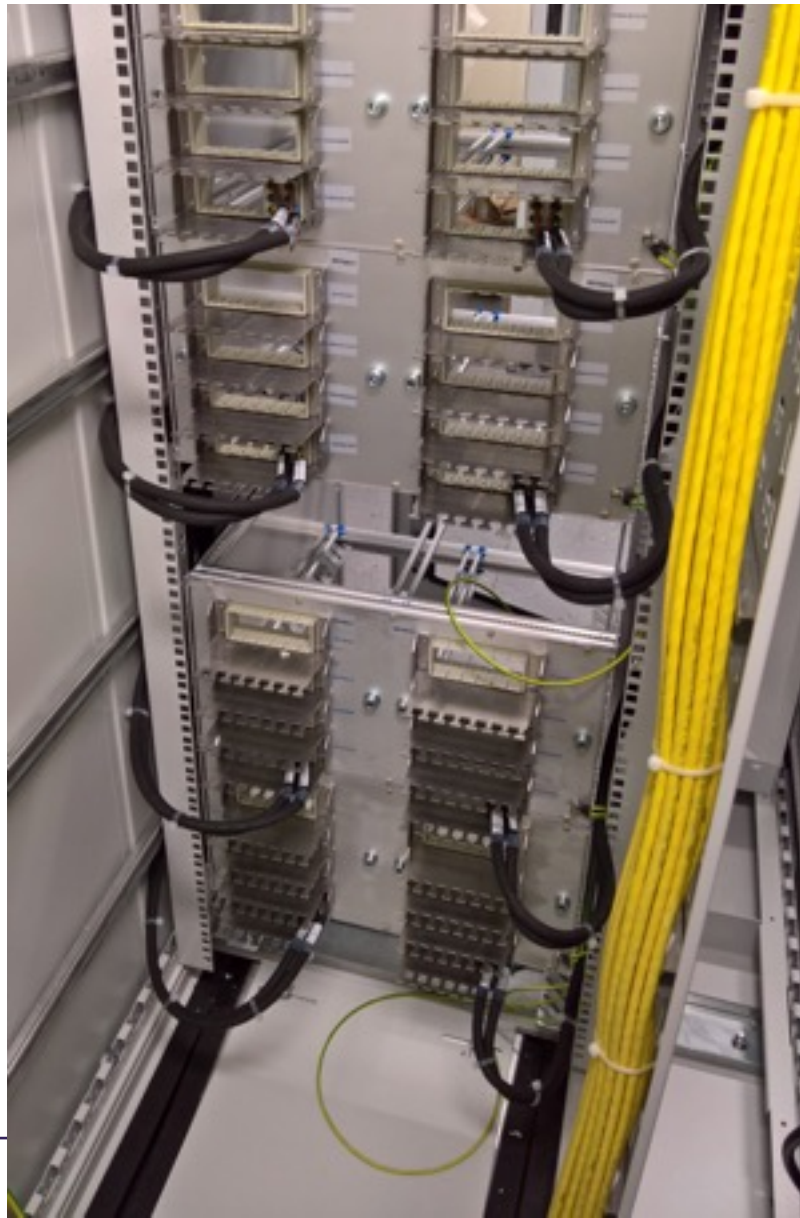
# FXE Rack Room: Beckhoff frames

- A bump in the floor of the FXE hutch gives trouble for air pad movement. Floor is out of specs.
  - A solution is being prepared with TS (Emmerich)
- Installation of rack cooling units delayed
  - not critical at the moment
- Installation of Frames for Beckhoff electronics started in the FXE rack hutch
