XFEL-Gun Operator Training

F.Brinker

- Overview Gun system
- Typical measurements
- Critical parts
 - RF-window
 - Cathode holder
- Diagnostics and interlock systems
- RF-operation

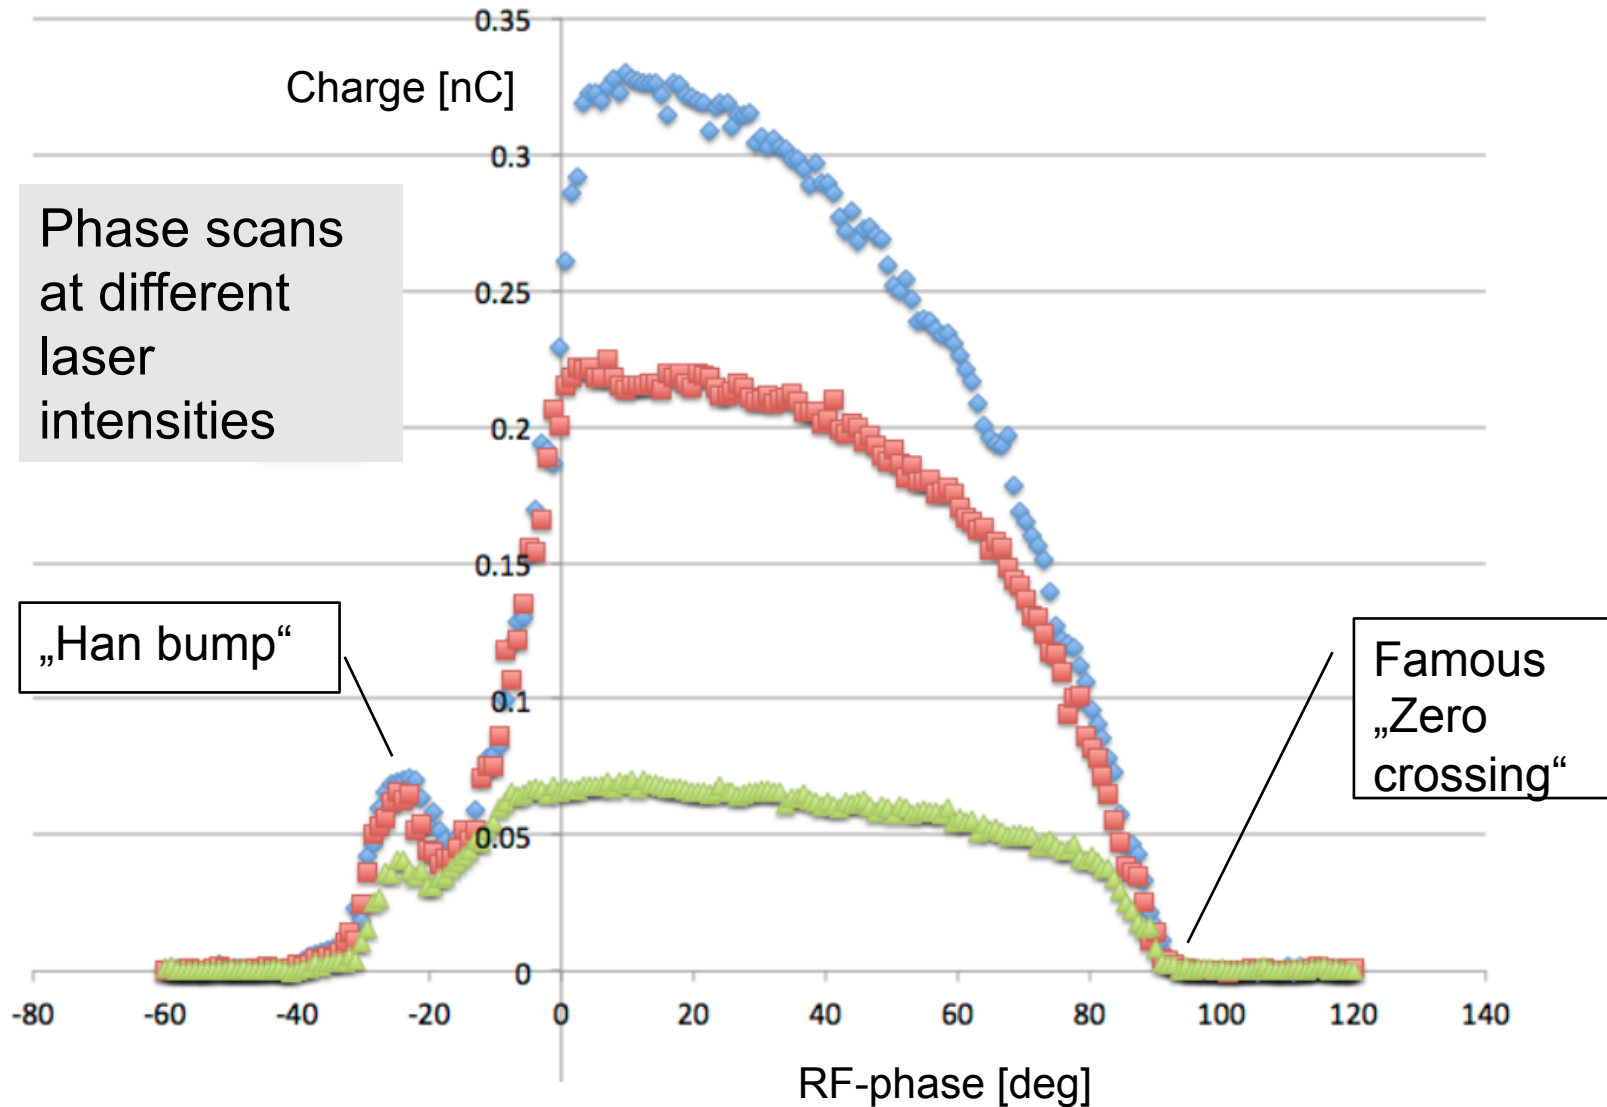
First measurements with beam: Phase scan for different laser intensities

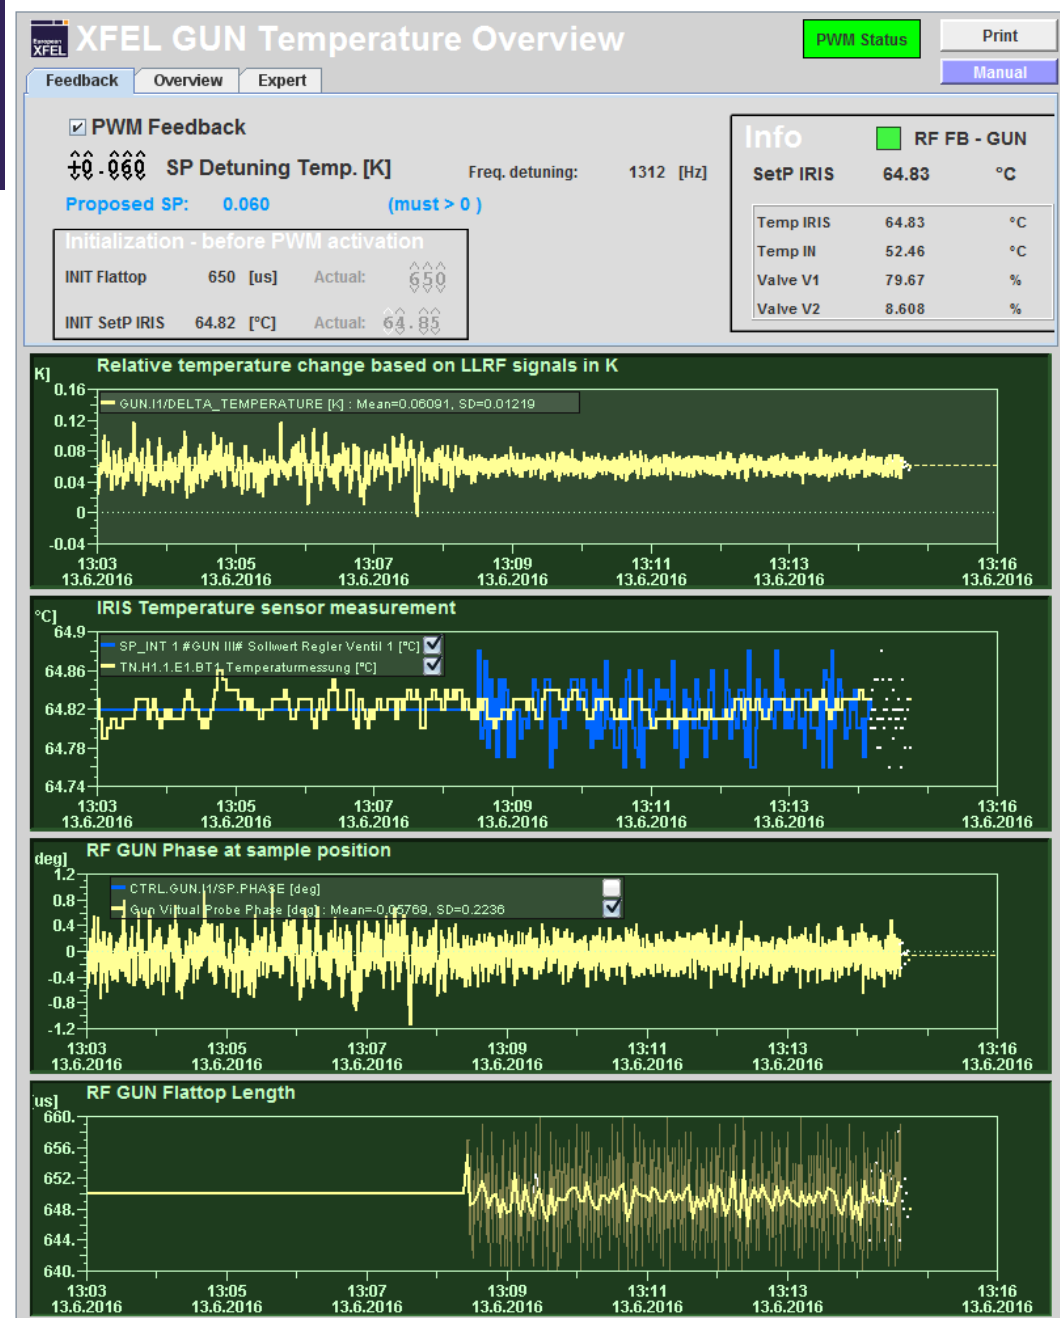
Pulse width modulation

- Fast measurement of gun temperature (0.1sec vs. 7 sec)
- compensate temperature deviations with the RF pulse width
