## Hamamatsu Silicon Sensors

Arkadiusz Moszczynski, Wojciech Wierba, Krzysztof Oliwa, Eryk Kielar,  
Leszek Zawiejski, Institute of Nuclear Physics PAN  
Marek Idzik, University of Science and Technology AGH

# LumiCal calorimeter - toward the prototype

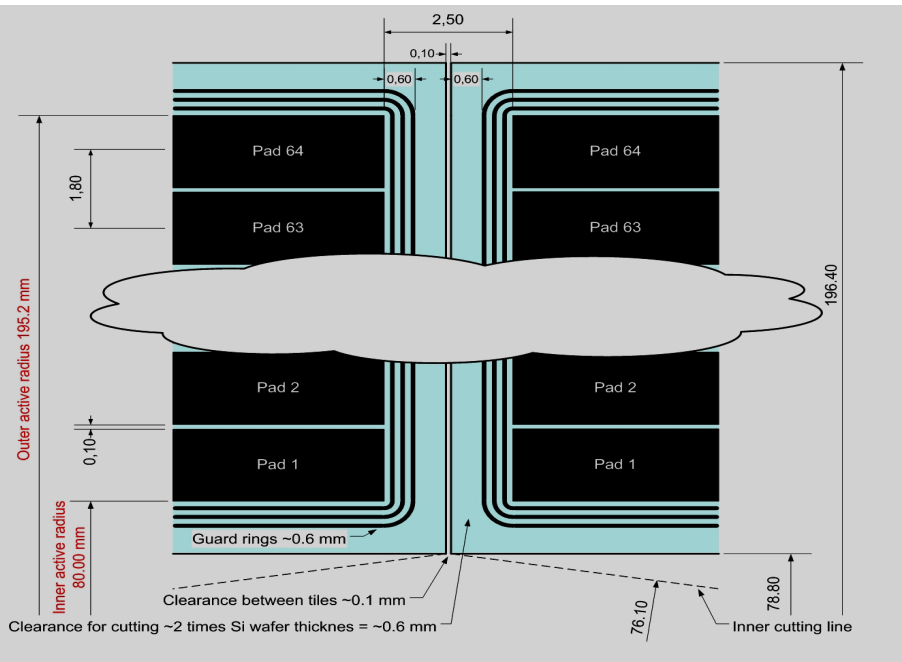
Details of the structure: gap between tiles

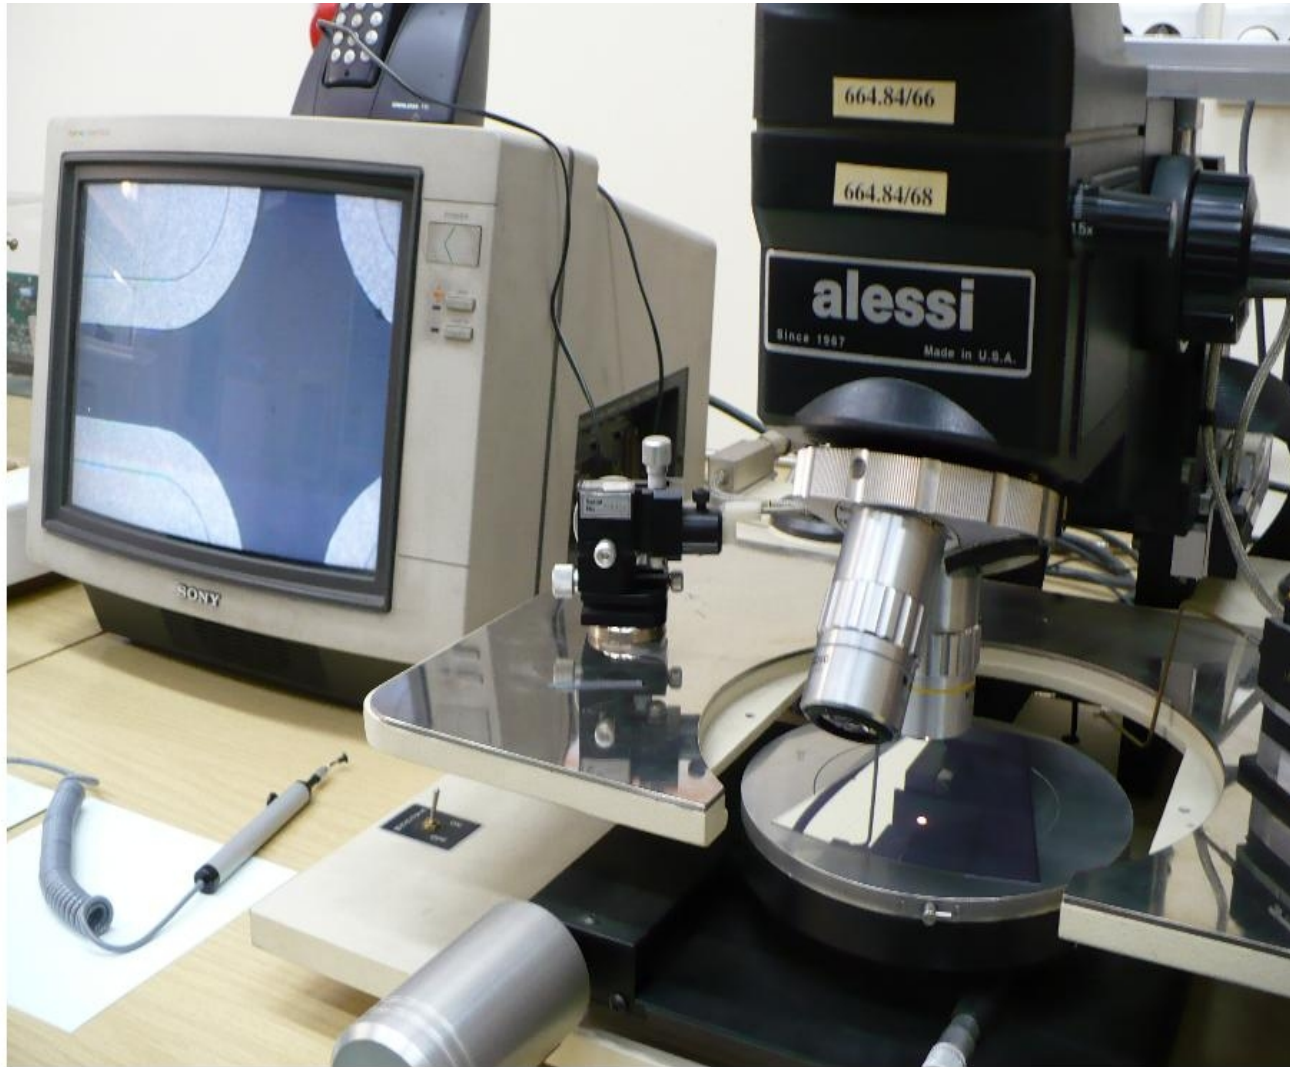
The device is used  
For visual inspection only.

The installed  
in microscope camera  
allows  
to receive picture of the  
Investigated sensor on  
the monitor screen.

Electrical movable table  
supplied  
a X,Y movements  
in steps of  $1\ \mu\text{m}$   $\rightarrow$   
inspection of the details  
of the sensor structure

Alessi probe station used for visual inspection of Hamamatsu detectors

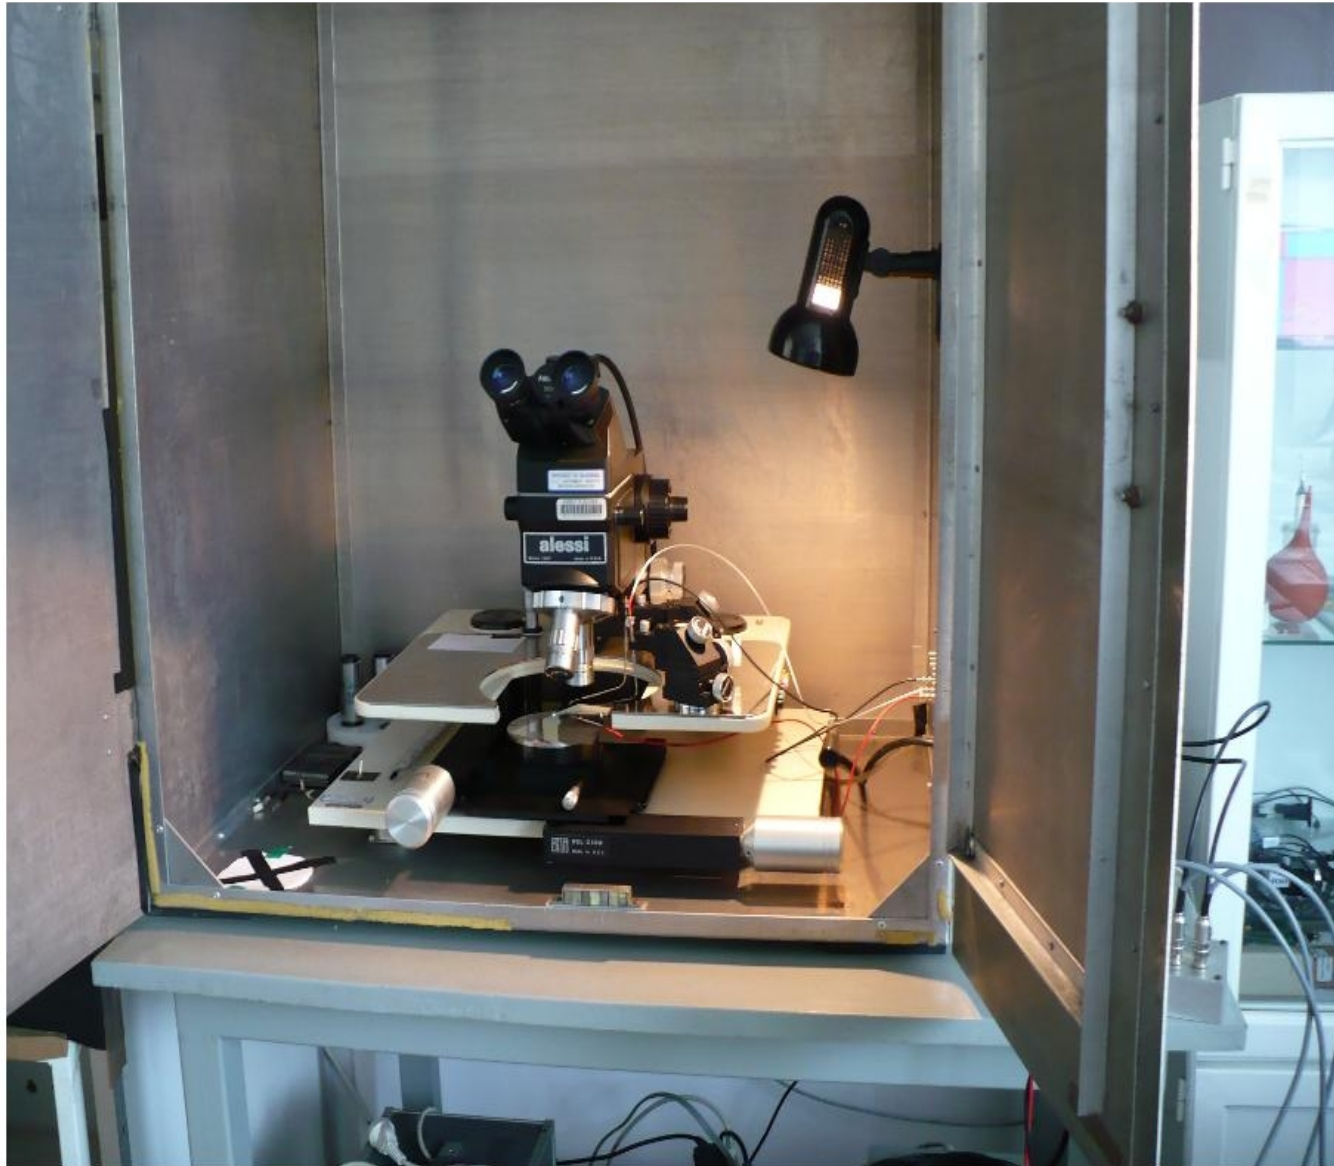
Device has „black box” – measurements in darkness.

To check measurements, two different methods were used:  
with GPIB (General Purpose Interface Bus) for automatic transfer data between device and computer and old style HP instrument

Alessi probe station used for electrical measurements on Hamamatsu detectors

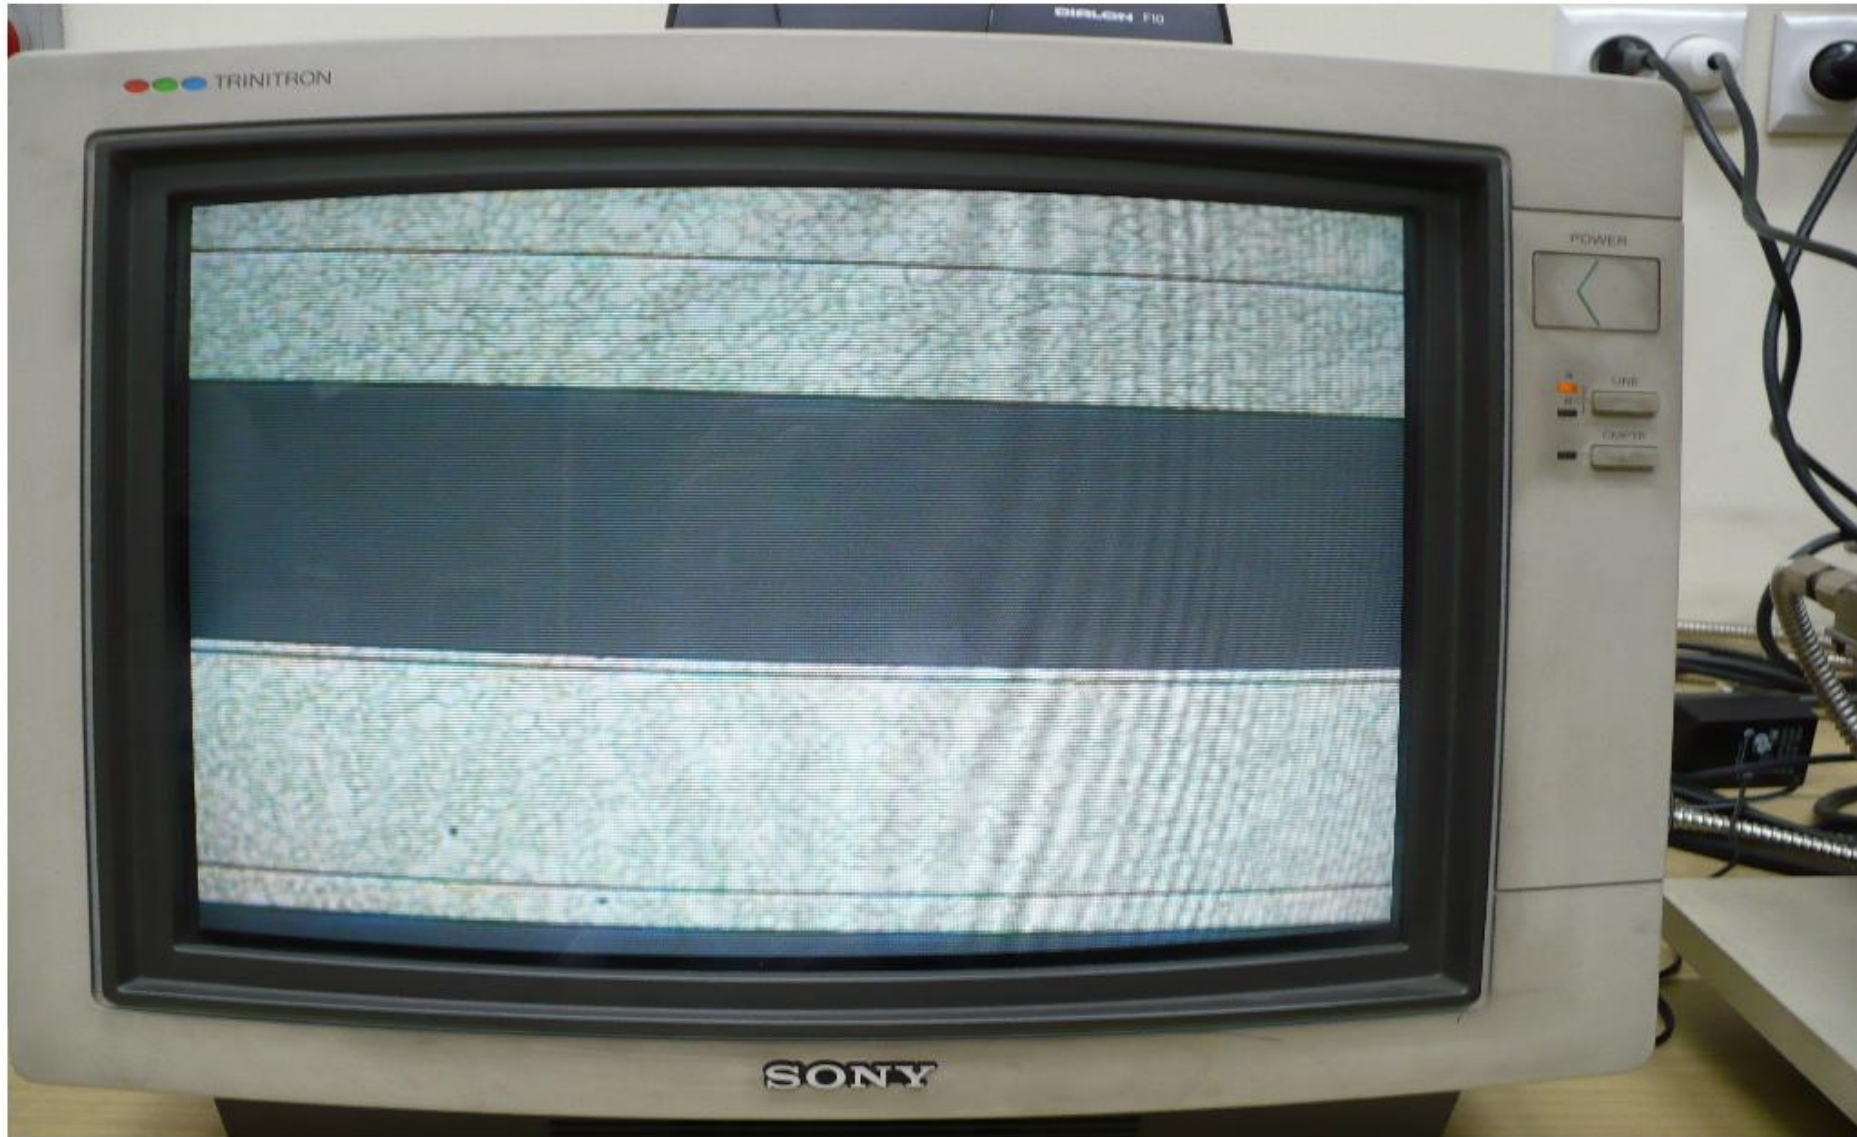
Fragment of boundary region between guard-ring and pad. The difference between dimensions of metallization outstanding over  $p^+$  implants can be clearly seen.

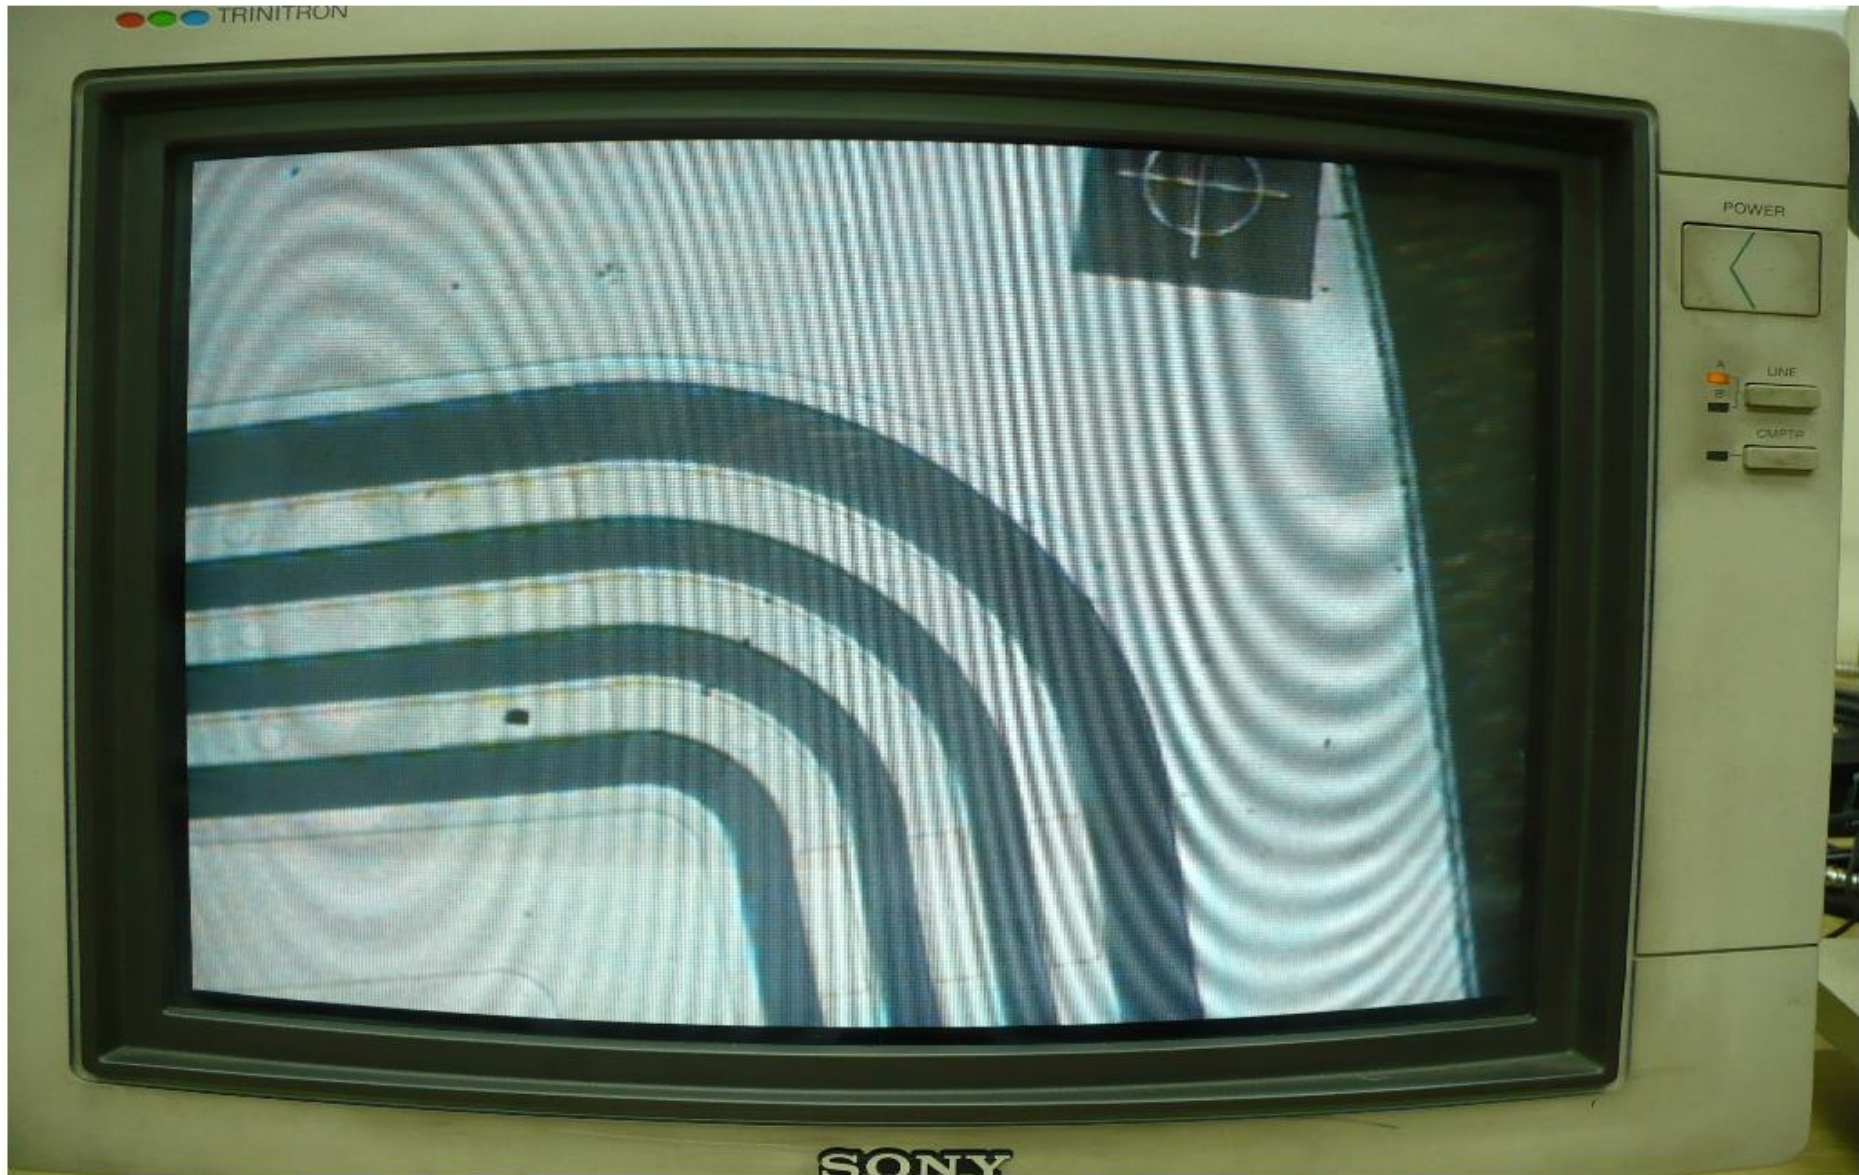
The corner fragment of guard-rings system

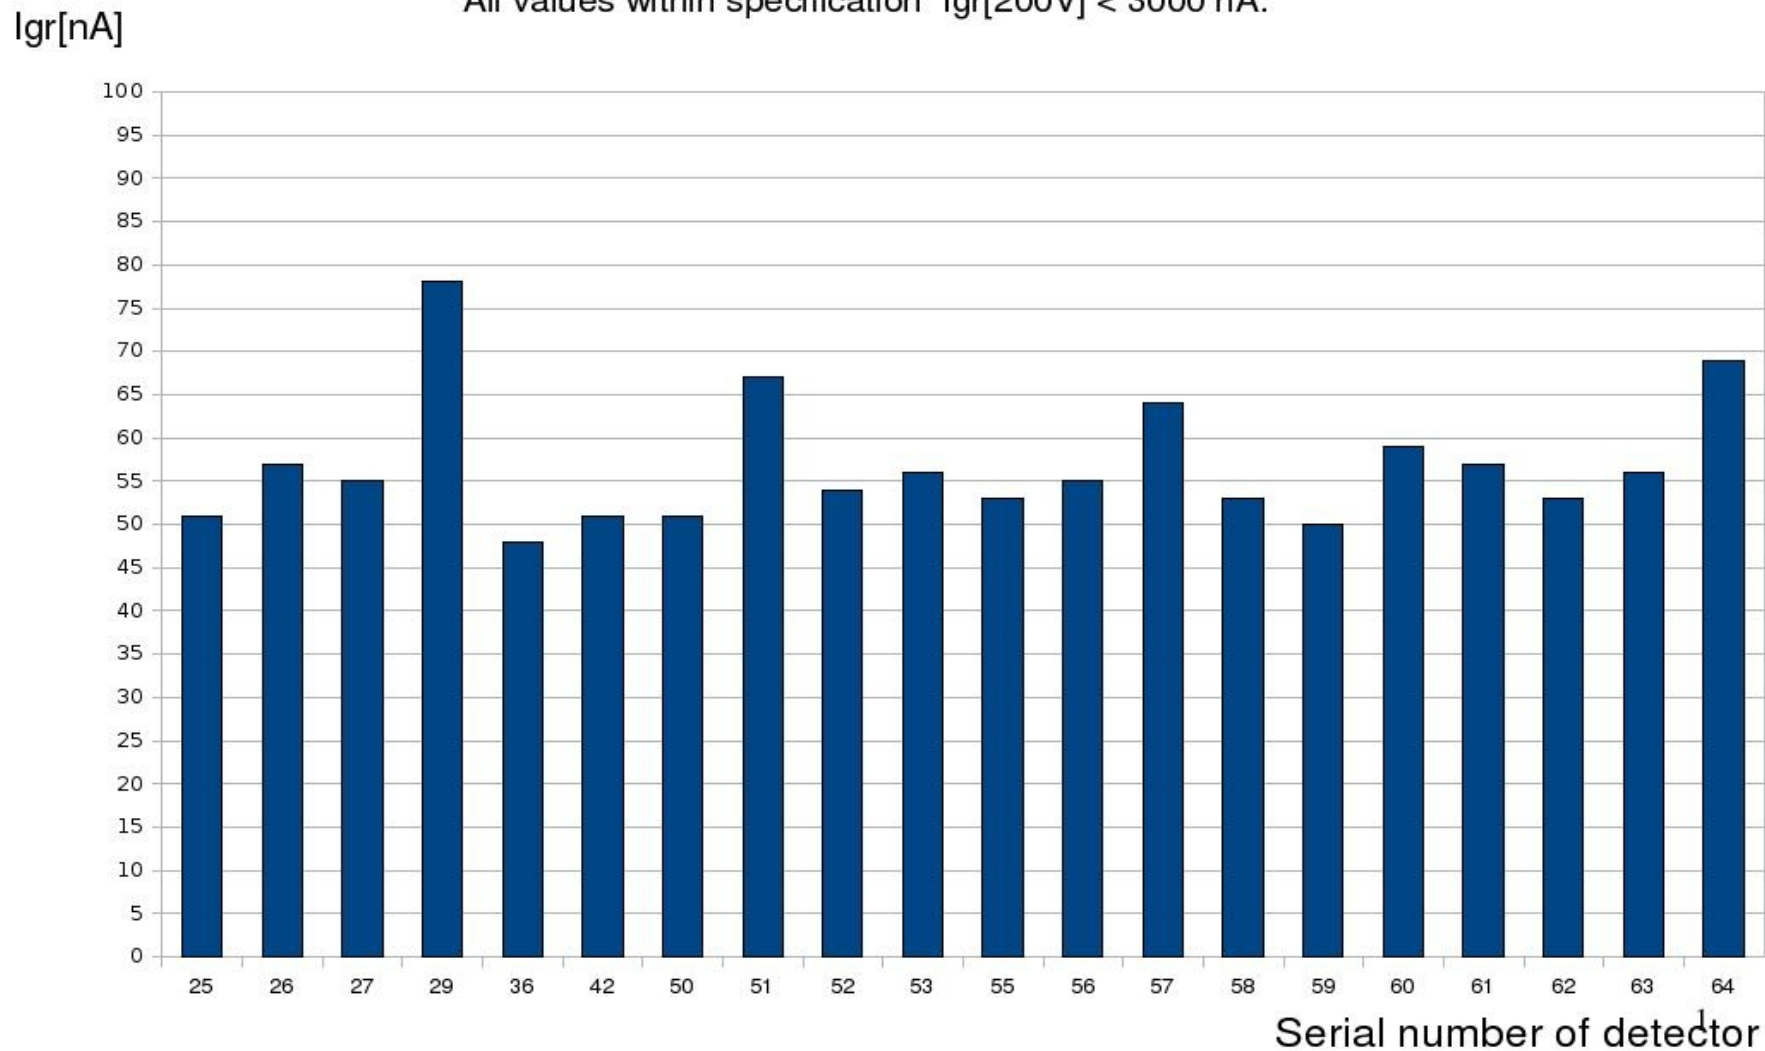
Values of  $I_{gr}$  [200V] at most inner guard ring, taken from Hamamatsu data sheet.

All values within specification  $I_{gr}[200V] < 3000$  nA.

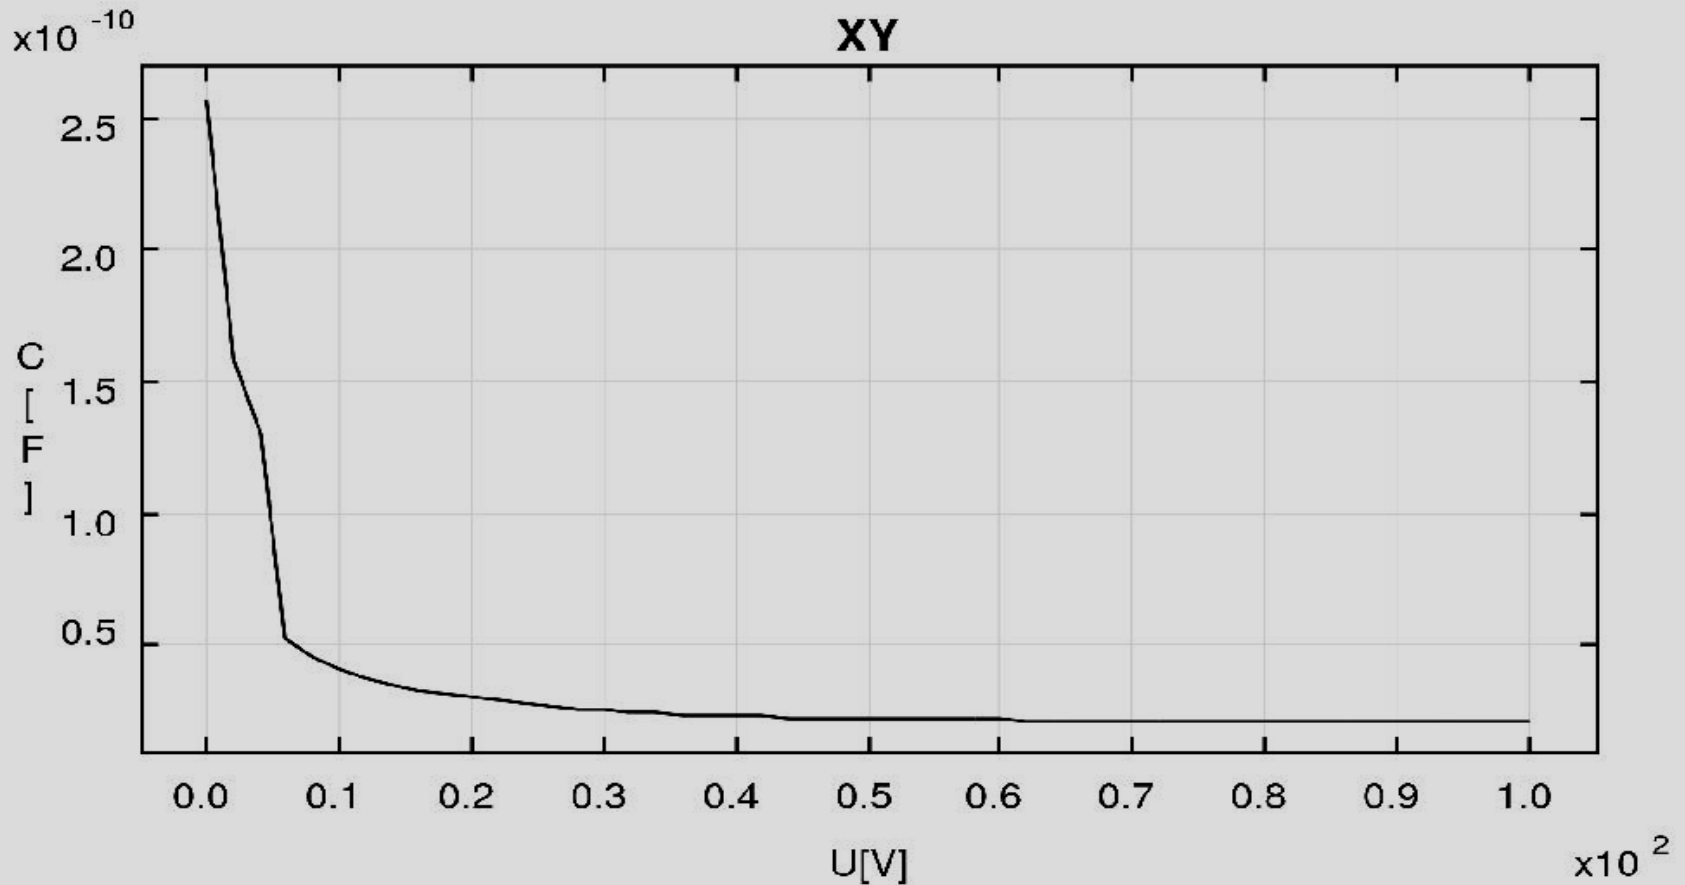
## Typical example of C-V measurements on Hamamatsu detectors.

The measurement in figure was taken on pad L263 of detector 25.

Signal frequency  $f = 1\text{MHz}$ , signal amplitude  $U_m = 100\text{mV}$ , step = 2V.

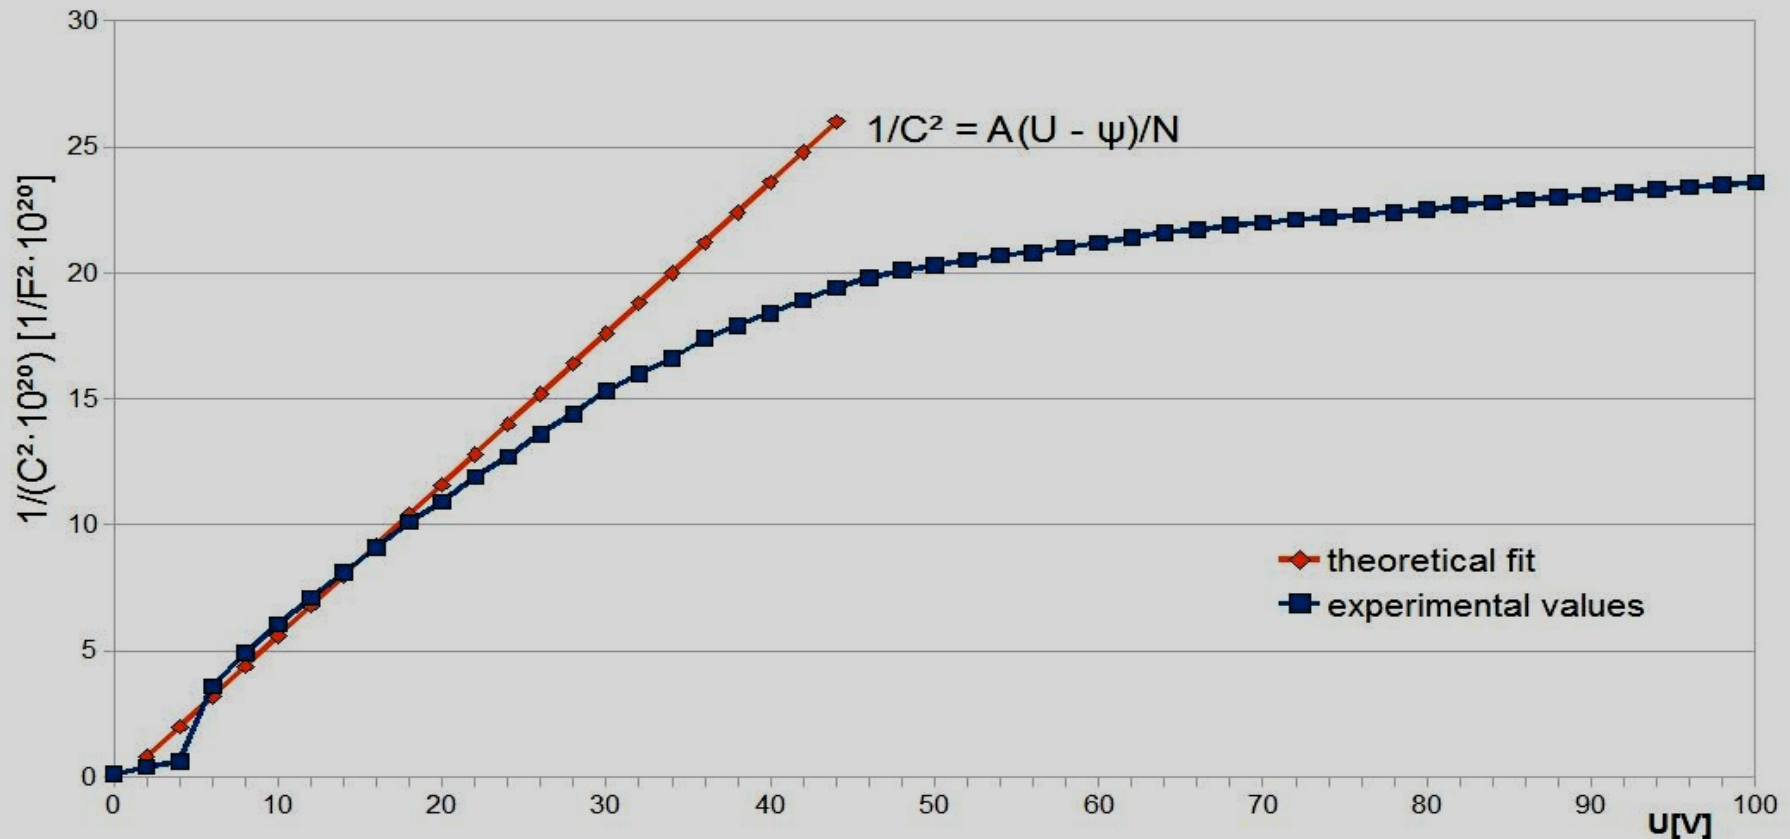
Pad measurement : C-V plot transformed to  $1/C^2 - V$  plot  
Estimation: depletion voltage, donor concentration in Si -> resistivity

**Experimental data in figure were taken from measurement on pad L263 of detector 25**

Here: **A** - geometrical/material factor,  **$\psi$**  - diffusion potential = 0.7 V,  
**N** - donor concentration in Si bulk, **U, C** - voltage, capacitance

From the slope of linear fit in figure one can roughly estimate value of  **$N \sim 7 \cdot 10^{11}$  [1/cm<sup>3</sup>]**,  
and hence silicon resistivity to be about **6 – 8 k $\Omega$ cm**.

Value of depletion voltage can be also roughly estimated from figure to be in range 30 – 60V.

- The sensors measurements were done on two of twenty supplied by Hamamatsu detectors  
All the measured values were within specification
- C-V measurements indicate that Si material used by Hamamatsu has very high resistivity, what resulted in relatively low value of depletion voltage

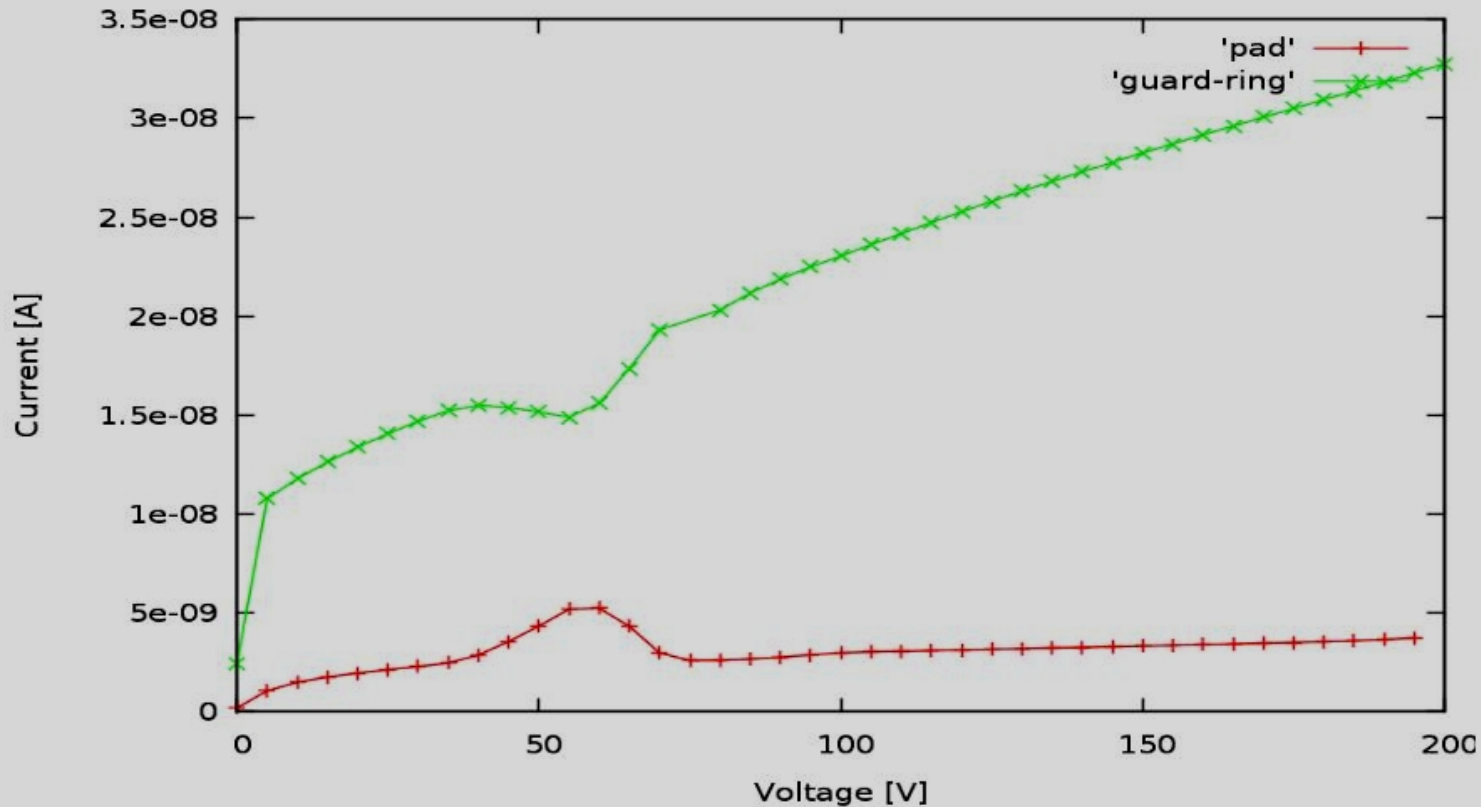
## I – V measurement on detector 25.

The voltages on pad 64L2 and most inner guard-ring were applied simultaneously. One can see that in region 40 – 70V, current division between pad and guard ring is disturbed. It is result of specific geometry of electric field in boundary region – **pad 64L2 has relatively long „common boundary” with guard ring – about 28 mm!** That is why the effect is clearly visible. **Next slide presents pad 63L2 with „common boundary” of about 2 mm – the effect is not so strong.**
