SRF Test Environment at the S-DALINAC

Status and Upgrades

Ralf Eichhorn

1st annual RFTech Meeting 2010

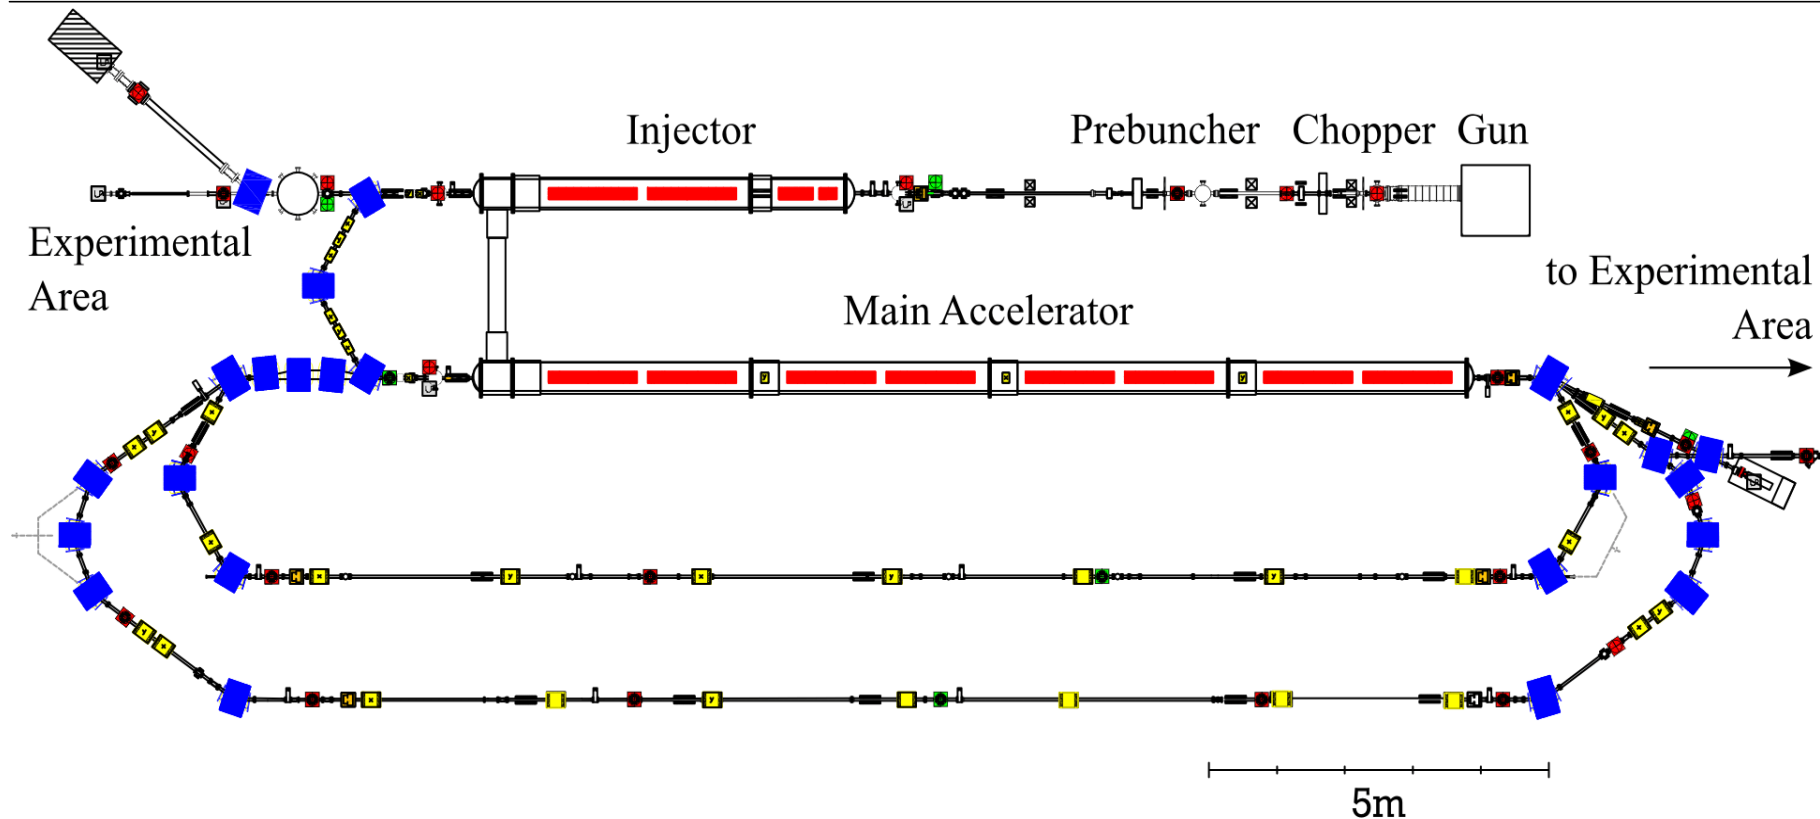
S-DALINAC Layout

Designparameter: Maximum Energy: 130 MeV
Maximum Beam Current: 60 μ A
Mode of Operation: cw

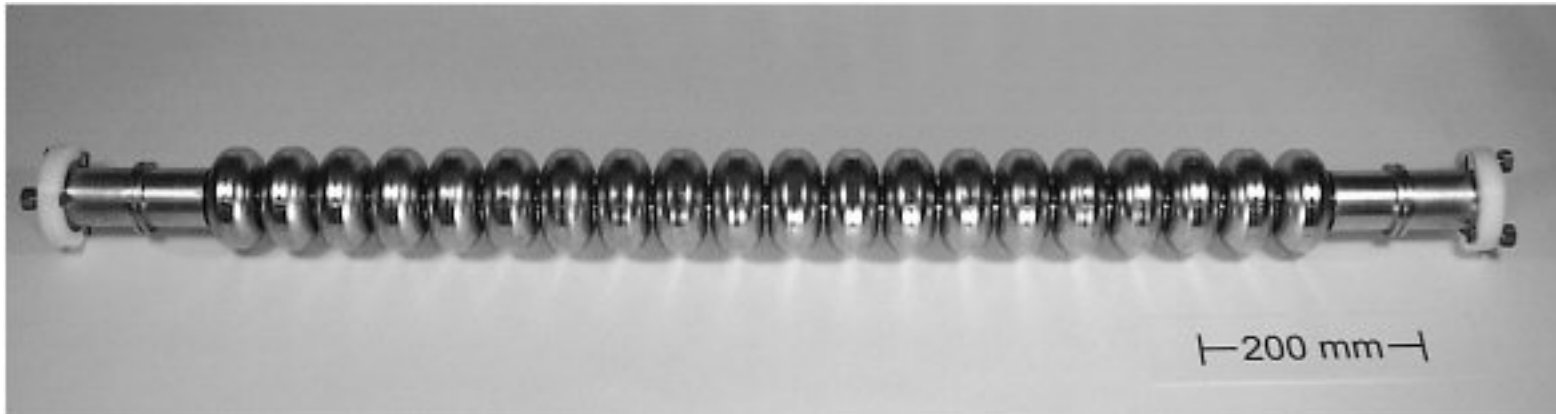
Supraleitende 20-Zeller

Design values

Material	Niob (RRR = 280)
Frequency	3 GHz
Temperature	2 K
E_{acc}	5 MV/m
Unloaded quality factor Q_0	$3 \cdot 10^9$

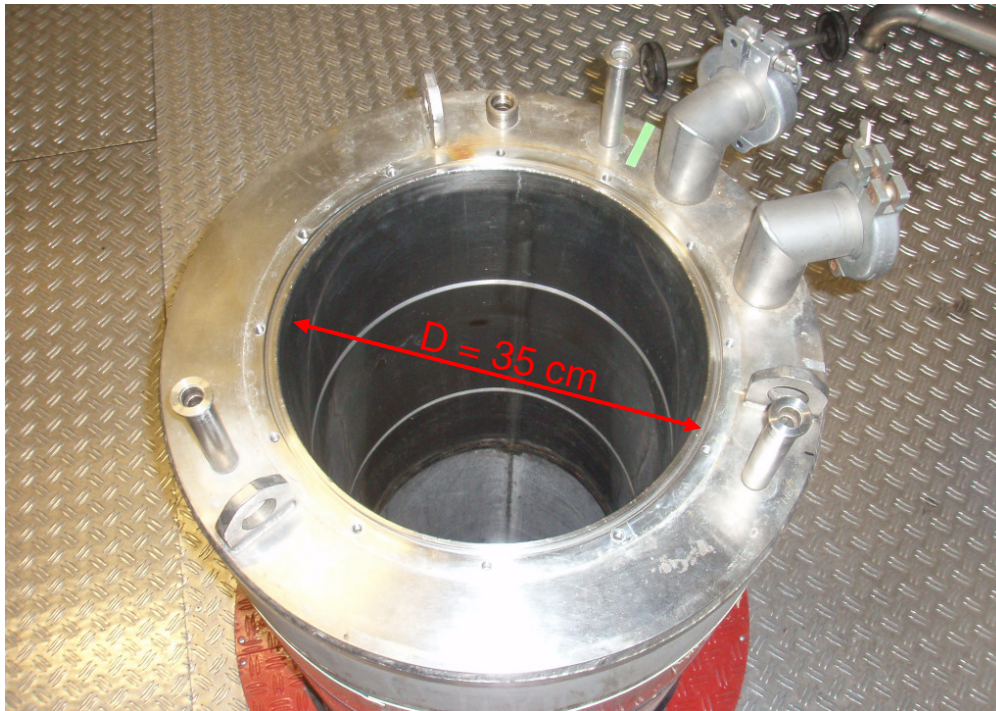
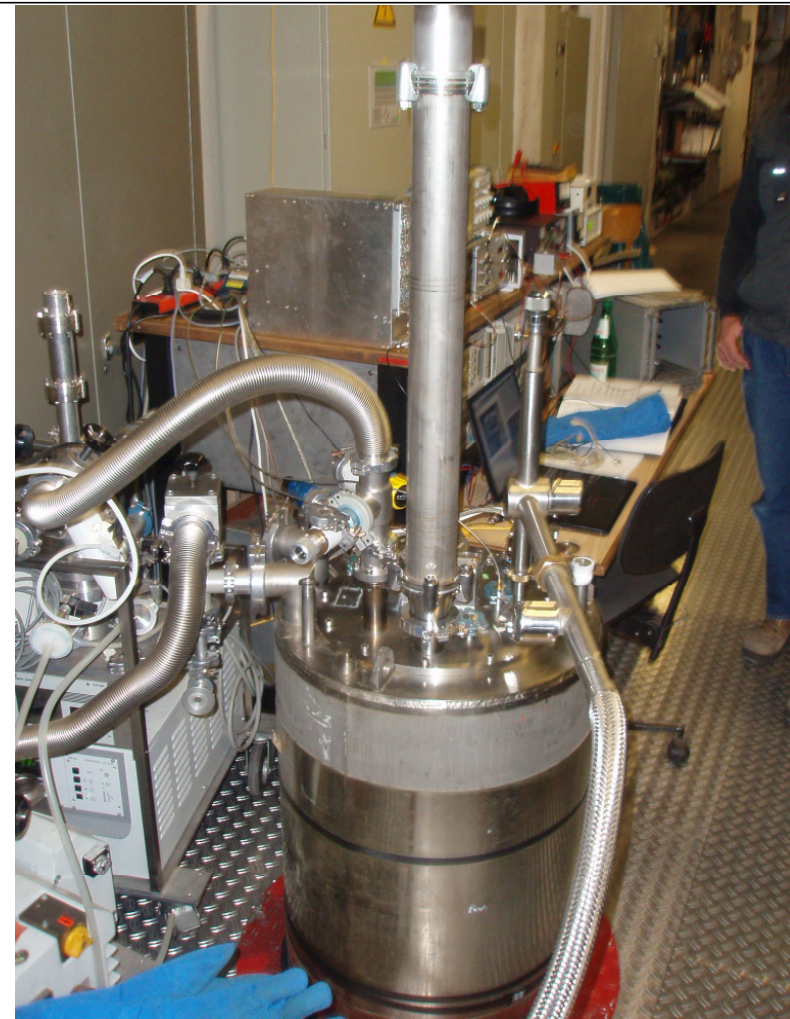
Vertical Bath Cryostat

Diameter: 35 cm
Depth: 260 cm
Minimum required LHe-level: 150 cm
Maximum LHe-level: 190 cm

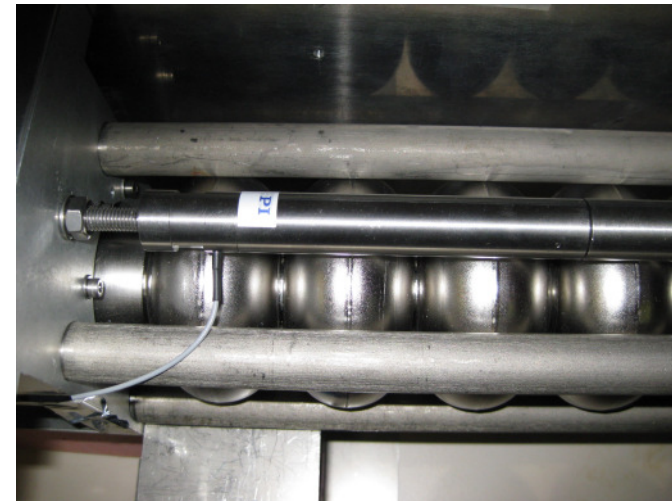
Stroke of piezo-actor @ 4 K
to replace magnetostrictive elements
of fine tuning system

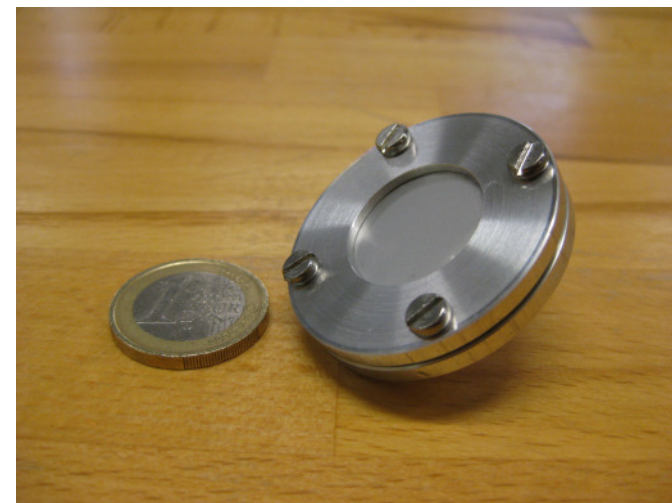
Performance check of the prototype of an
oscillating superleak transducer (OST)
for quench localisation @ 2 K

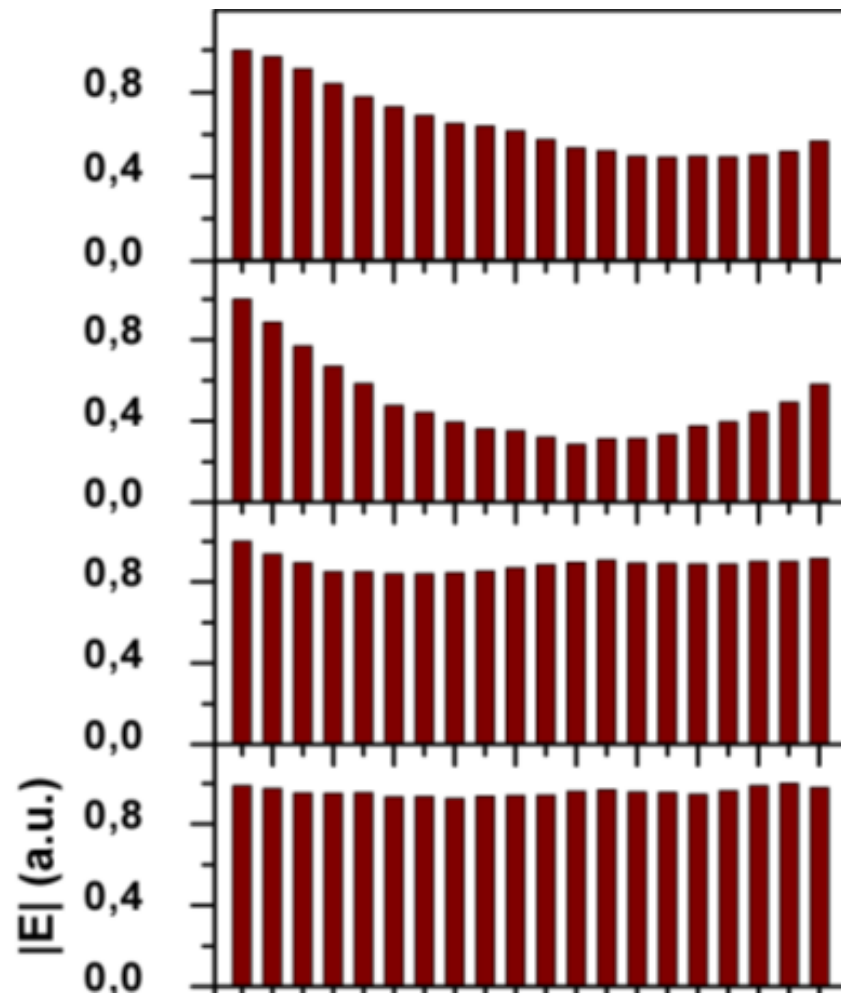
Field Flatness retuning

All cavities were tuned to flat field
when installed in the 90s
10 years later that's how they look like

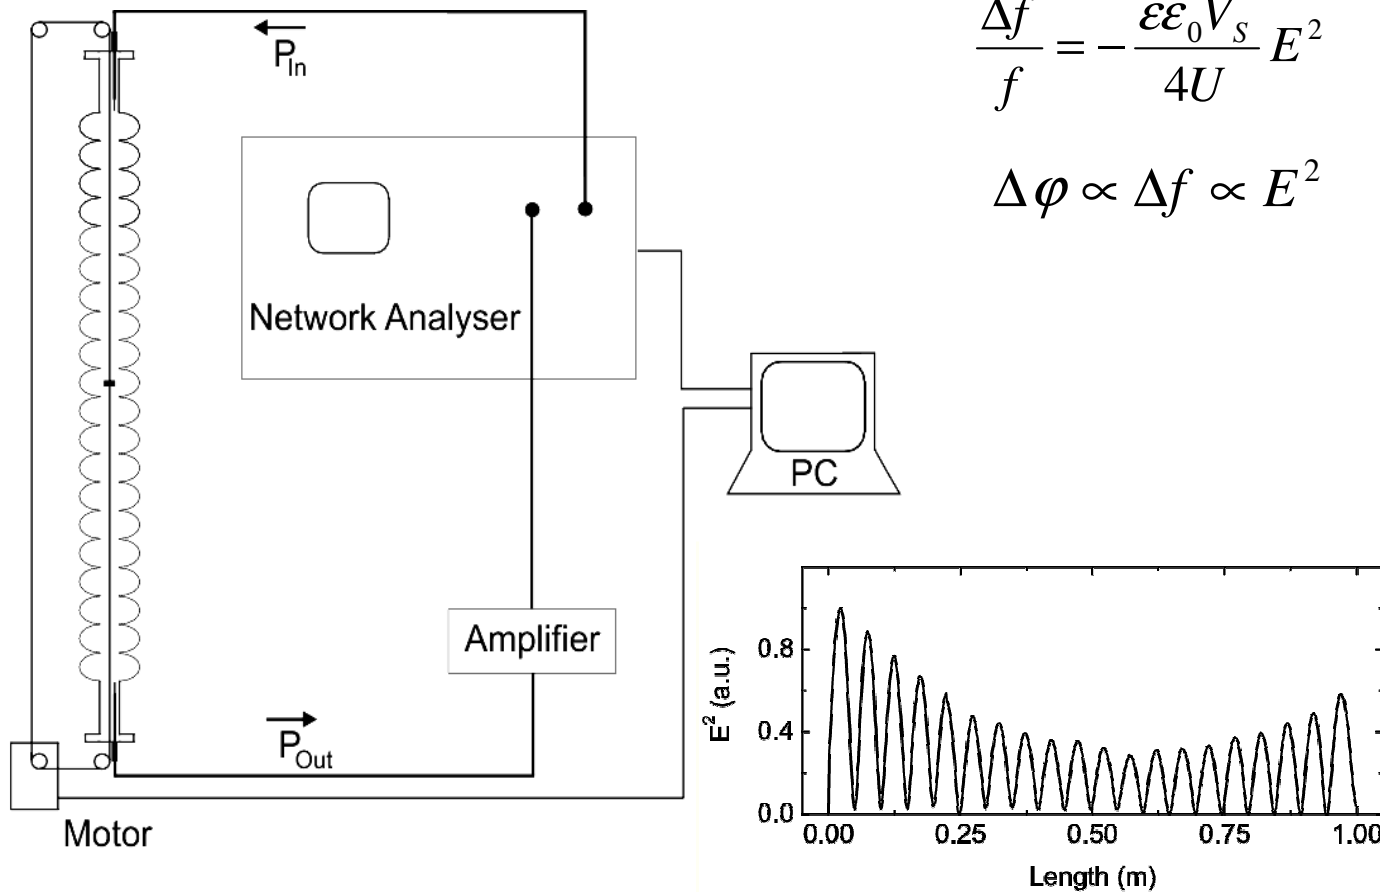
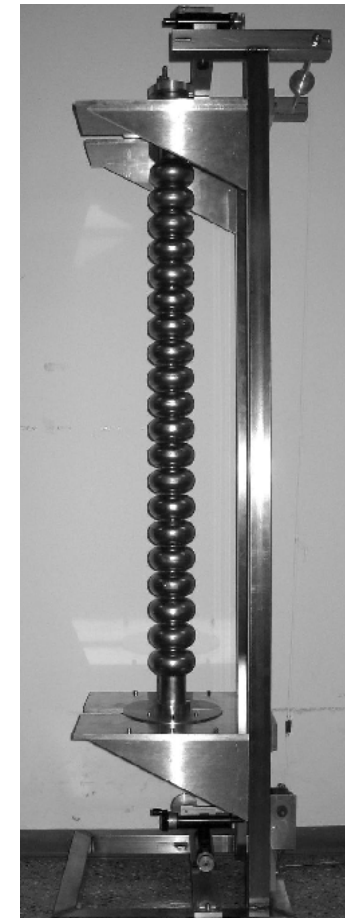
Field profile measurement bead pull set-up, clean room design

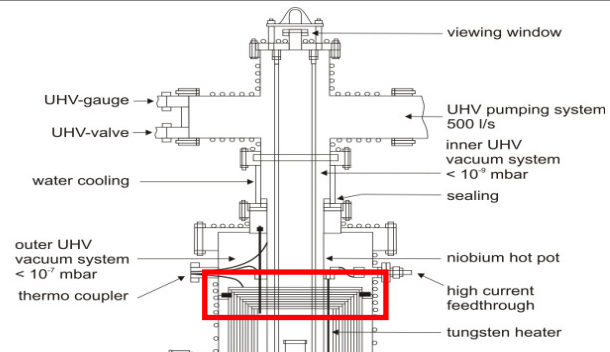
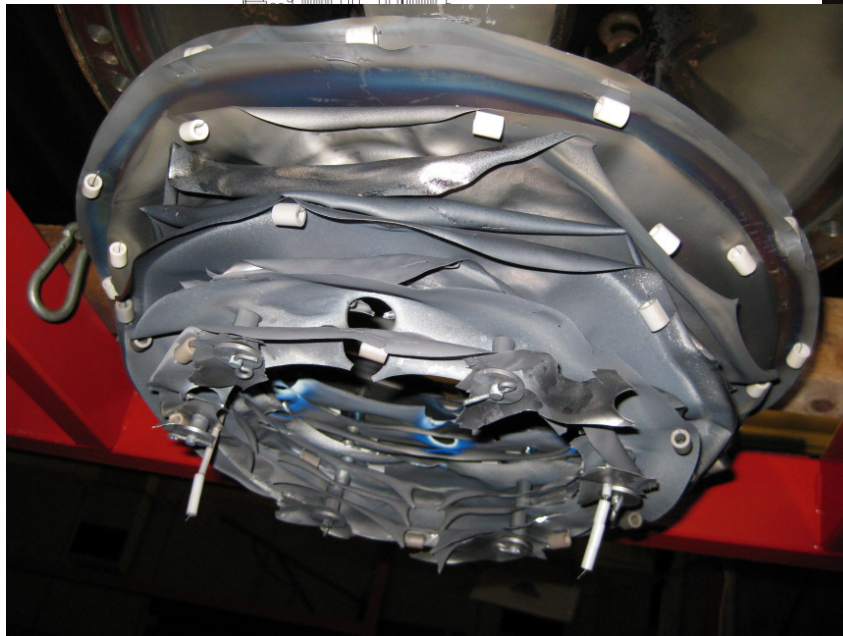
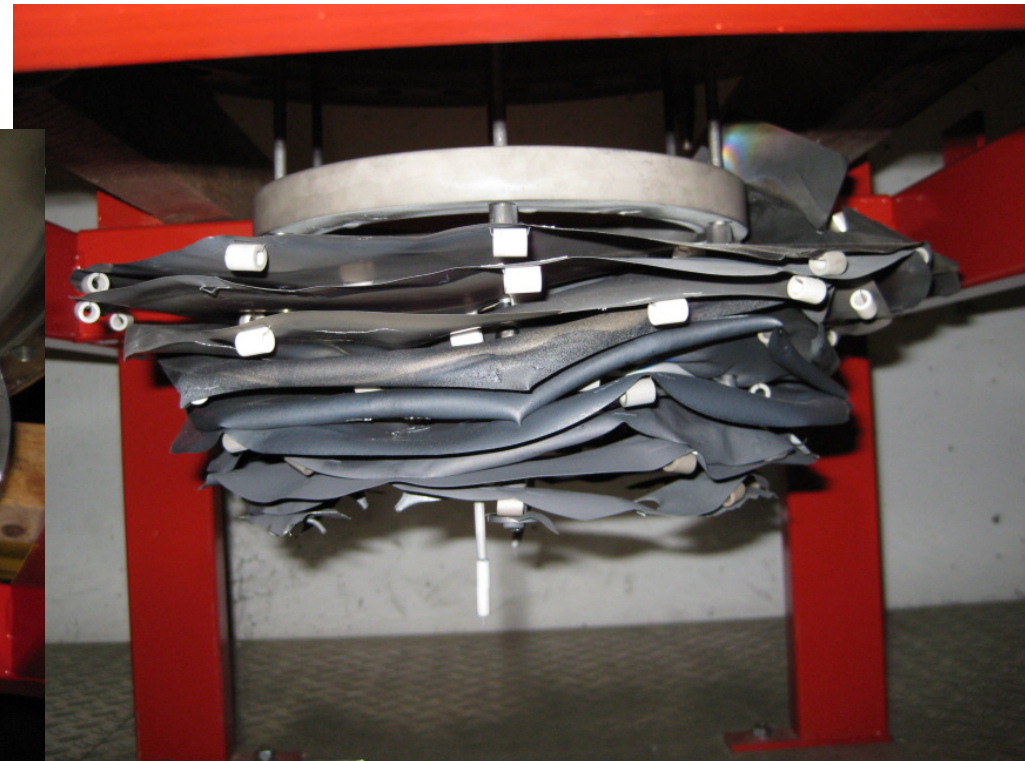
UHV-Furnace after electrical short-circuit

- Innermost radiation shield was damaged (niobium)
- Heaters were broken (tungsten)
- Current feeds were un-tight

- All parts are currently replaced
- Furnace back online by mid April 2010
