# Piezo operation experience at FLASH

Mariusz Grecki, Marcus Walla (DESY), Konrad Przygoda, Tomasz Pozniak (DMCS)

**Abstract:** Some of the FLASH superconducting accelerating modules are equipped with fast piezo tuners. From the total number of seven modules three of them are equipped with double piezos and two with single piezos. They are used to compensate the Lorentz Force Detuning (LFD) and to tune cavities in limited range. In the double piezos modules it is possible to probe the piezo sensor signal in order to investigate the cavity vibrations. The operation experience over last run period is presented, including also some results from piezo tests at Chechia horizontal test stand.

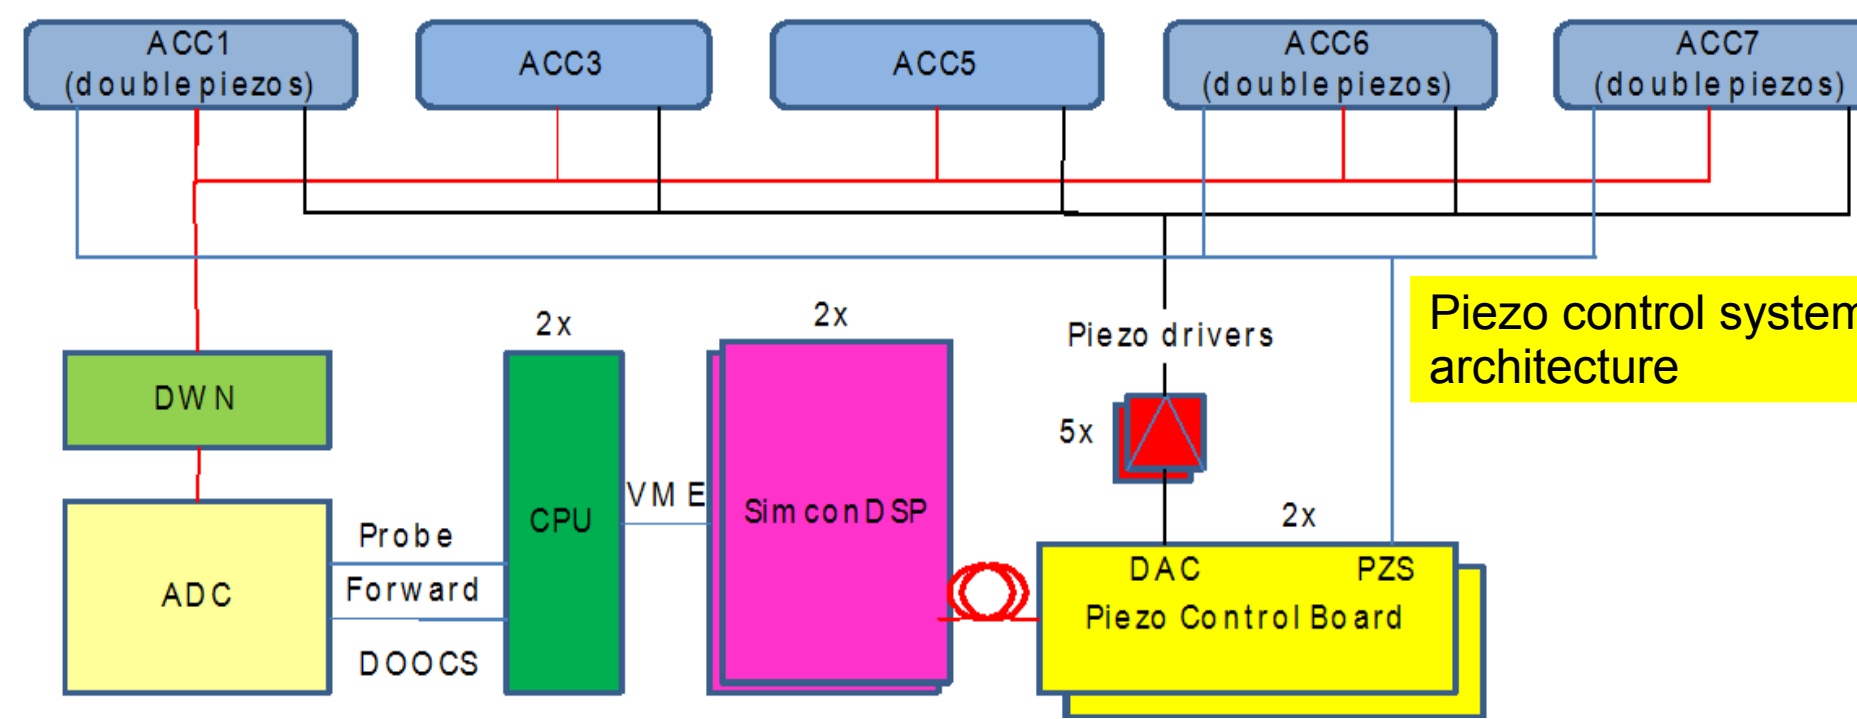
$$\Delta\omega = \frac{d}{dt} \varphi_c + 2\omega_{1/2} \frac{|V_{for}|}{V_c} \sin(\varphi_{for} - \varphi_c)$$

$\Delta\omega$  - detuning,  
 $V_c, \varphi_c$  - field amplitude and phase,  
 $\omega_{1/2}$  - cavity bandwidth  
 $V_{for}, \varphi_{for}$  - forward power amplitude and phase

C1ACC6 perfectly tuned

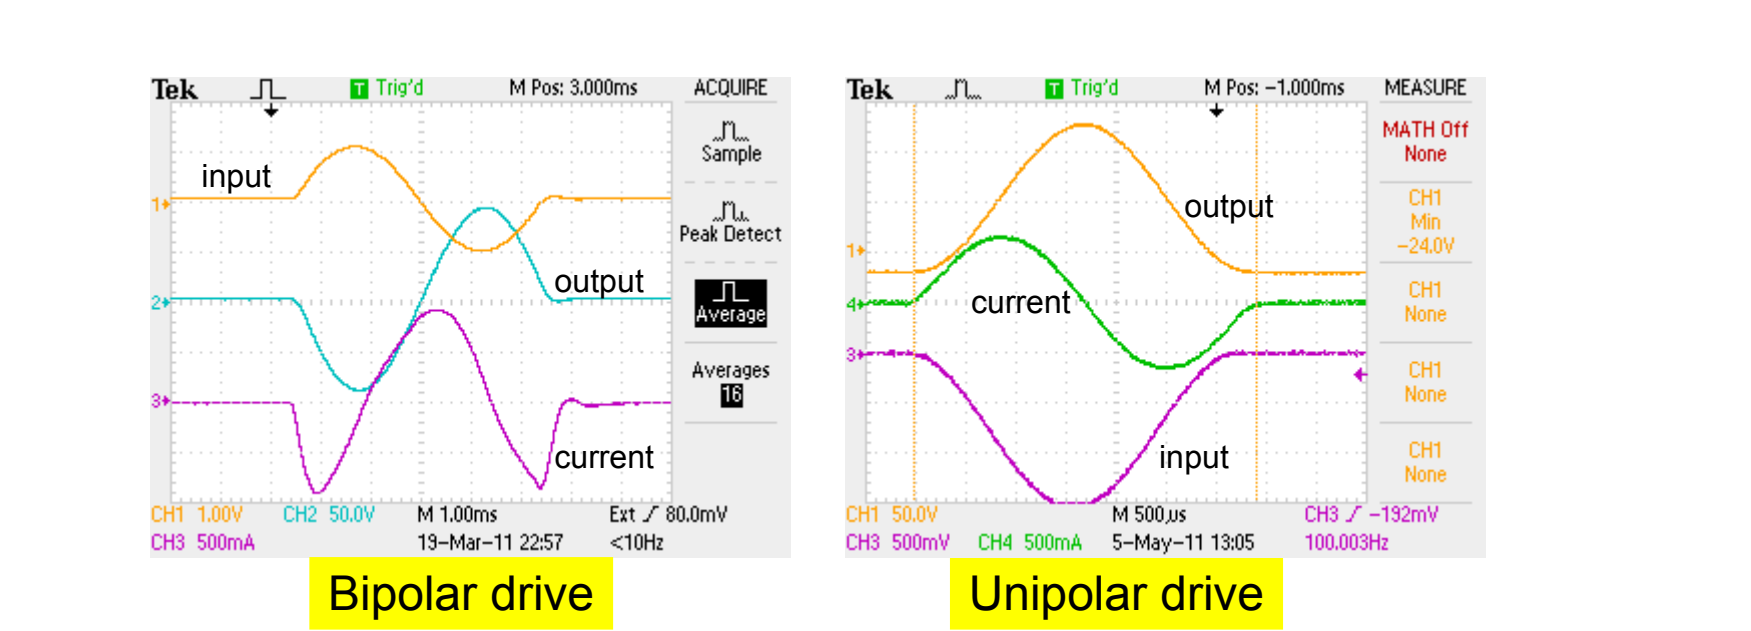
- November 2010 piezo event in C1ACC7 - the piezo in C1ACC7 stopped operation in the middle of the scan tests. The scan tests determines piezo voltage->detuning relationship. Therefore during scan the piezo voltage was slowly increased from -70V up to +70V. Each new test begun with rapid voltage change from +70V to -70V.
- ~3 weeks of tests in February 2011, 2 piezos installed in the cavity. Mostly focused on piezo no.1, for piezo no.2 the same tests but for short time.
- Goal: to learn on piezo damage mechanism.
- Bipolar mode 0, ±70V, 10/200Hz, single pulse.
- Simulation of scan tests (failure reason?).
- Bipolar mode 0, ±120V, 10Hz, rectangular waveform.
- DC ±300V for few minutes.

- LFD can be well compensated with fast piezo tuners.
  - Fast tuners with piezos are installed at FLASH (ACC1,3,5,6,7) and are operable through piezo control system.
  - The failure reason for piezo in C1ACC7 is unknown. Other piezos works without problems.
  - After discussions with piezos manufactures it has been decided the piezos will be operated in bipolar mode (in cryo temperatures repolarization happens at voltages much higher than available from piezo driver).
- Future plans:**
- Detuning calculation also with beam.
  - Implementation of automatic cavity tuning / training of the operators to use piezos routinely.
  - Investigations of piezo sensor signals for microphonics evaluation.
  - Further piezo reliability study.
  - Development of piezo control system for XFEL.
