John-Erik Meißner

Silicon sensor qualification and electric field simulations for the BCM1F detector at CMS

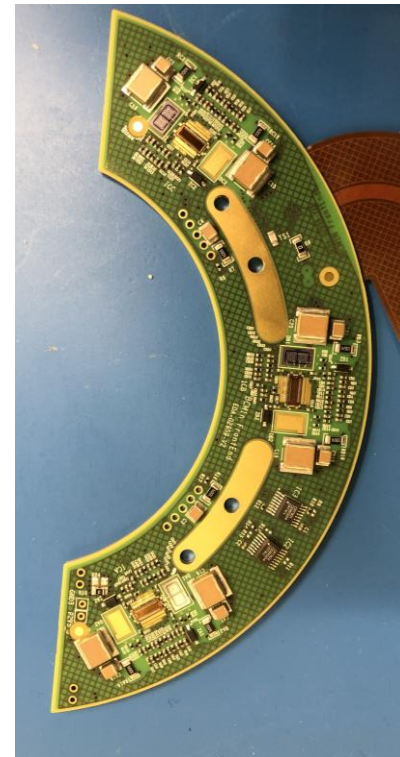
Fast Beam Condition Monitor /BCM1F

- Detector dedicated to the luminosity measurement and monitoring of beam induced background
- 24 Si-double-sensors mounted on two rings around the beampipe
- 1.8m from interaction point

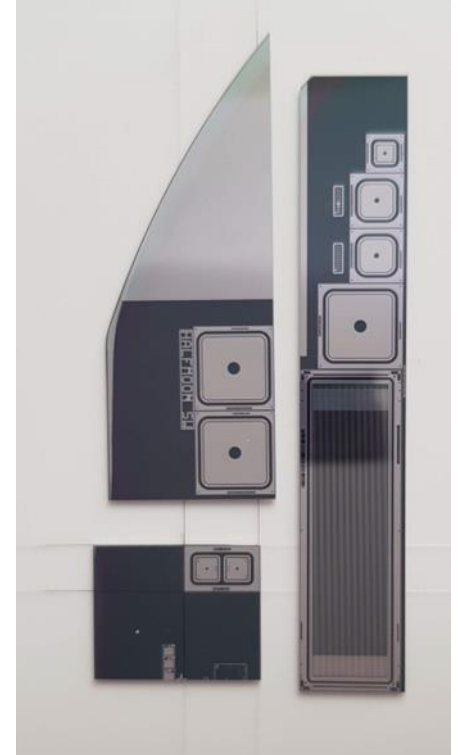
Sensor design

- n-on-p sensor
- $1.7 \times 1.7 \text{ mm}^2$ sensor area
- Produced as part of the CMS phase-2 tracker wafer.

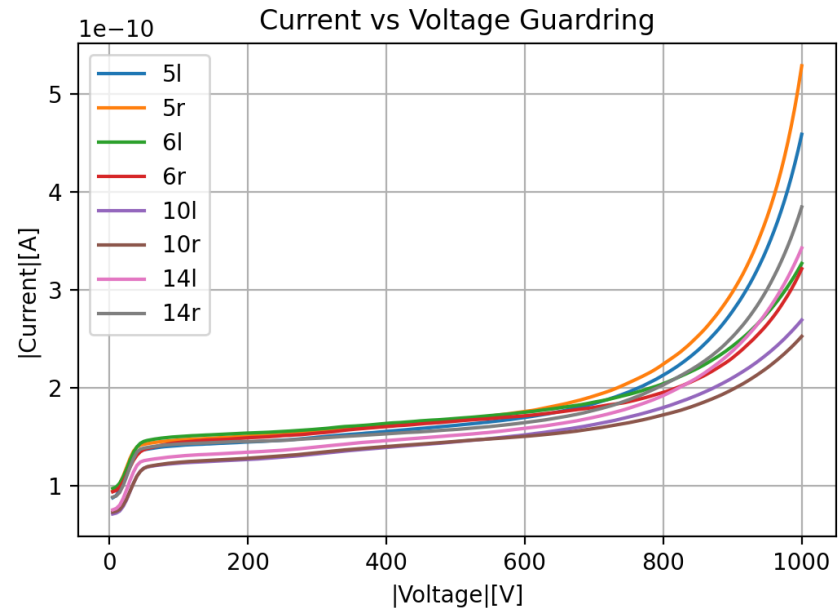
Current vs Voltage

- Low variation between the different measurements
- Small current for 1000V, no breakthroughs

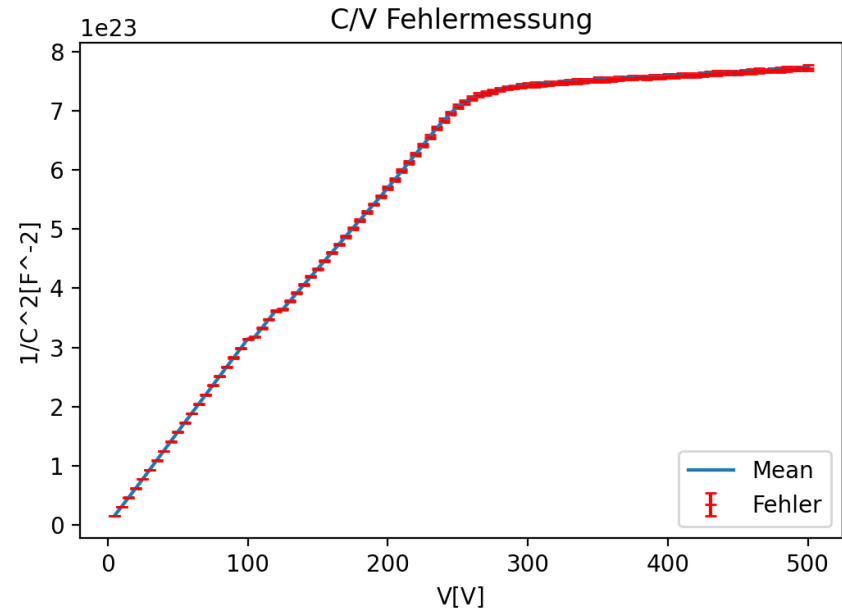
Error measurement C/V-curve

- Low varianz between measurements for the same diode

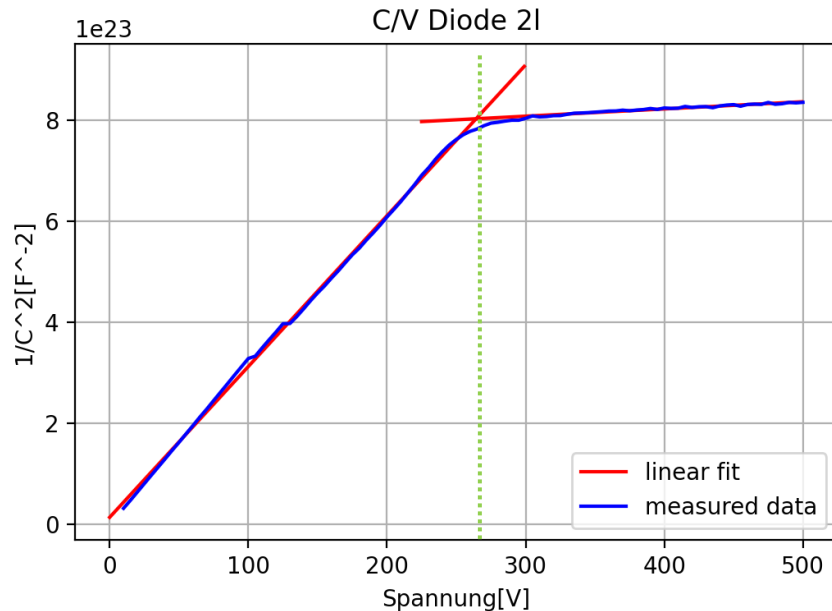
Determination of the depletion voltage

Width of depleted area: $w \propto \sqrt{V}$

→ $V \propto 1/C^2$ for $V < V_{dep}$

V_{dep} corresponds to the intersection of the two linear fits

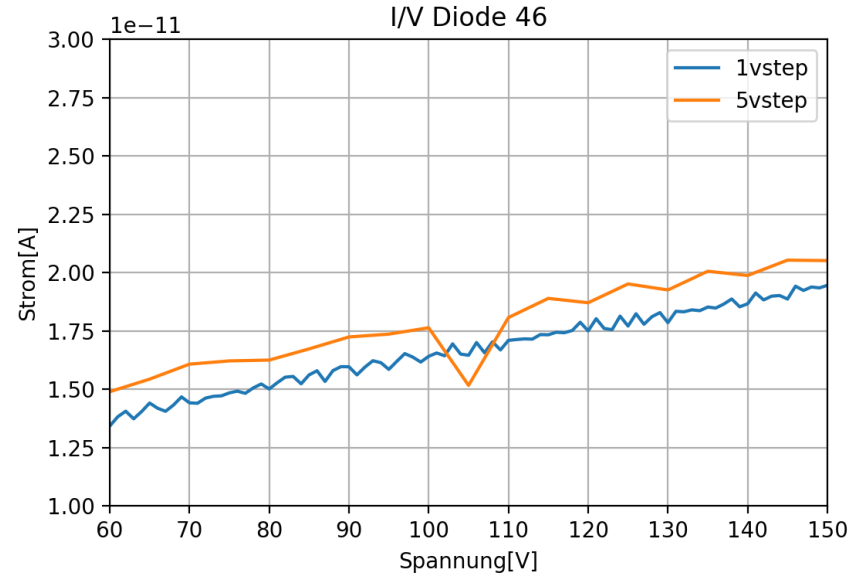
Bumps I/V

$$\Delta t = 5s, \Delta t = 1s$$

- Bump disappears for smaller volt steps and larger time intervals between measurements
 → probably caused by the voltage source, when switching between different voltage ranges

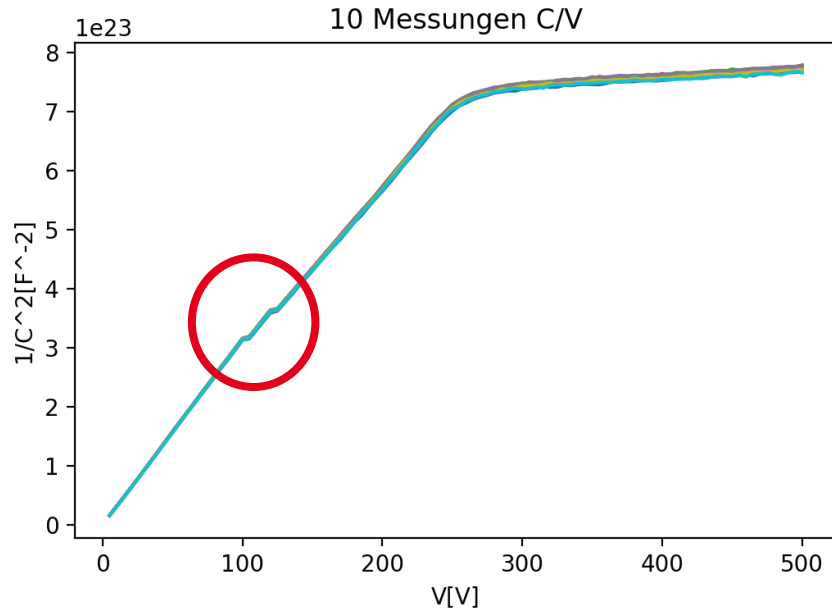
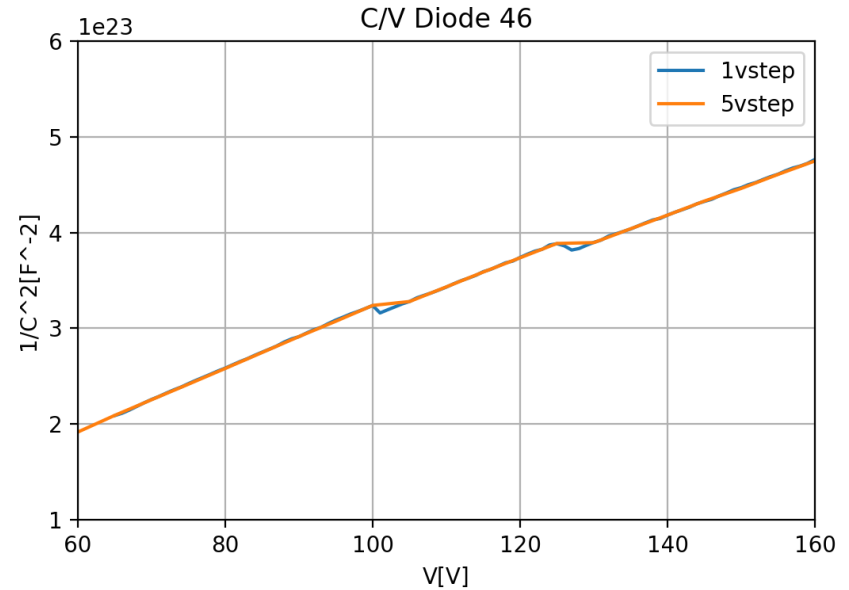
Bumps C/V

$$\Delta t = 5s, \Delta t = 1s$$
