Investigations of a BiCMOS Pixel Sensor

A close look on its early breakdown

Physikalisches Institut, Universität Heidelberg

Verbund Meeting CMOS - 27.02.2023

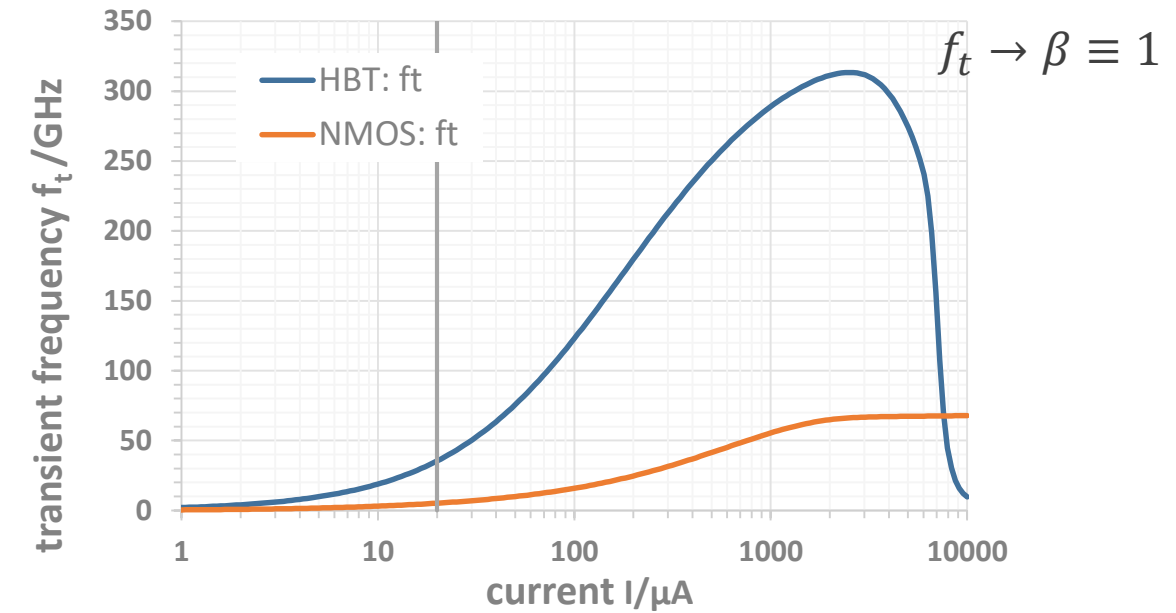
- combines bipolar (HBT) and MOS transistors
 - allows to benefit from CMOS logic
- advantages of bipolar transistors:
 - fast switching times
 - large current gain

} scales with current

- build HV-MAPS in a BiCMOS process
- use single HBT to boost the performance of the in-pixel amplifier
- achieve very good time resolution

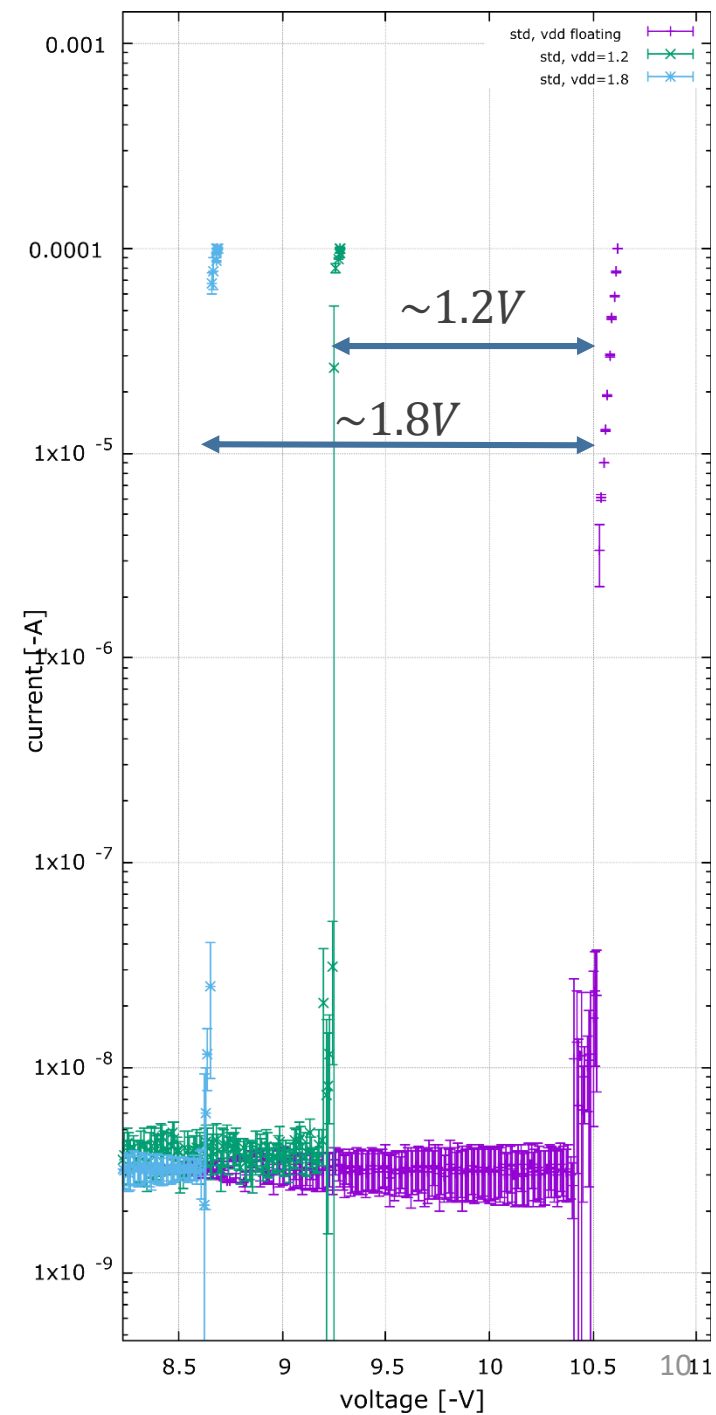
🔗 dependency on vdd-voltage (vdda floating)

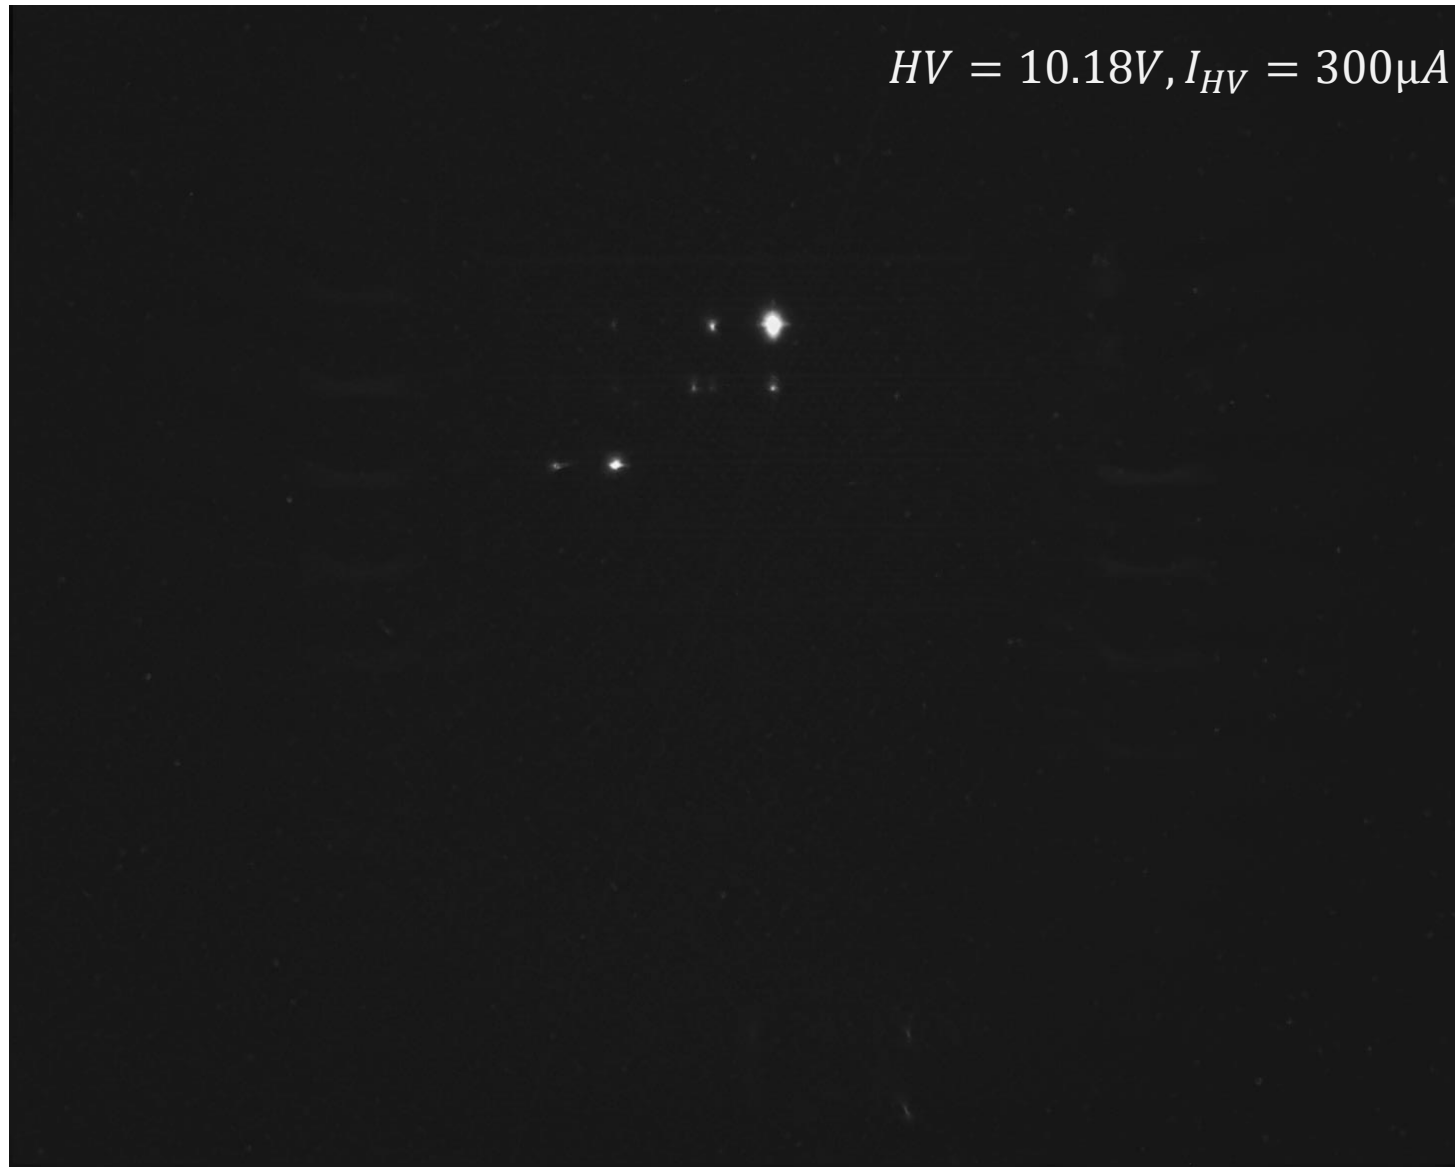
$HV = 10.18V, I_{HV} = 300\mu A$

- exposure of a part of the BeBiPix
- sensor breakdown: $BDV \approx 10.1 V$
- without LED
- 30min exposure
