RRR Degradation and Gas Absorption in the EB Welding Seam of High Purity Niobium

W. Singer, X. Singer, A. Brinkmann, J. Tiessen

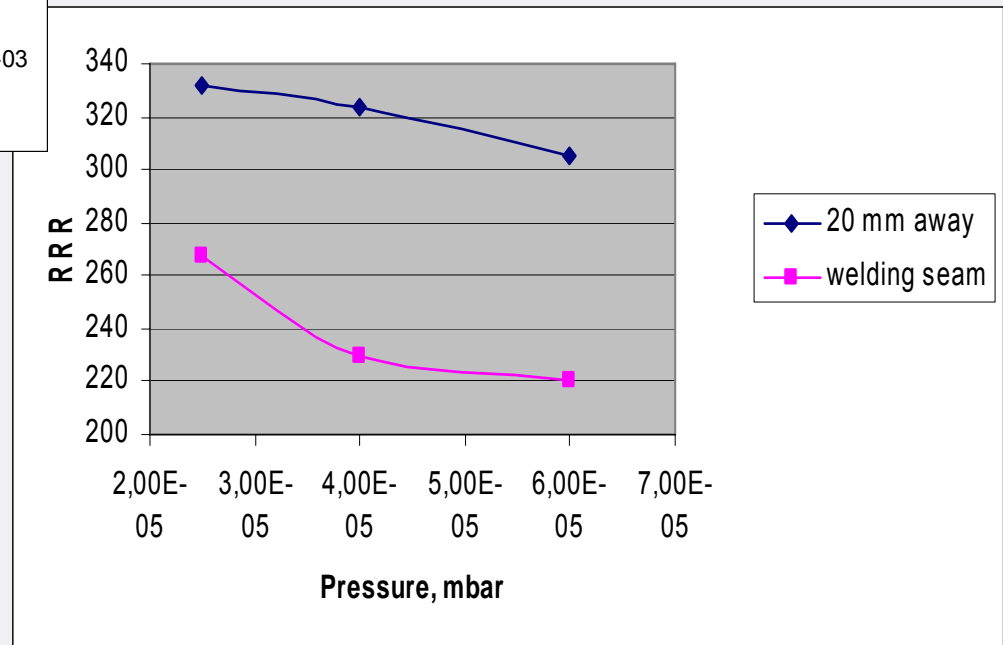
RRR degradation of Nb in the EB welding seam takes place for pressure 10^{-3} - 10^{-5} mbar

RRR in the welding seam and 20 mm away versus pressure in the chamber during EB welding (Fa. Dornier 94)

RRR in the welding seam and 20 mm away versus pressure in the chamber during EB welding (Fa. Zanon 95)

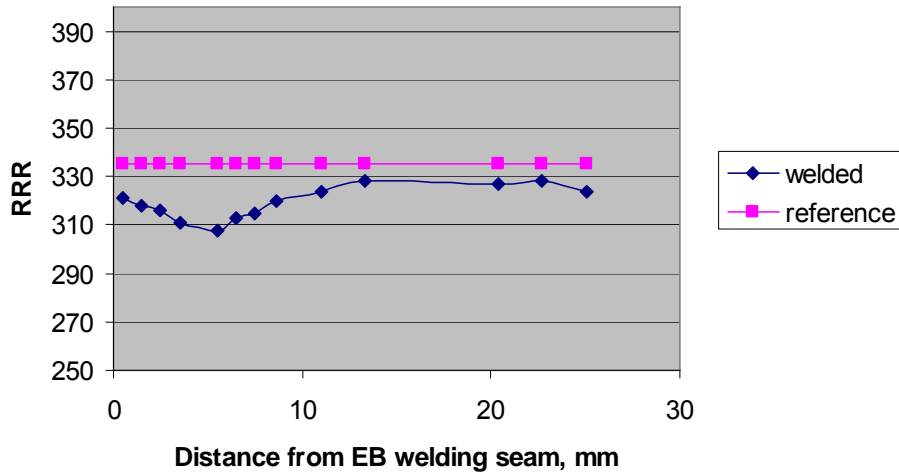
RRR in the EB welding area versus distance from the welding seam (welded at pressure 2×10^{-5} mbar, ACCEL 96)

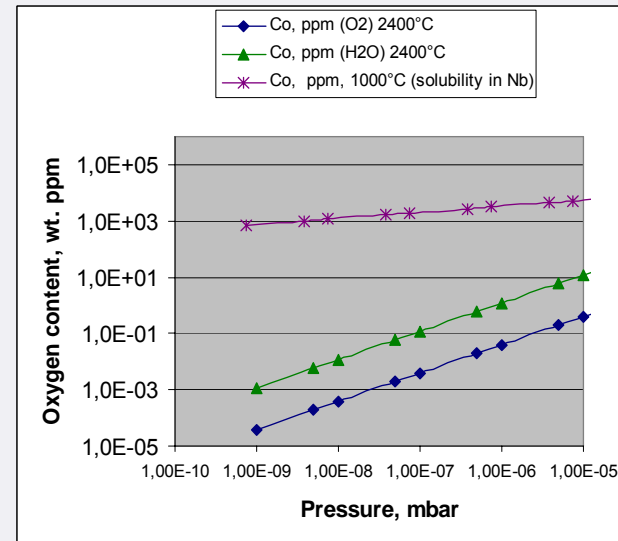
Pressure – concentration isotherms of oxygen solubility in Nb in steady state condition

$$C_{O_2} [\text{wt. ppm}] = P \cdot 6.9 \cdot 10^{-6} \cdot \exp(4.82 \cdot 10^4 / T) \cdot 10^2$$

$$C_{H_2O} [\text{wt. ppm}] = P \cdot 8.55 \cdot 10^{-6} \exp(4.52 \cdot 10^4 / T) \cdot 10^2$$

$$\text{Log} C_{O, \alpha-Nb} [\text{wt. ppm}] = 0,5 \cdot \log P_{O_2} - 7,46 + 20050 / T$$

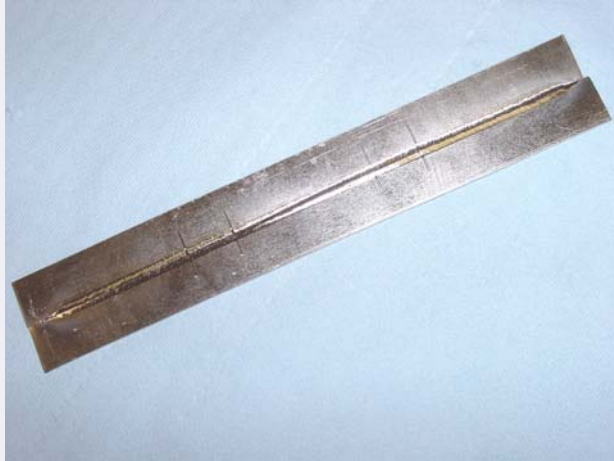
- Pressure range of EB welding was 10^{-5} - 10^{-8} mbar, thickness at welding area 1,8 mm, welding speed ca. 8 mm/sec
- Welding procedure: tack, 50% penetration (circle raster), full penetration (circle raster)
- During welding the total pressure reaches the order of magnitude 10^{-6} mbar (independently of the initial pressure)

Clamping system for EB welding and example of Nb welding strip

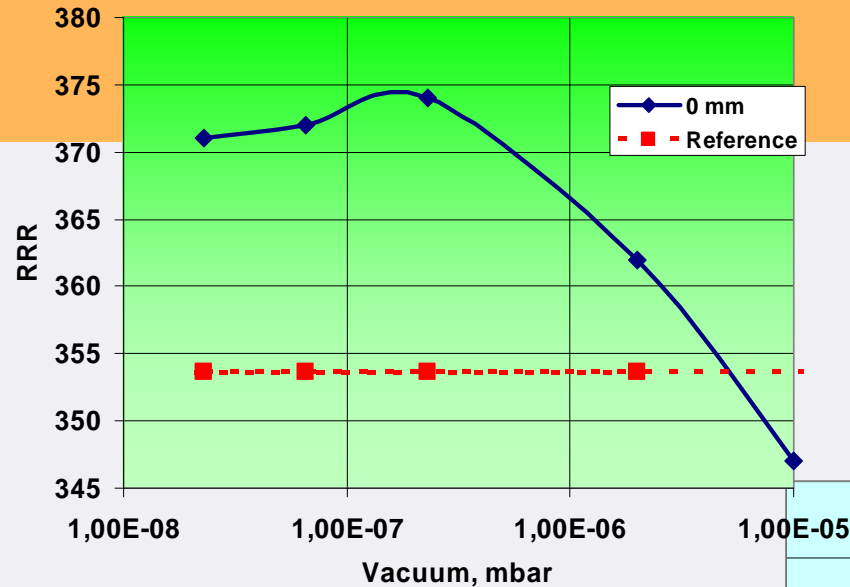
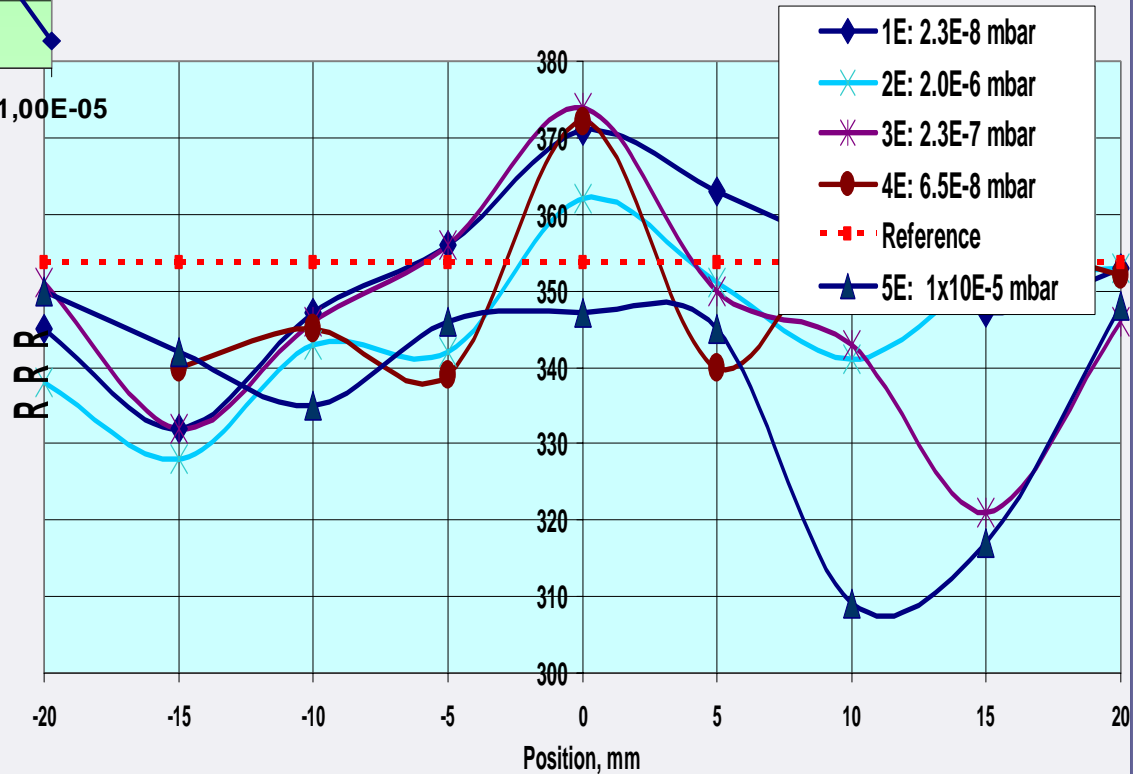
The RRR degradation at welding seam started since pressure of ca. 10^{-5} mbar

The RRR degradation take place in the area close to welding seam (thermally affected area)

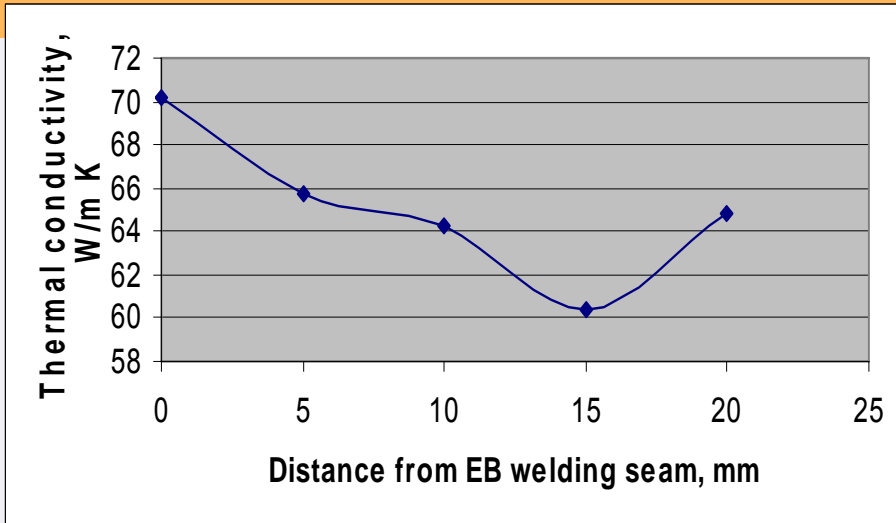
Thermal conductivity of Nb in the superconducting state (parametrisation done by F. Koechlin and B. Bonin)

$$\lambda(T, RRR, G) = R(y) \cdot \left[\frac{\rho_{295K}}{L \cdot RRR \cdot T} + a \cdot T^2 \right]^{-1} + \left[\frac{1}{D \cdot \exp(y) \cdot T^2} + \frac{1}{B \cdot G \cdot T^3} \right]^{-1}$$

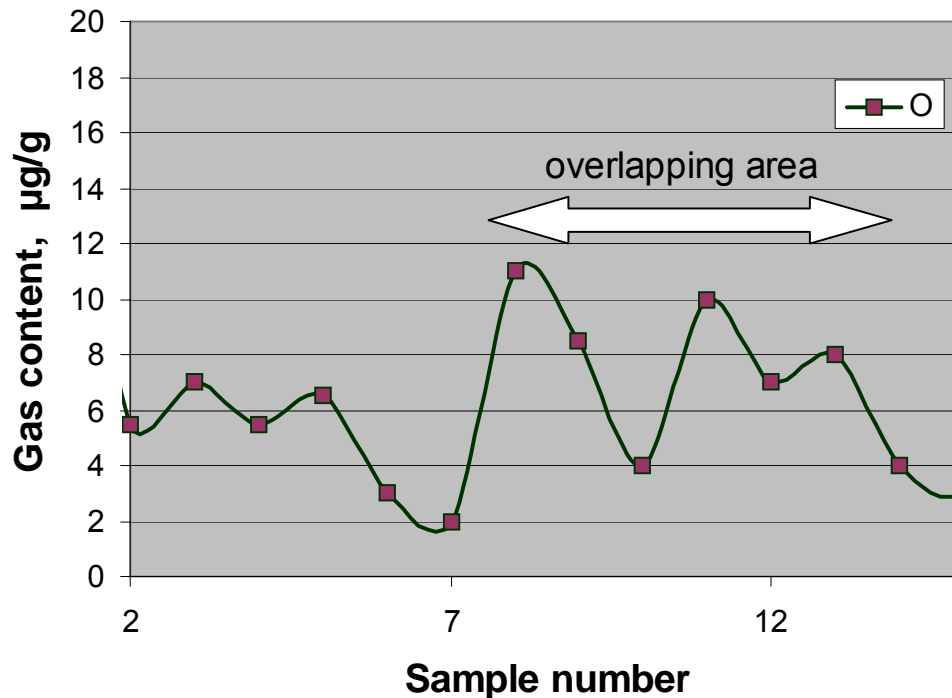
Oxygen distribution along the EB welding (CERCA)

Oxygen distribution along the welding seam. RRR= 280 in the welding seam and **RRR= 207** in the overlapping.

The RRR degradation can take place in the welding seam, in the thermally affected area but additionally in the overlapping area

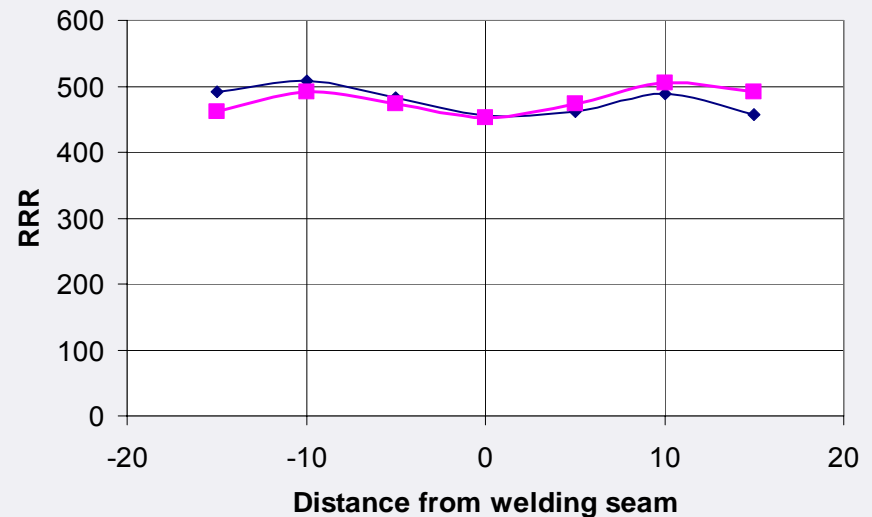
Zanon EB welding sample E-part

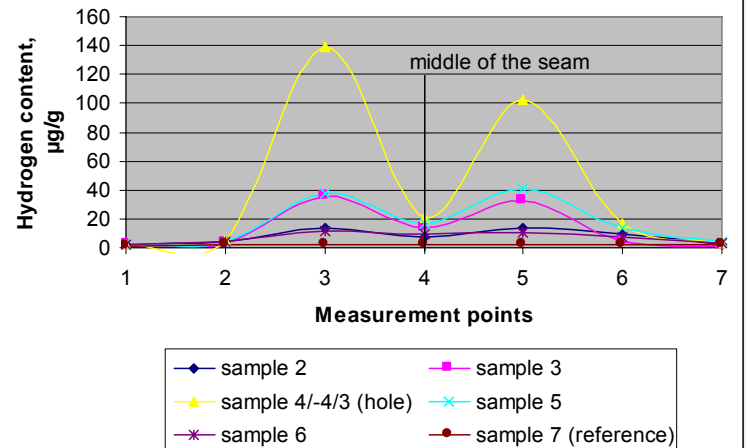
Hydrogen distribution in the EB welding with burned hole

Cavity C43 with repaired burned hole

CERCA Cavity, during EB welding was burned a hole,
hole repaired by EB welding.

Bad cell identified during mode measurement.

T-Mapping found the quench location. The repaired hole
caused a quench at 13 MV/m.

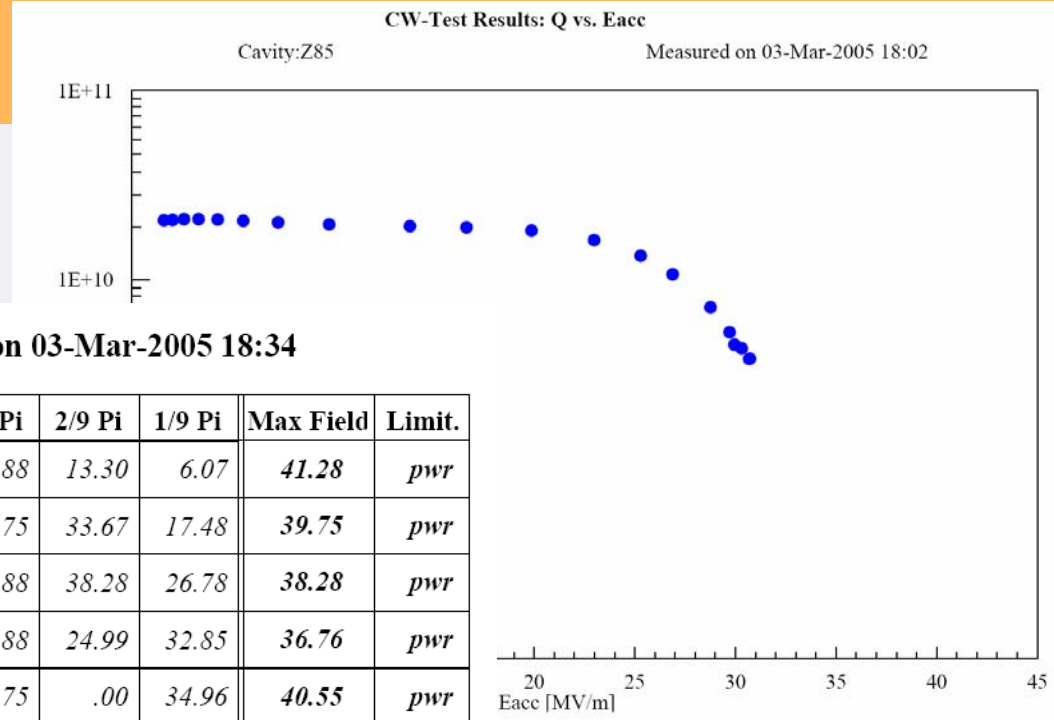
Z85: 190 μ mEP, 800°C,
2h, 48 μ m EP, HPR

Mode limits of cavity Z85 measured on 03-Mar-2005 18:34

Z85: ZANON repaired the burned through hole with success

During welding of the cell 3 a hole was burn through. The hole was repaired by covering the holes area with previously cleaned piece of Nb and heating them by the defocused EB.

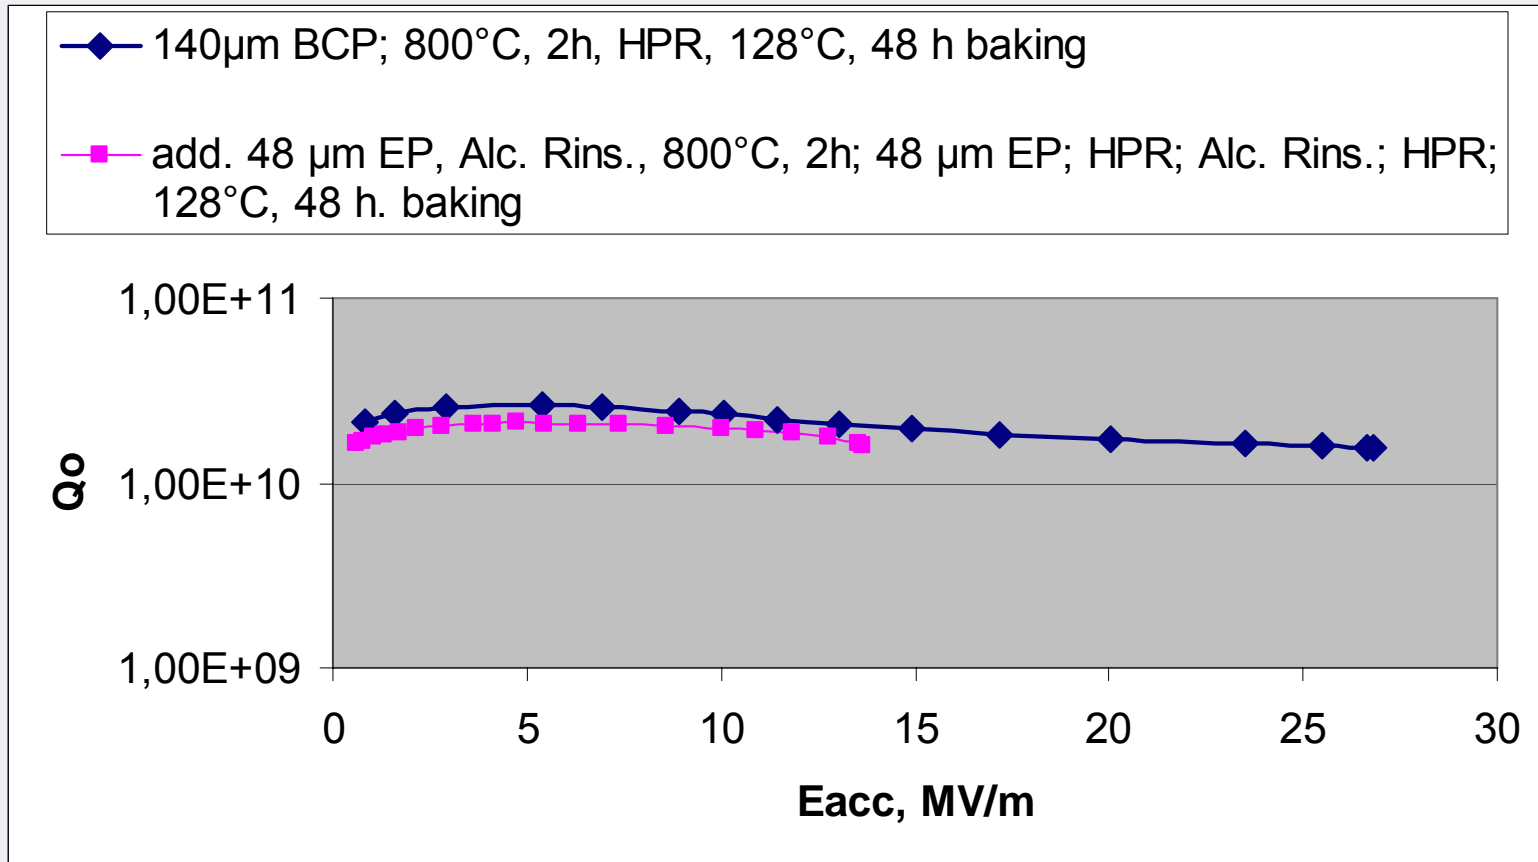
AC 114; Performance degradation after additional treatment
