**Suggestions of  
H.G limitations from single cell study  
@ KEK**

**KEK**

**K.Saito, F.Furuta, J.Hong and T.Saeki**

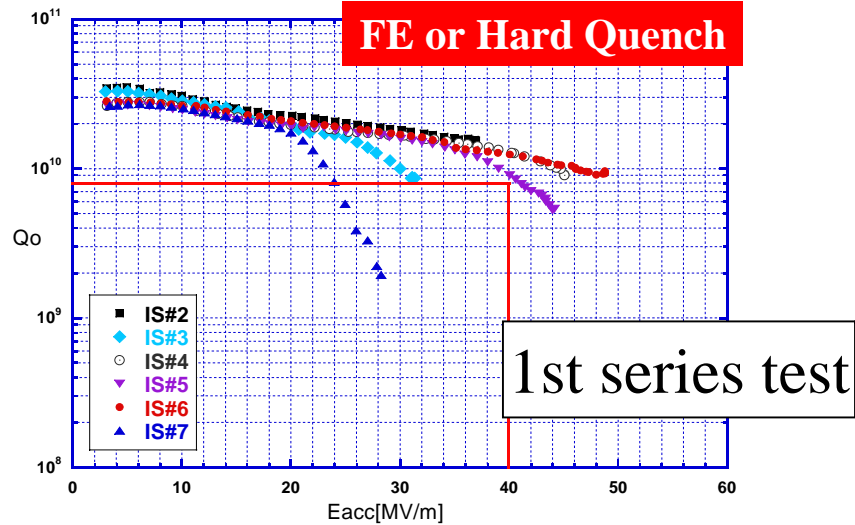
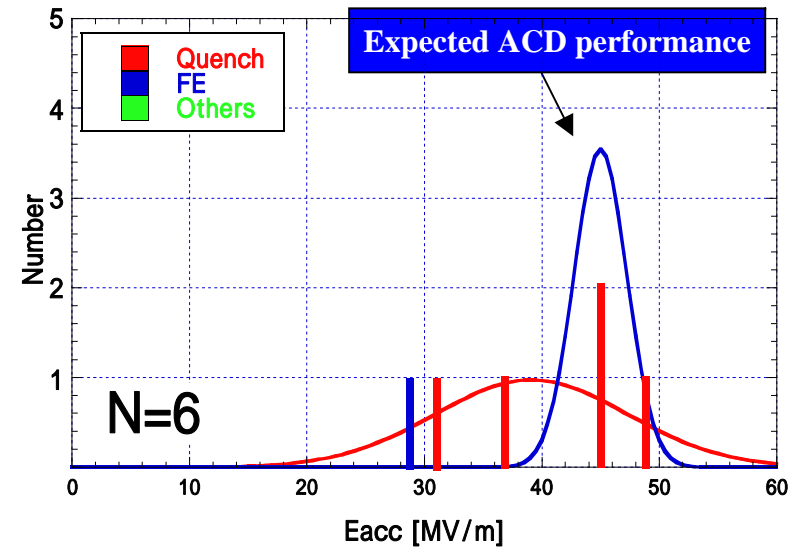
**CBP(100 $\mu$ m)+BCP(10 $\mu$ m)+AN(750 $^{\circ}$ C, 3hr)+EP(80 $\mu$ m)+HPR+Bake:**

**Ave. Eacc=39.1 $\pm$ 8.2MV/m, Scattering:20%, Acceptability@40MV/m(ACD):50%**

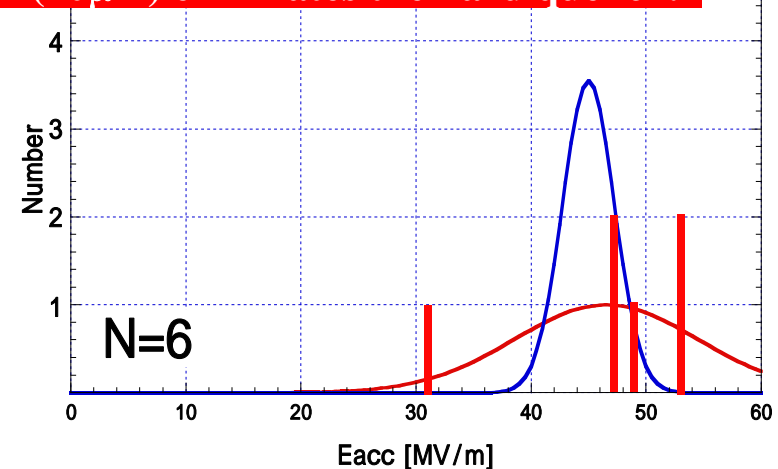
**+EP(20 $\mu$ m)+HPR + Bake**

**Ave. Eacc=46.5 $\pm$ 8.0MV/m, Scattering:17%, Acceptability@40MV/m(ACD):83%**

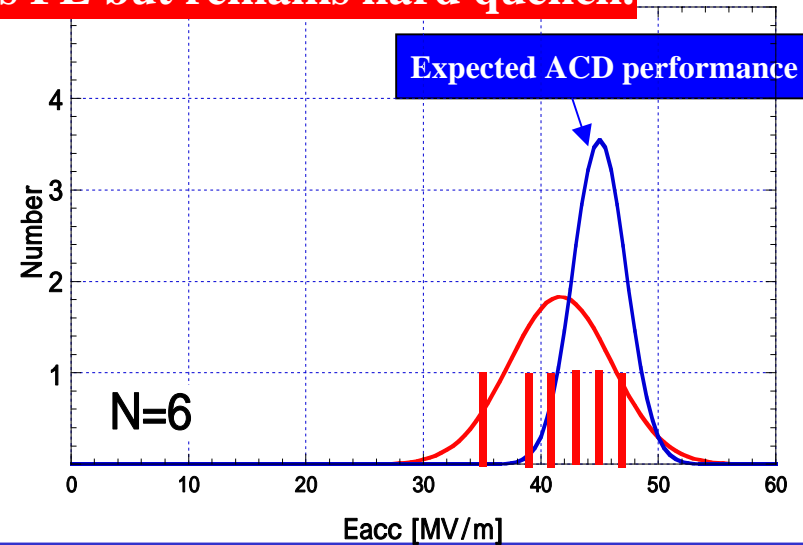
CBP(100 $\mu$ m)+BCP(10 $\mu$ m)+AN(750 $^{\circ}$ C, 3hr)+EP(80 $\mu$ m)+EP(3 $\mu$ m, fresh acid) + HPR+Bake:

Ave. Eacc=41.7 $\pm$ 4.4MV/m, Scattering:10%, Acceptability@40MV/m(ACD):67%

**The flash EP(3) after EP(80) eliminates FE but remains hard quench.**

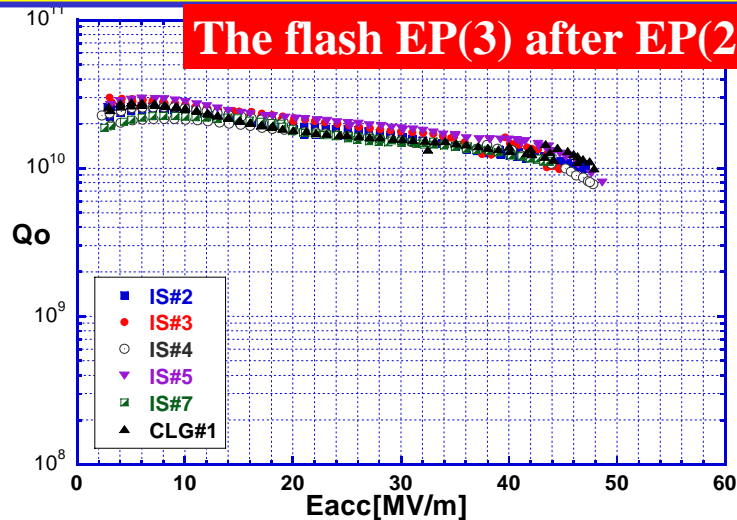
+EP(20 $\mu$ m)+ EP(3 $\mu$ m, fresh acid) + HPR + Bake: Ave. Eacc=46.7 $\pm$ 81.9MV/m, Scattering:4%, Acceptability@40MV/m(ACD):100%

**The flash EP(3) after EP(20) eliminates both FE and hard quench.**

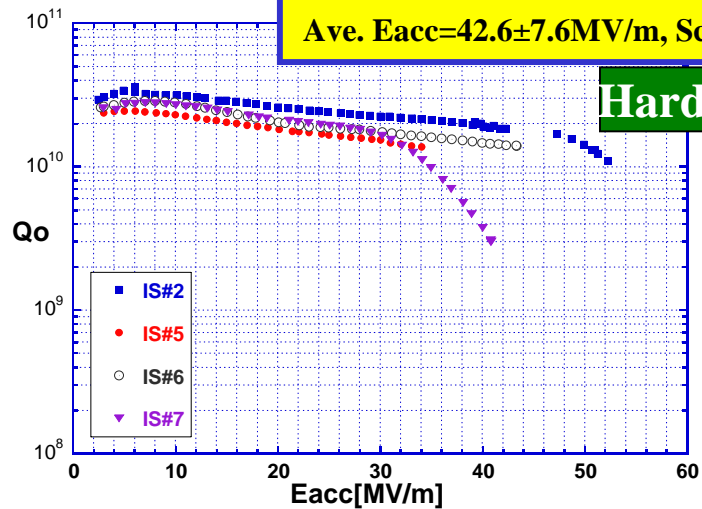
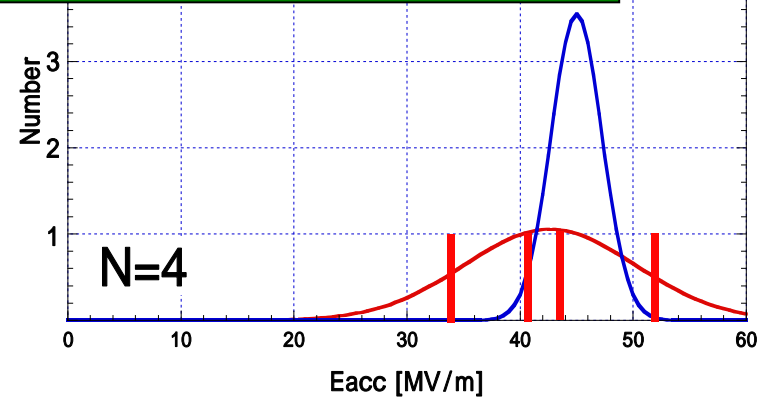
+EP(20 $\mu$ m)+H<sub>2</sub>O<sub>2</sub> rinsing+HPR+Bake

Ave. Eacc=42.6 $\pm$ 7.6MV/m, Scattering:18%, Acceptability@40MV/m(ACD):50%

Hard quench appears at Eacc < 40MV/m.

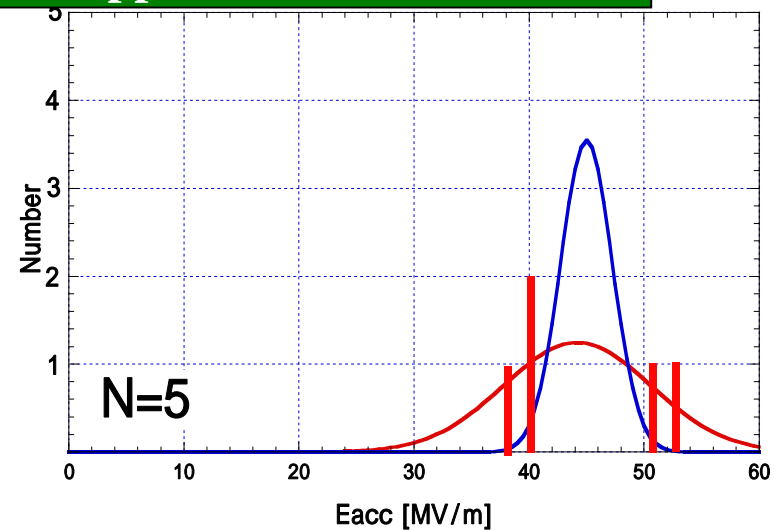
+EP(20 $\mu$ m)+Degreasing(0.2%)+HPR+Bake

Ave. Eacc=44.2 $\pm$ 6.4MV/m, Scattering:14.5%, Acceptability@40MV/m(ACD):60%

Hard quench appears at Eacc < 40MV/m.

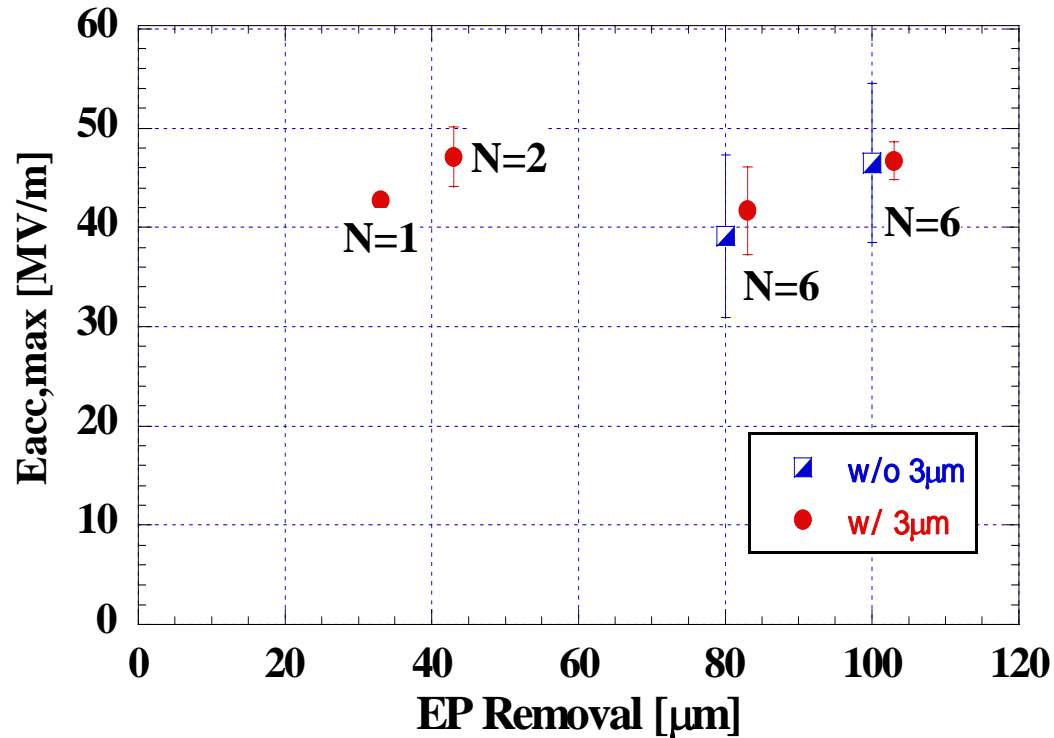
# EP Material removal effect and Surface roughness after CBP(100 $\mu\text{m}$ , Rz $\sim$ 2 $\mu\text{m}$ ) on Ichiro center single cell cavity

Correlation between EP material removal after CBP100 $\mu\text{m}$  and  $E_{\text{acc,max}}$

Surface roughness  $\sim$ 1 $\mu\text{m}$ , which relates to field enhancement, is enough for 40MV/m on Ichiro center single cell cavities.

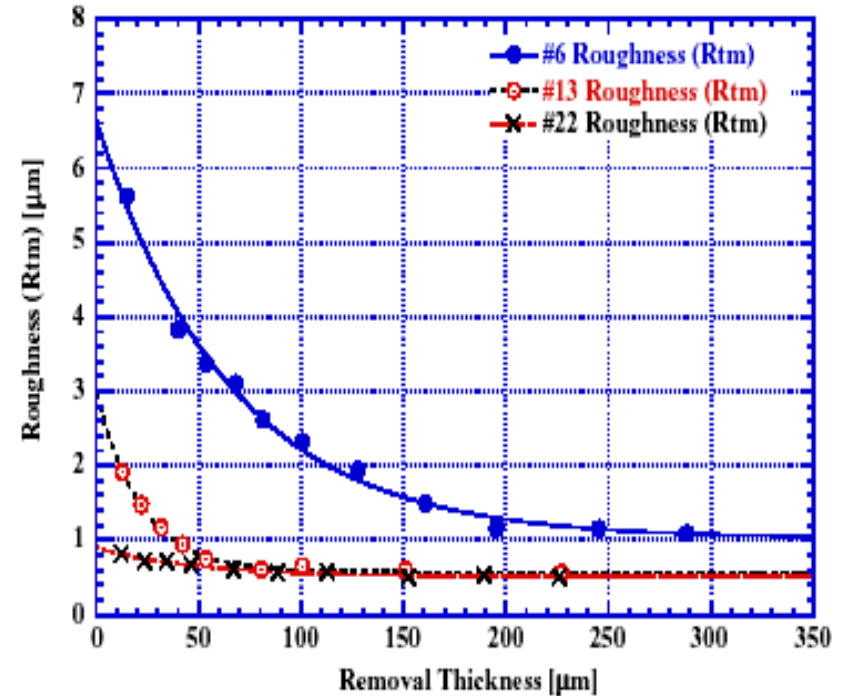
Relationship between EP material removal and Surface roughness

EP material removal could be reduced to 30-40  $\mu\text{m}$ , if CBP is applied before the EP.

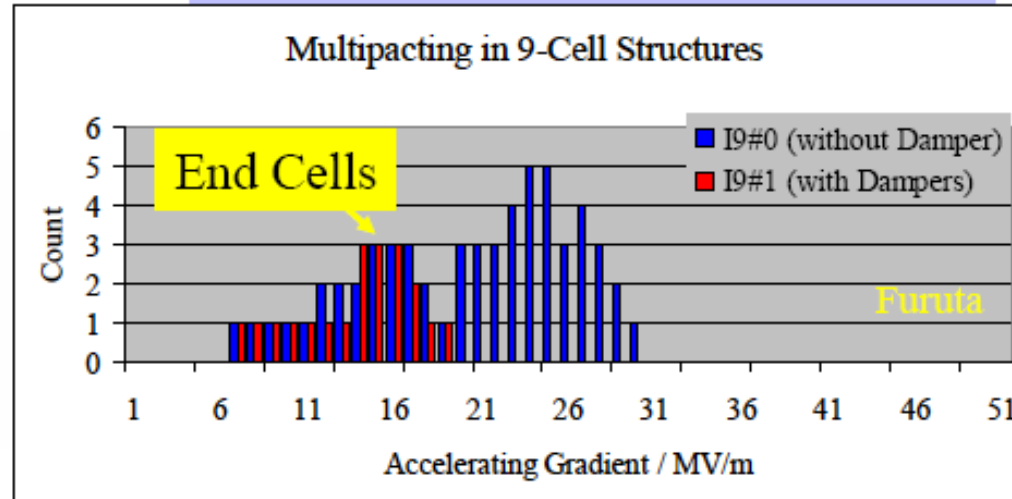
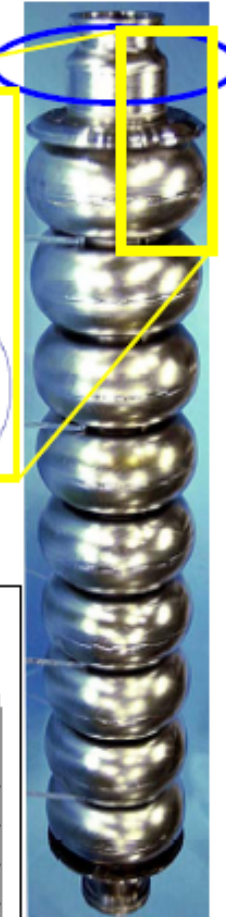
Multipacting at Tapered Beam Port

Multipacting in Cells

Multipacting in Dampers

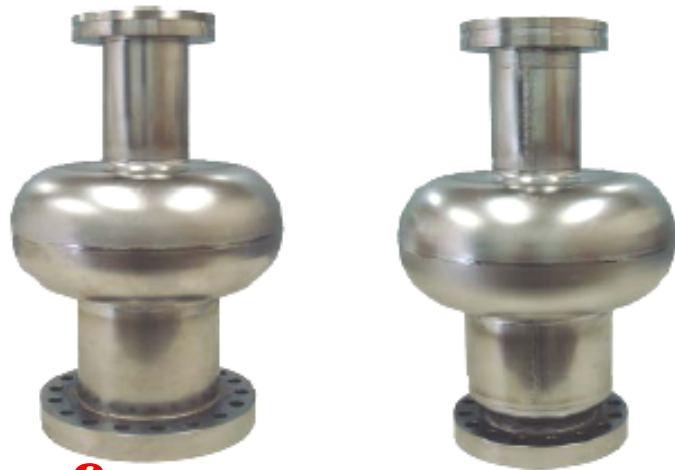
ISE#1  
**Ichiro Cavity END Cell**

**So far:**

**30MV/m**

**41MV/m**

**Theoretical limitation : ~ 40MV/m**

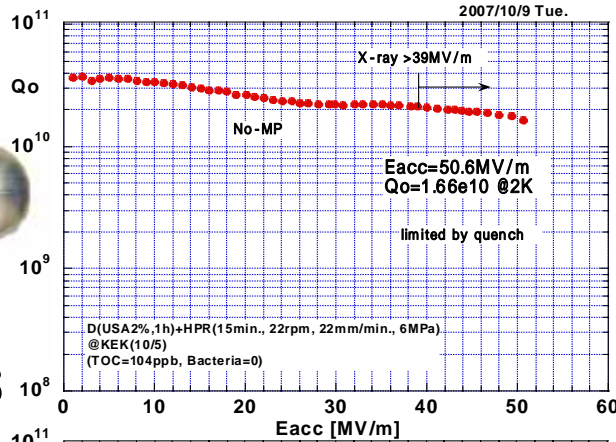
ISE#3

New Ichiro End cell

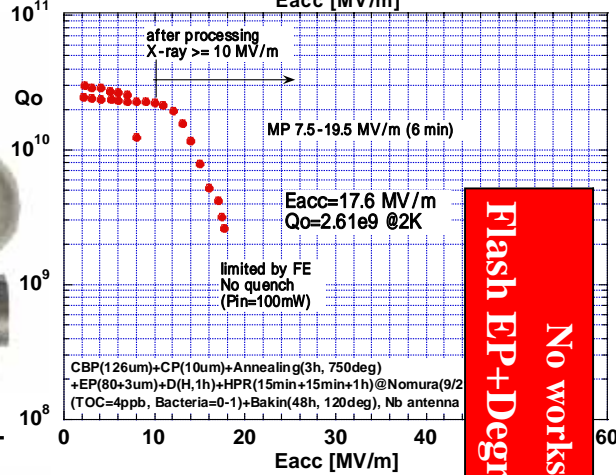
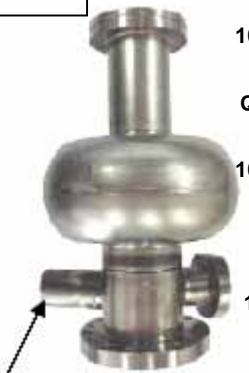
ISE#4

Just HOM cylinder

Sulfur contamination might remain on the complicated beam pipe.

Flash EP+Degreasing No works

+ Ethanol Rinsing

4<sup>th</sup> Summary  
 Complicated END group happens FE, if rinsing is poor.  
 Ethanol rinsing looks effective to remove the FE.

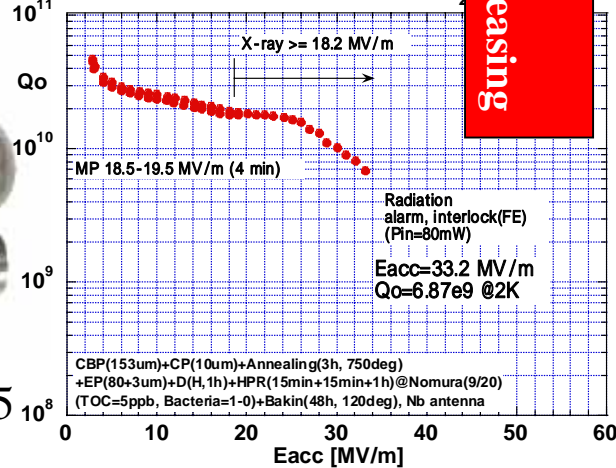
ISE#5

Full HOM

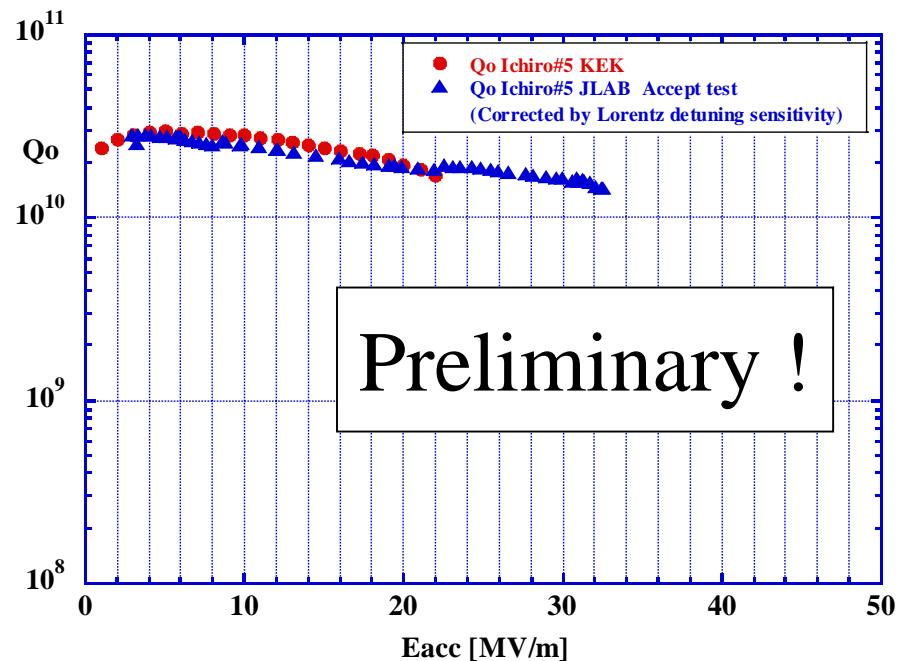
We expect to improve the gradient by the Tight Loop Tests @ JLAB

# Accept test result (preliminary) @ JLAB on the Ichiro#5
