# Report from Dee integration test

SiDet Meeting  
04.06.2023

# Overview

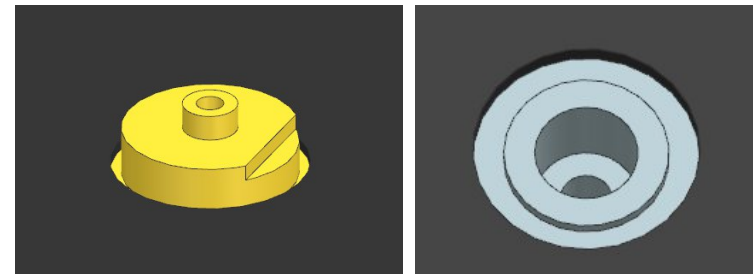
- Highly embedded 10 mm thick Sandwich
  - Airex foam core
  - CFRP facings
- 6 wedge shaped cooling sectors
  - Symmetry: Identical design for sectors 1 & 6, 2 & 5, and 3 & 4
- Step at straight edge of Dee
  - Pipe routing requires step to be on opposite sides.
- Modules are positioned with Al inserts.
  - 2S inserts is also cooling contact.
  - PS insert receive a shoulder screw for precise positioning.
- PS cooling through carbon foam blocks.
- Additional inserts for coordinate system and mechanical connections.

2S insert

PS insert

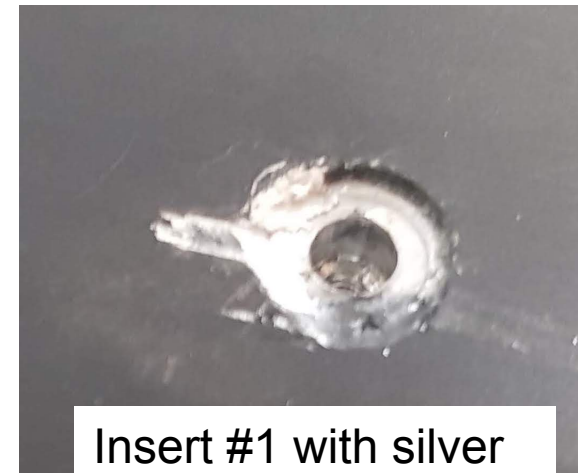
- PS is attached to Dee through 3 inserts.
  - In #1 a shoulder screw is used.
  - #2 is an elongated hole (pointing to #1) to be used with a shoulder screw.
  - In #3 a normal screw is used (large play, no positioning)
  - A 4th fixation clip holds down corner without insert.
- Baseline is to use two pins screwed into the Dee insert for positioning.
- 0.5 mm thick thermal pads cut to the shape of the base plate used as TIM.
  - Mechanically the thermal pads worked well for placing and removing. (cooling performance tests not yet done)

Insert #1 with silver epoxy for grounding

- Dee insert #1 grounding is reliable if the silver epoxy connection is done well.
  - Influence of spring fingers to be re-checked with final design modules.

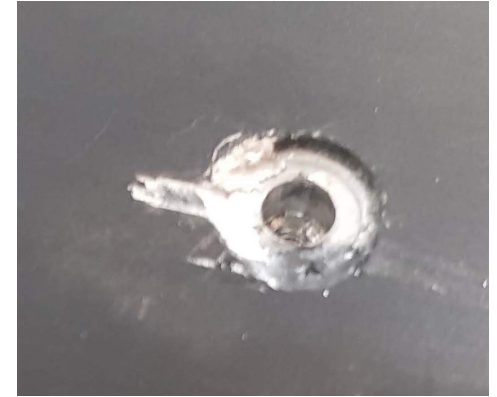
- Measurement of module LV ground to the mechanics to ensure proper grounding.
- Almost all modules showed 6-7  $\Omega$ .
  - Coincidentally 2S and PS are similar, even though they have different grounding paths.

- One PS module we measured about 27  $\Omega$ .
- The one with higher resistivity turned out to be due to a worse insert #1 to facing connection compared to the other ones.

- PS hybrid spring fingers were not properly making contact with the facing due to the increased distance with the used thermopad pads.
  - Retrospectively tested with one module. Others to be checked.

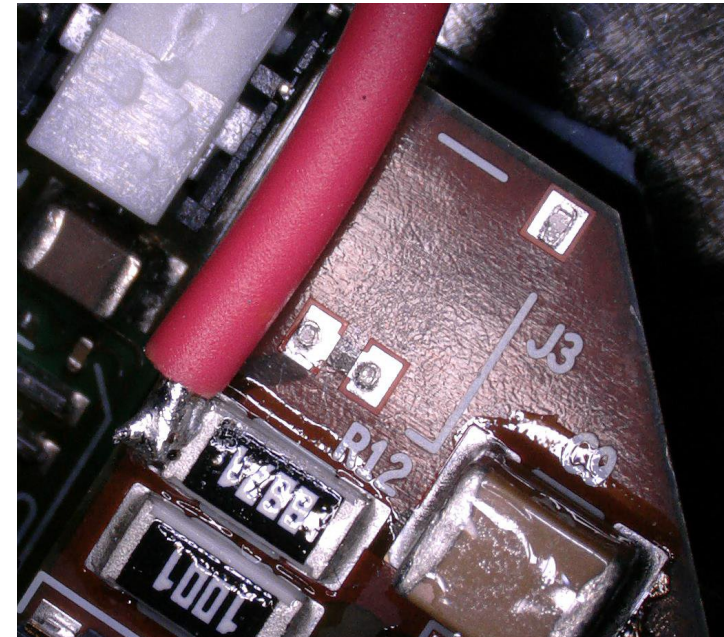
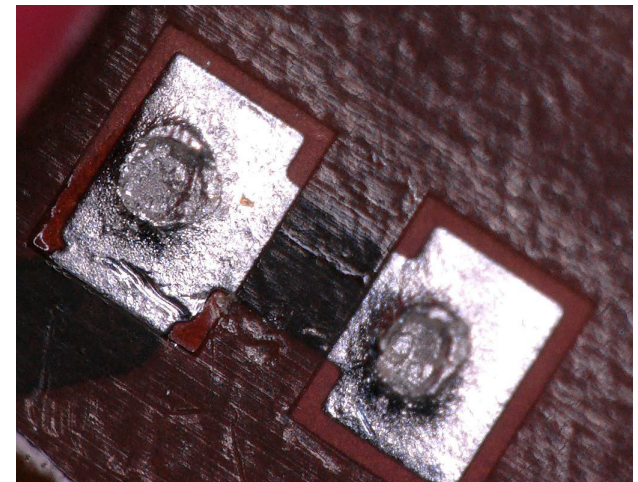
- This problem did not occur in the integration test, but in this context remains to be a worry.
- On several modules the HV cable connector fell of the hybrid when removing the cable.
  - Soldering quality seems to be insufficient?
- Only occurred on HV, no problems with LV
- Prototypes were repaired with a cable soldered to the SMD components of the input filter.
- Later, the cable needs to be removed at least once, when taking modules from the carrier.  
-> Currently we can expect this problem to occur during integration.
- Is this seen elsewhere? Can we expect it to be better with final components?
