JRA SRF

Work package 7

Power Couplers

Tasks of the work package 7

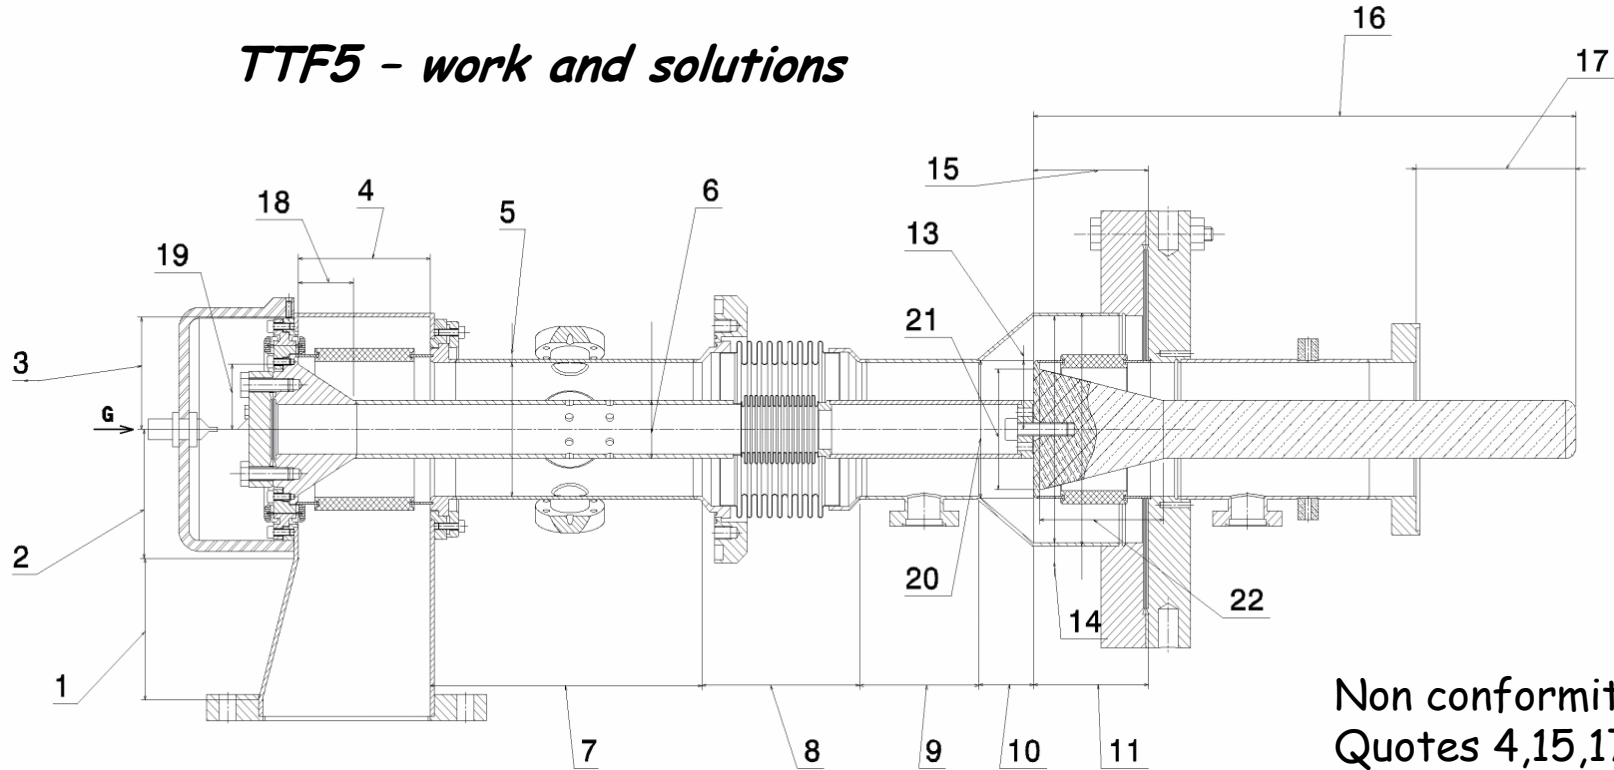
TTF5 - work and solutions

Non conformities on Quotes 4,15,17

- RF frequency mismatch (maybe)
- RF leakages in "warm transition "

- LAL made seal in indium wire to avoid RF leakages in "warm transition".
- LAL made spacers in order to adjust antenna depth in the test box and to solve frequency mismatch. Solution leak checked (problem of tightness with spacers).
- LAL is making drawings to build a new test box in order to test TTF5 under vacuum and with couplers adjusted at 1,3Ghz.

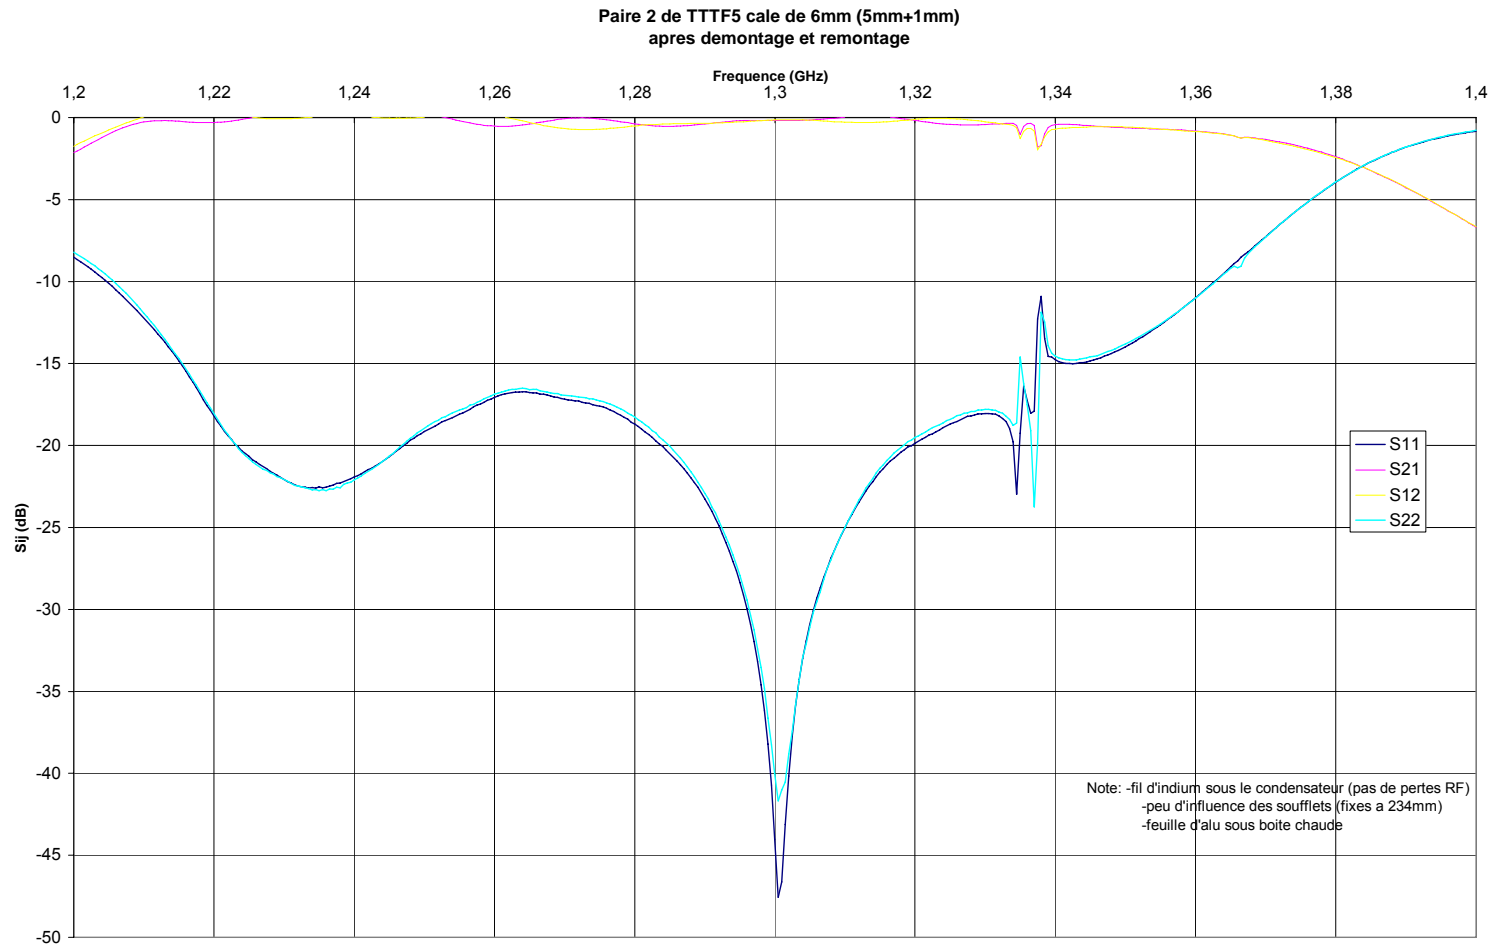
TTF5 low level tests: spacers 6 mm for both couplers

- TTF5 has been tested at low level with spacers.

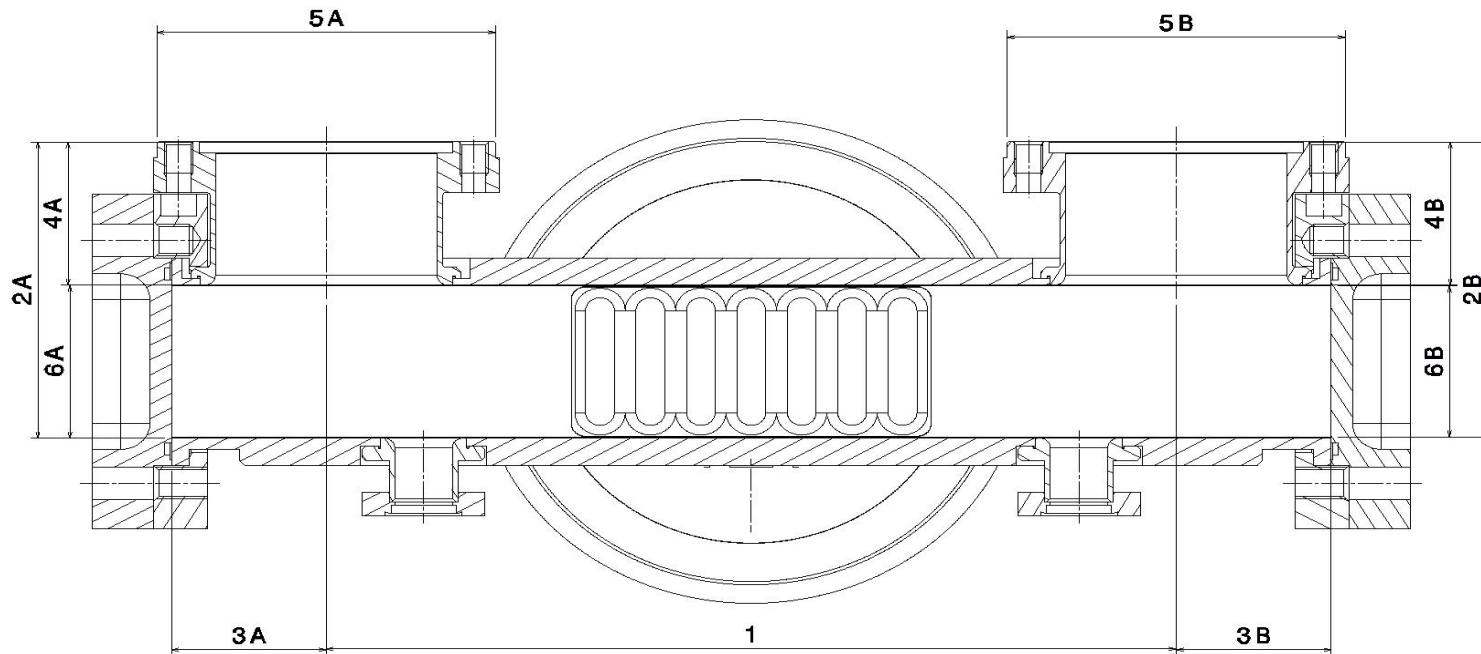
Transition box.

Non conformities on
Quotes 2,3,4,6

- Tightness between box flange and coupler cold flange
- Rf tolerances. Rf frequency mismatch?

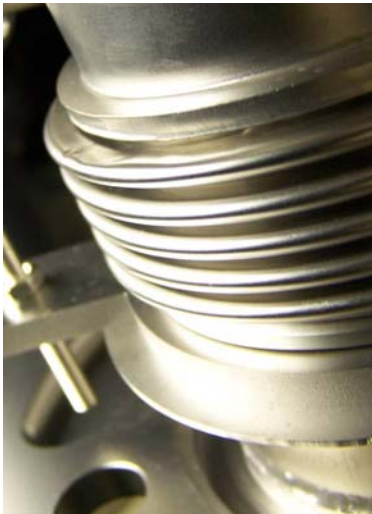
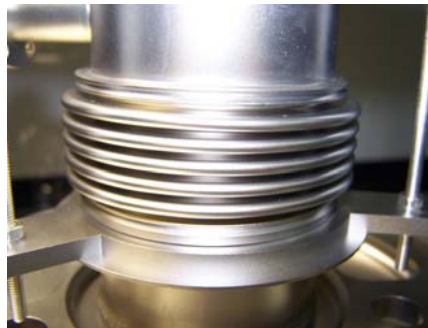
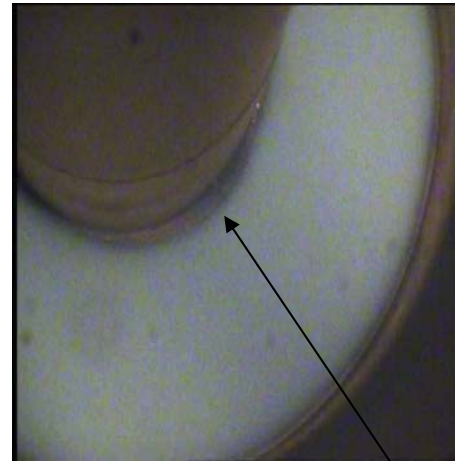
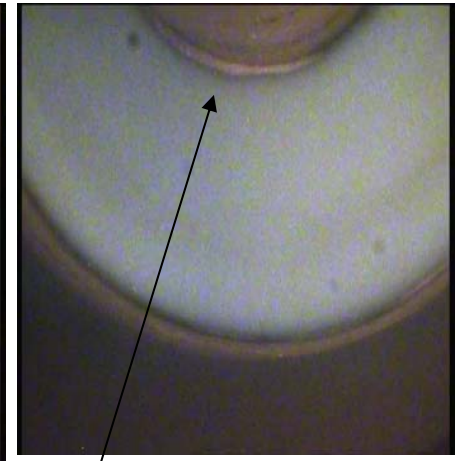
- Visual anomalies on TW60 couplers:
- TW60 2 Warm part bellow
- Metal on ceramic in the warm window
- We noticed a strong deformation on the bellow of TW60-2 coupler and when we let the part under its own weight the bellow is bent.
- Flakes in copper plating

Metal on ceramic

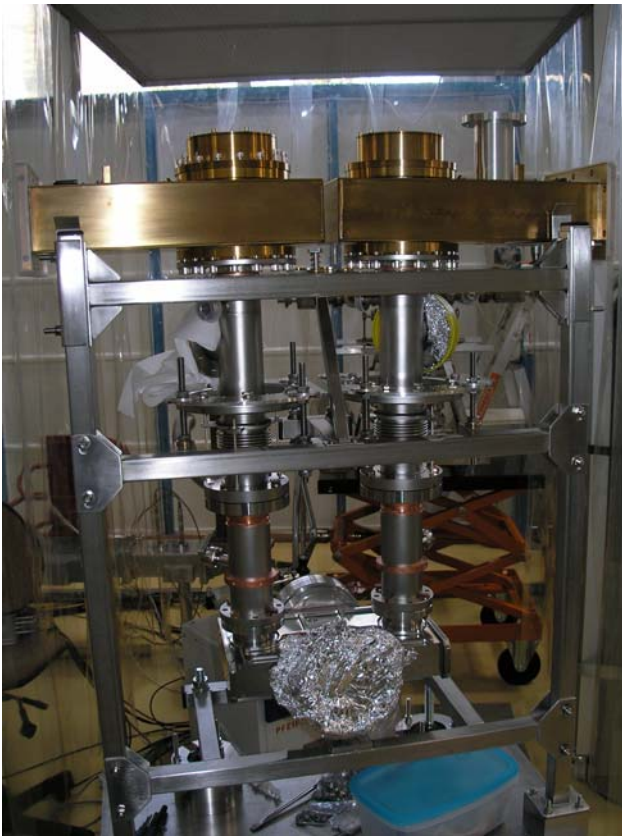
Assembly and conditioning of one TW60 coupler pair

Assembly fulfilled but use of sandpaper : source of surface pollution => Heating after machining

Cleaning using the TTF-III cleaning procedure

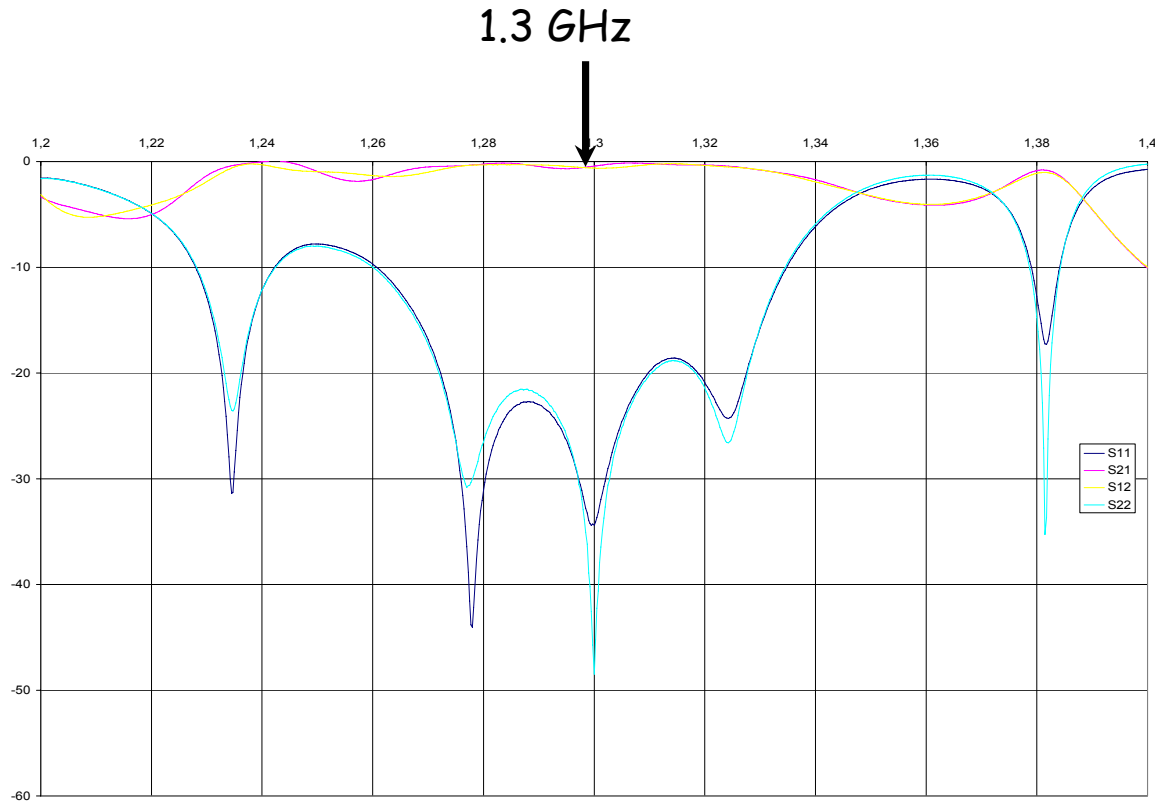
Low level RF measurements

- 40 dB →

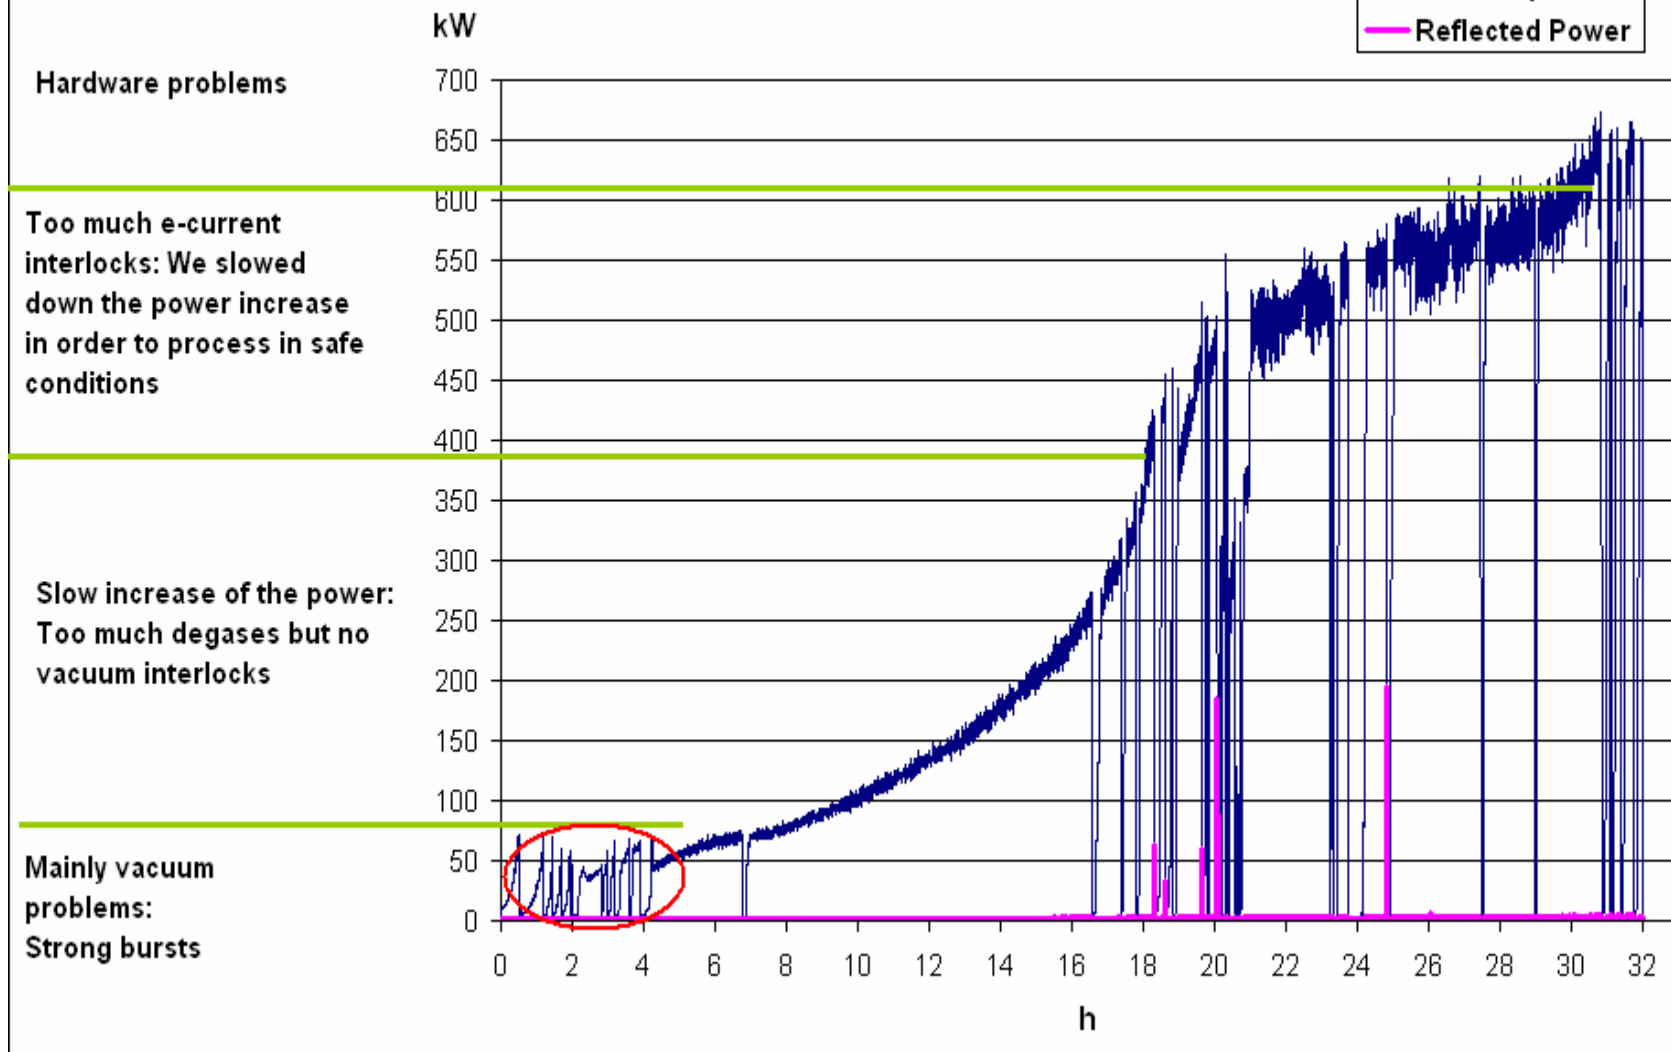
RF Power 20 μ s < 700 kW

The processing of TW60 will be continued in September 2007

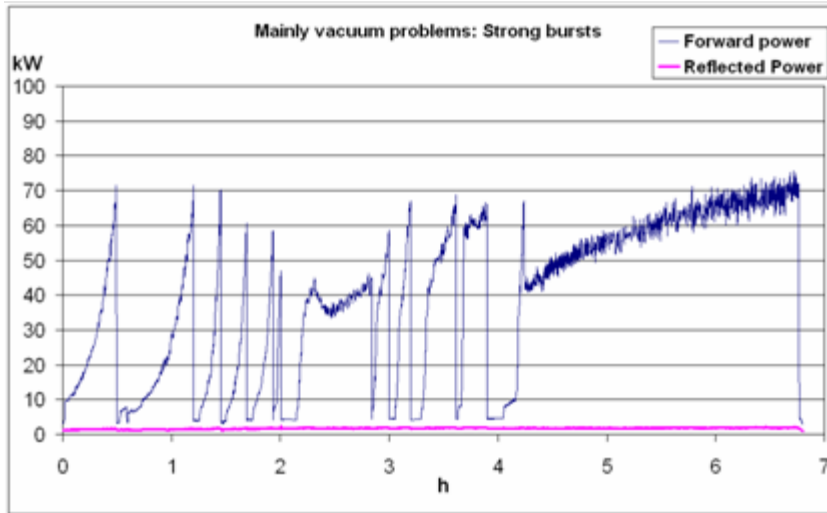
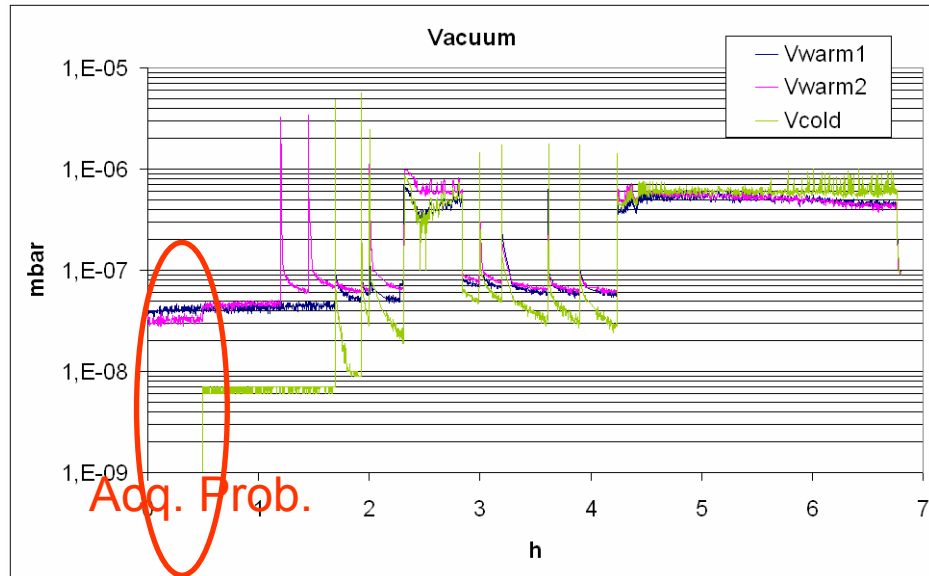
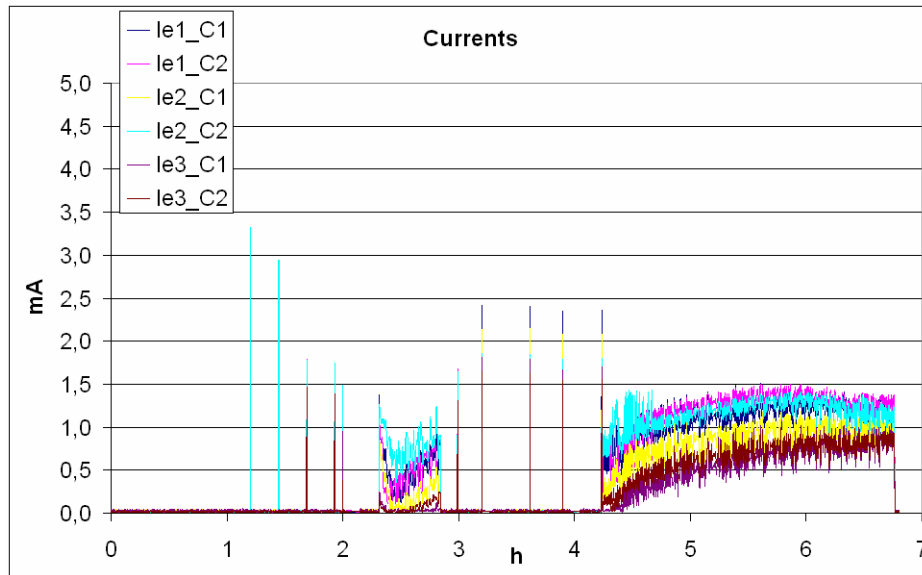
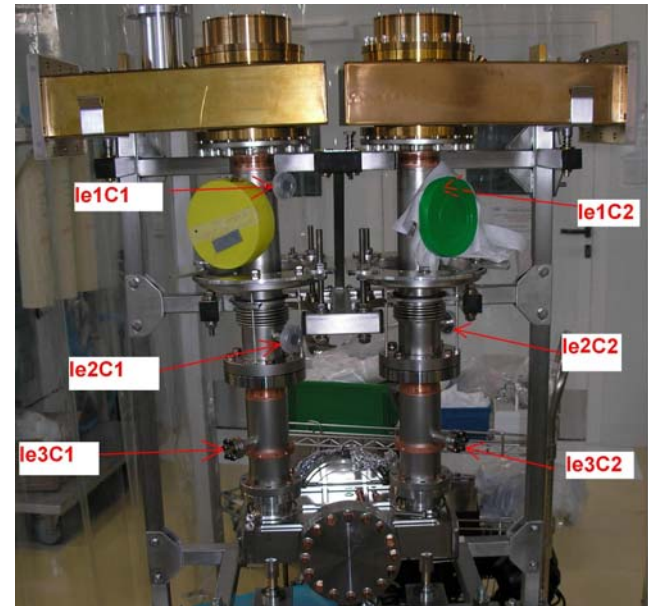
Slow increase of the power: Too much degasing but no vacuum interlock

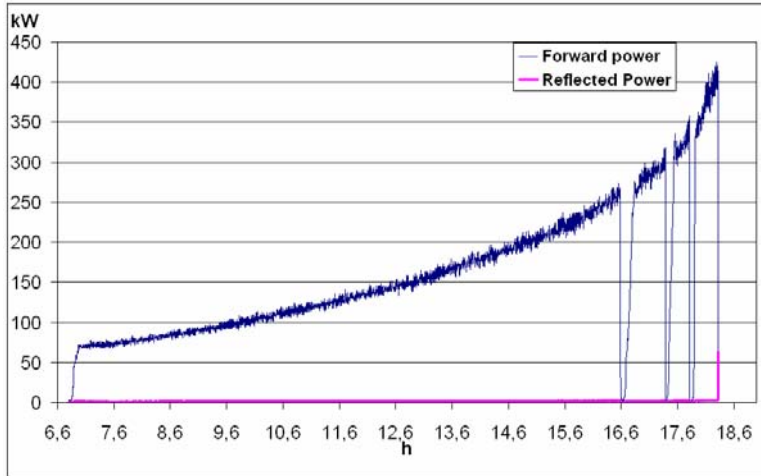
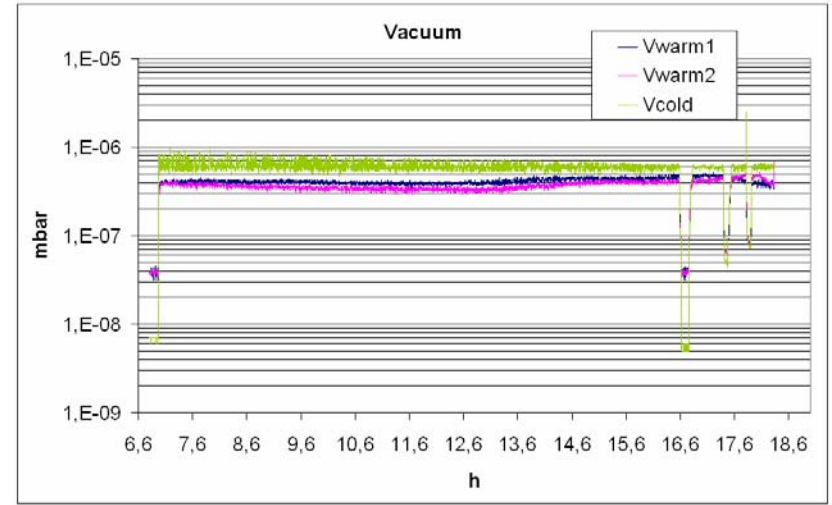
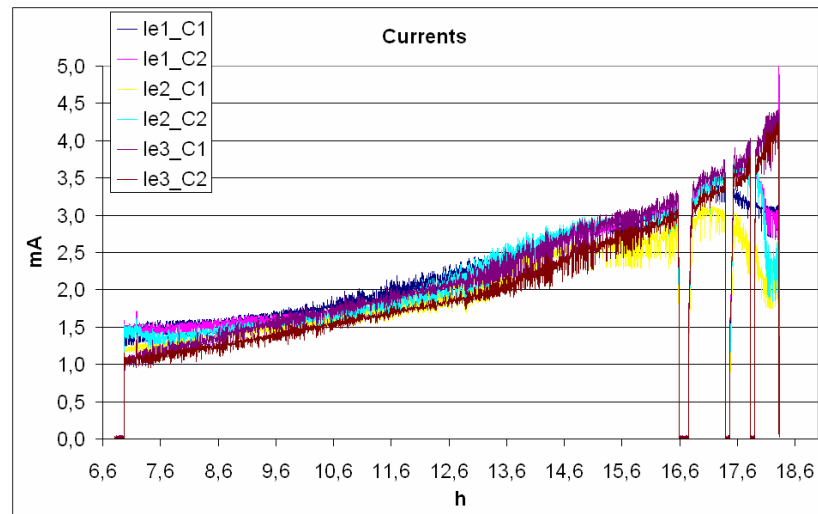
Too much e-current interlocks: We slowed down the power increase in order to process in safe conditions

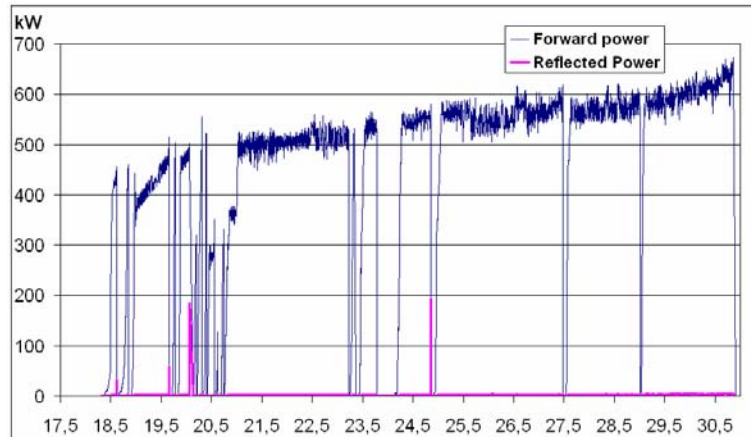
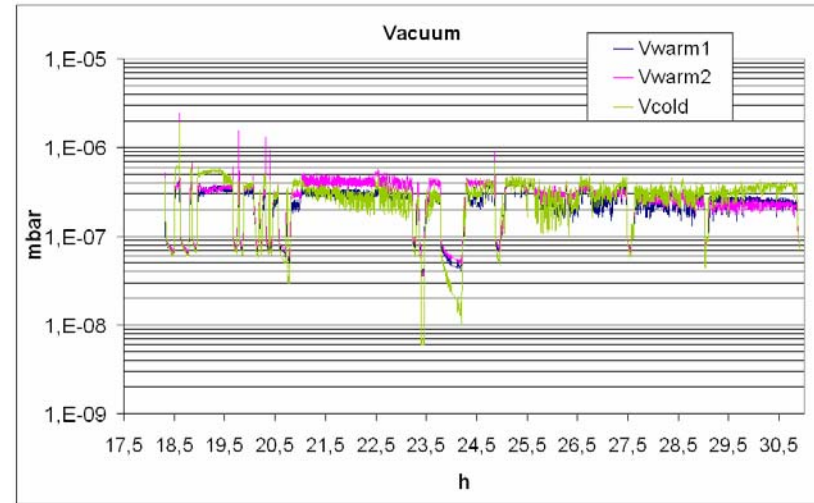
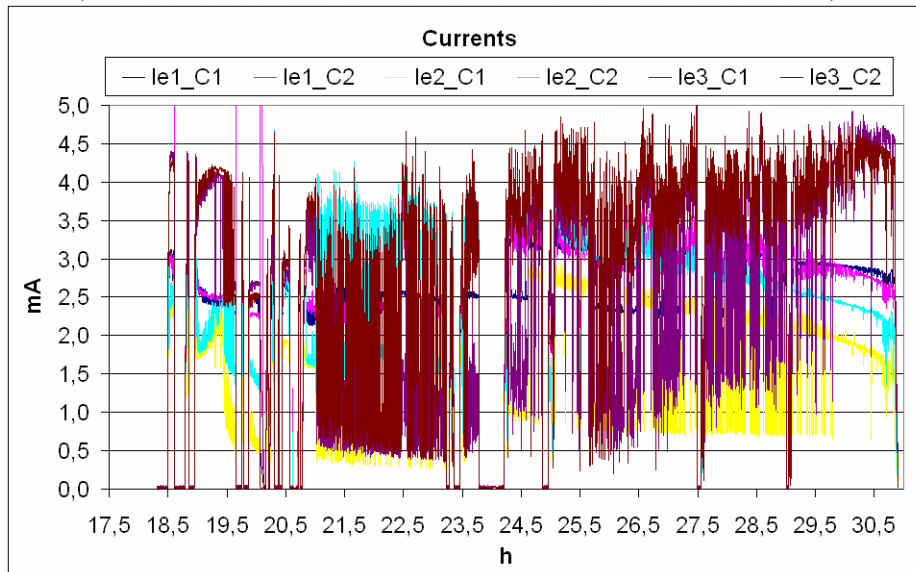
We changed the conditioning parameters very often during this step in order to find the way to increase the power.

After this step : many hardware problems (end of conditioning)

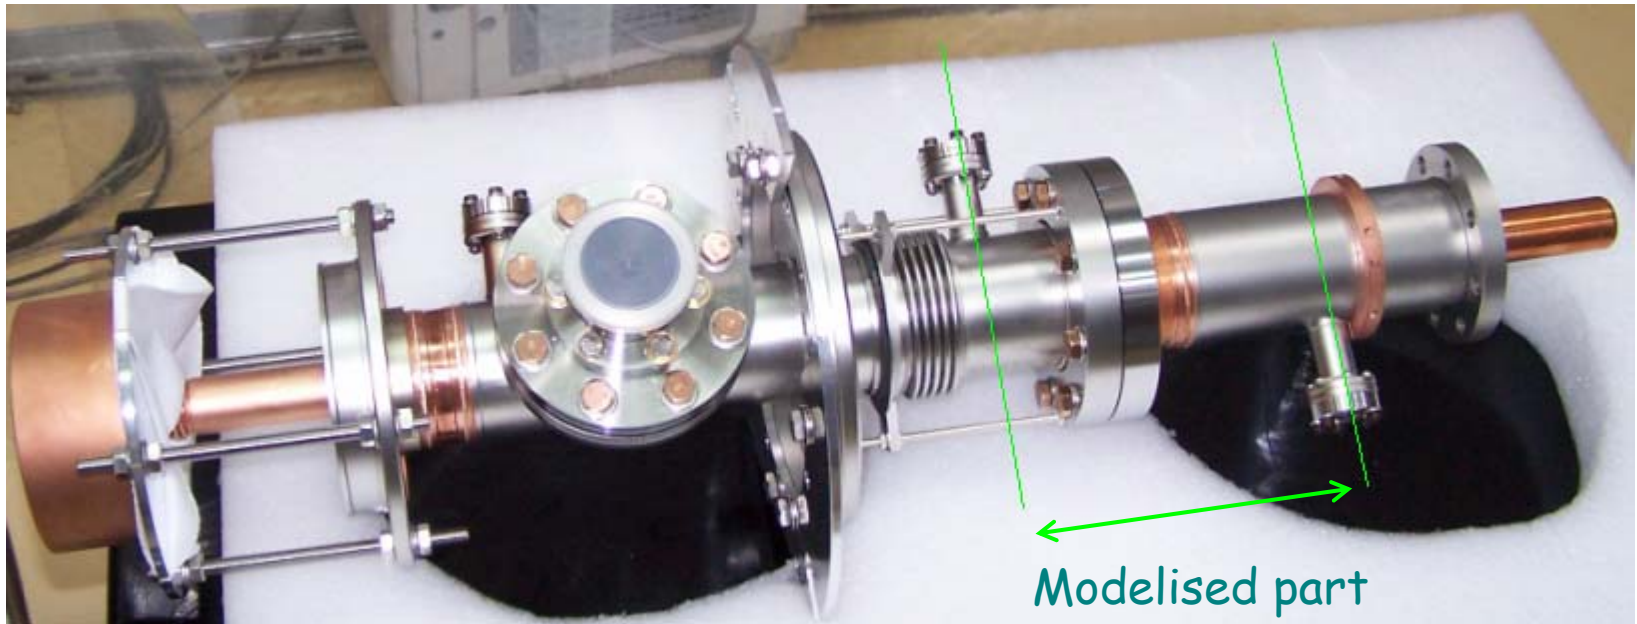
TW60 MP simulations

Simulations results ready. Waiting for clear measurements to establish clear correlations

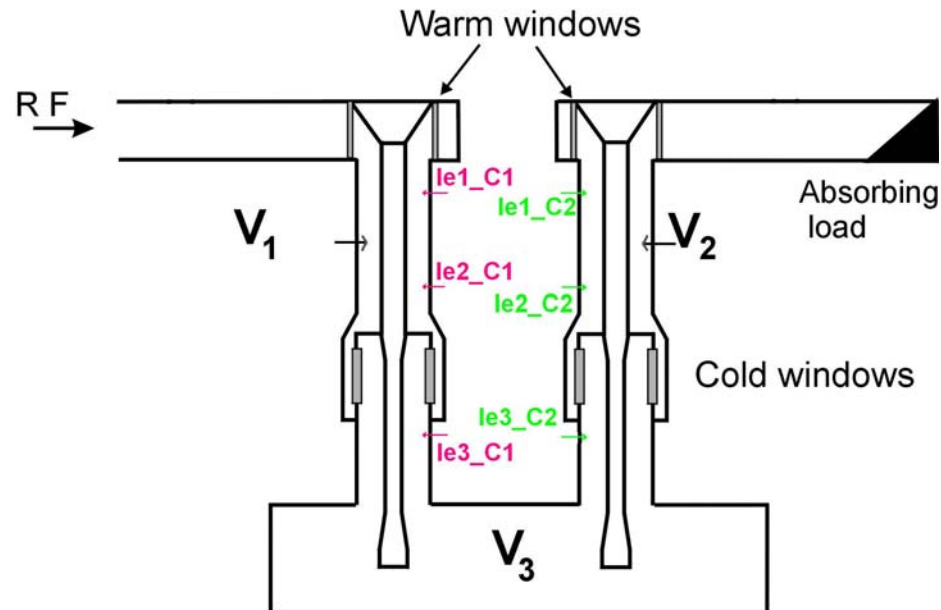
Antenna DC biased TTF-III coupler

DC bias

$V = + 4.5 \text{ kV}$

DC Bias was applied to already conditioned couplers (to test a controlled process)

We found a controlled bias level to suppress e- activity with conditioned couplers. Unfortunately we are stopped with the station but there is already an experiment planned (in collaboration with DESY) to acquire e- Signal on the antenna. In the same framework we will study the application of the bias to non conditioned couplers.

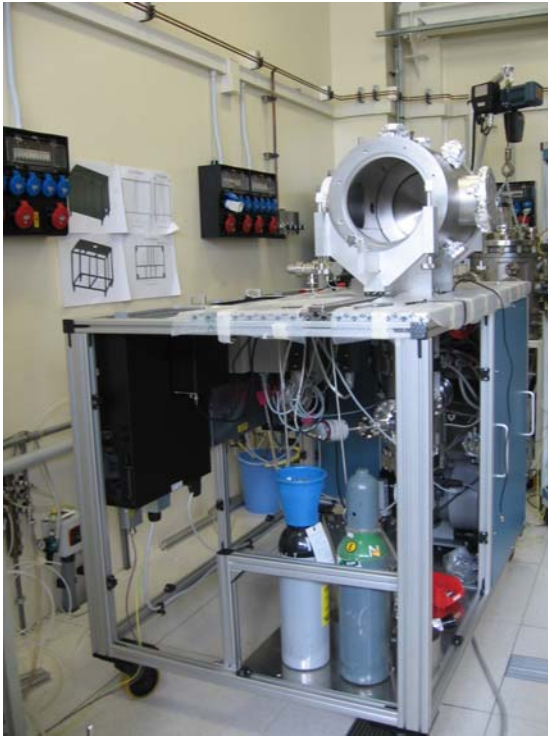
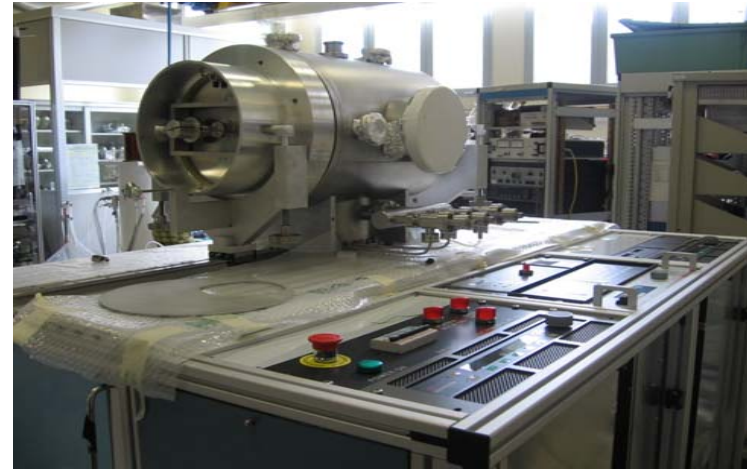
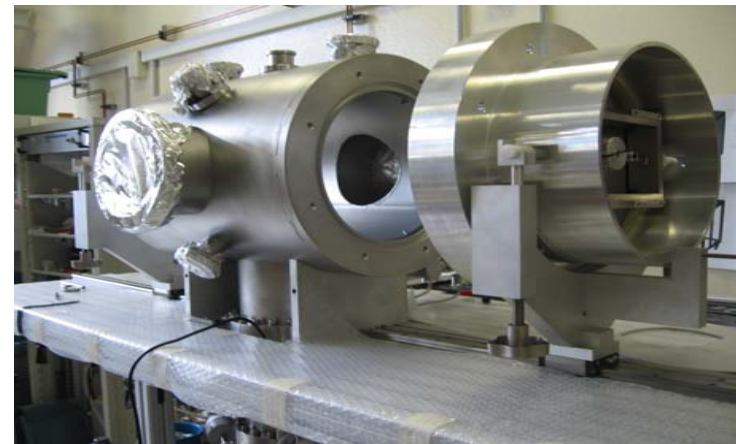
2]TiN Bench

Design and manufacturing of TiN sputtering machine in collaboration with Ferrara Ricerche Association (Italy)

First tests (in Italy) using several
TTF-III coupler ceramics
(beginning of September 2007)

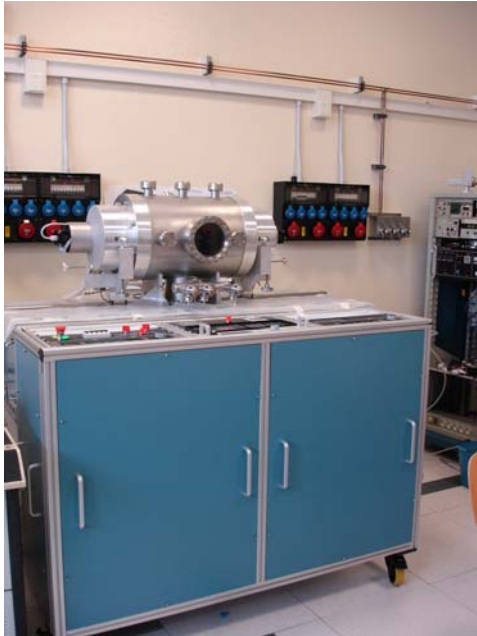
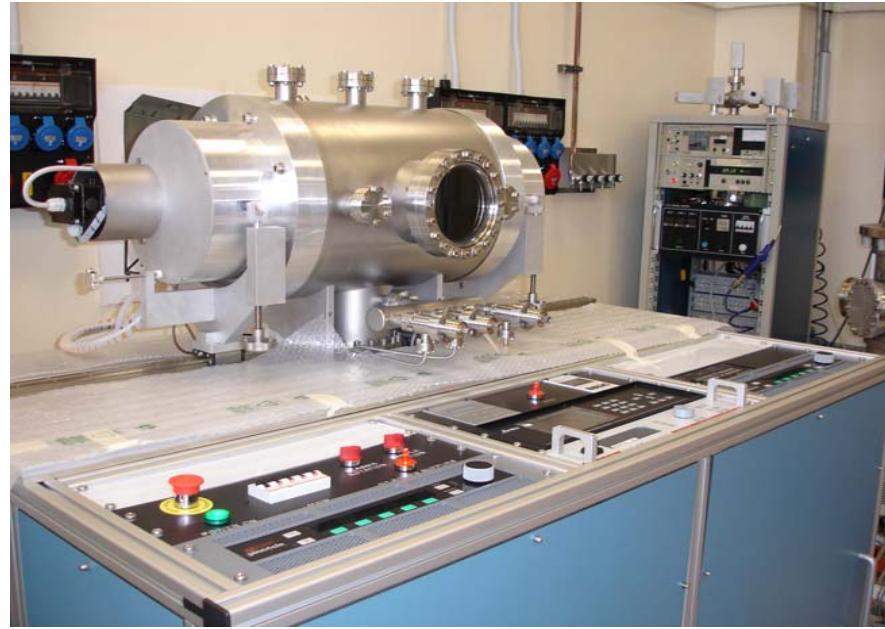
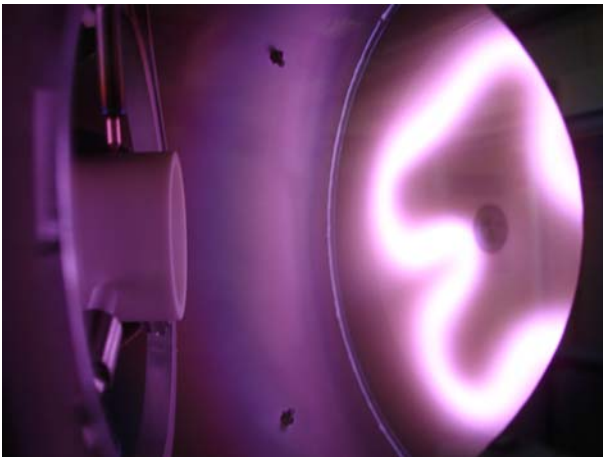
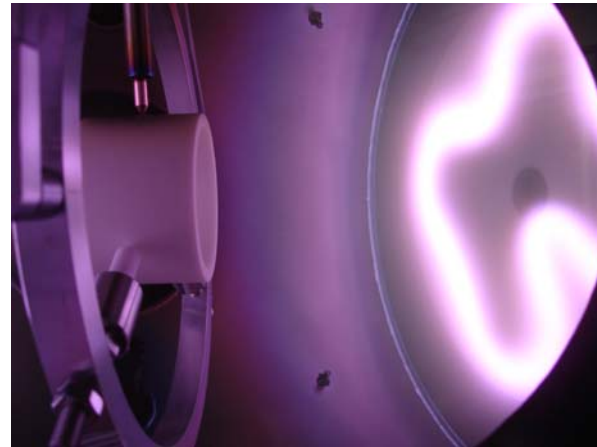
TiN bench is ready. We need further tests before reception

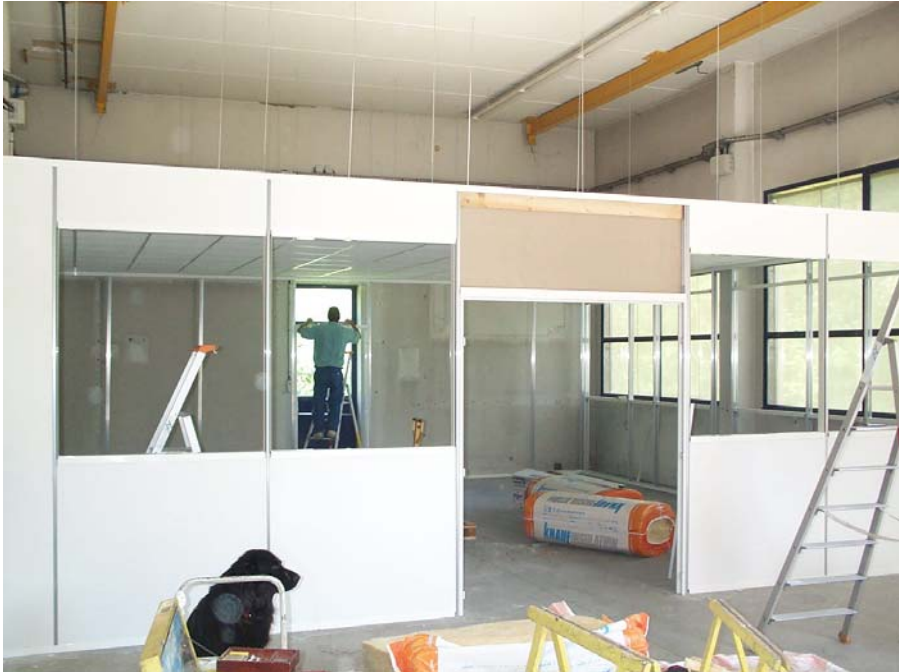
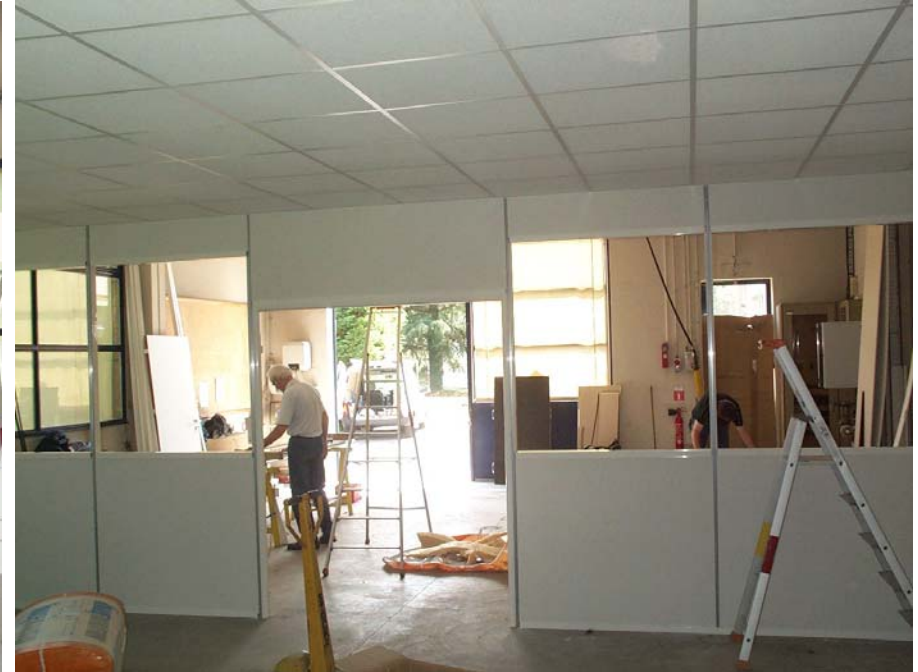
Fitting out of a local for sputtering bench

- ✓ Partitions and ceiling installation
- ✓ Electrical and computer work
- ✓ Plumbing
- ✓ Ground painting

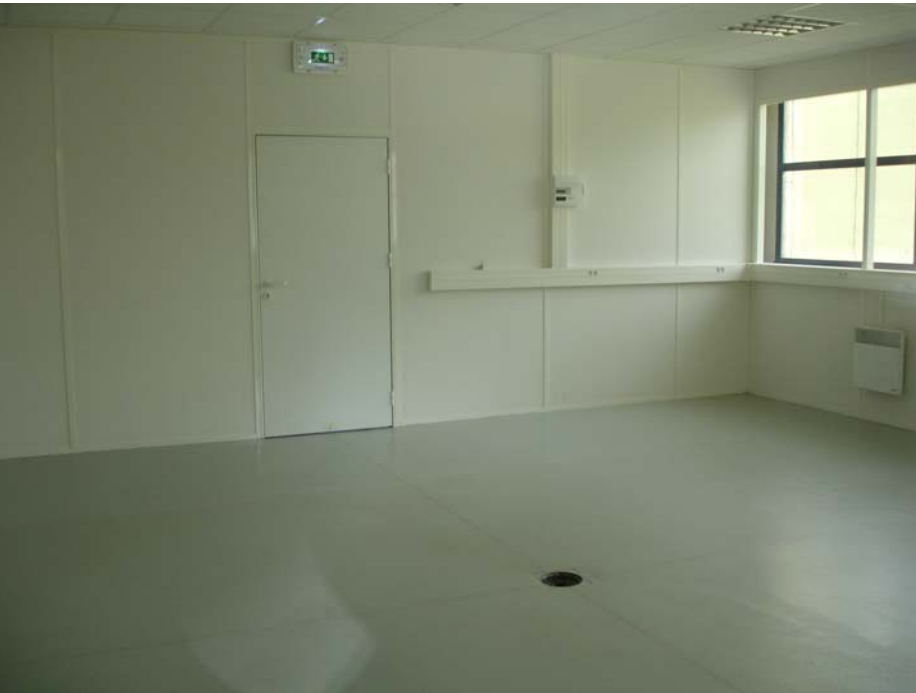
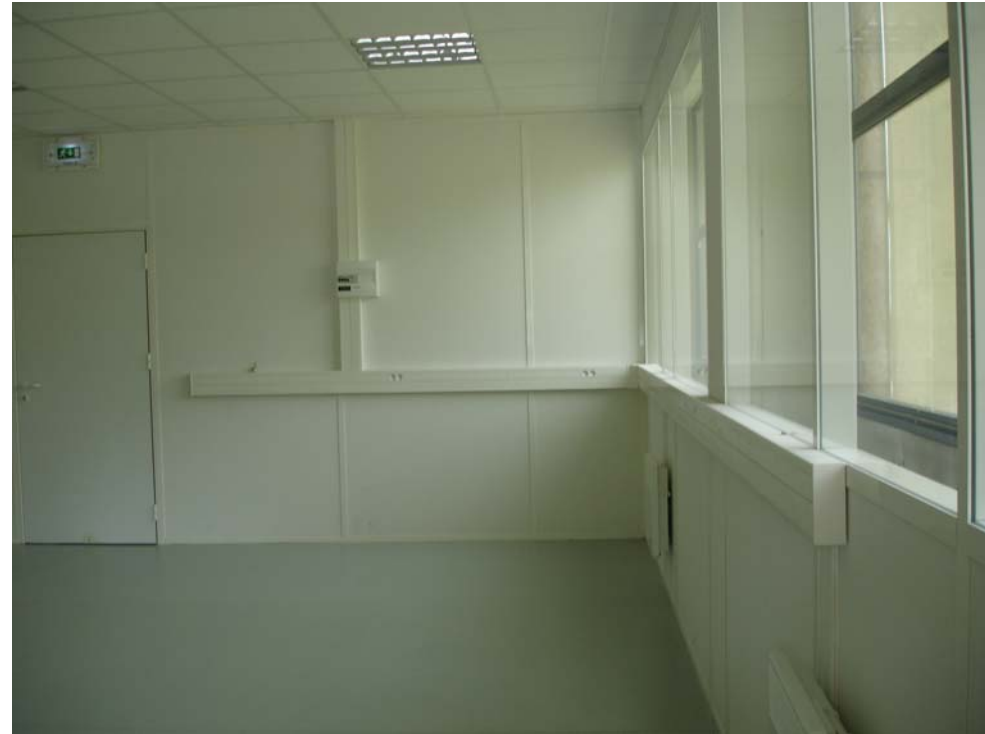
TiN Bench experimental hall is ready

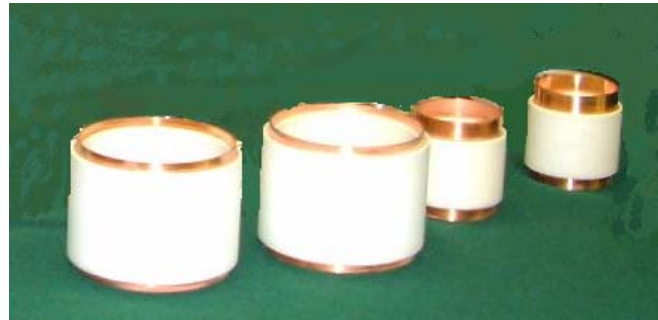
TTF-III coupler window type

Deposition on cylindrical ceramic
windows (internal and external
surfaces)
