## MAGO update - May 2024

# Flash BCP on MAGO cavity

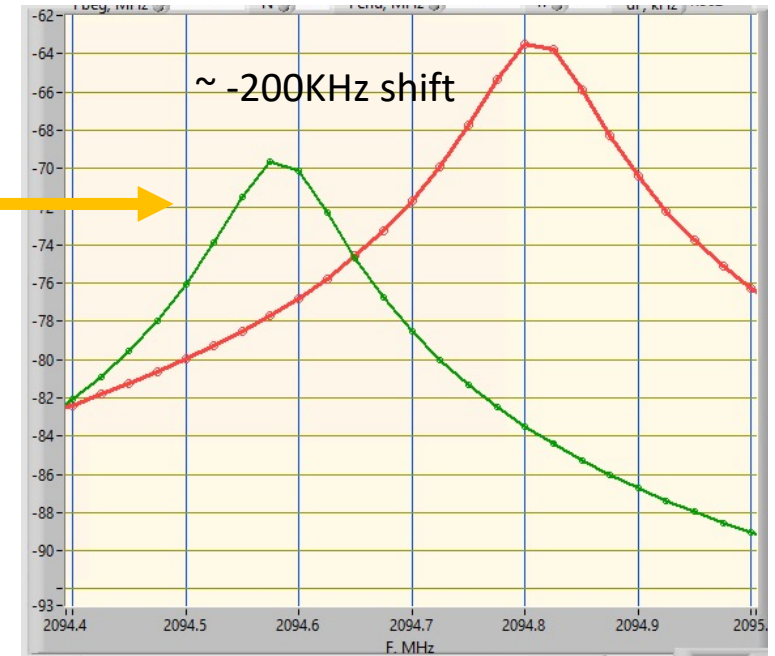
# RF measurements after BCP

RF measurements and tuning  
conducted by Timergali Khabibouline

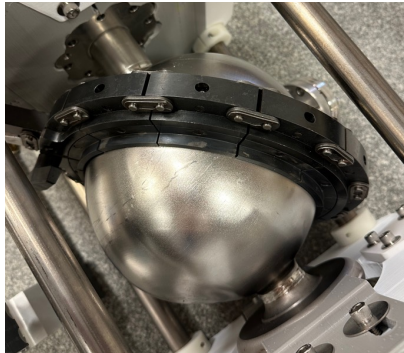
# Initial tuning of spherical cells

Plastic tuning started after BCP, **before** furnace bake (due to misunderstanding in planned activities).

Tuning was not completed.  
Will restart after the furnace bake and straightening.

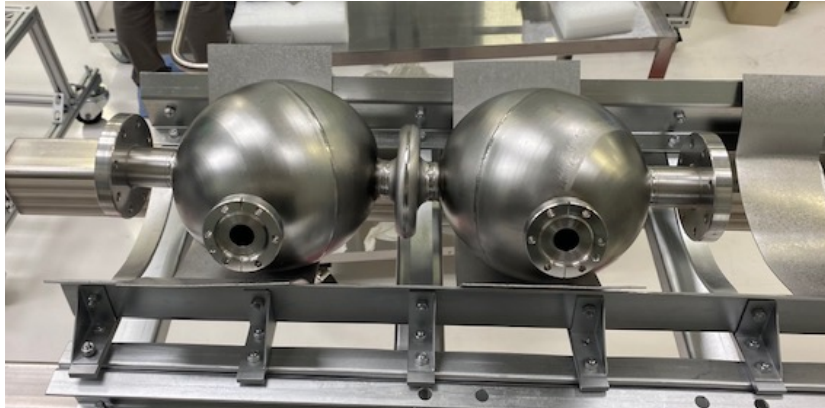
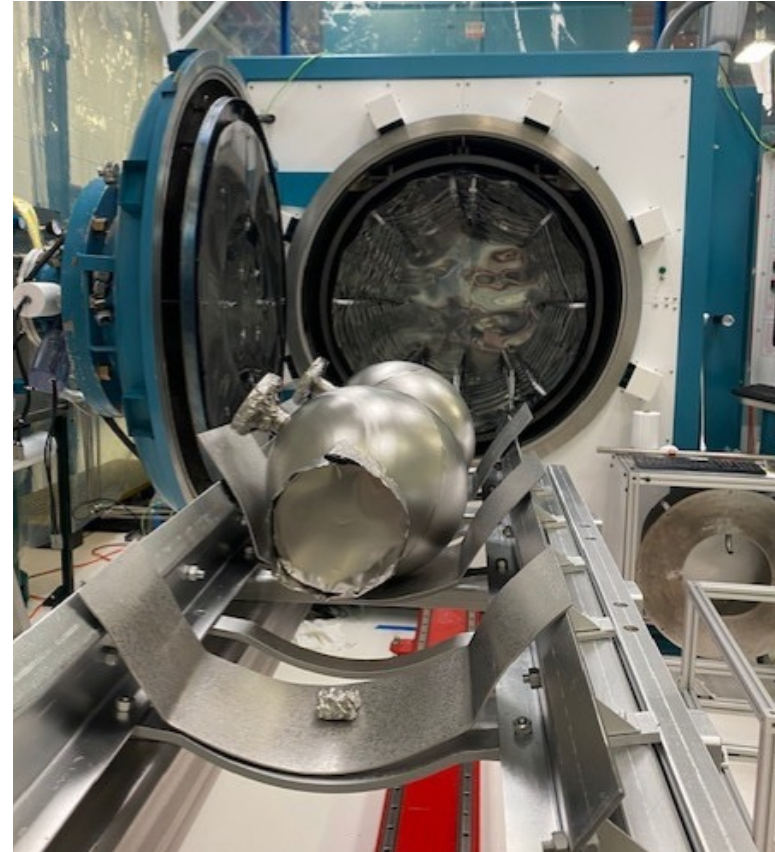
## Furnace bake: 600C x 24h

- Before starting furnace preparation: cleaned the outer surface with isopropyl alcohol and used scotch brite to remove contaminants (i.e. epoxy traces from old sensor)
- US cleaning + Hand HPR with frame
- Bake
