# The STAR Heavy Flavor Tracker (HFT)

(with a focus on the MAPS based PXL detector)

J. Schambach  
(University of Texas at Austin)

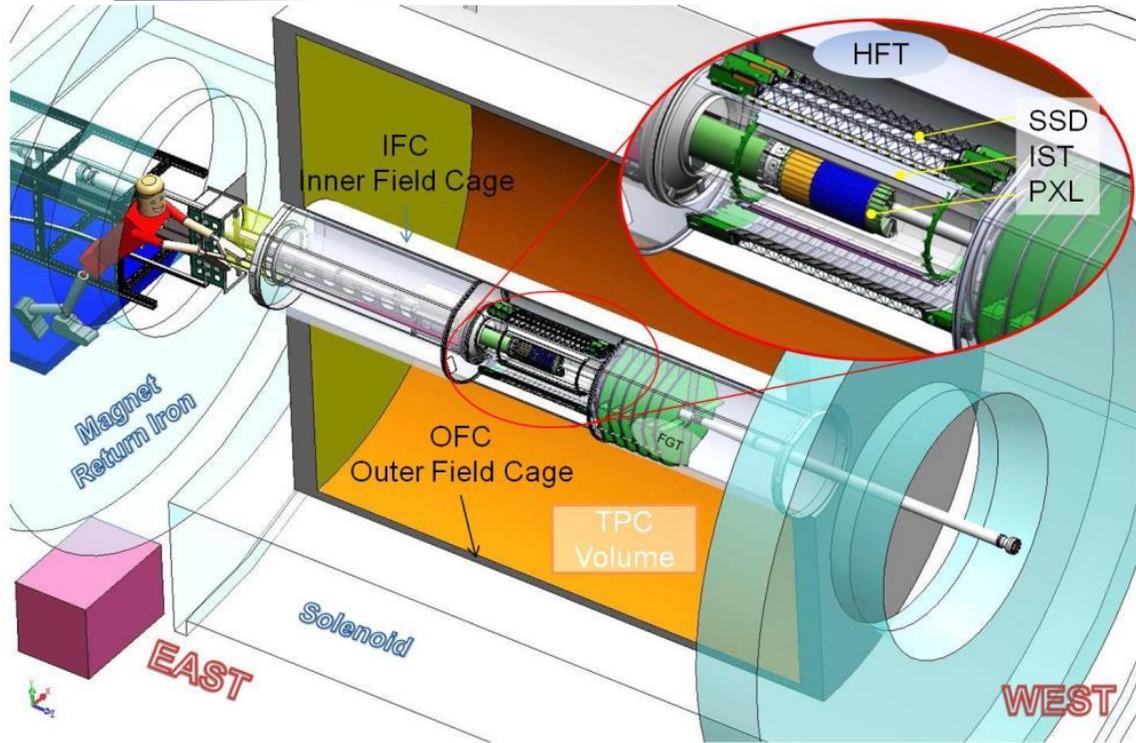
TPC – Time Projection Chamber (main tracking detector in STAR)

HFT – Heavy Flavor Tracker

SSD – Silicon Strip Detector

IST – Intermediate Silicon Tracker

PXL – Pixel Detector

We track inward from the TPC with graded resolution:

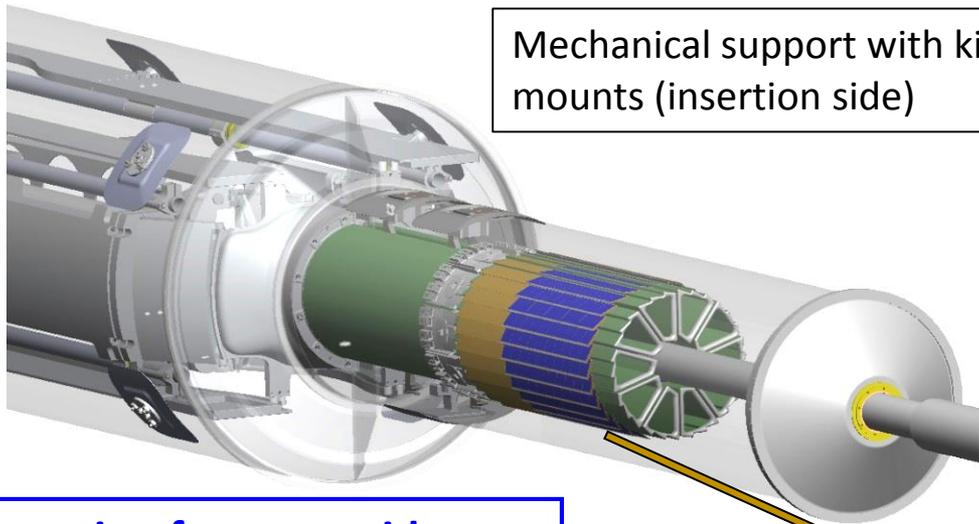
Mechanical support with kinematic mounts (insertion side)

**Insertion from one side**  
**2 layers**  
**10 sectors total (in 2 halves)**  
**4 ladders/sector**

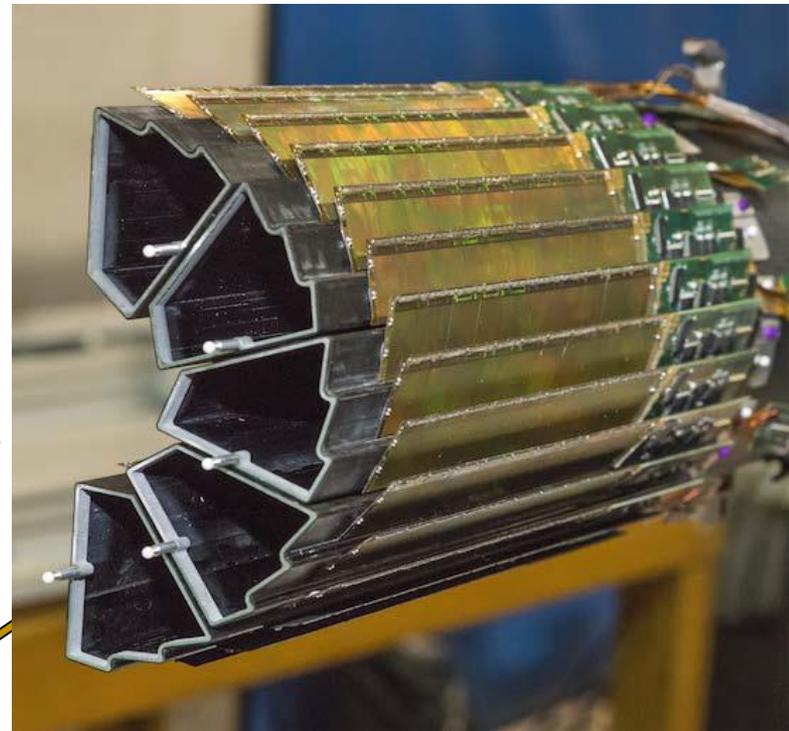
Ladder with 10 MAPS sensors ( $\sim 2 \times 2$  cm each)

carbon fiber sector tubes ( $\sim 200 \mu\text{m}$  thick)

RDO Buffers / Drivers

MAPS

2-layer kapton flex cable with Al traces

20 cm

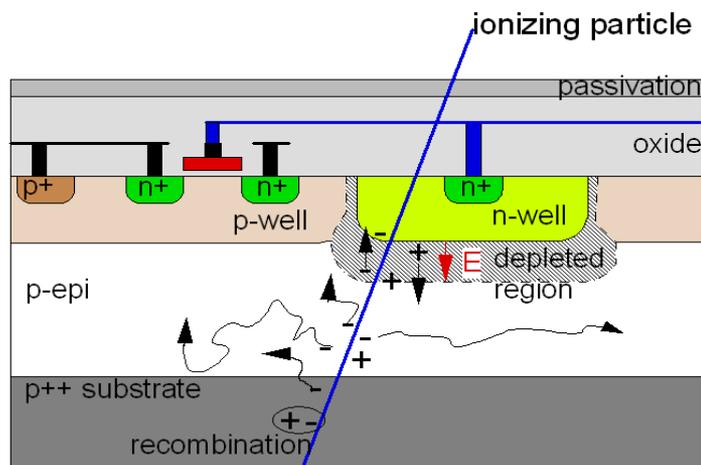
MAPS pixel cross-section (not to scale)

- Reticle size  $\sim 2\text{cm} \times 2\text{cm}$ 
  - Pixel pitch  $20.7\ \mu\text{m}$
  - 928 rows  $\times$  960 column array ( $\sim 890\text{k}$  pixels)
- Power dissipation  $\sim 170\text{mW}/\text{cm}^2$  @ 3.3V (air cooling)
- Short integration time  $185.6\ \mu\text{s}$
- Sensors thinned to  $50\ \mu\text{m}$
- Hi-Res Si option for increased S/N and radiation tolerance

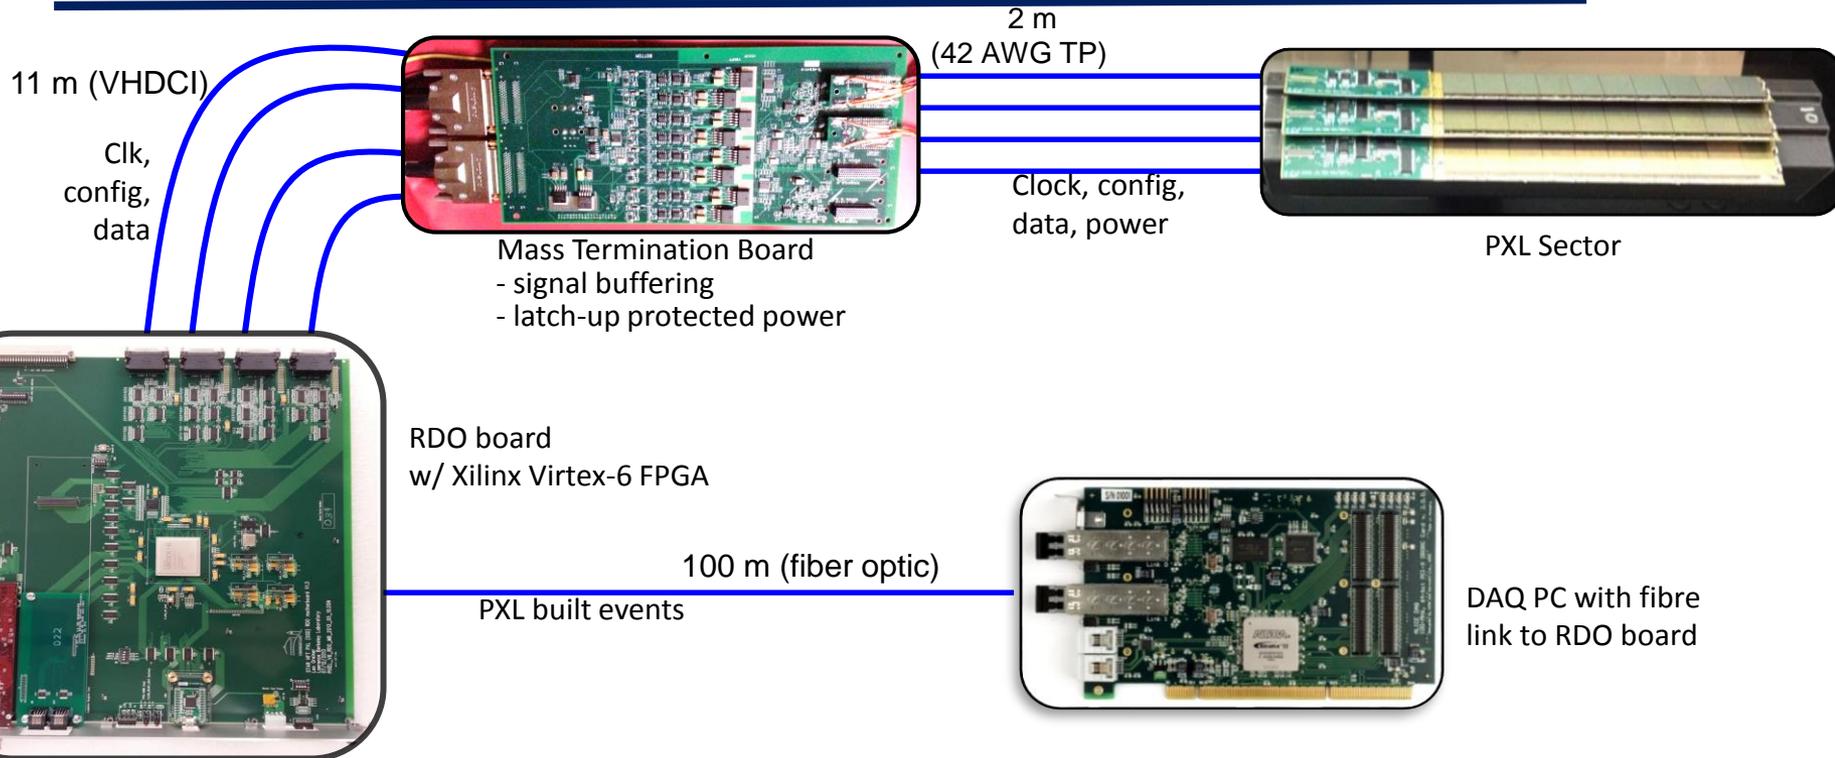
Trigger,  
Slow control,  
Configuration,  
etc.

Existing STAR  
infrastructure

## Highly parallel system

- 4 ladders per sector
- 1 Mass Termination Board (MTB) per sector
- 1 sector per RDO board
- 10 RDO boards in the PXL system

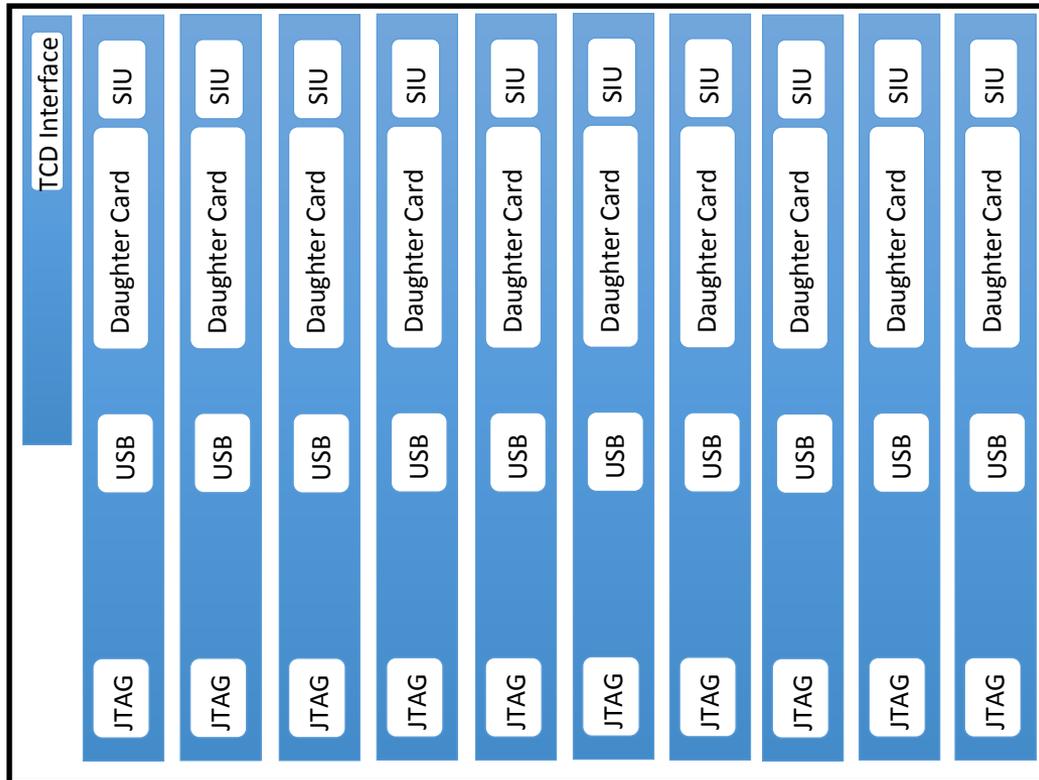
356 M pixel readout in a single 9U size crate

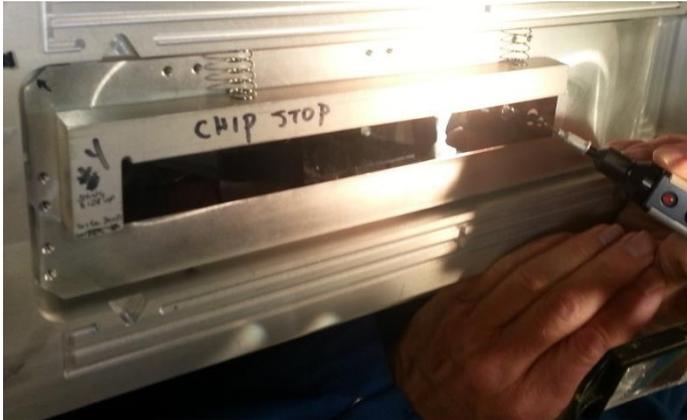
Precision vacuum chuck fixtures to position sensors

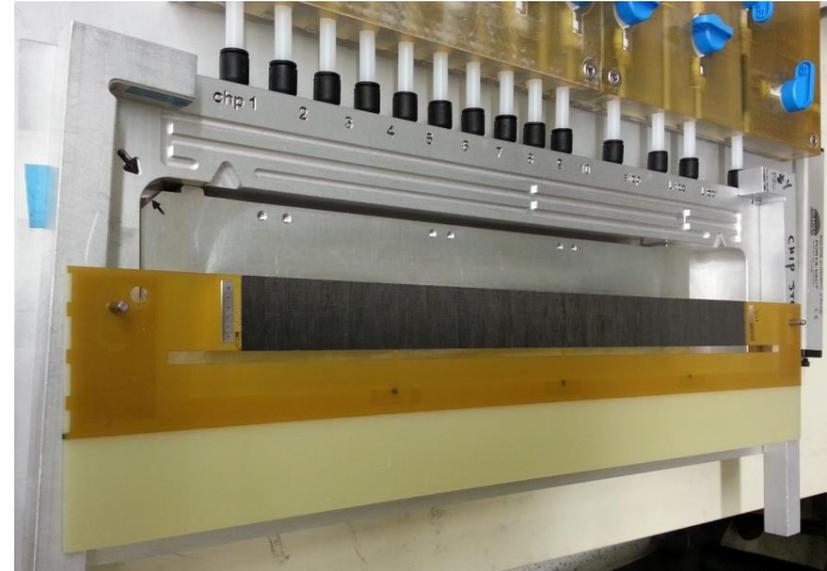
Assembled ladder

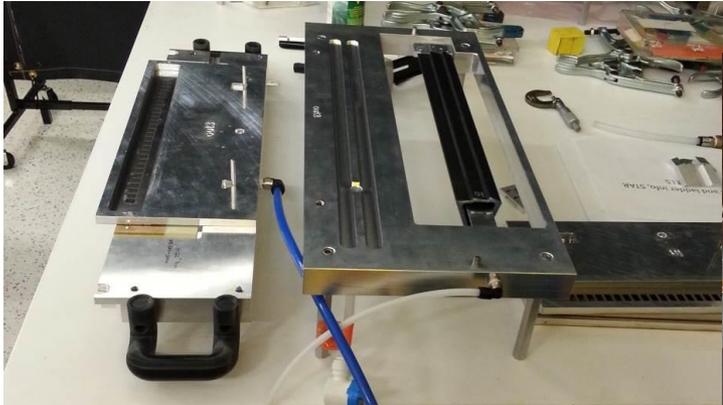
*Sector assembly fixture*

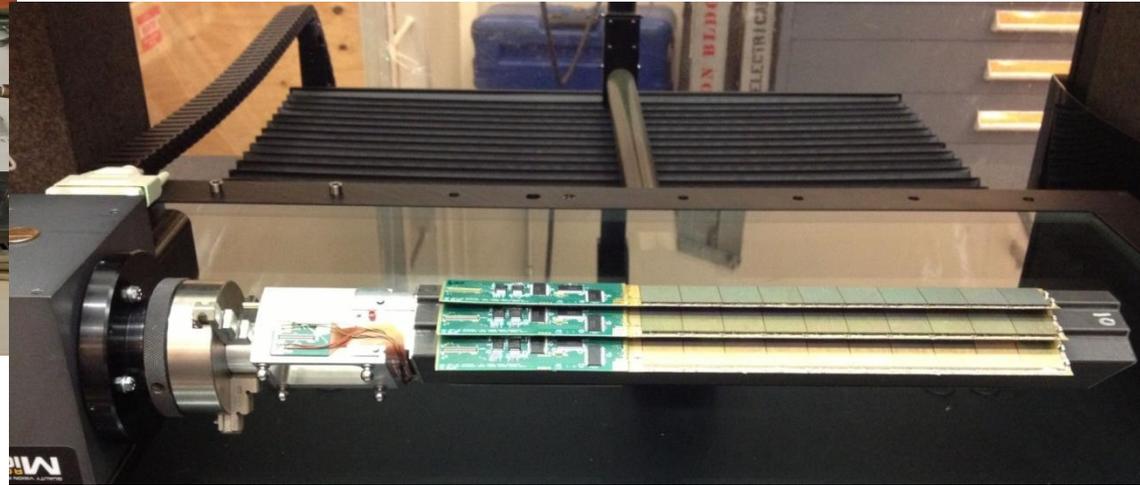
*Sector in the metrology setup*

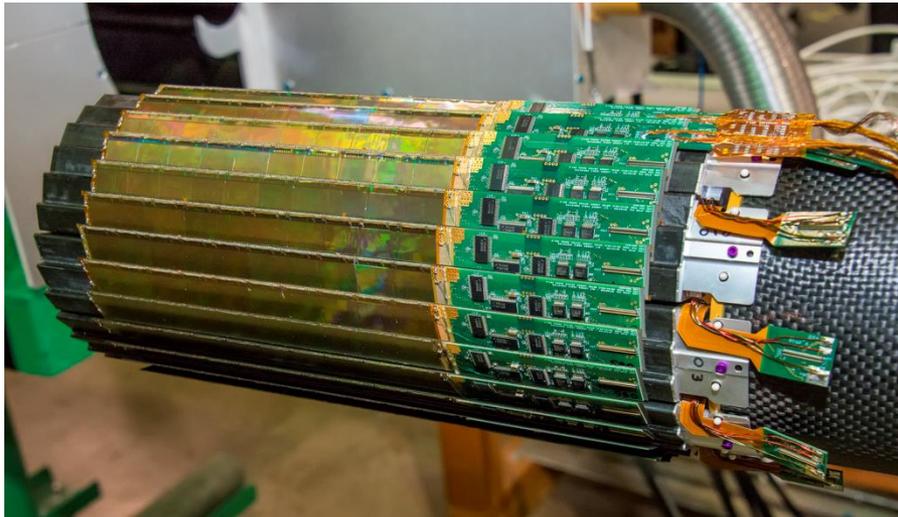
*A detector half*

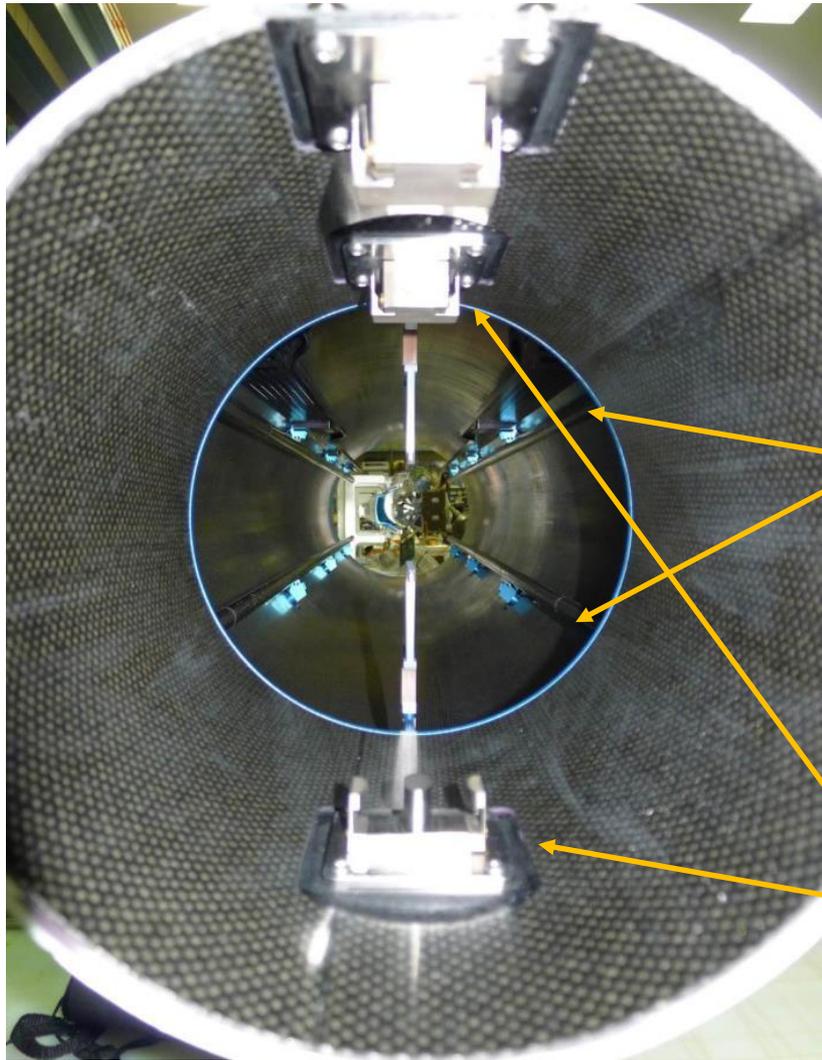
View from Interaction point:

Detector is inserted along  
Carbon fiber rails

Detector locks into place on  
Kinematic mounts mounted  
to support cylinder

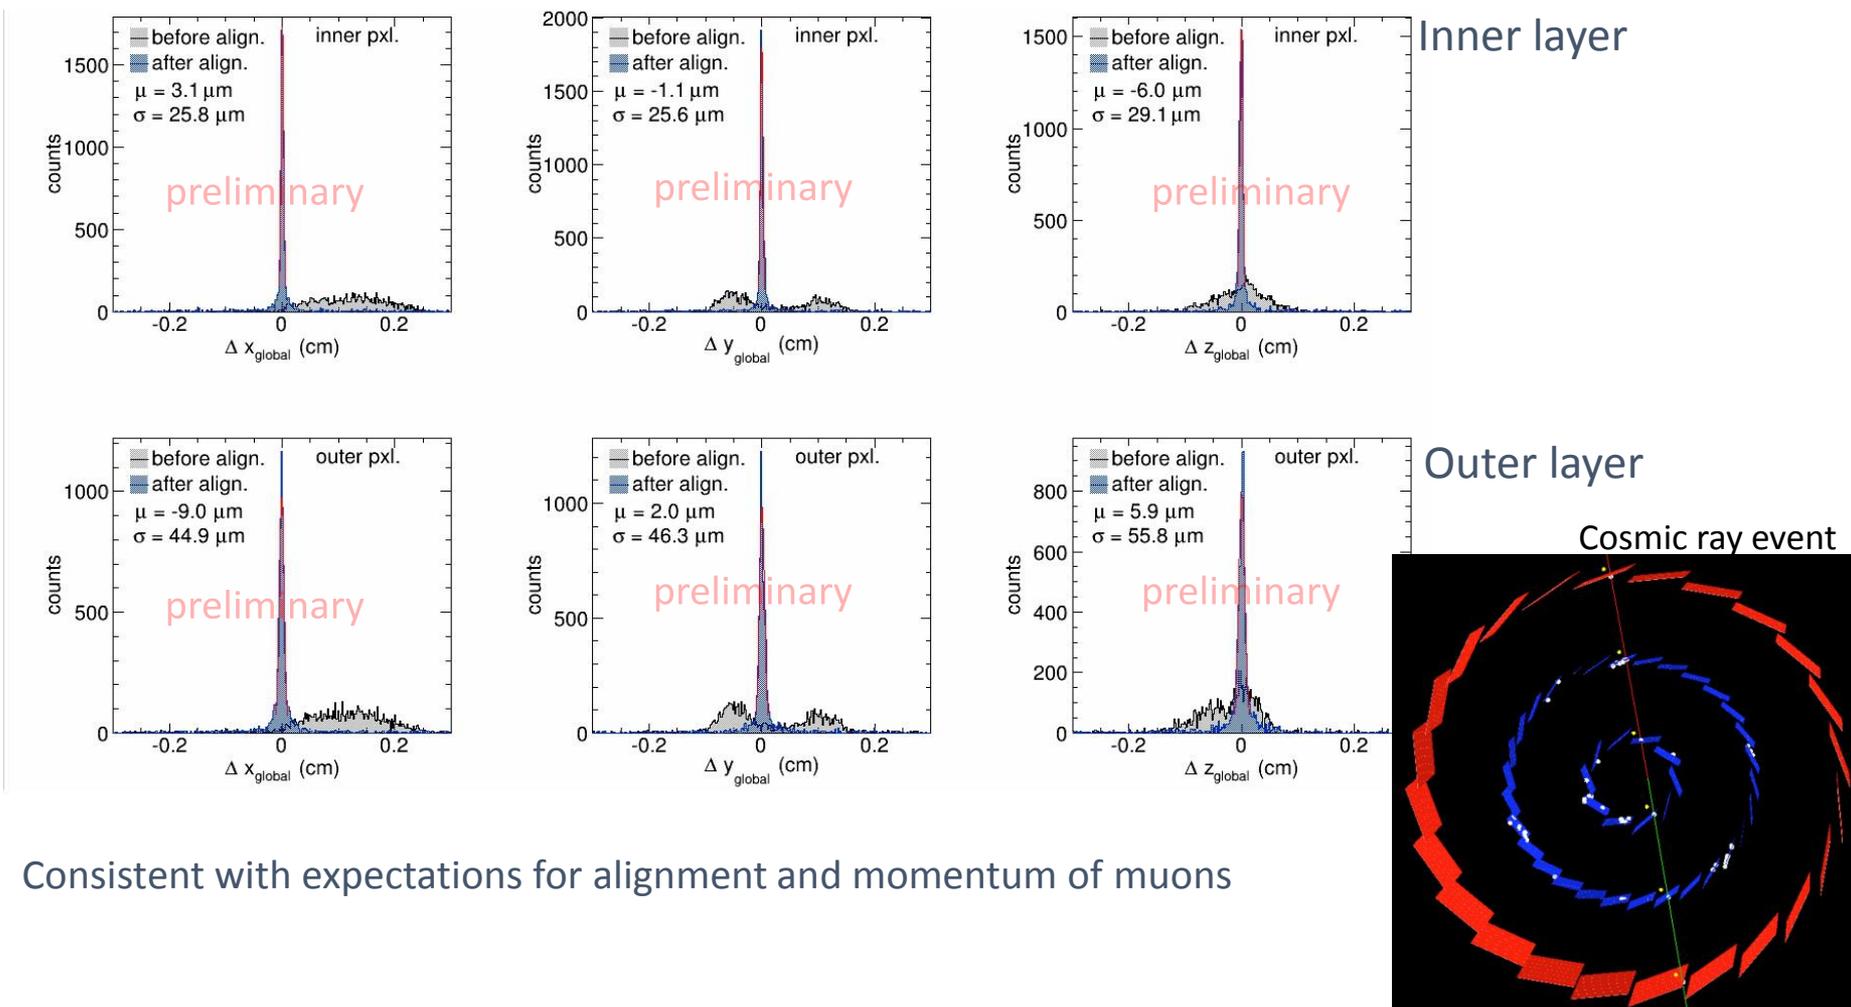
PXL hit residual distributions before and after PXL half to half alignment (analysis by A. Schmah)

Consistent with expectations for alignment and momentum of muons

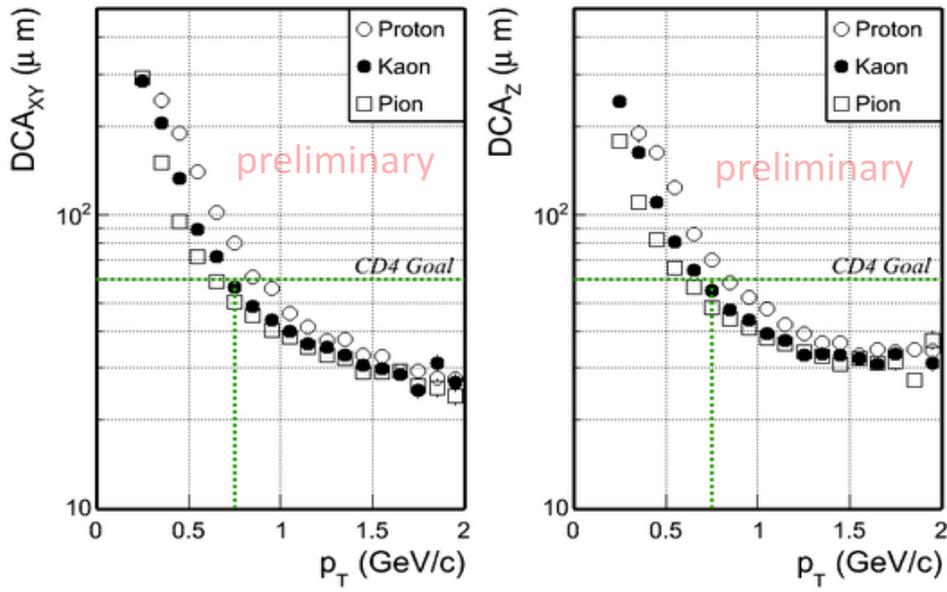
Au + Au @ 200 GeV

- PXL hit residuals (for cosmics) after sector alignment  $< 25 \mu\text{m}$
- DCA resolution for TPC tracks with 1 IST + 2 PXL hits  $\sim 30 \mu\text{m}$  at high  $p_T$  (better alignment still in progress will improve these results)
- CD-4 requirement for DCA resolution:  $60 \mu\text{m}$  for kaons with  $p_T = 750 \text{ MeV}/c$

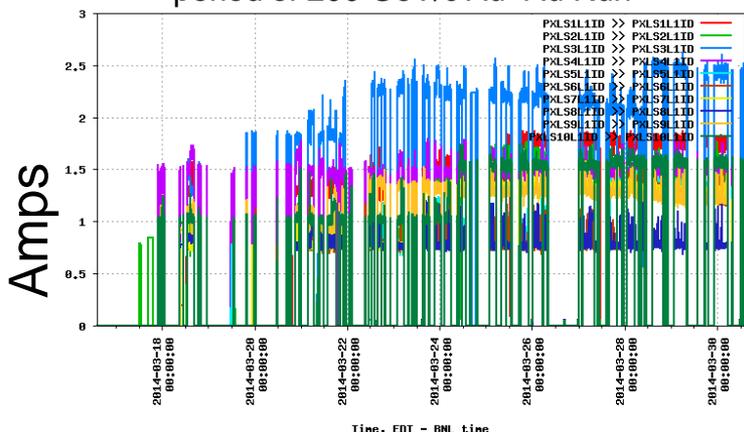
Digital current on the inner ladders during initial period of 200 GeV/c Au+Au Run

- First sensor damage observed in last week of 15 GeV running after several beam loss events; damage continued into 200 GeV run
- PXL sensor damage appears to be radiation related damage possibly due to latch-up events in thinned sensors and takes on many forms: increased digital current, loss of or damaged columns, damaged JTAG registers, loss of full or partial sub-arrays, etc. (mostly in inner ladders)

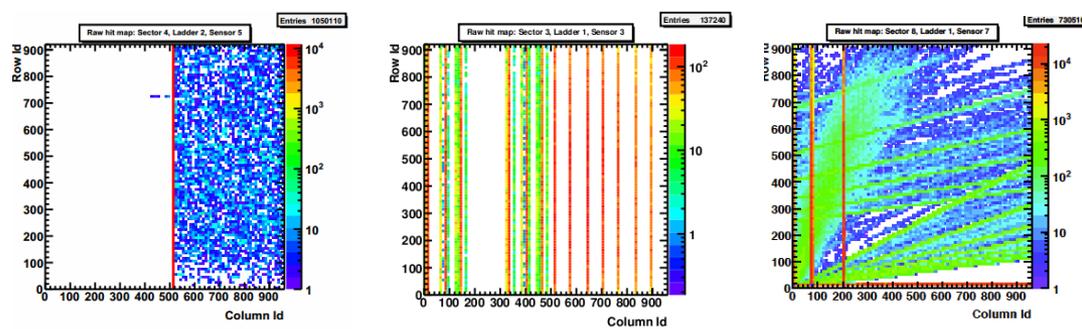
Sensor damage examples

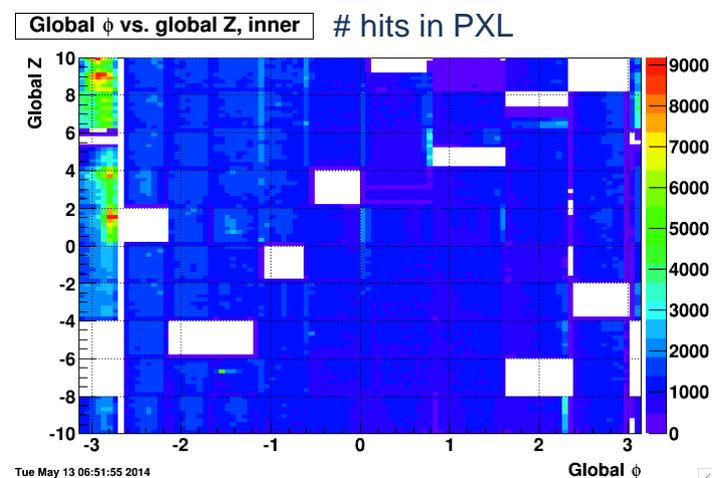
Inner Layer: 14% damage  
(Outer layer: 1% damage)

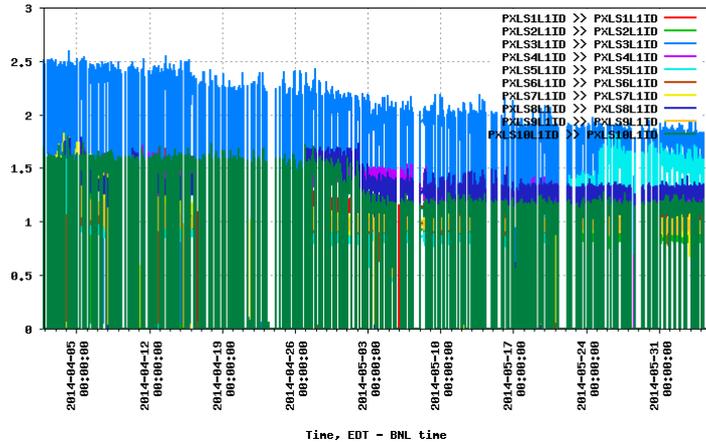
Digital current on the inner ladders after implementing remediation

- Trend of current in inner ladders over time (~2 months) after operational optimizations.
- Note that this requires continuous adjustment of both LU current threshold and voltage supplied to each ladder.

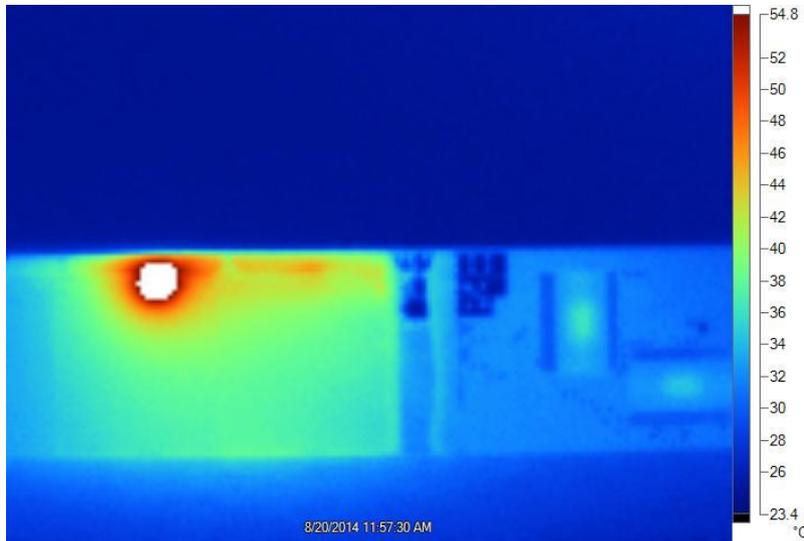
Post run IR picture showing a hot spot in digital section of a sensor. These hot spots are present on all ladders with increased current draw. Testing is still in progress.

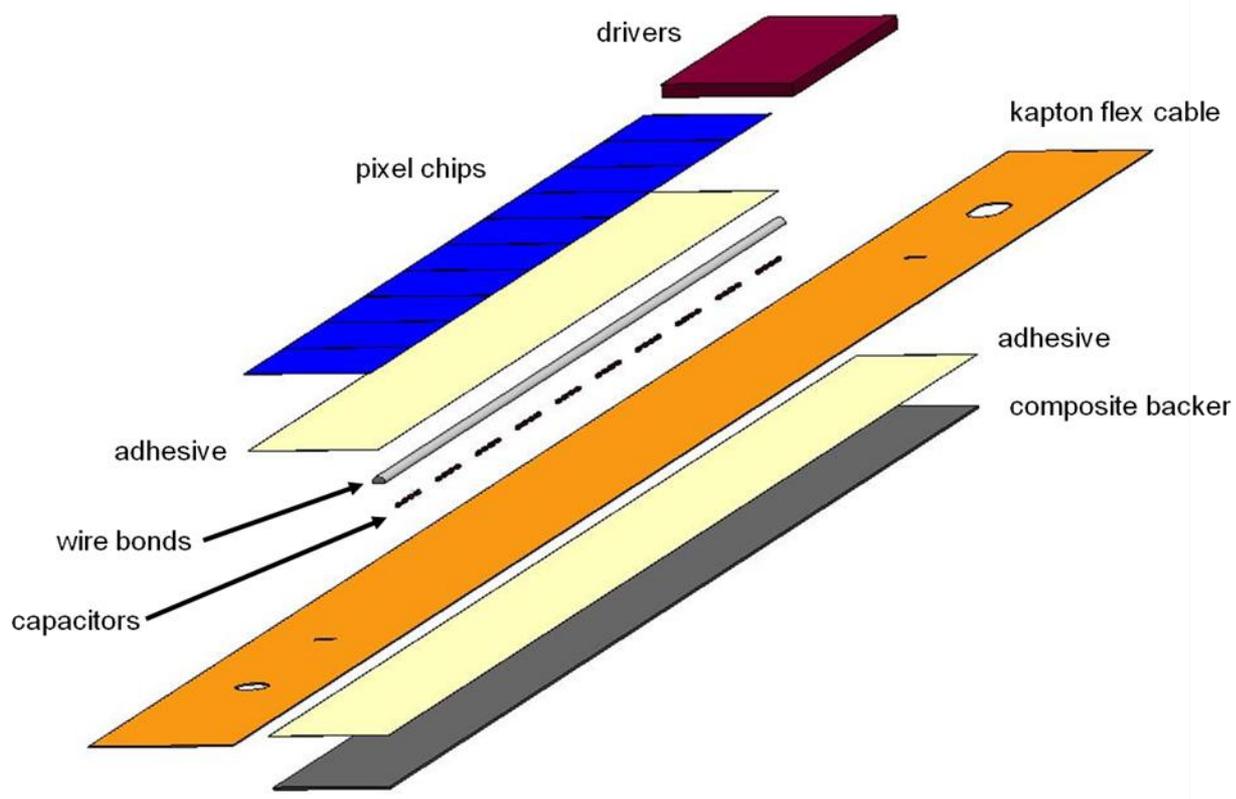
## Ladder cable concept

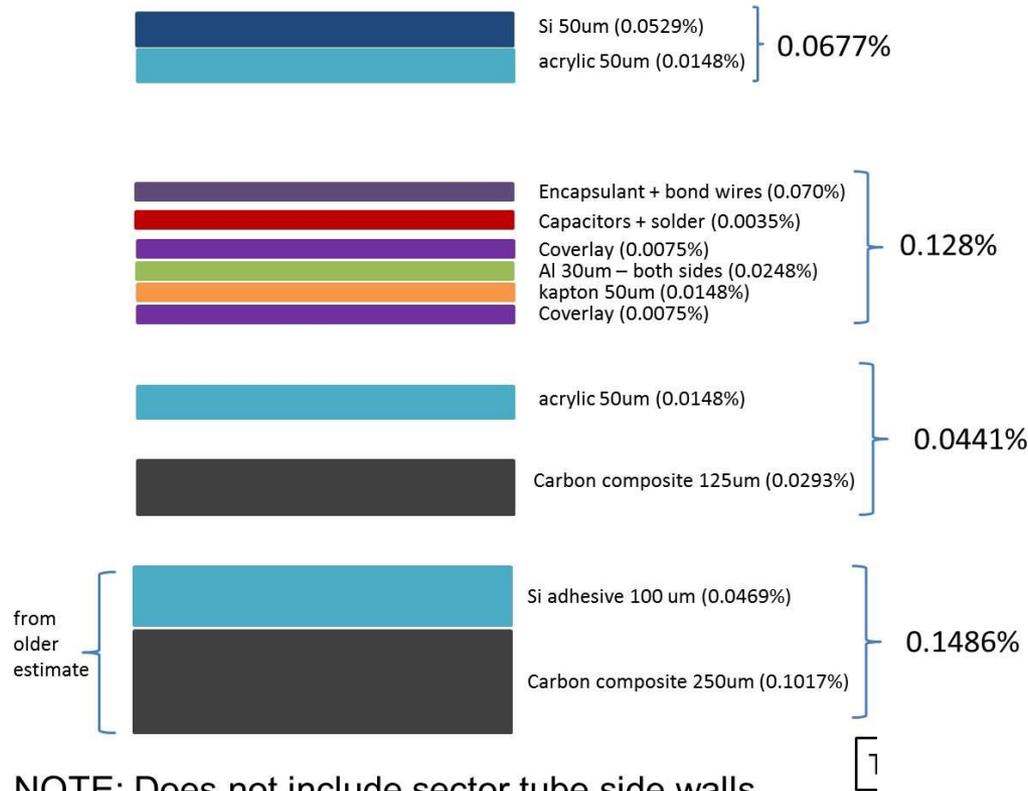
The measurements of an aluminum ladder were performed. In the active area, the breakdown of radiation length is shown below.

Radiation length in low mass area

The copper conductor PCB version increases the radiation length of the conductor to 0.129%  $X_0$  (corrected for the thinner copper layer). This increases the overall radiation length of the copper based inner ladders to 0.492%  $X_0$ .

**Total = 0.388%**

NOTE: Does not include sector tube side walls

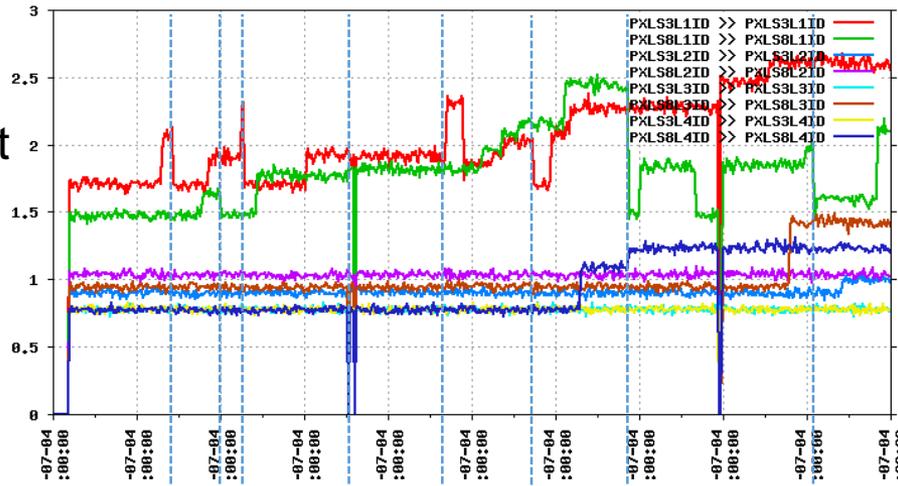
Set LU thresholds to 500mA above operating current and run for ~8 hours with <sup>3</sup>He-Au. (sectors 3 and 8 to allow for cosmic ray data after testing)

Current increases and some resets observed in inner and outer ladders. (some resets take multiple attempts before ladder operation is re-established)

All currents returned to pre-test levels after power cycling the system.

- Non-reset current increases are observed with high LU thresholds in  $^3\text{He}$ -Au running ( $\sim 1/2$  multiplicity).
- Some increases are reset, some persist and do not trigger reset.

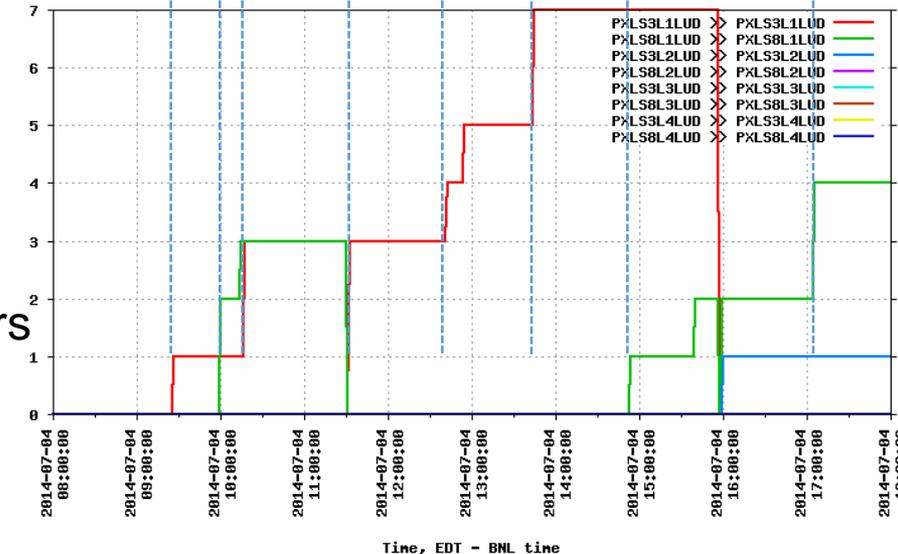
LU Counters

Sampled every few minutes, some increases were missed.
