Cooling @ Test beam Status and prospect

Cooling @ TB: Outline

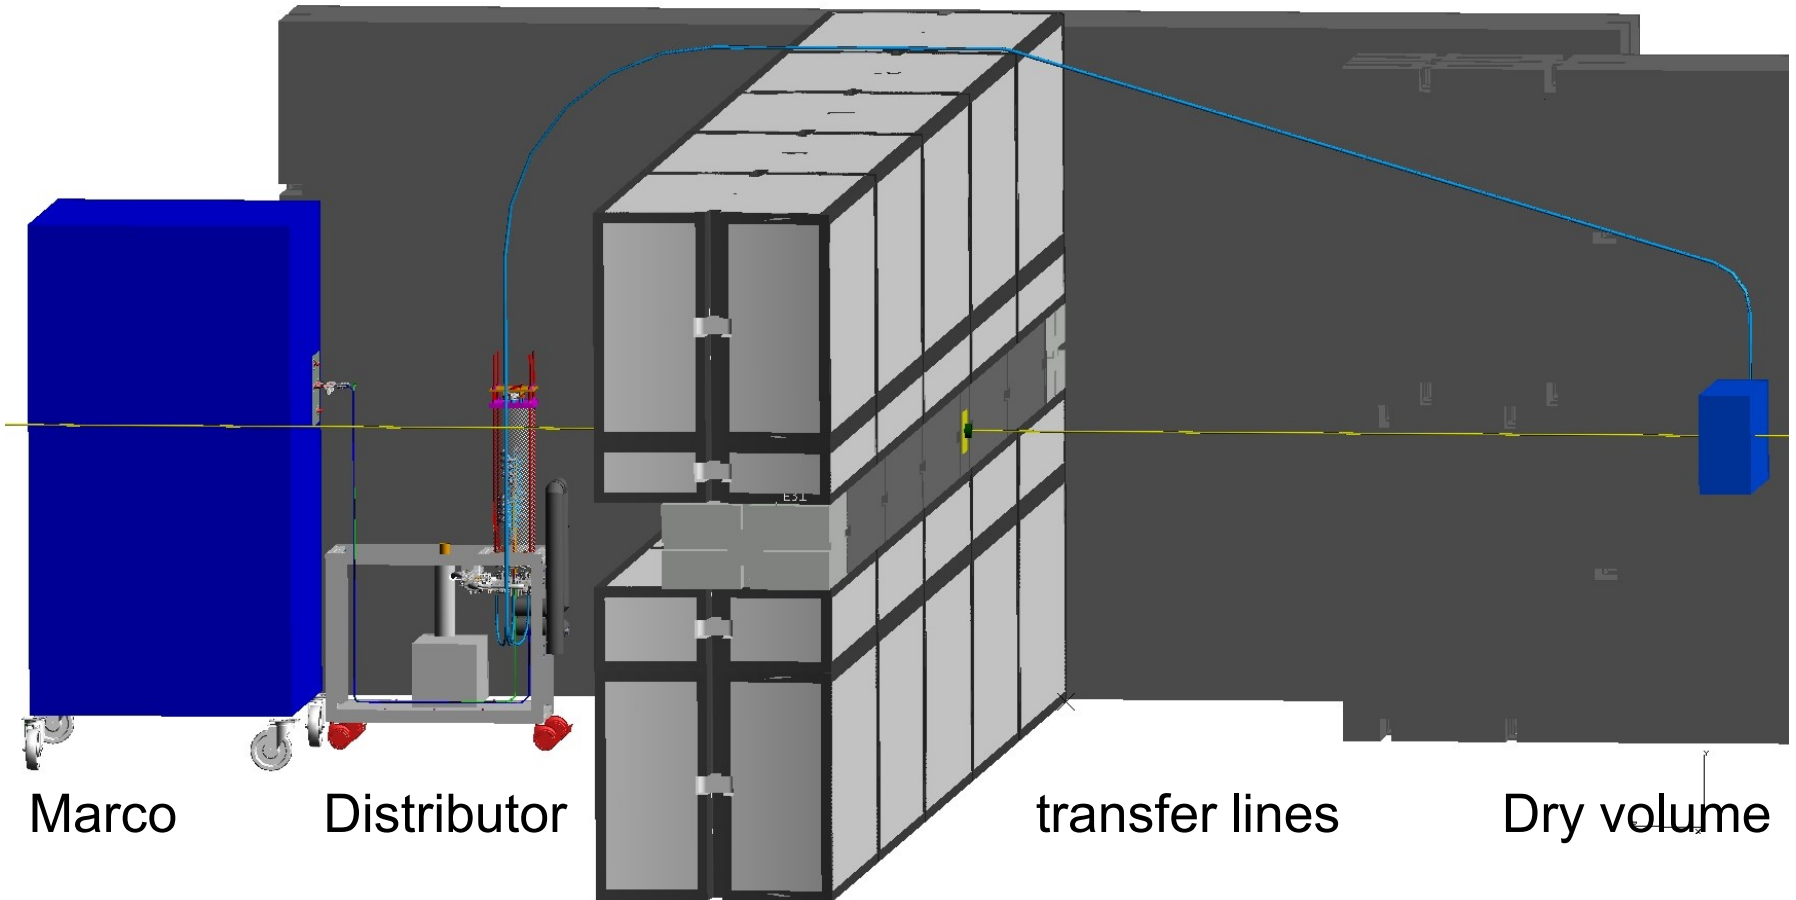
Cooling Setup

TB24

TB24/1

Solenoid

Marco

Distributor

transfer lines

Dry volume

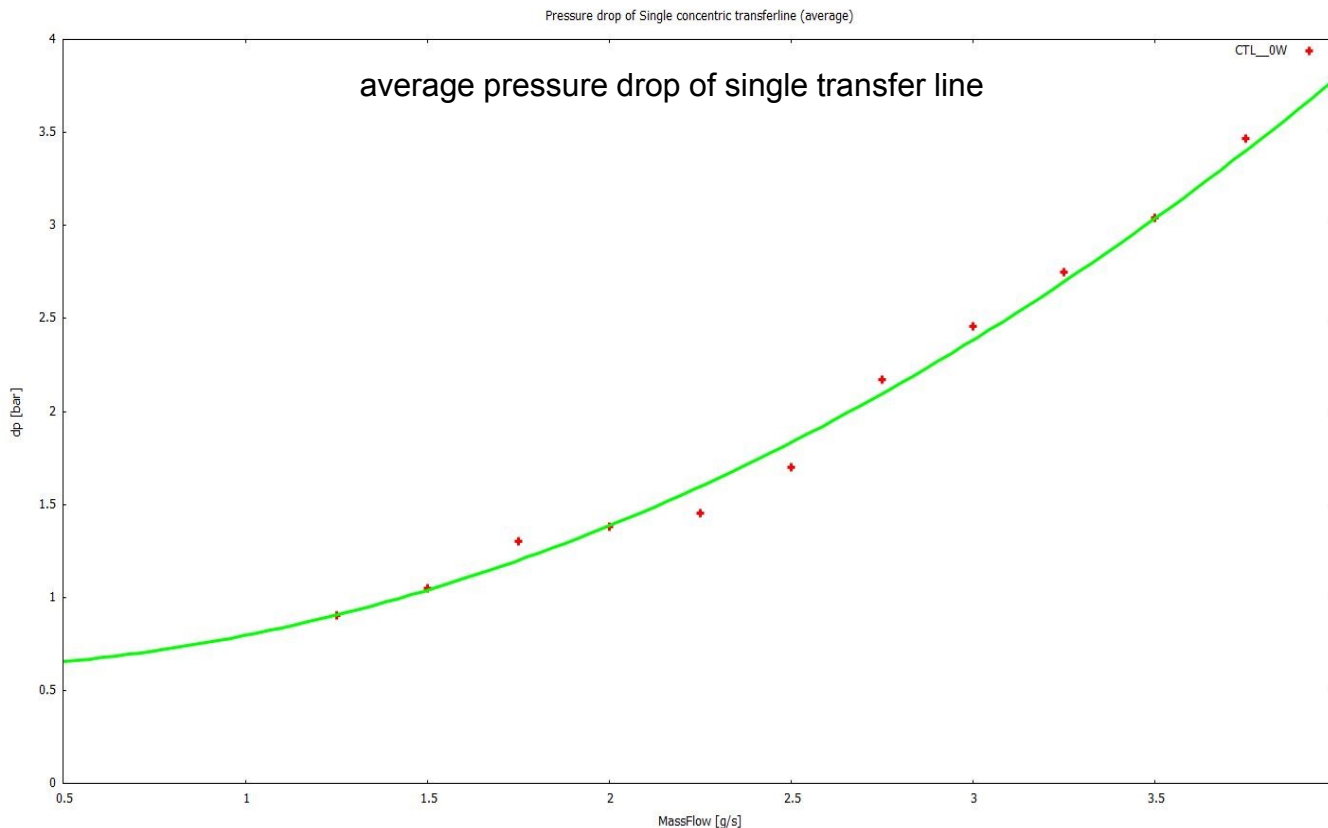
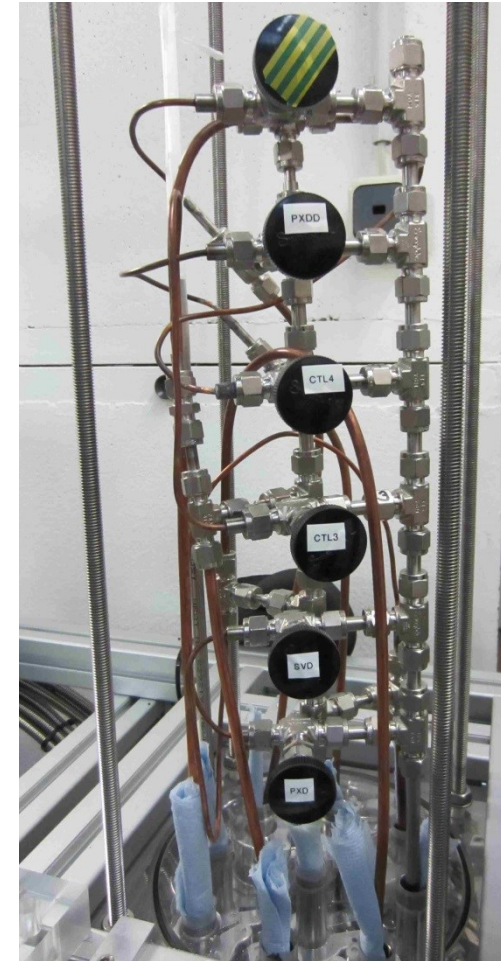
Concentric Copper Transfer Lines

- 6 Transfer lines of 11m
- inner tube: 3.2x0.6mm Cu
- outer tube: 6x1mm Cu
- Vac.iso. : 12mm flex tube St

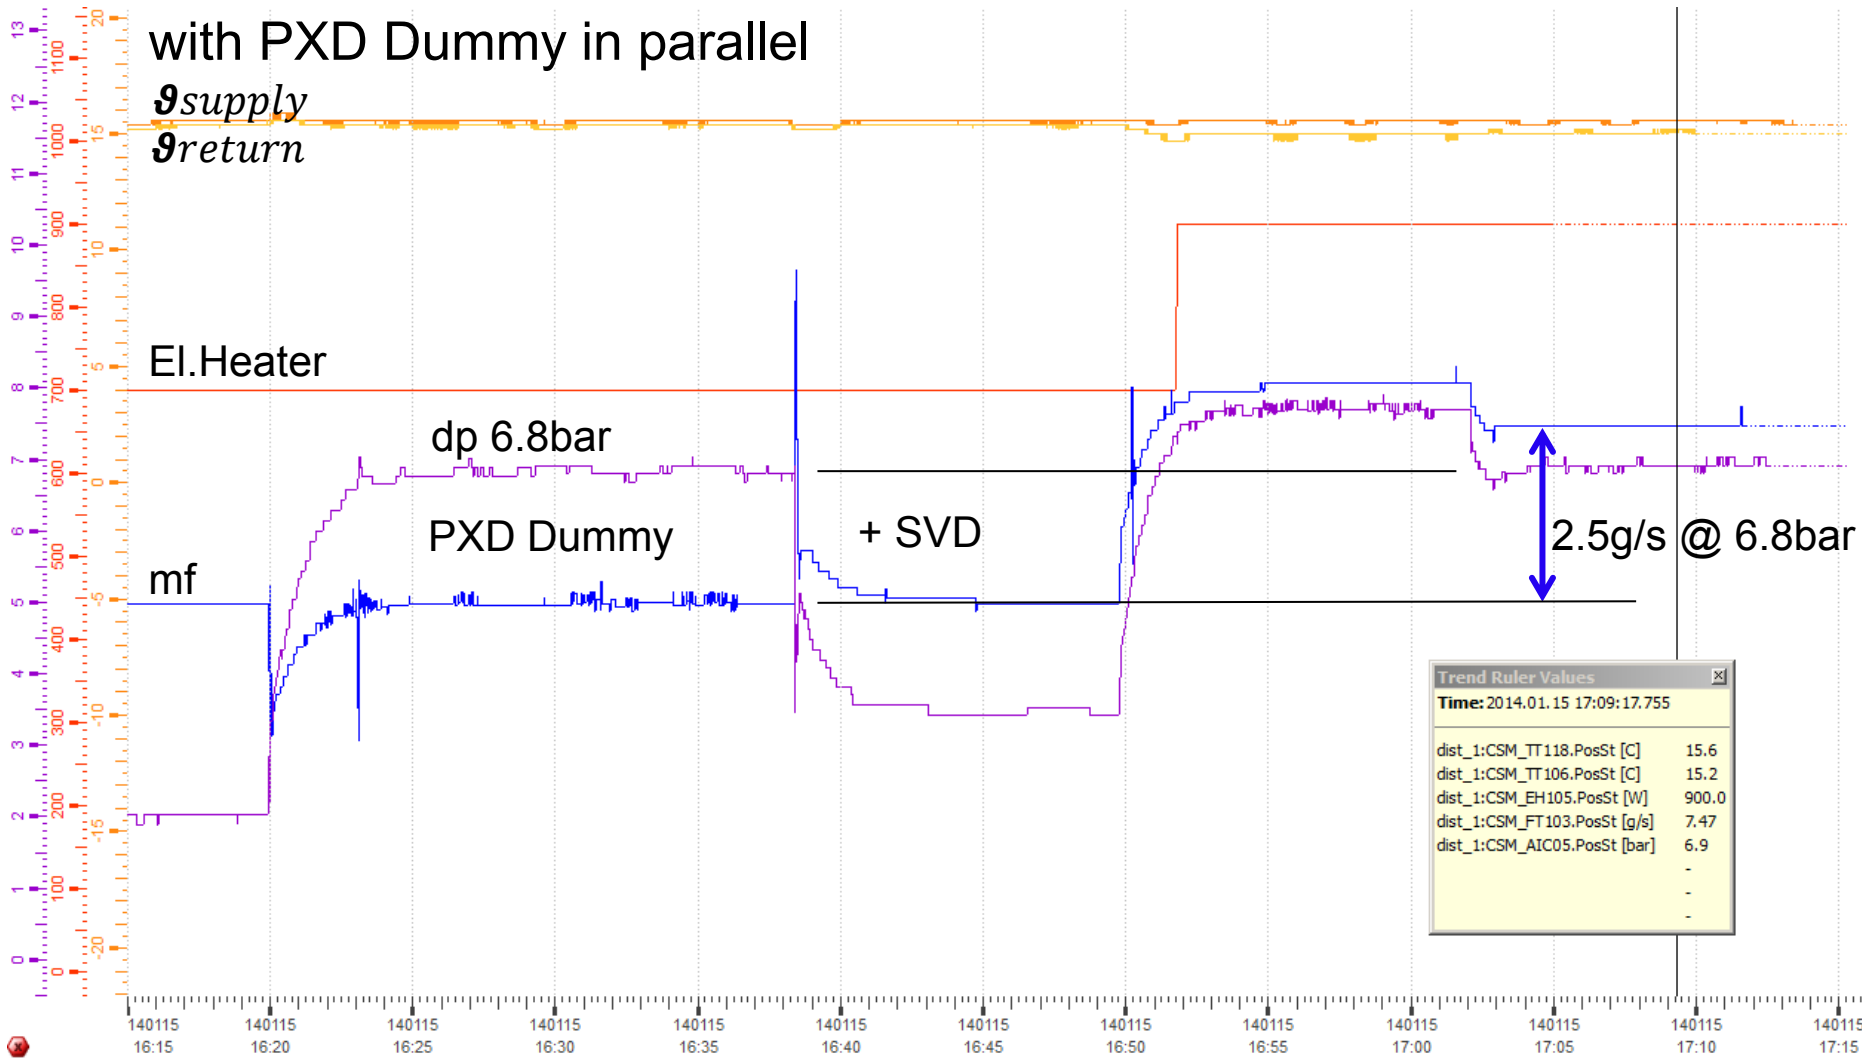
mass flow through SVD

1/15/2014 5:09:17 PM.755	<input checked="" type="checkbox"/> dist_1:CSM_TT118.PosSt	15.6	C	<input checked="" type="checkbox"/> dist_1:CSM_AIC05.PosSt	6.9	bar
	<input checked="" type="checkbox"/> dist_1:CSM_TT106.PosSt	15.2	C			
	<input checked="" type="checkbox"/> dist_1:CSM_EH105.PosSt	900.0	W			
	<input checked="" type="checkbox"/> dist_1:CSM_FT103.PosSt	7.47	g/s

- Run Marco at 15`C with 1 separate PXD cooling block connected and heater running at 700W.
- Pressure drop 6.8bar at mf 5g/s.
- Opened additional SVD loop: pressure dropped to 3.5bar.
- Increased the mass flow to 7.5g/s to reach again 6.8bar pressure drop. Also the heater power needed an increase to 900W.
- The additional 2.5g/s are the mass flow going through the SVD loop.

- > minimum mass flow: 5g/s
- > with only one transfer line and SVD cooling tube 1.6mm x 0.2mm 2m long
- > pressure drop over the experiment: greater than 10bar
- > the limit for Marco control to the stop the pumps.

- > second transfer line and spare PXD cooling block added as a bypass

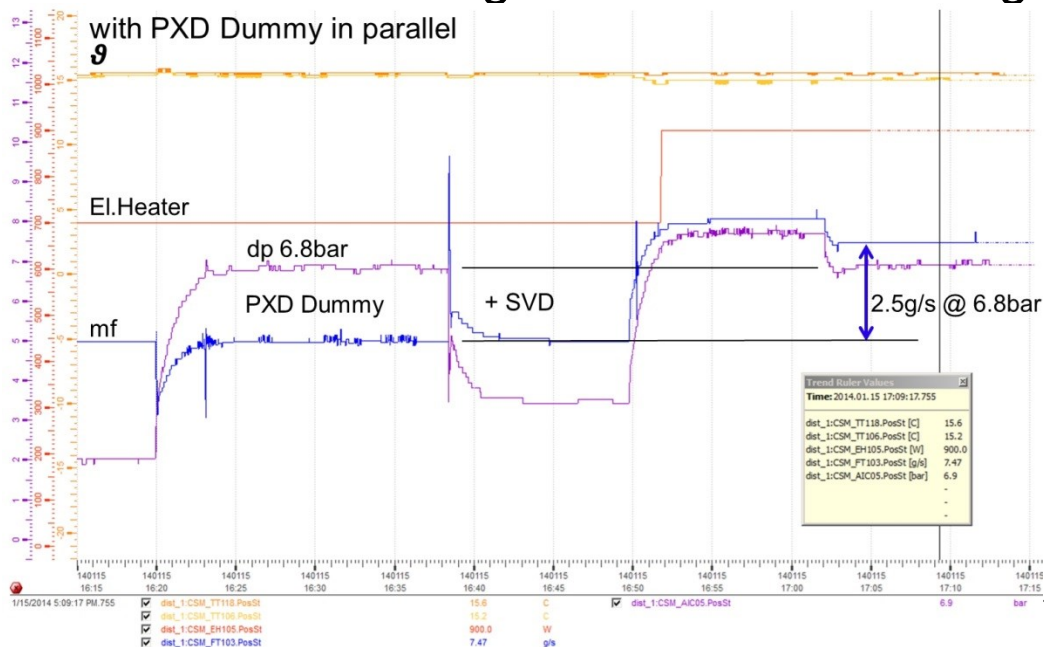
pressure and temperature drop

- Even if the return temperature equals the supply temperature
- there is a pressure drop along the thin SVD cooling tube
- leading to a corresponding temperature drop in the 2-phase region

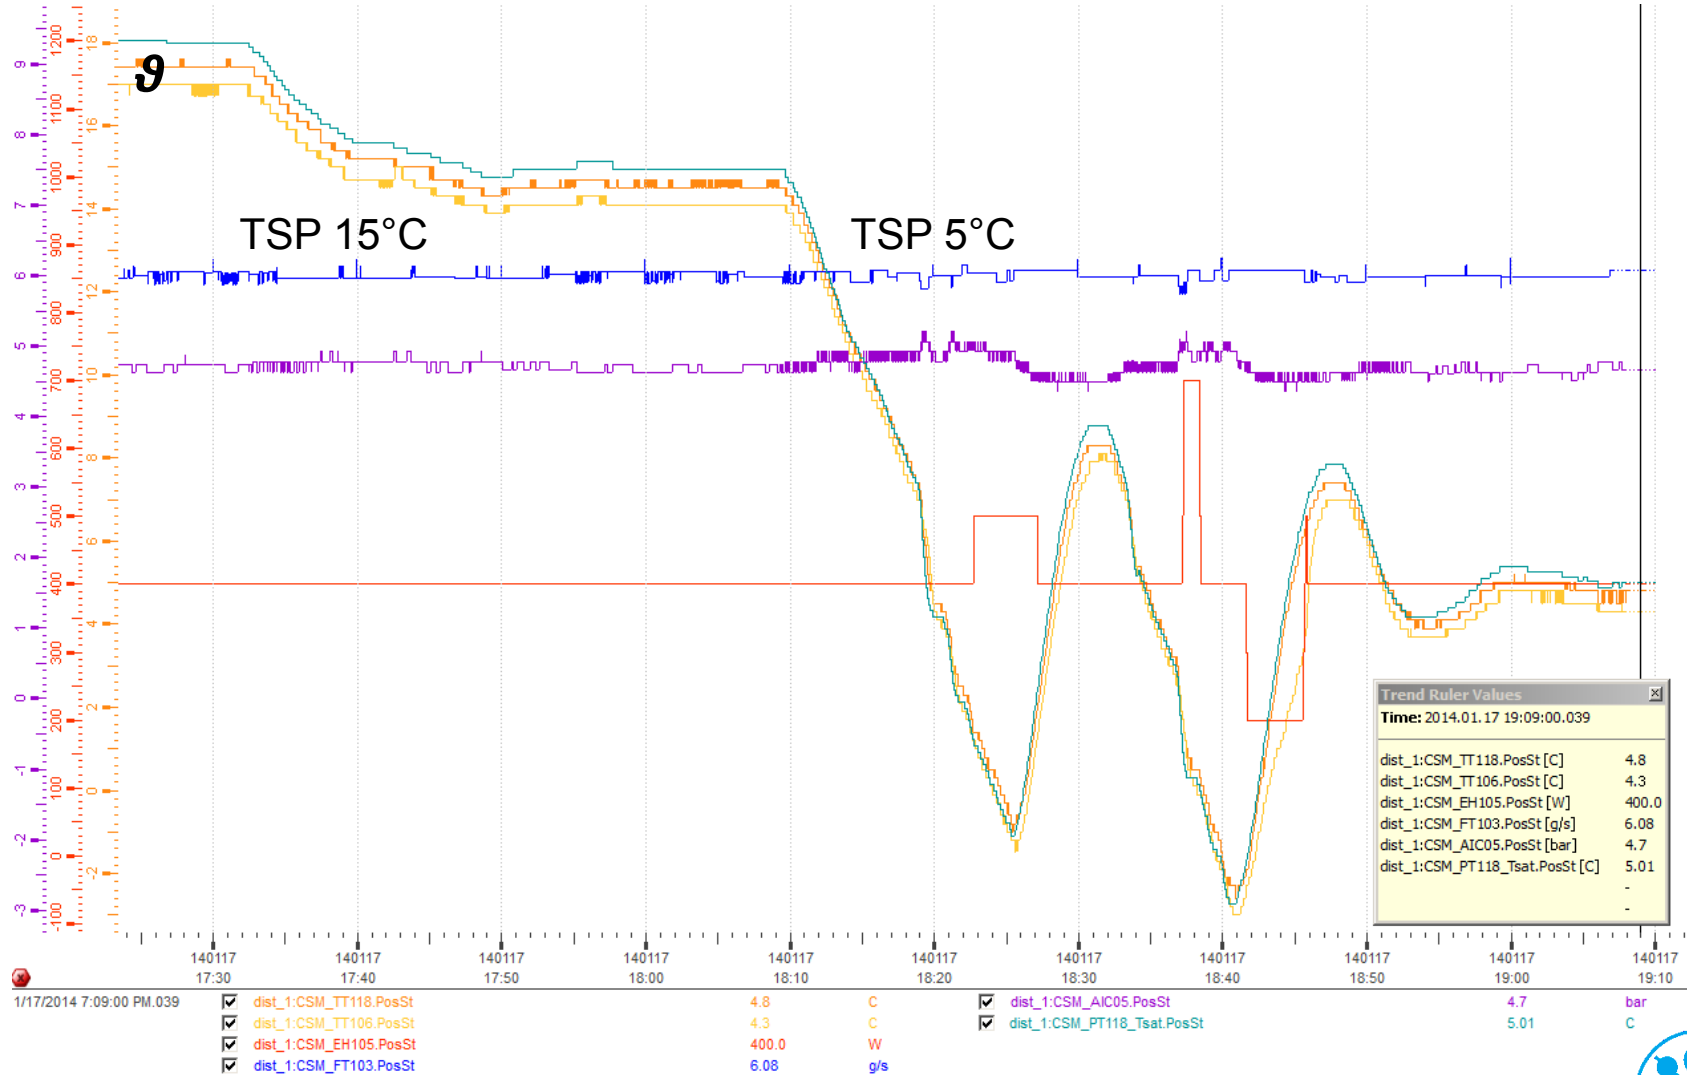
Lowering Temperature Set point

➤ Overshooting at larger change

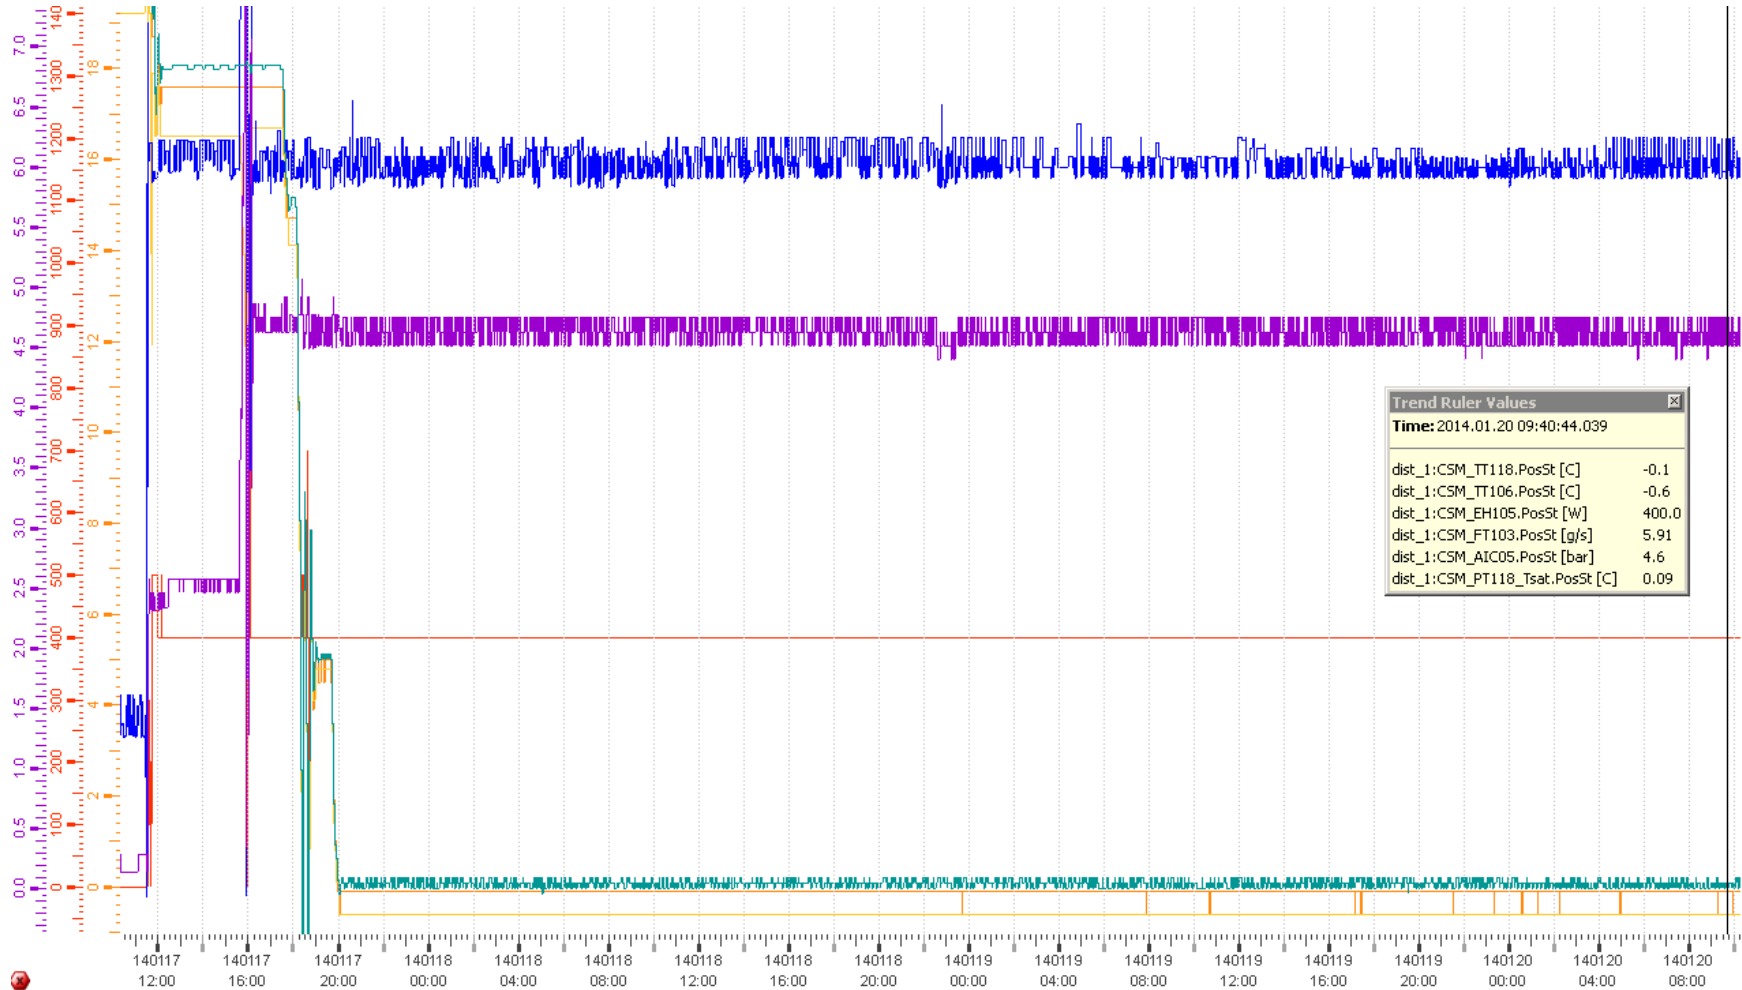
Weekend run

but increasing pressure drop over filter FL103 after CO2 pumps

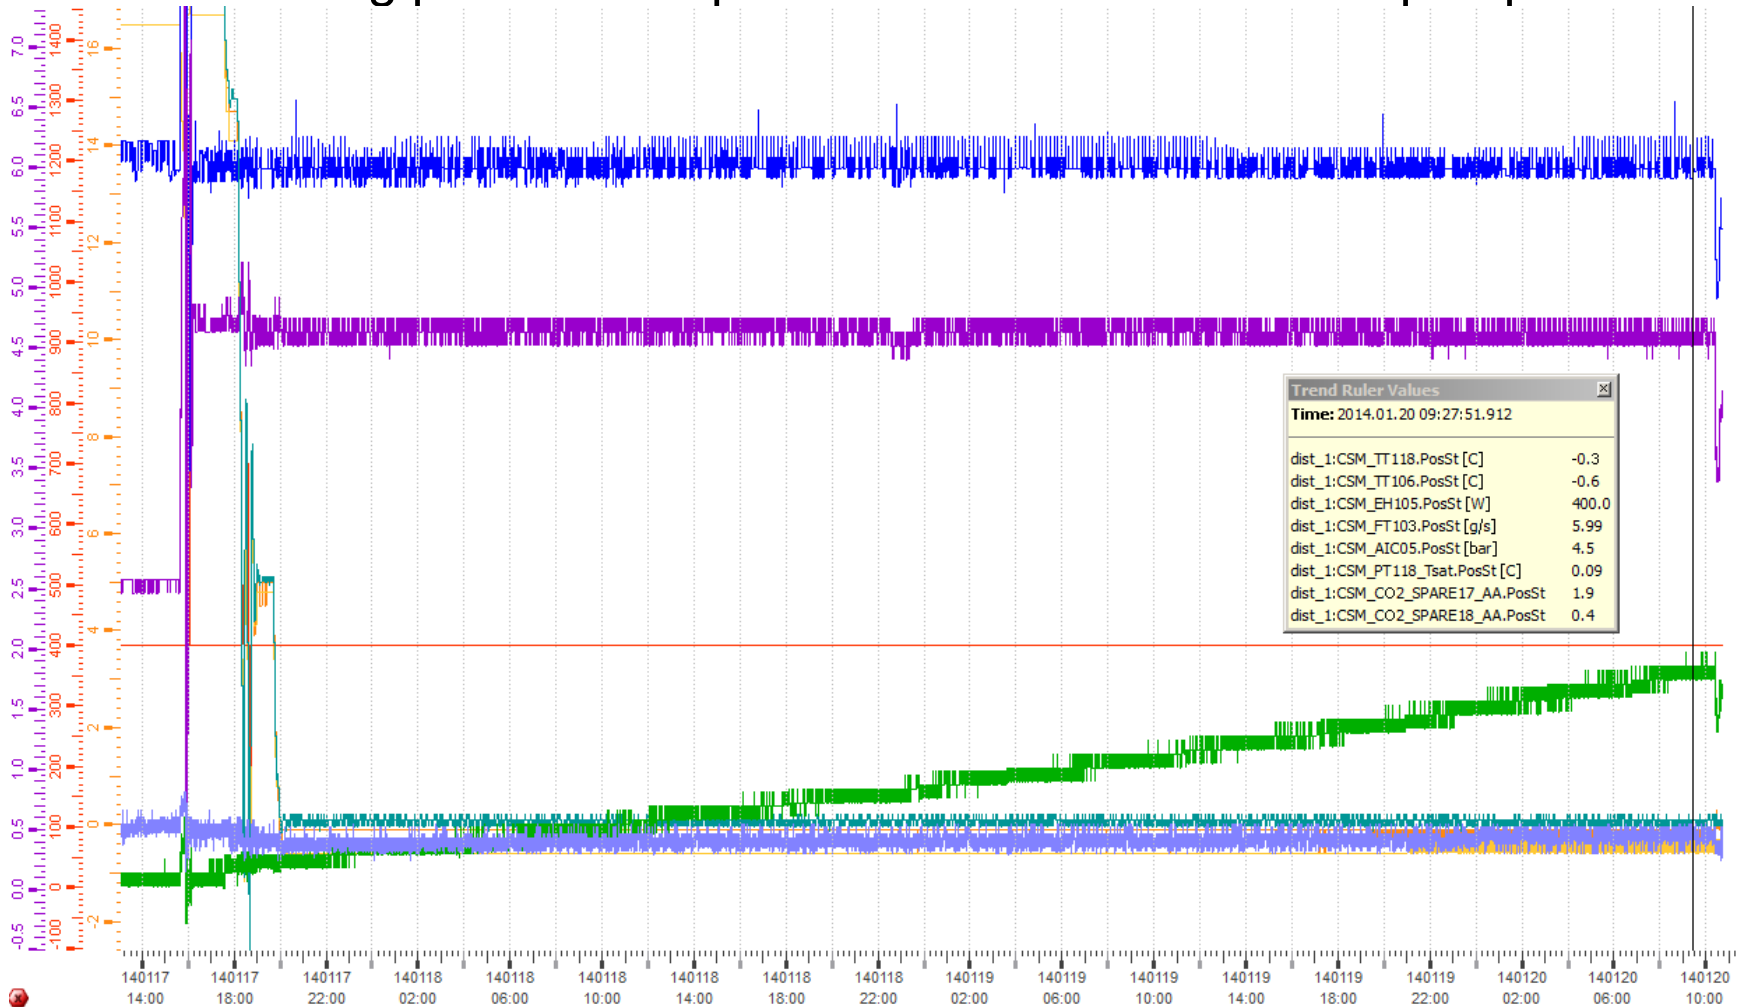
Filter filled

➤ After pumps stopped for short filter pressure drop falls to 1bar

but rose over 5 hours again to 1.5bar.

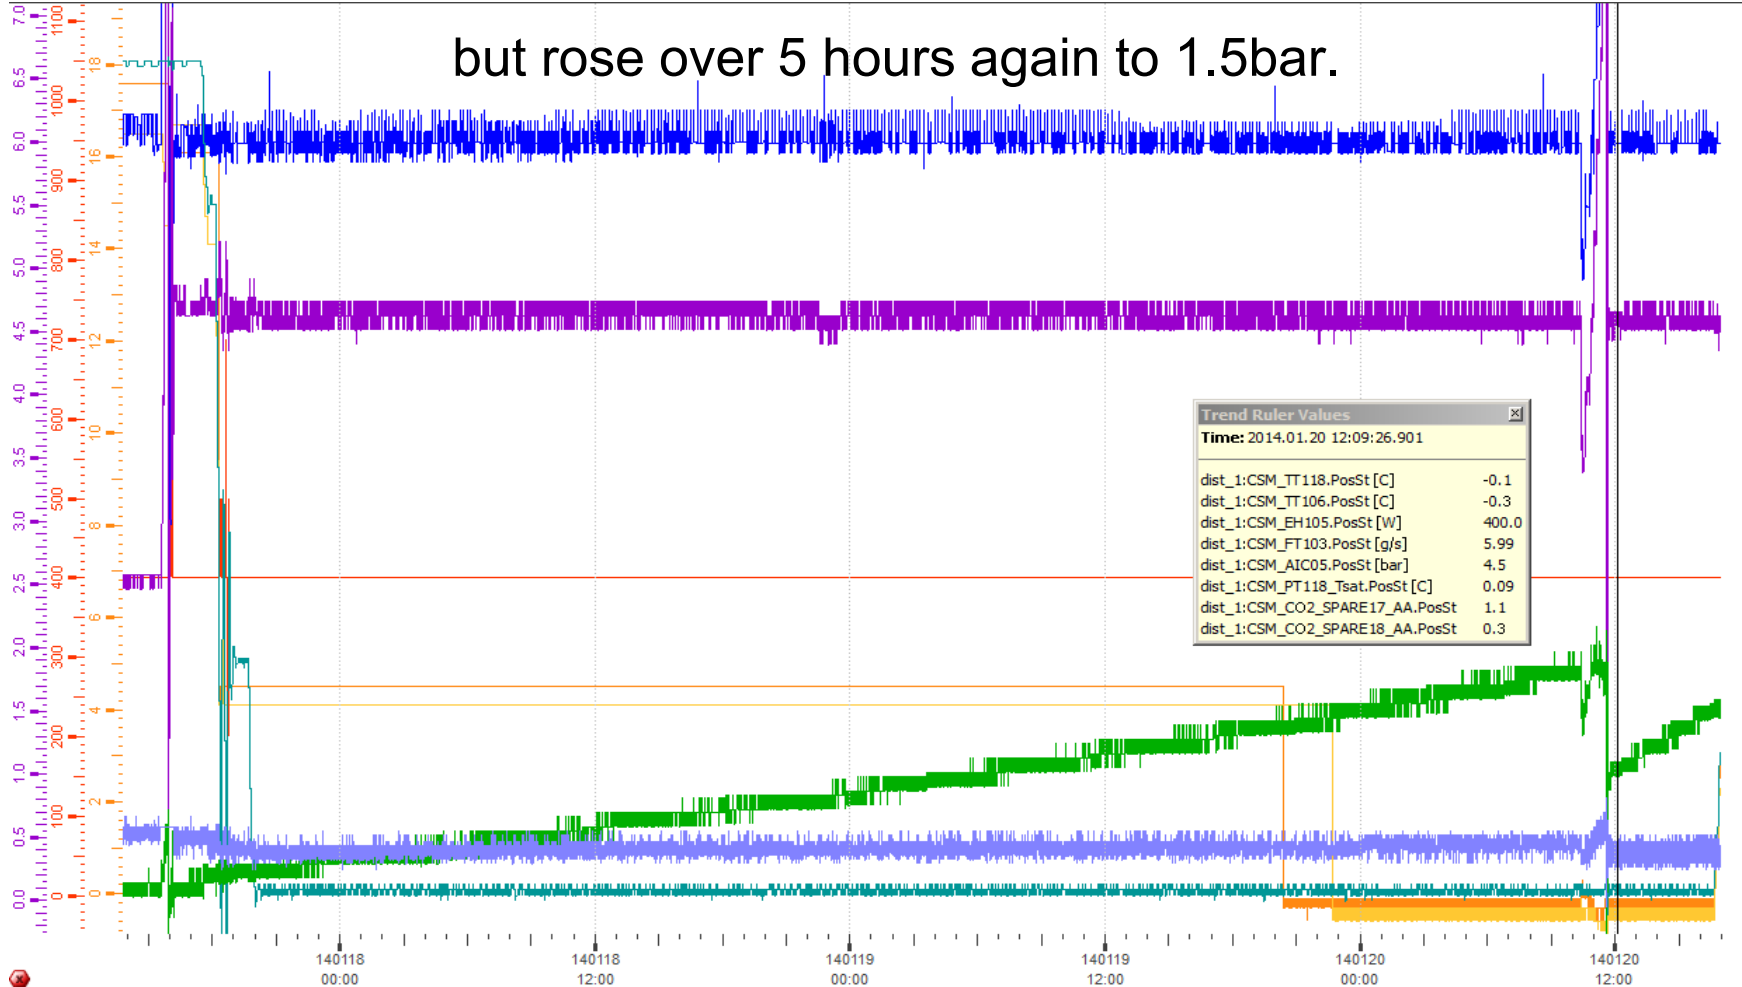
Filter cleaned ...

- After cleaning the filter also filter FL101 in front of pumps shows a high pressure drop of 1.3 bar at mf 5g/s. Flushing in CO2 filling might have distributed dirt.

- > Until filters and probably pump heads are changed and tubes cleaned

- > for a timespan of hours
- > till the filters pressure drop reaches 2.5bar
- > an interrupt of the mass flow might bring a relieve
