Recent inspection results by Kyoto-camera

Ken Watanabe (KEK)

TTC meeting at New Delhi

October 20-23, 2008

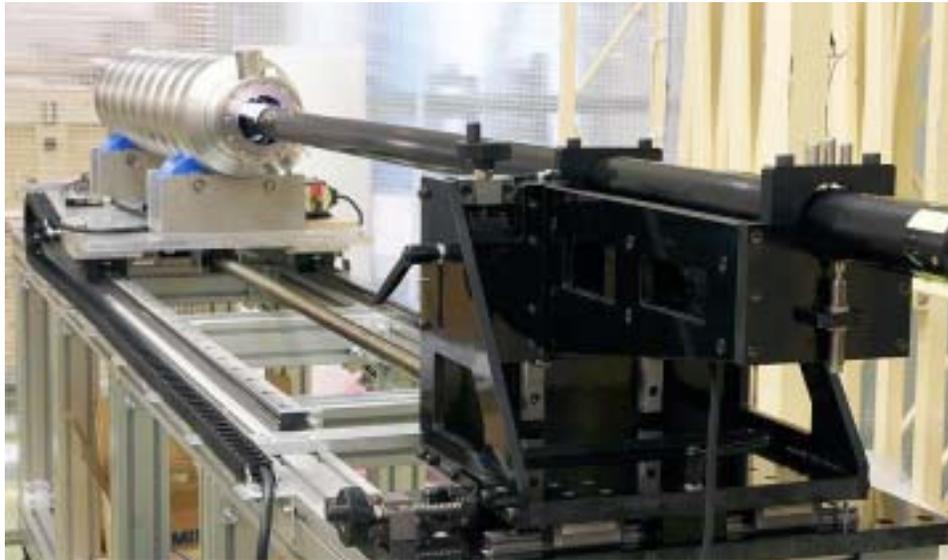
Schematic drawing of the wall gradient measurement

- * The High resolution images can be taken.
- * The wall gradients of inner surface can be measured to use the Strip line EL illuminator. (Judge -> Pit or Boss ?)
- * The heights or depths can be also estimated by measured wall gradients for some well-conditioned defects.

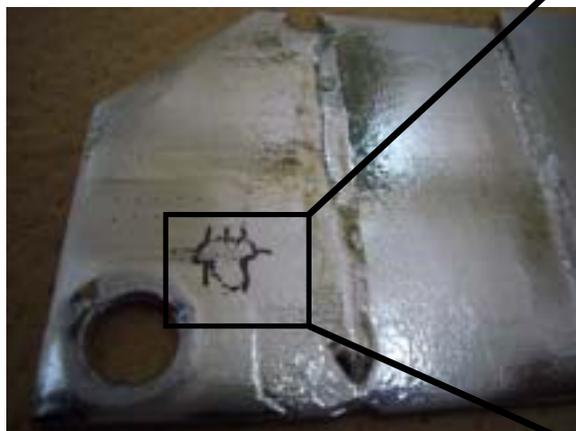
Niobium sample plate

- (1) Make a pits on the Niobium plate (Finished EP) by using a stainless ball (Diameter is 2.44 mm)
- (2) The shape analysis of these pits made as following methods,
 - : Kyoto camera system (Tajima method)
 - : Laser microscope (Keyence VK-8500)

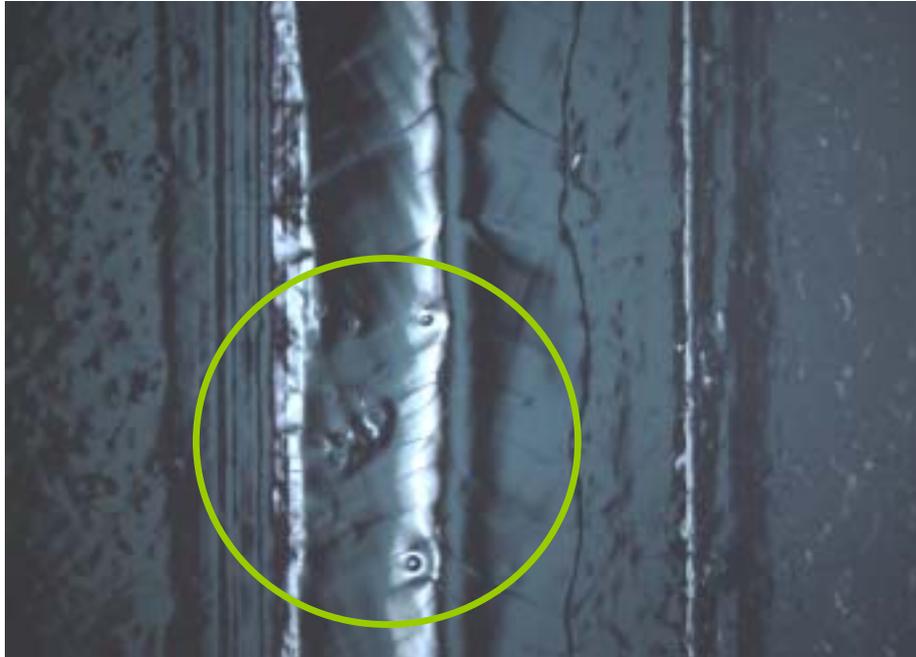
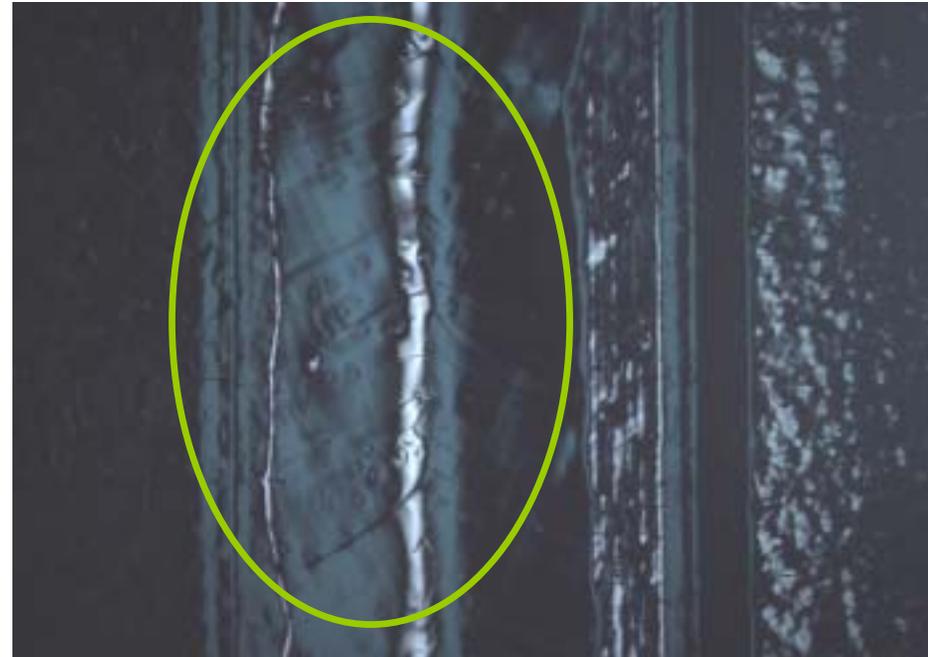
ex) Z111 #4 equator, $t=296$ deg, group of spot

ex) Z111 #5 equator, $t=43$ deg, group of spot

There was almost no type-2 spot in Z110.
Material removal difference?

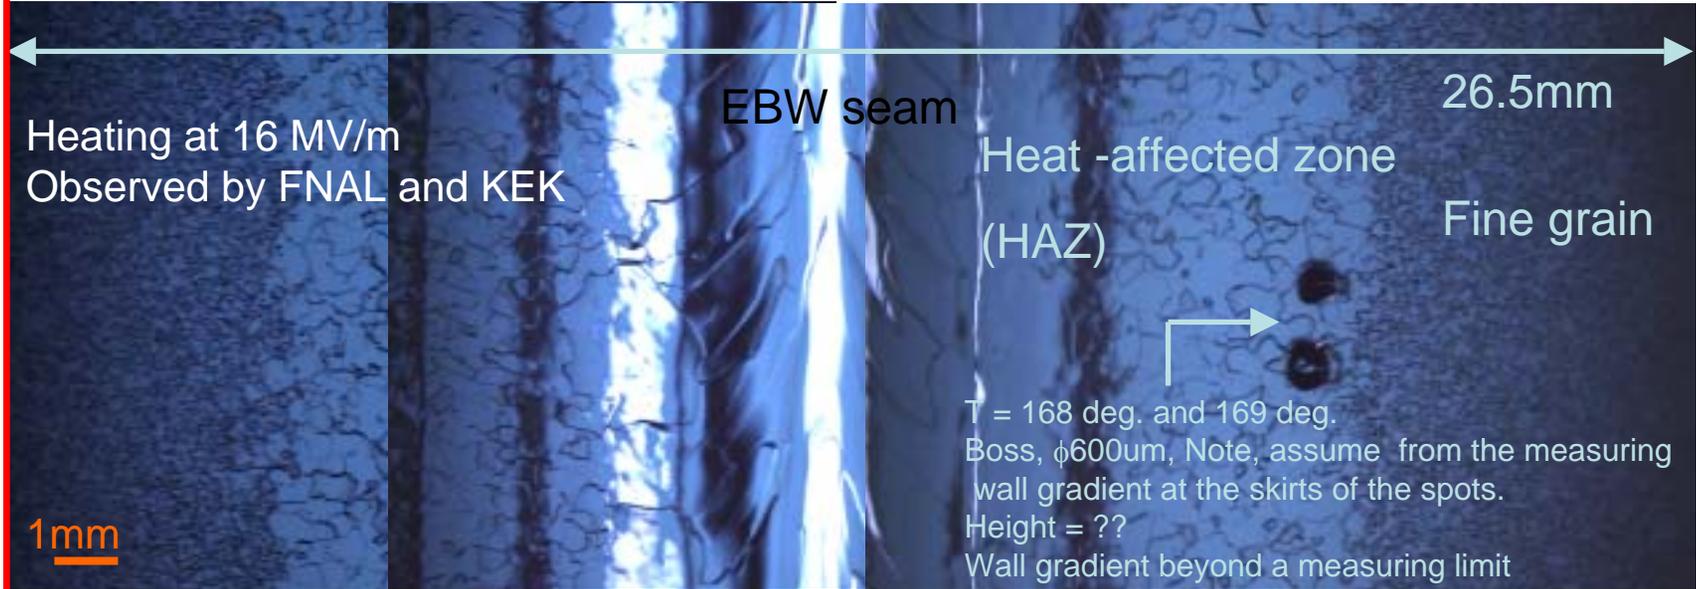
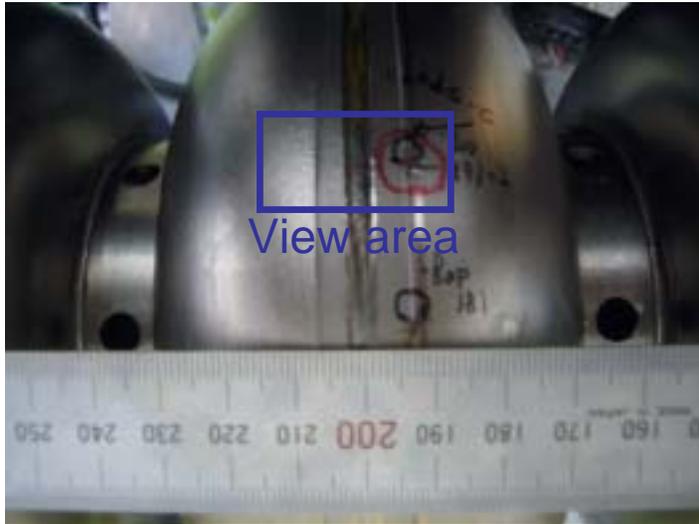
Twin spots were observed on the heat-affected zone (HAZ). EBW seams were very smooth at all cells equator.

Other spots position : #3 cell equator, $t = 181$ deg on the HAZ.
(Boss, diameter = 400, height = 42 μm)

#7 cell equator, $t = 325$ deg on the HAZ.
(Pit, diameter = 500 μm , depth = 28 μm)
Max Eacc = 16 MV/m, But no heating.

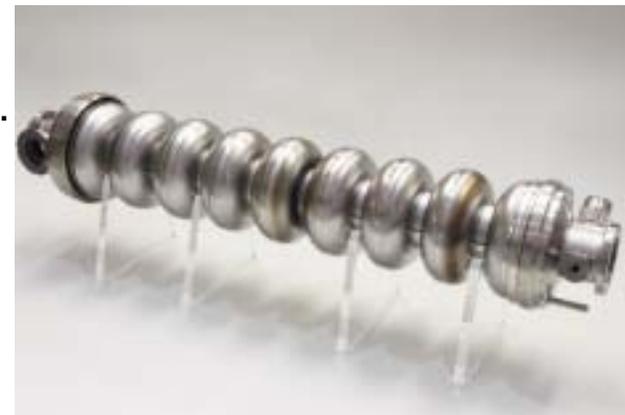
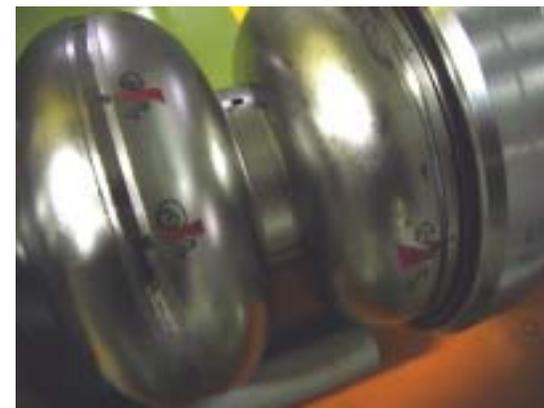
The cat eye can find after EP-1 process (25 + 100 um removed) , and can measure the shape of the spot.

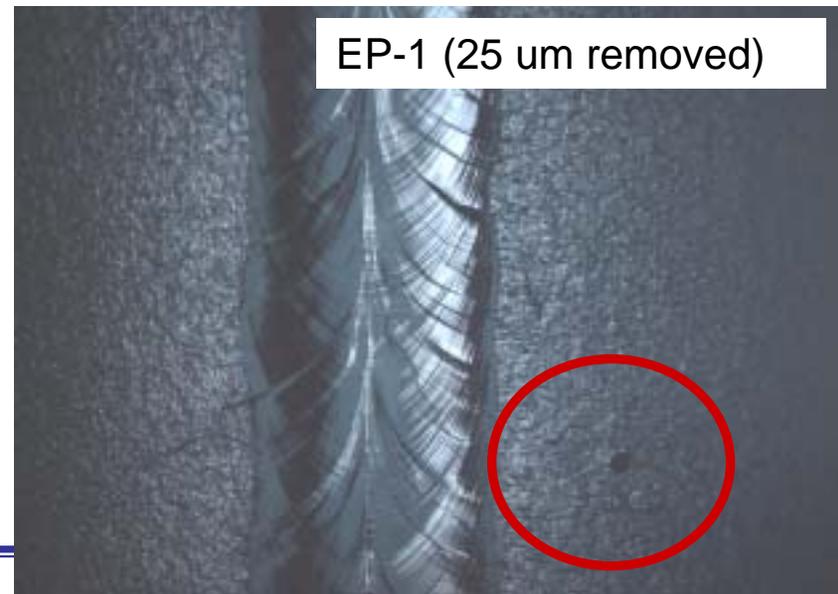
Two type of spots were observed on the STF Baseline cavities.

- 1) Boss on the HAZ at equator (diameter: $> \phi 300 \mu\text{m}$)
- 2) Pit on the HAZ at equator (diameter: $> \phi 300 \mu\text{m}$)

EBW seams were smooth.
