High Pressure Vessel Code Test of Module 3*

TESLA Technology Collaboration Meeting
New Delhi, October 20th – 23th, 2008

Pressure test of cavity and He vessel

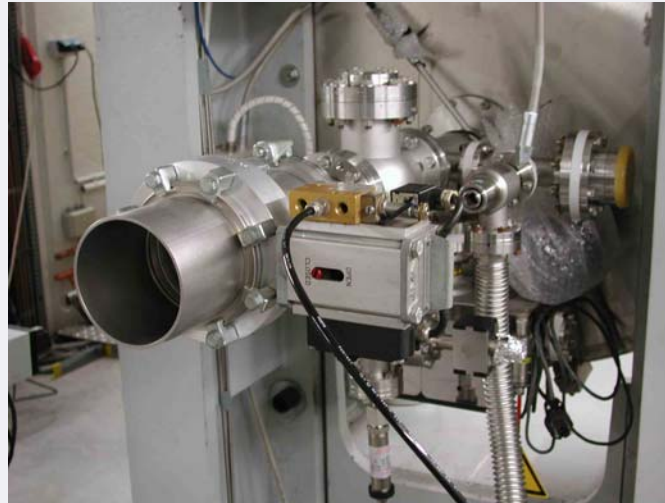
Venting system
beam-pipe-vac DN 100

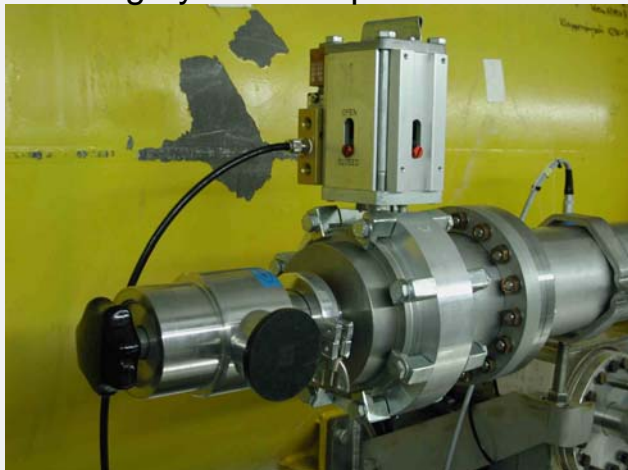
Venting system coupler-vac DN 100

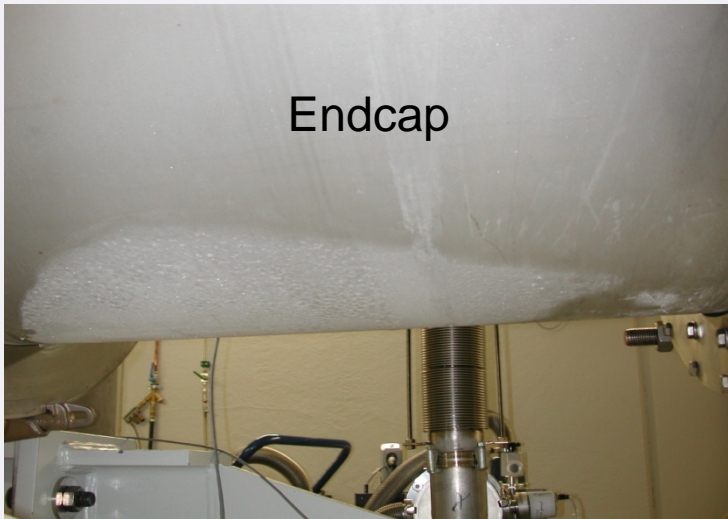
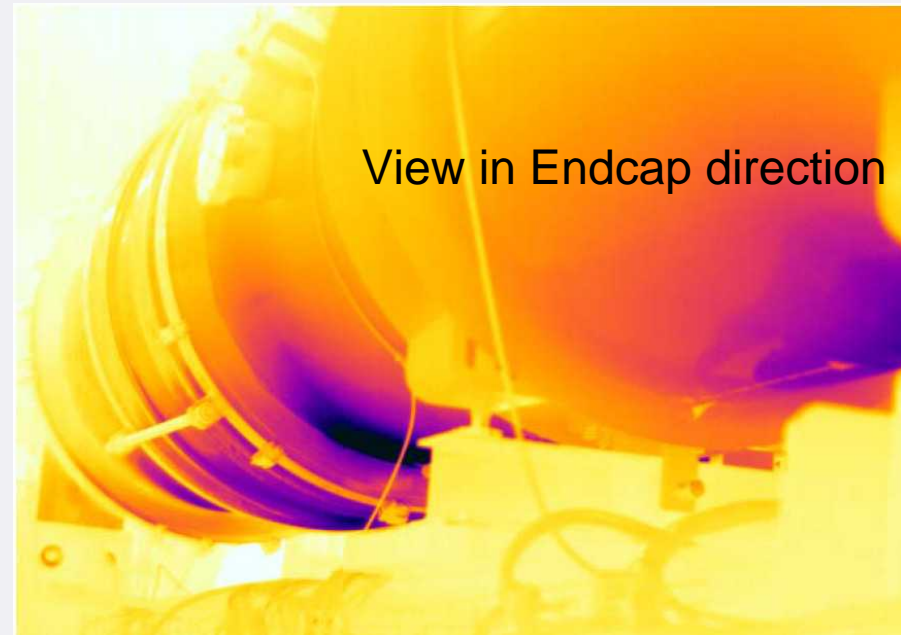
Cold areas after Iso.-Vac venting

Position of the additional
Temp.-sensors on the coupler flanges

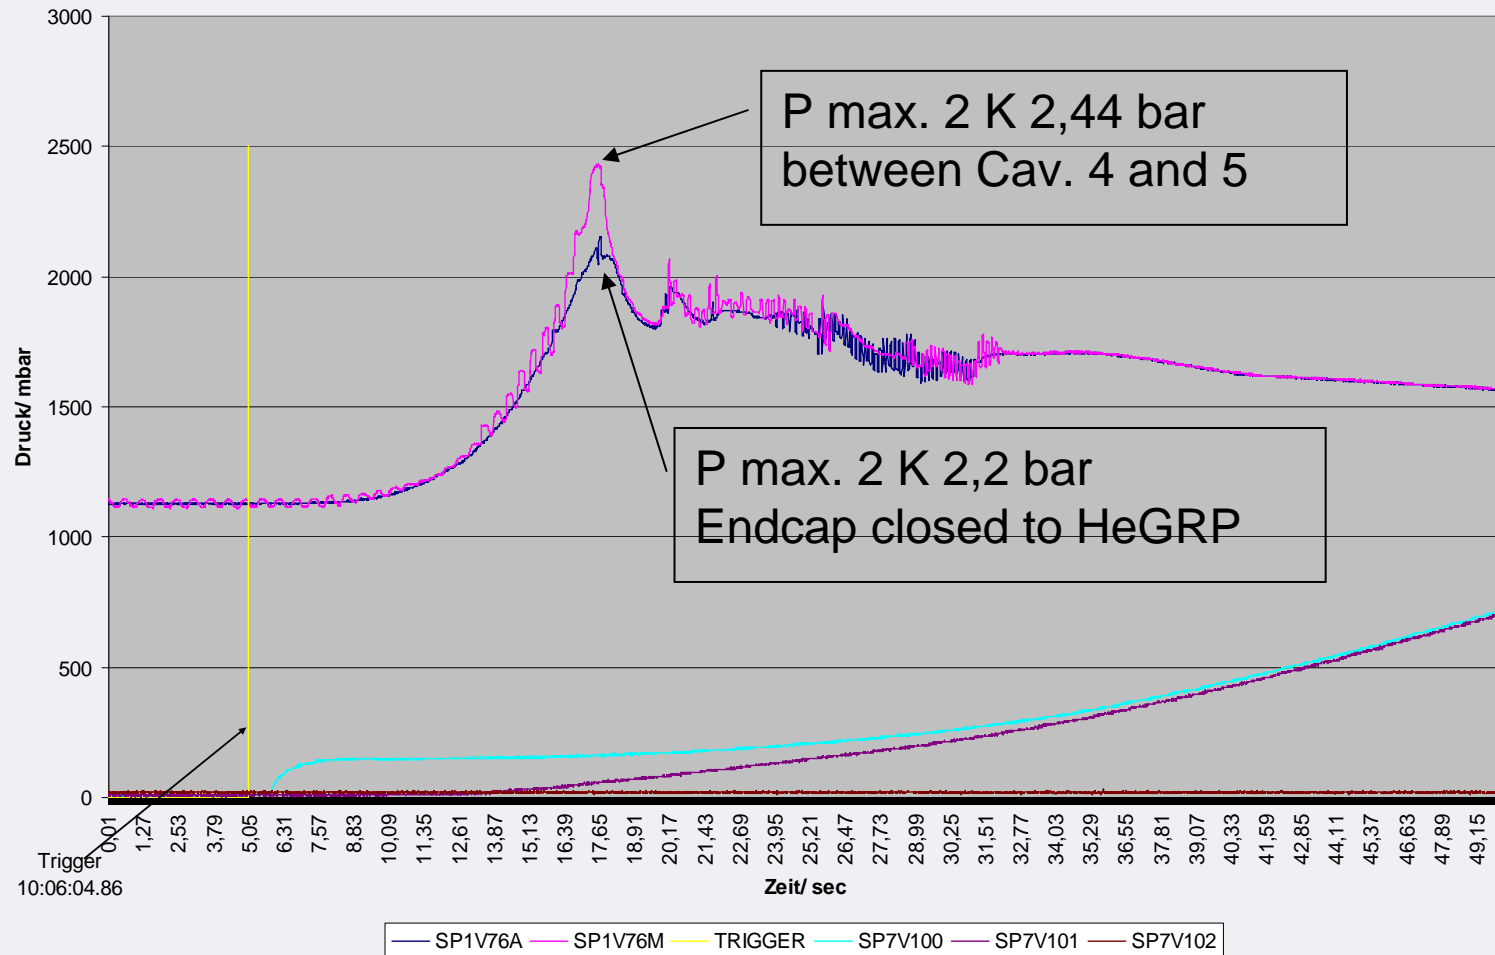
Worst case scenario: Iso.-Vac. venting with air at 4.5K with closed valves

Schnelle Auslese am 09.05.08 1-50 Sekunde

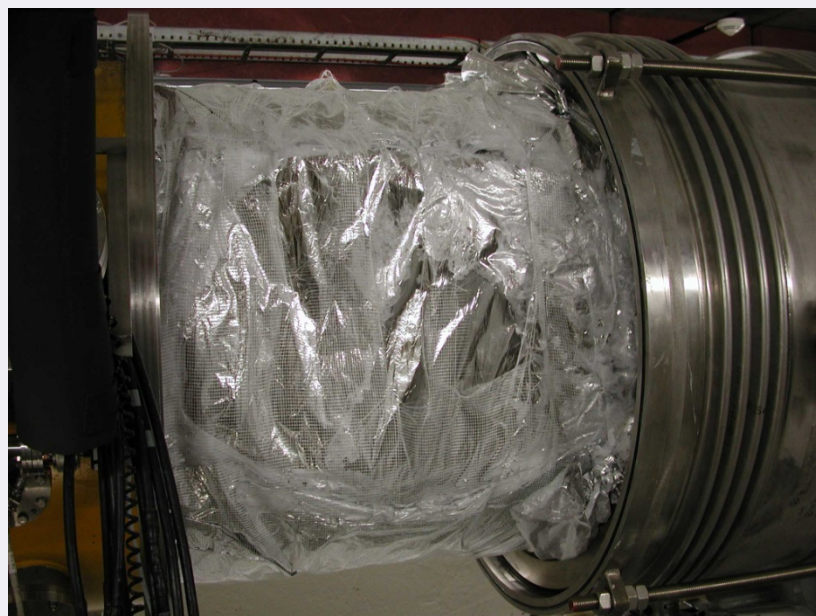
we have lost some of the layers from the insulation in the venting area

we see a 'small' deformation in the 70K shield, the extruded aluminium pipe is bent

- The deformation of the XFEL module's 70K shield is more relaxed because the expanse of the thermal shield is smaller then for the tested Type II module

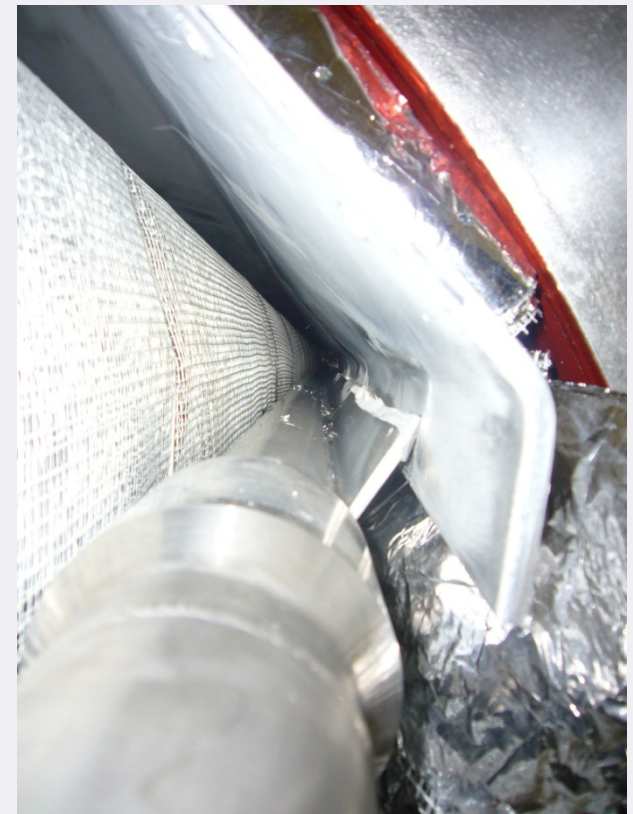
- Xray started at $\sim 4\text{-}5\text{MV/m}$ up-to 120mGray/min ($\sim 11\text{MV/m}$)
- Missing of some cables with temp.sensors in He-circuit (HeGRP)
- No detuning of the cavity frequency and field flatness
- All tuner drive systems work after all these Iso.-Vac ventings
- ***We see no mechanical defects/effects on the cavities, couplers and the magnet!!!!!!!!!!***

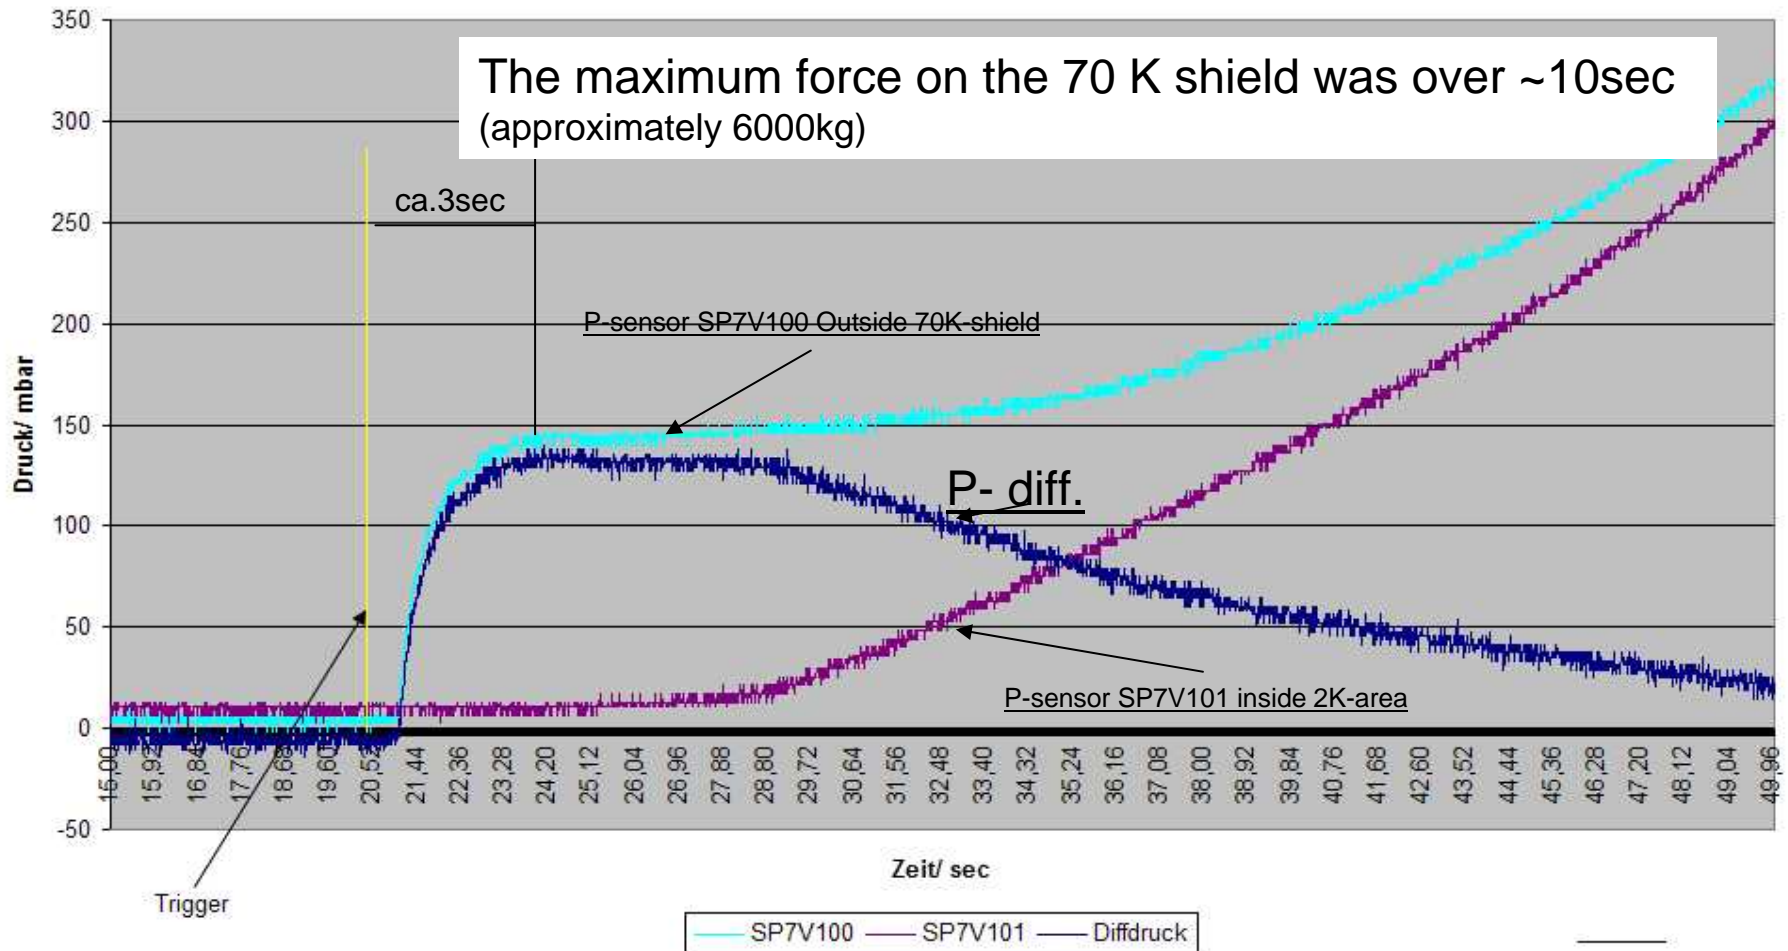
Diff-pressure Vac.-vessel vs. internal shields over 30 s

Schnelle Auslese am 9.05.08

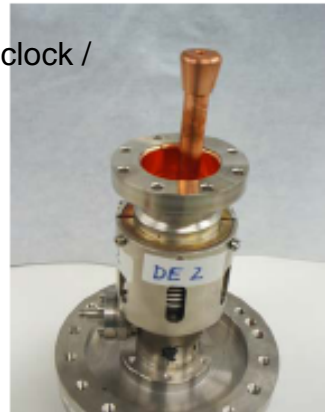
Coupler #2
difference: 5.5 mm

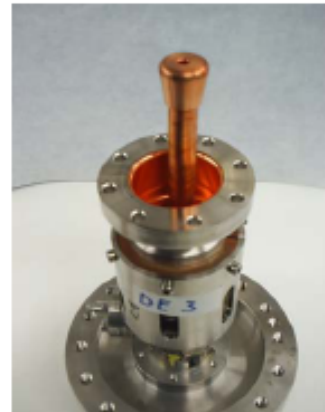
Coupler #3
difference: 2.8 mm

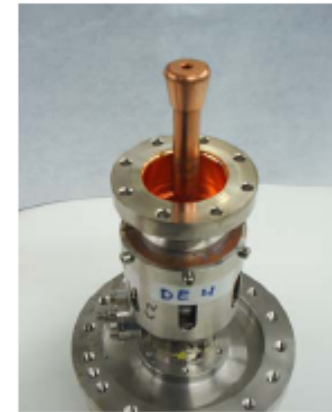
Coupler #4
difference: 0.5 mm

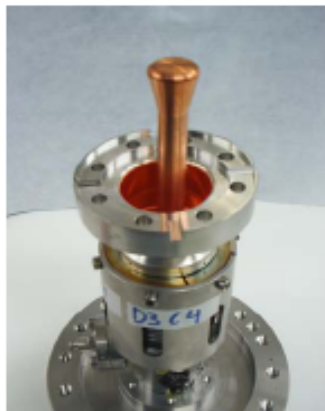
Coupler #5
difference: 2.7 mm

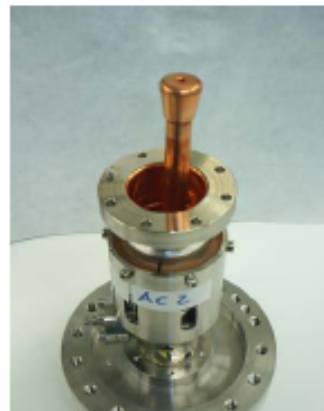
Coupler #6
difference: 5.0 mm

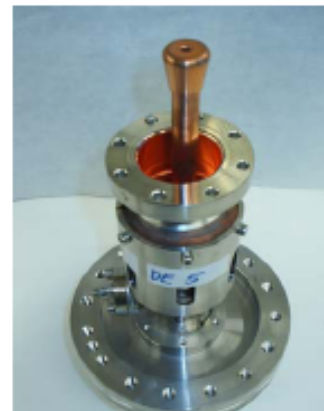
Coupler #7
difference: 2.4 mm

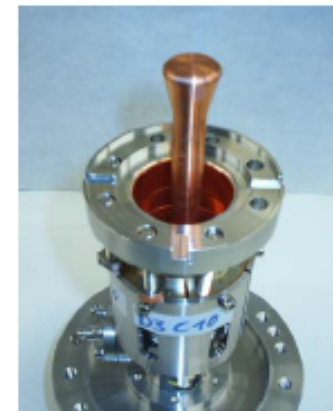
Coupler #8
difference: 1.7 mm

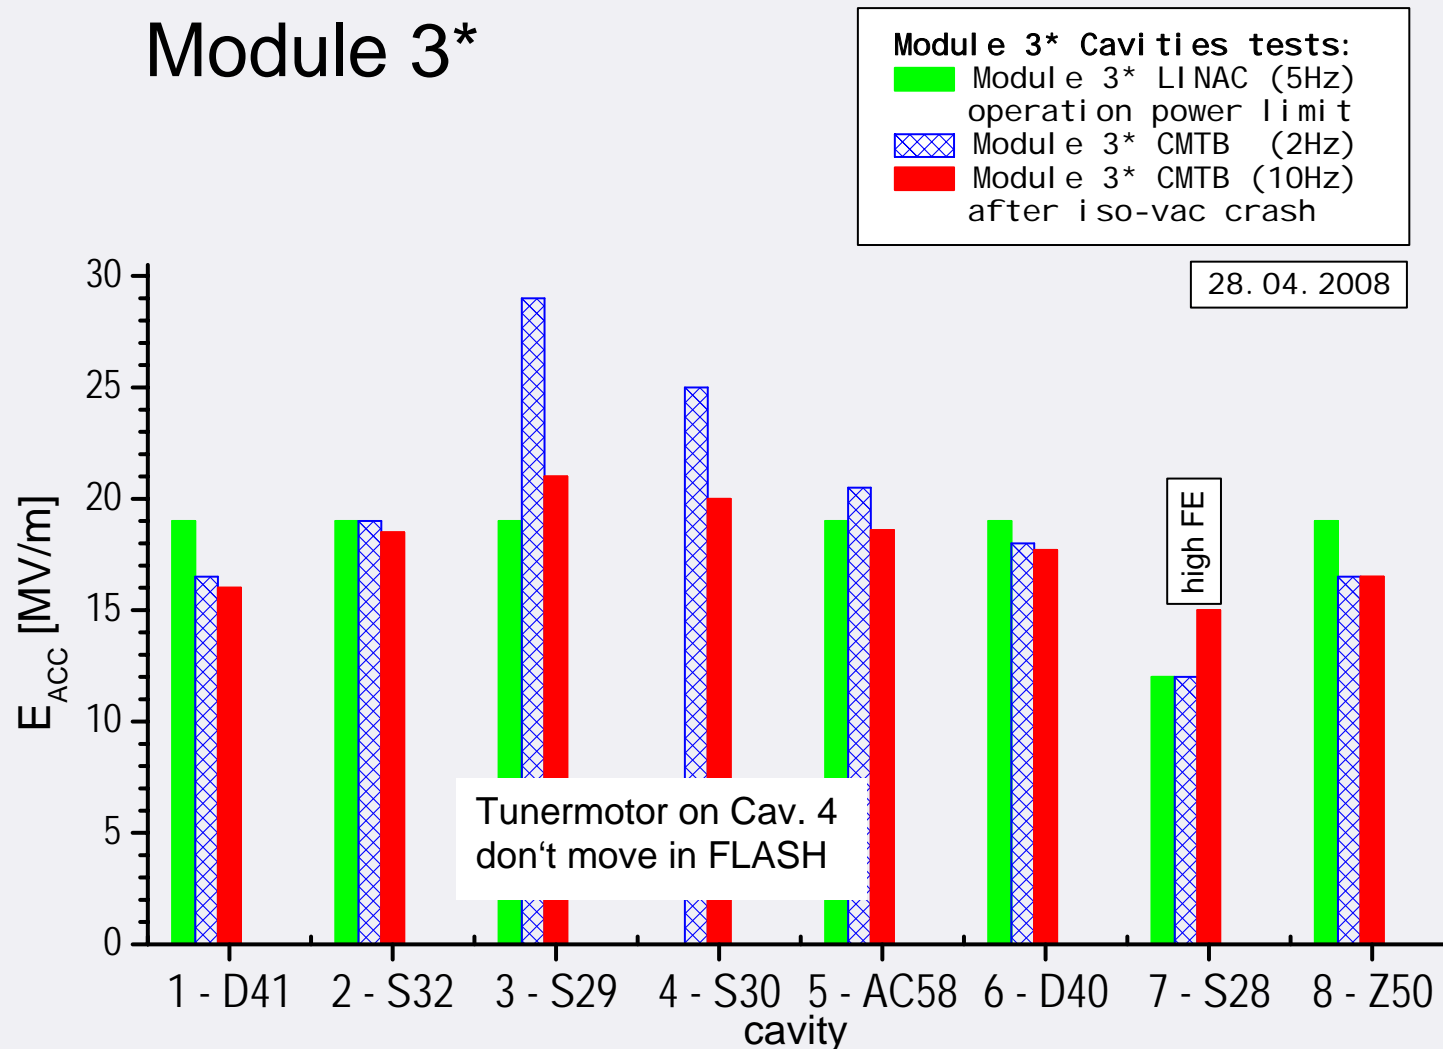
Last but not least: module 3* performance after Iso.-Vac venting

Module 3*
